## Flat A, 1 New Square, Lincoln's Inn

Works to compartment walls.

AMENDED DESIGN AND ACCESS STATEMENT

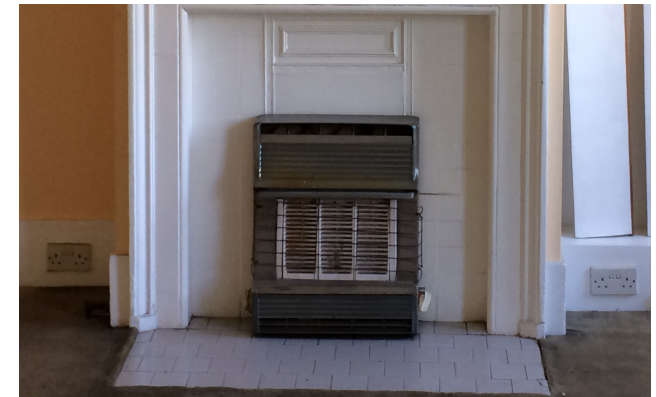
Reception Fireplace

An asbestos survey revealed asbestos lining behind the fireplace. For health and safety reasons this lining has since been removed. The style of the fireplace appliance, gas connection and the asbestos lining indicates that the fireplace is not an original feature of the Flat. The painted bookshelves are also not an original feature of the early 18th century Flat.

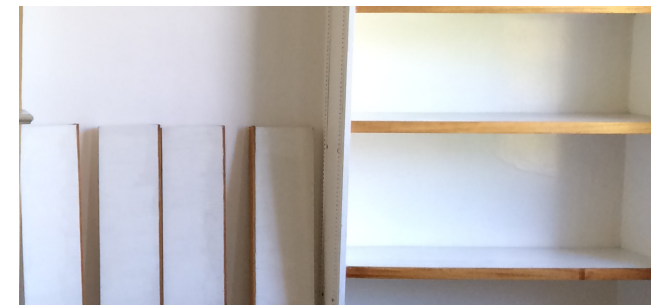
Reception Book Shelves

A review of the metal brackets that support the shelves indicated that they were a late 20th century addition of no historical interest.

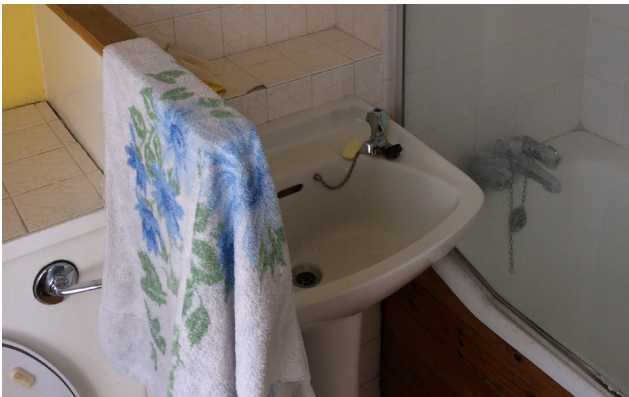
Bedroom 1 En-suite

This is the main bedroom that includes the only bathroom within the Flat. The built-in wardrobe is in a good condition, however due to the arrangement and construction it is certain that the wardrobe is not an original feature. The en-suite requires complete replacement.

Whilst the fittings are just still functional, the 1970's bath is stained and unsanitary in appearance. There are major repair works required to waterproof it and ensure that it does not cause any water damage to the Flat itself, or the adjoining office space.

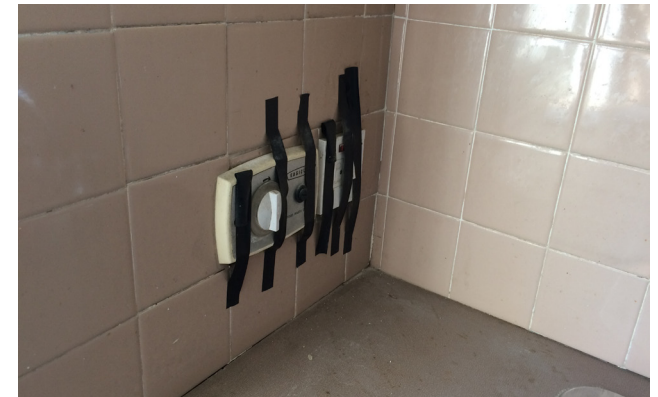
Kitchen Switches

The electrical switches and sockets are dated and poorly maintained and are a cause for safety concern and even more so because various switches had been taped by the previous occupant(s). The kitchen units are broken and beyond repair. The flooring is damaged and heavily worn to the structural floor boards above the joists. There are also signs of water damage from spillages. The remainders of the appliances are just barely functional but there is no evidence that they have been fully maintained.

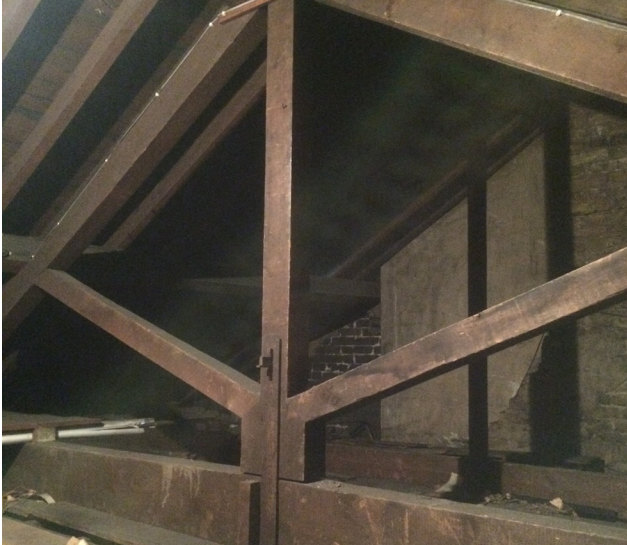
**Roof Truss**

As previously stated the Flat was refitted *circa* 1970's, thereby removing most of any original timber decor that may have existed, although this may actually have been removed even before the 1970's. The only remaining original features are the architraves around the windows and the roof trusses. The differing door heights and differing construction of the partitions indicate that not all of the internal walls are original.

The loft space above is partially boarded and was previously used as storage. The roof structure is currently made up of trusses and cut rafters, leaving plenty of room for storage. The loft space also provides access onto the roof for maintenance through another hatch and has adequate lighting.

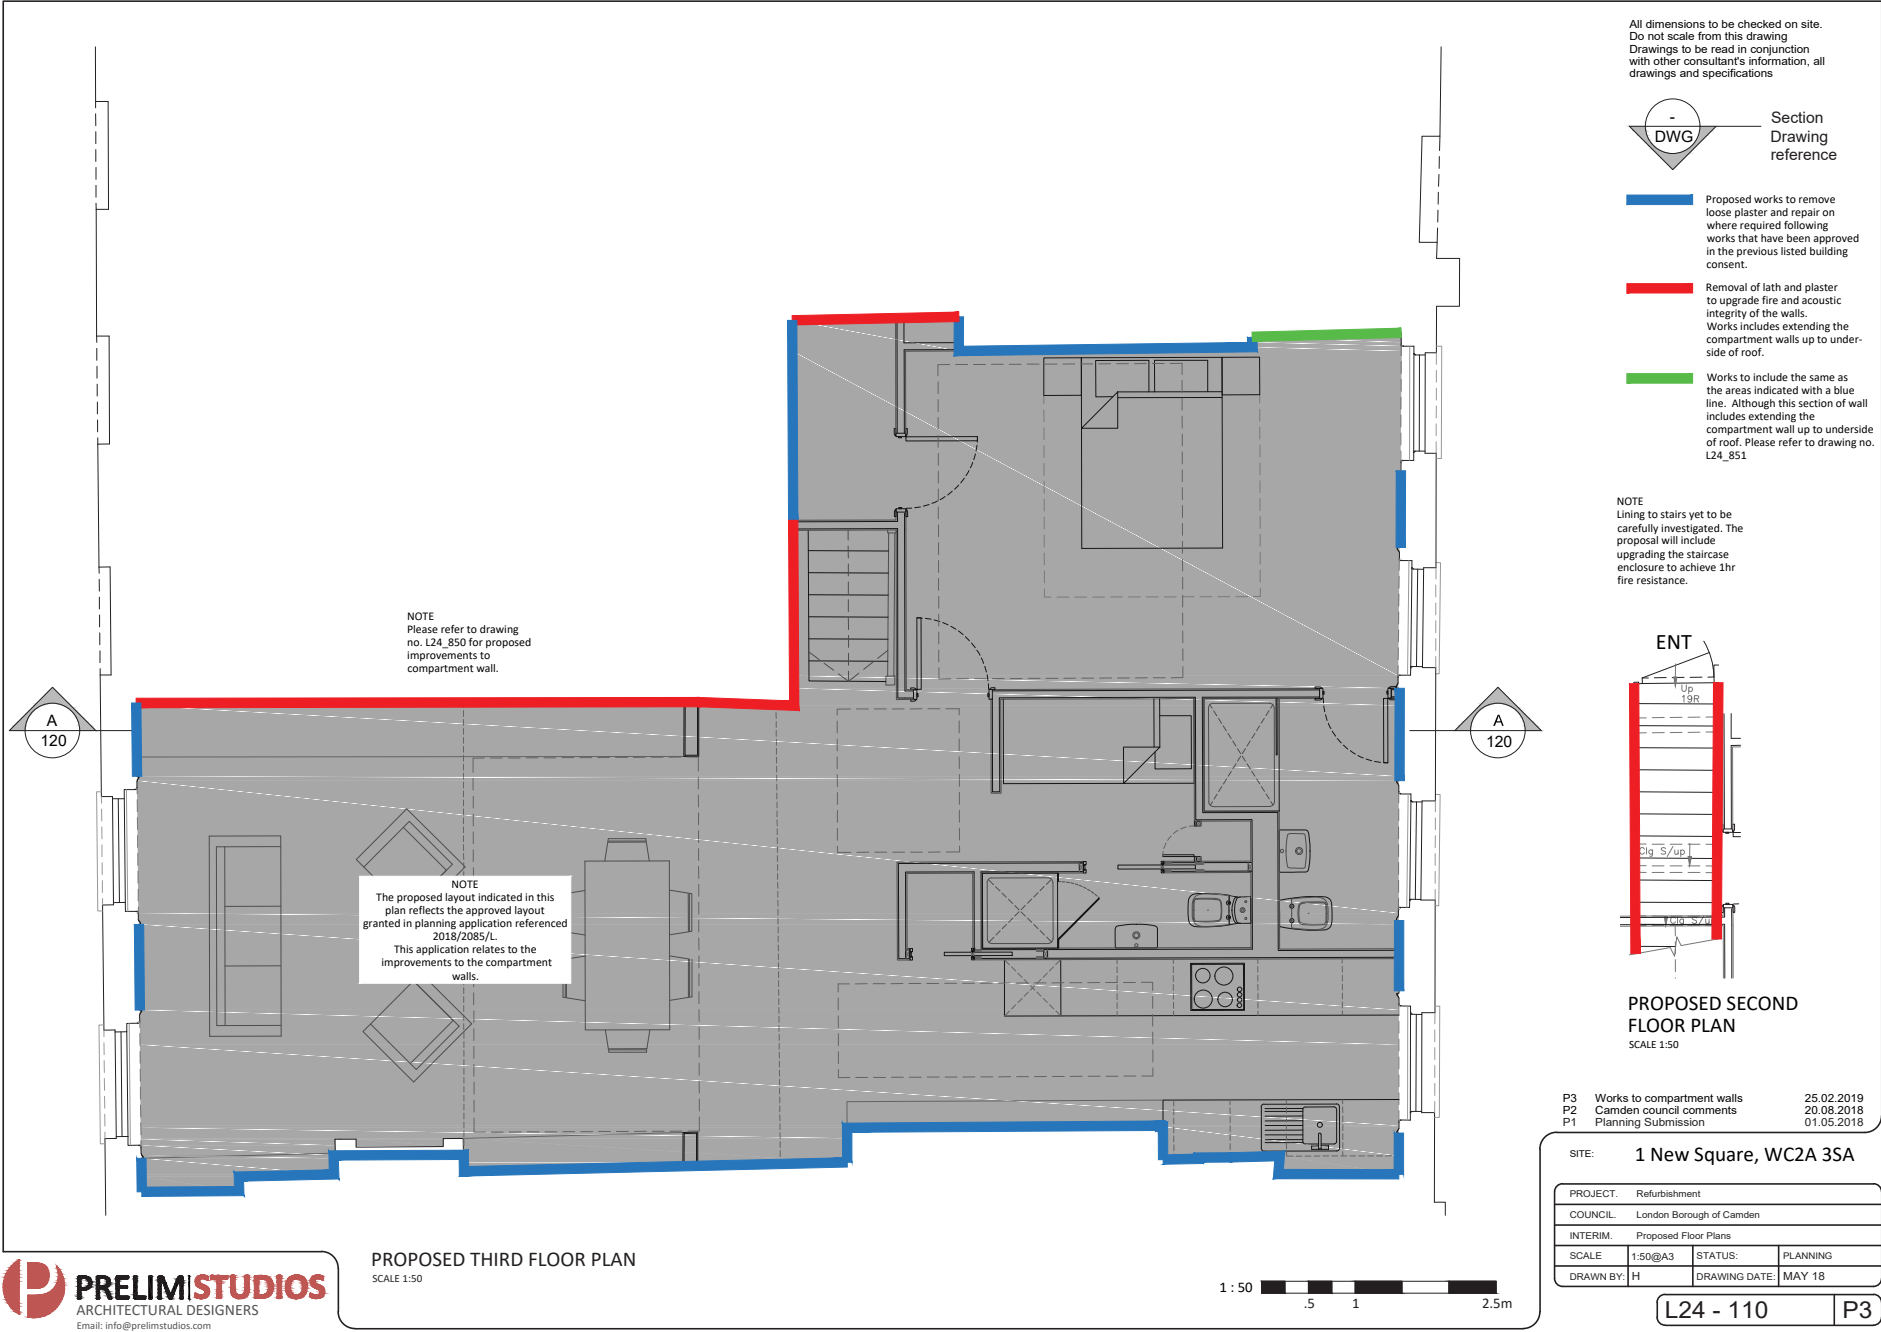
3.00 Proposed Floor Plan

The floor plan included in this application demonstrates our proposal to remove the lath and plaster from one side of the compartment walls and to replace it with insulation and fire-rated plasterboard lining. Where required, the compartment walls will be extended to the underside of the roof to ensure continuity of the compartment wall and to avoid flames from spreading through the loft void. The proposal also includes removing the plaster to perimeter walls where required to repair and/or renew the finishes that are damaged or in need of refurbishment.

The extent of the works required in order to upgrade the compartment walls is now determined following a series of intrusive investigations. The floor plan accompanying the application indicates the compartment walls that require upgrading.
