Keats House

Conservation Management Plan

First Draft_31st March 2017

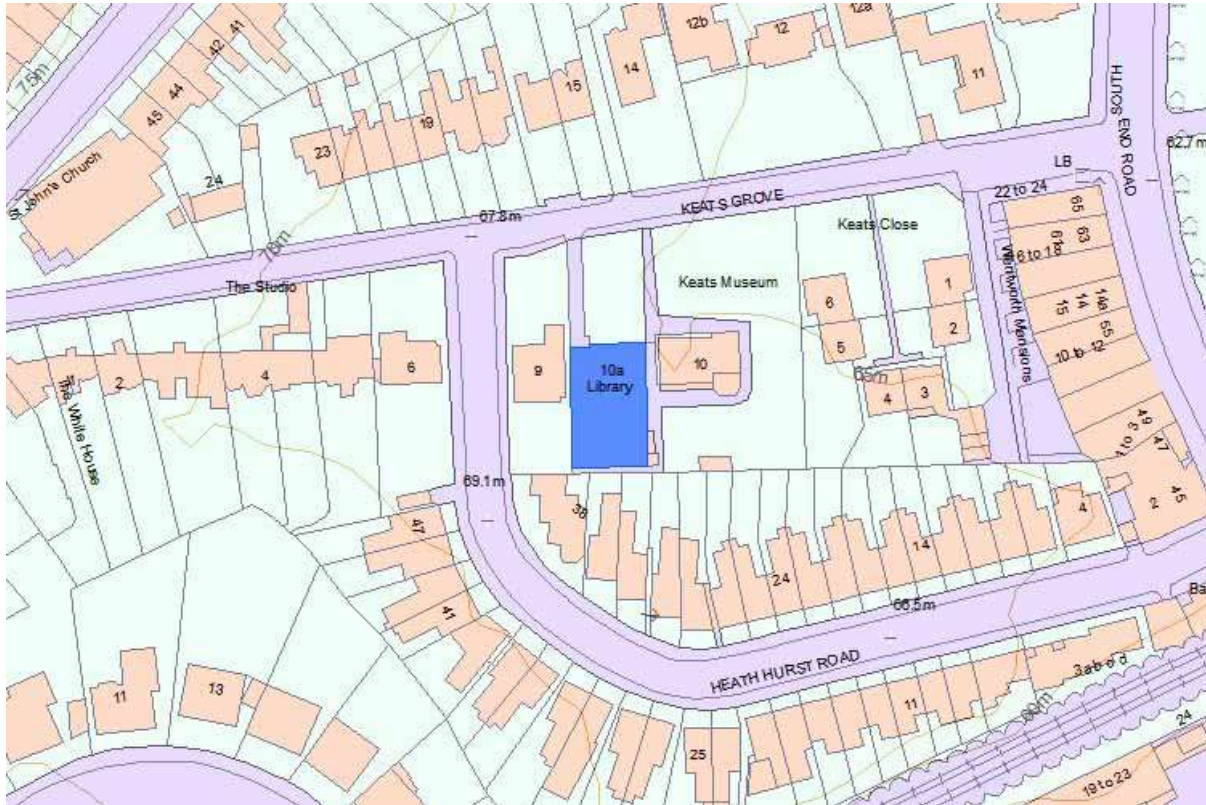
Plate One

Current site plan

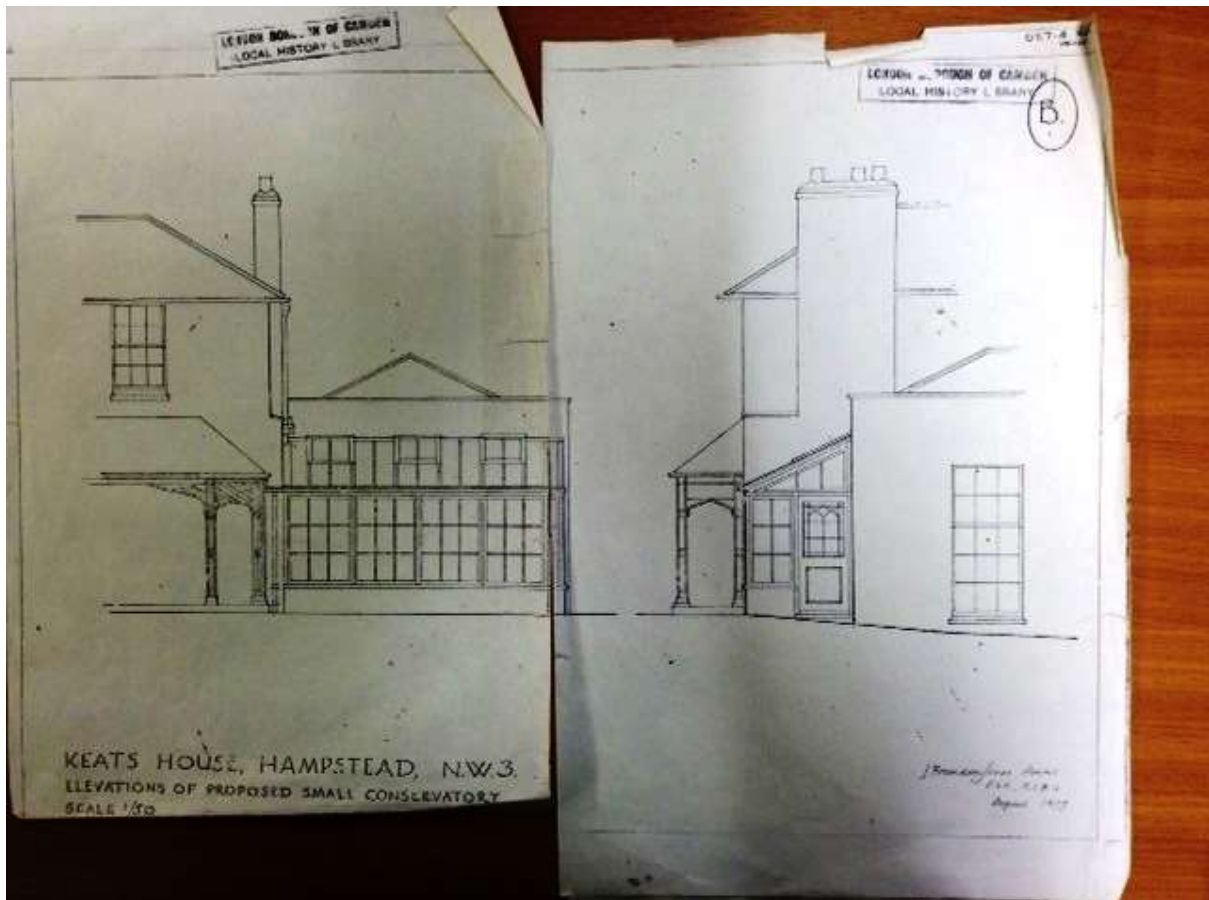
Plate Nine

Conservatory Proposals 1979

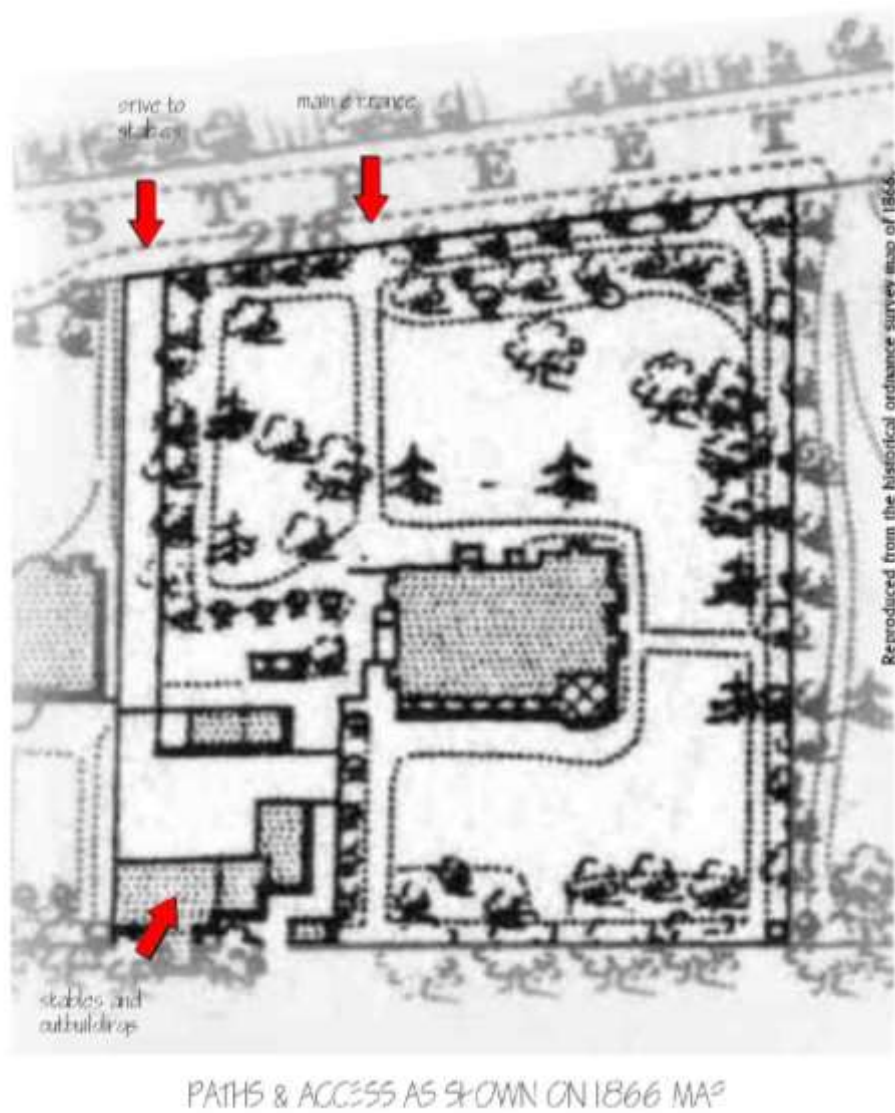
Plate Eleven

Investigation of garden paths layout based on 1866 layout

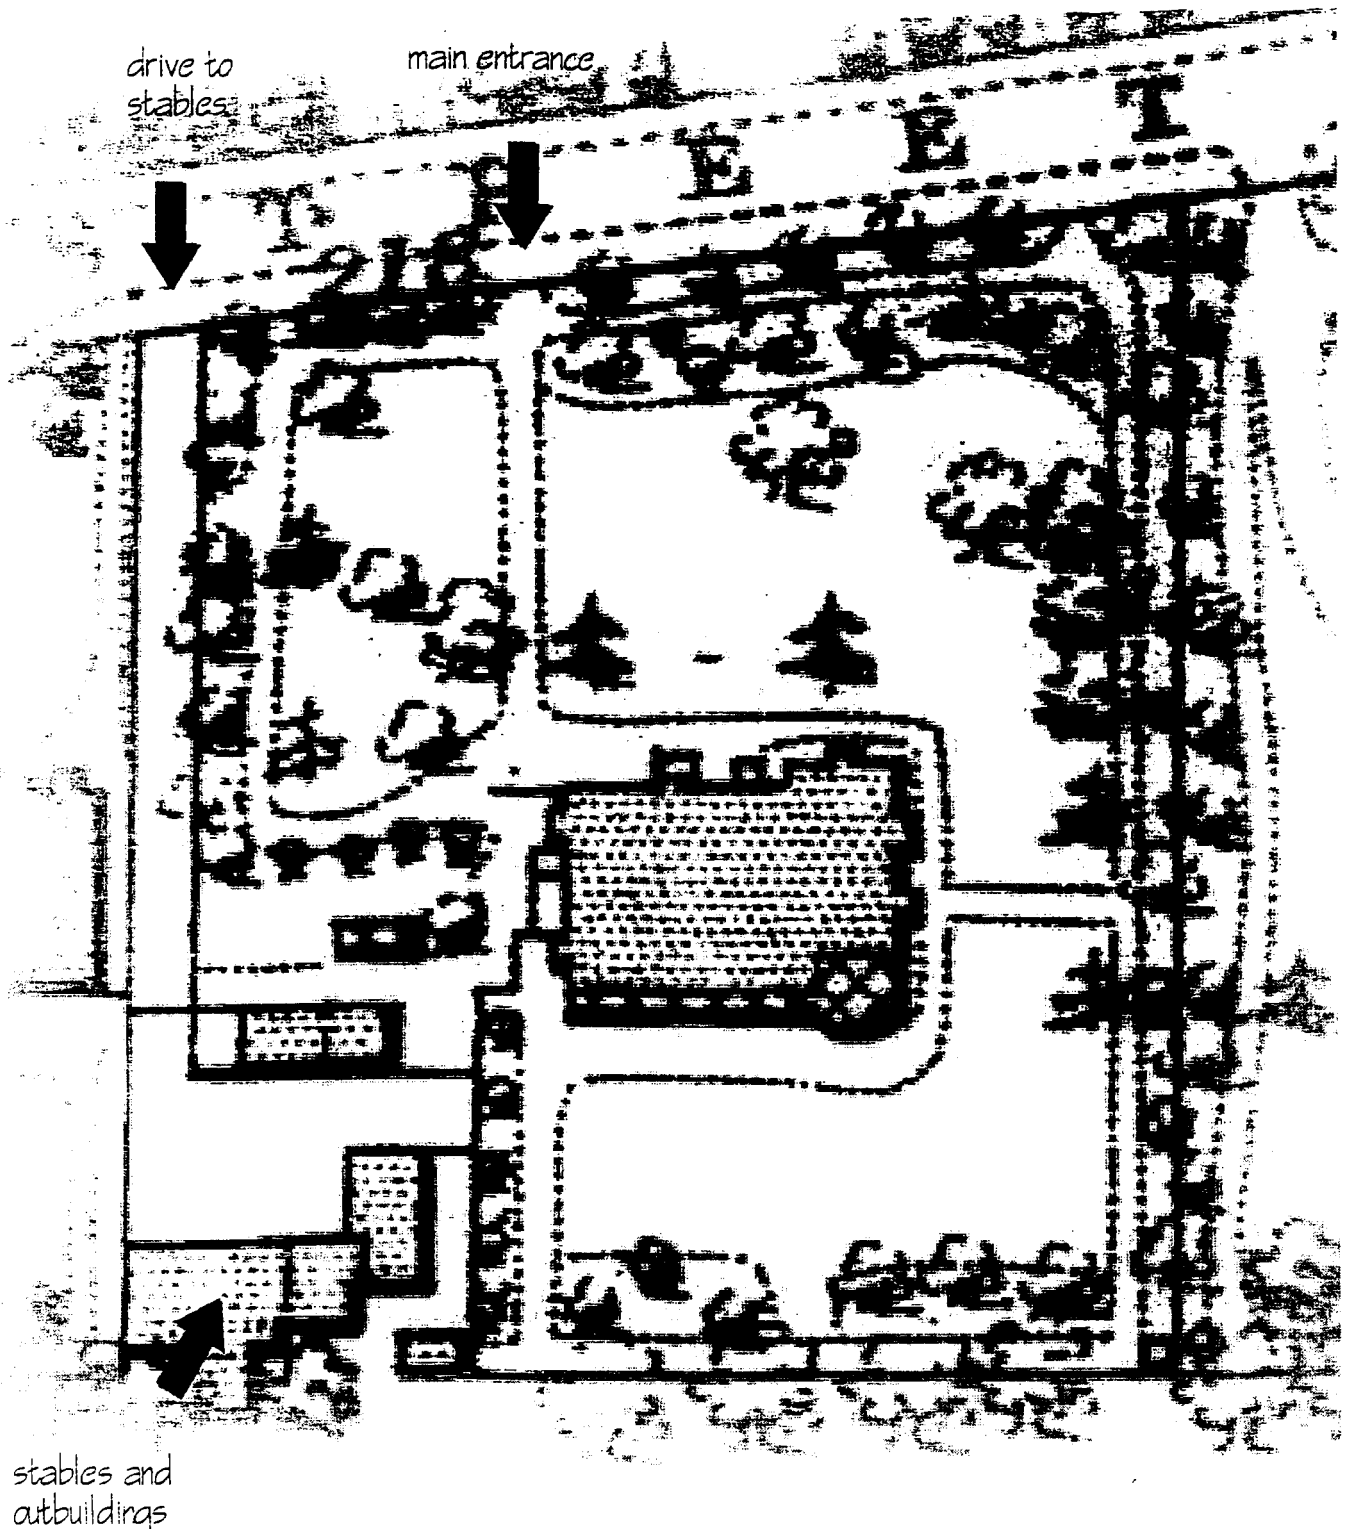
KEATS HOUSE
PATHS & ACCESS AS SHOWN ON 1866 MAP

Fig.1 Ordnance Survey plan of 1866 redrawn by the client for the purpose of this report

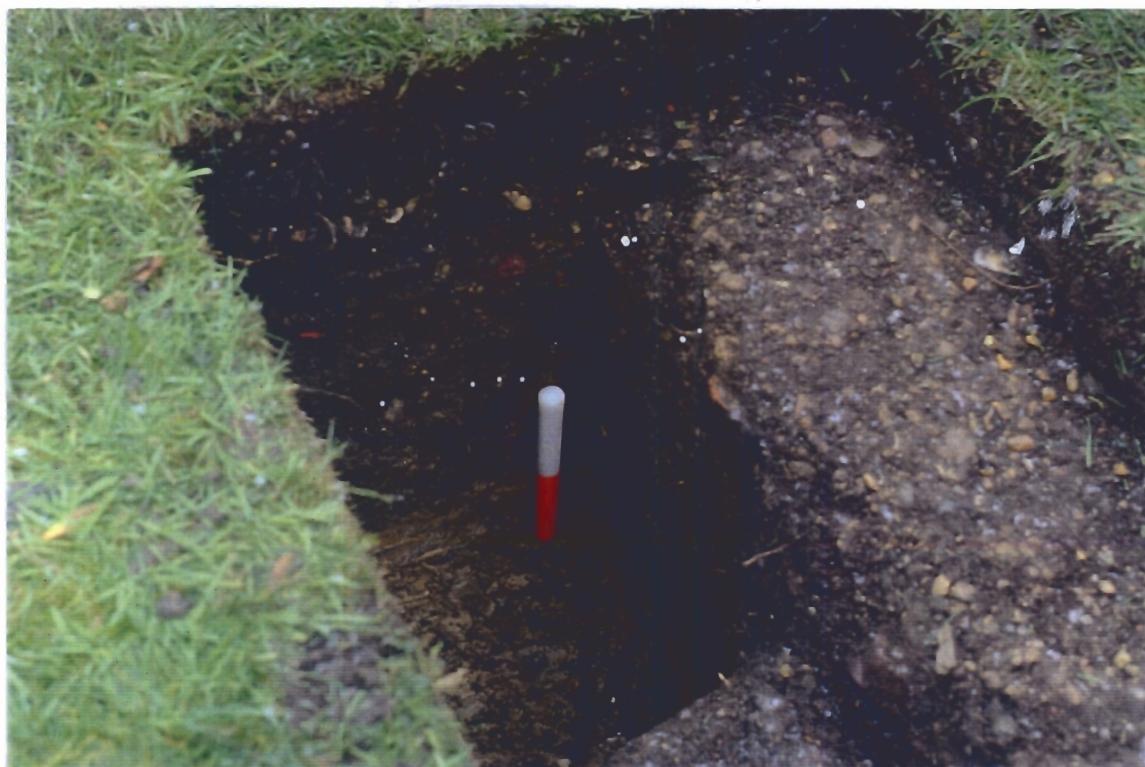
Fig. 5 Trench1. View of slot dug at south end of trench, looking to the south-west.

The excavation and probing identified what was probably a path running east/west path c2.5m wide and c0.16m in depth, the southern edge of the path being c1.2m to the south of the southern edge of trench 1. A base for the path, (c0.2m in depth), had been made by filling a cut with rubble. Remains of a similar nature recorded in trench 2 indicated that, c 8.5m to the east of the house, the east/west path joined up with a path running north/south. There was no evidence to suggest that the path had been resurfaced, redressed or that it gradually went out of use. It would appear that it was still in use immediately before being covered over with topsoil and turf.

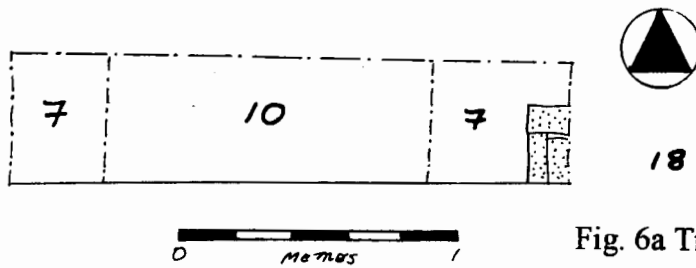
Fig. 6a Trench 2, excavated plan

The gravel path surface [10] clearly formed a continuation of that in Trench 1 [2], although it also turned a corner to the north (fig.6a). This corner evidently represents the junction of east-west and north-south paths which is shown on historic plans.

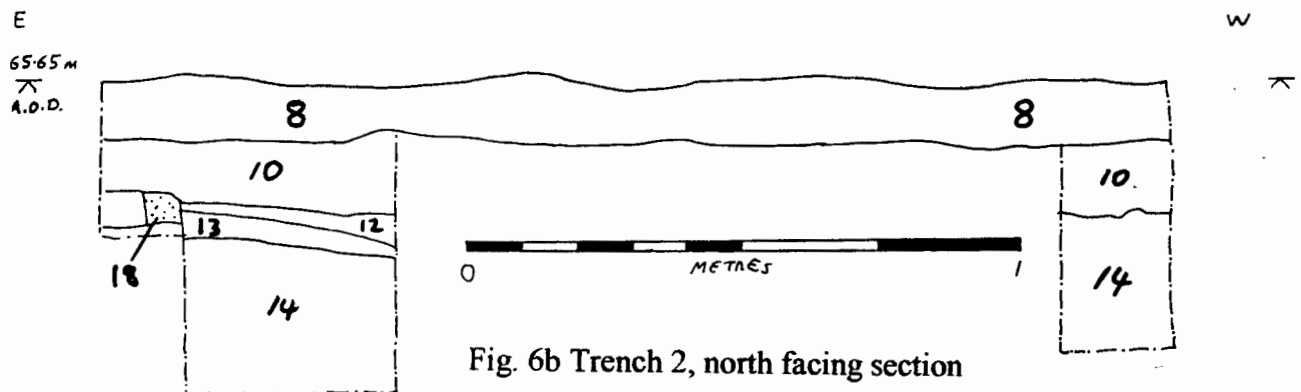
Fig. 6b Trench 2, north facing section

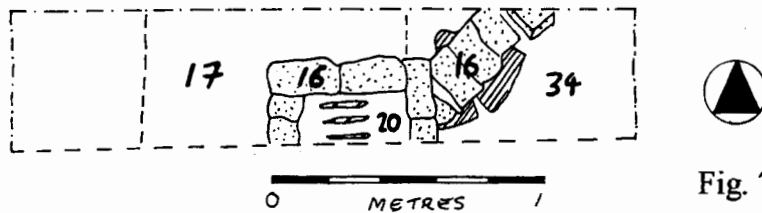
Fig. 7a Trench 3, excavated plan.

The natural clay in Trench 3 was overlaid to the west by disturbed or made ground [17] and to the east by a probable path construction [34], [33] and [15]. The latter possibly represent the western edge of the north-south path shown on historic plans.

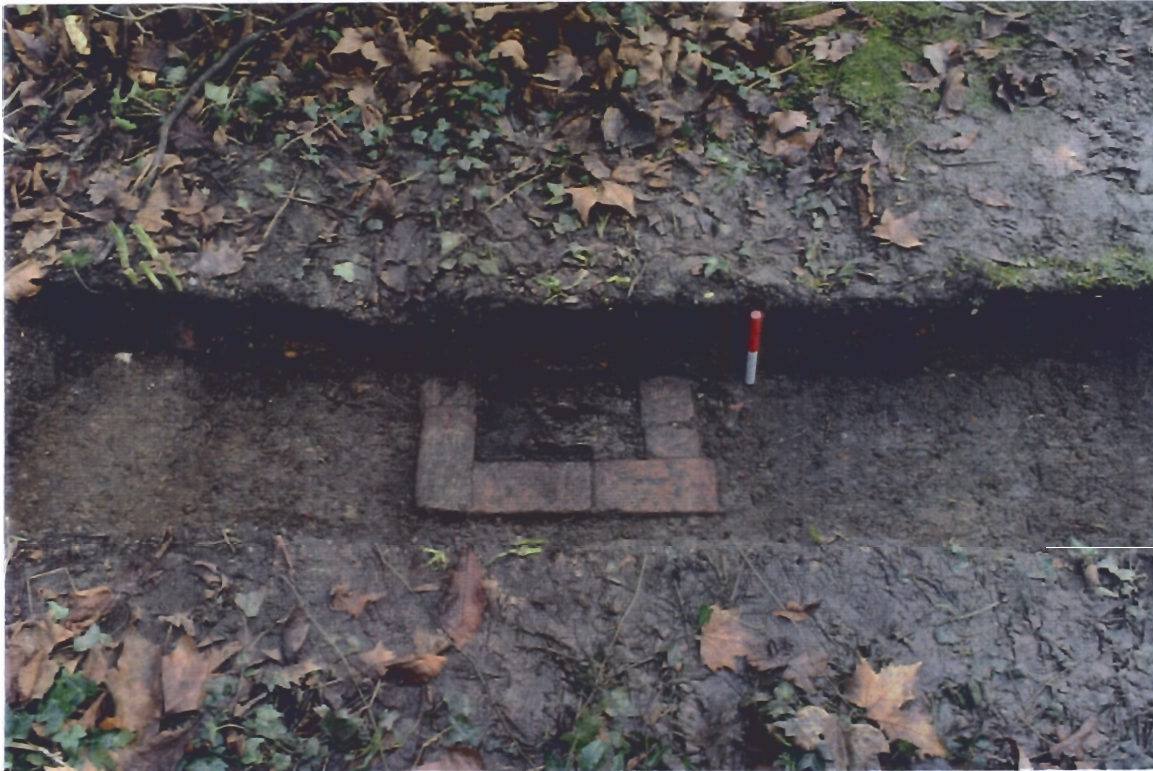
Fig. 8 Trench 3 showing the drain prior to full excavation . Looking to the south

Although the drain or soak away was of a similar construction to the drain recorded in trench 2 the slate detail was unique to trench 3. It is possible that the upright slates acted as a trap for debris, which would have otherwise blocked the outflow.

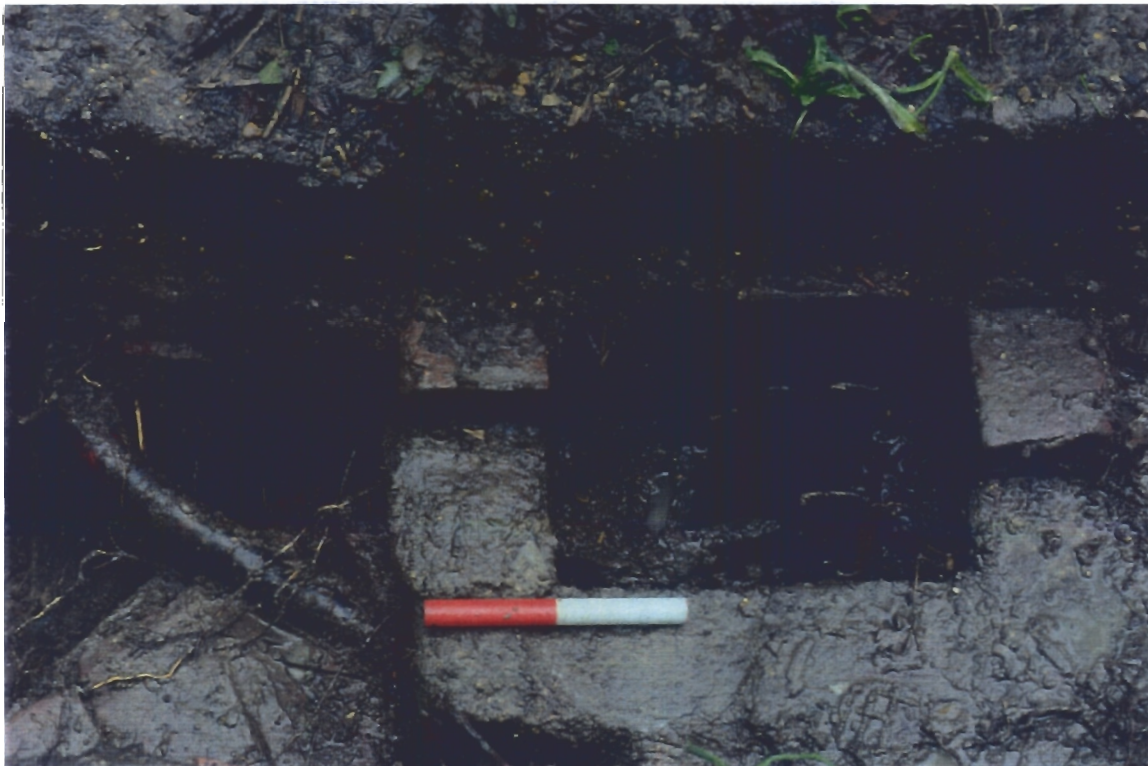
Fig. 9 Trench 3. The drain partially excavated showing slate detail. Looking to the south

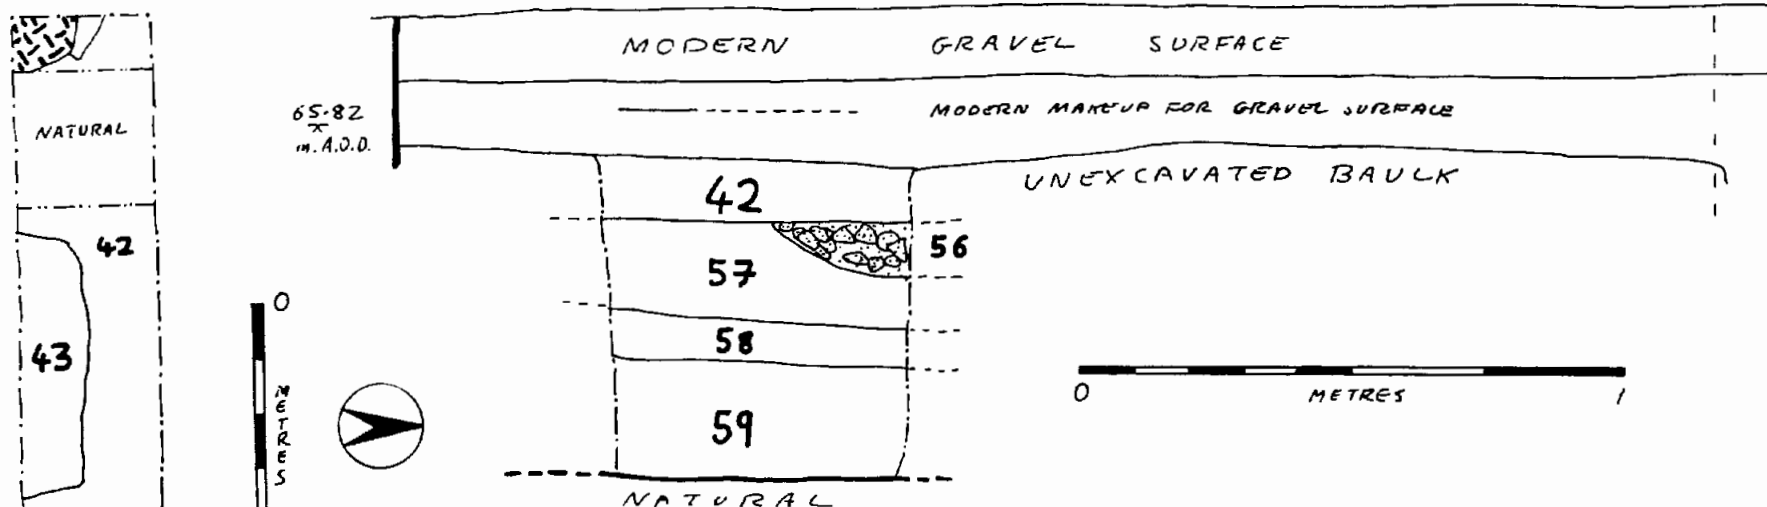
Fig.13b Trench 7, west facing section (northern part)

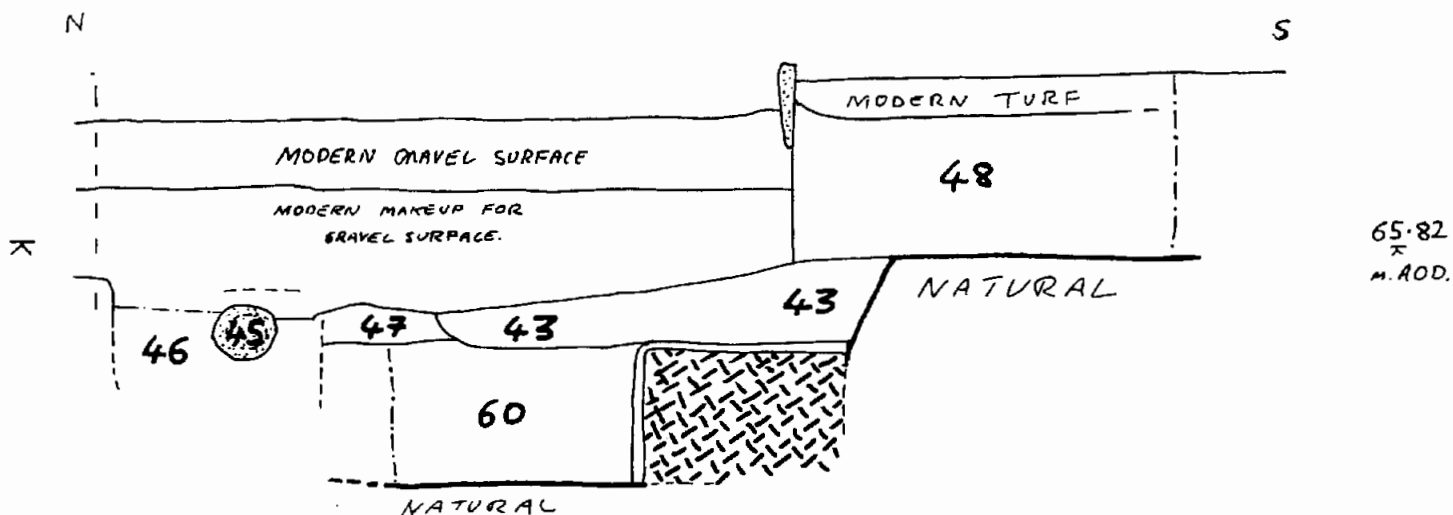
Fig.13c Trench 7 west facing section (southern part)

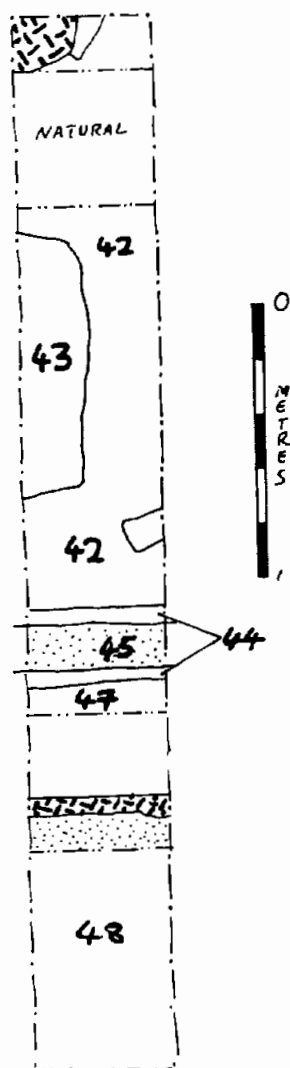
Fig.13a Trench 7, excavated plan

The natural clay within Trench 7 was truncated, at least to the north, and was directly overlain by deposits [59] and [60]. These contexts appear to form parts of contiguous layer, quite possibly dating from the time of the house construction.

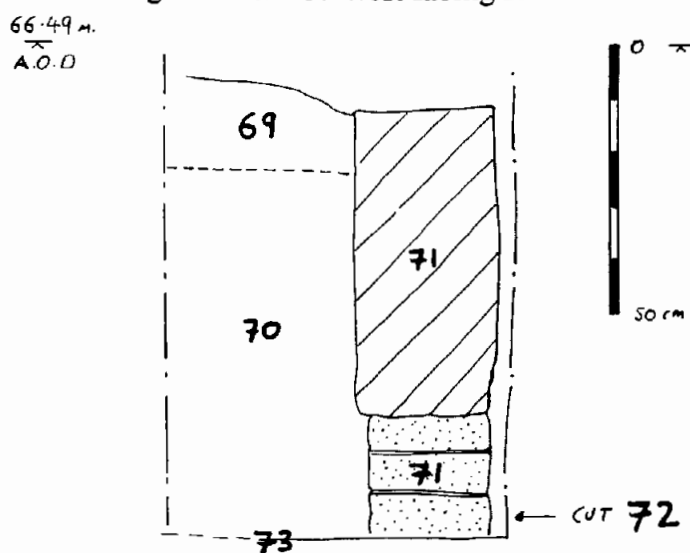
Fig. 15 Trench 9 west facing section

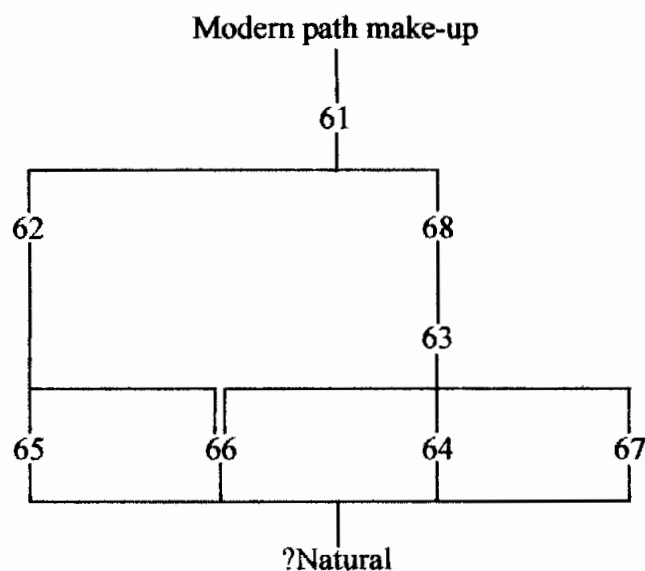
4.10.2 Matrix to show stratigraphic relationship of contexts

Context no.	Description	Interpretation
61	Dark brown sandy silt with scattered pebbles and brick frags.	?Redeposited garden soil: levelling for modern path over
62	Mid-dark brown sandy clay and building rubble	Deposit inside former conservatory – ?demolition backfill
63	Dark grey-brown clay	Deposit outside conservatory – ?construction backfill
64	Fe bar running SW-NE	Iron lintel (removed)
65	Fe frame on line of conservatory wall	Top of iron frame of firebox for small stove.
66	Mortared brickwork	Foundation at SE corner of former conservatory
67	Mortared brickwork running NW-SE	Drain, bonded to north into conservatory wall & [64]
68	Mortar layer	Localised deposit over [63]

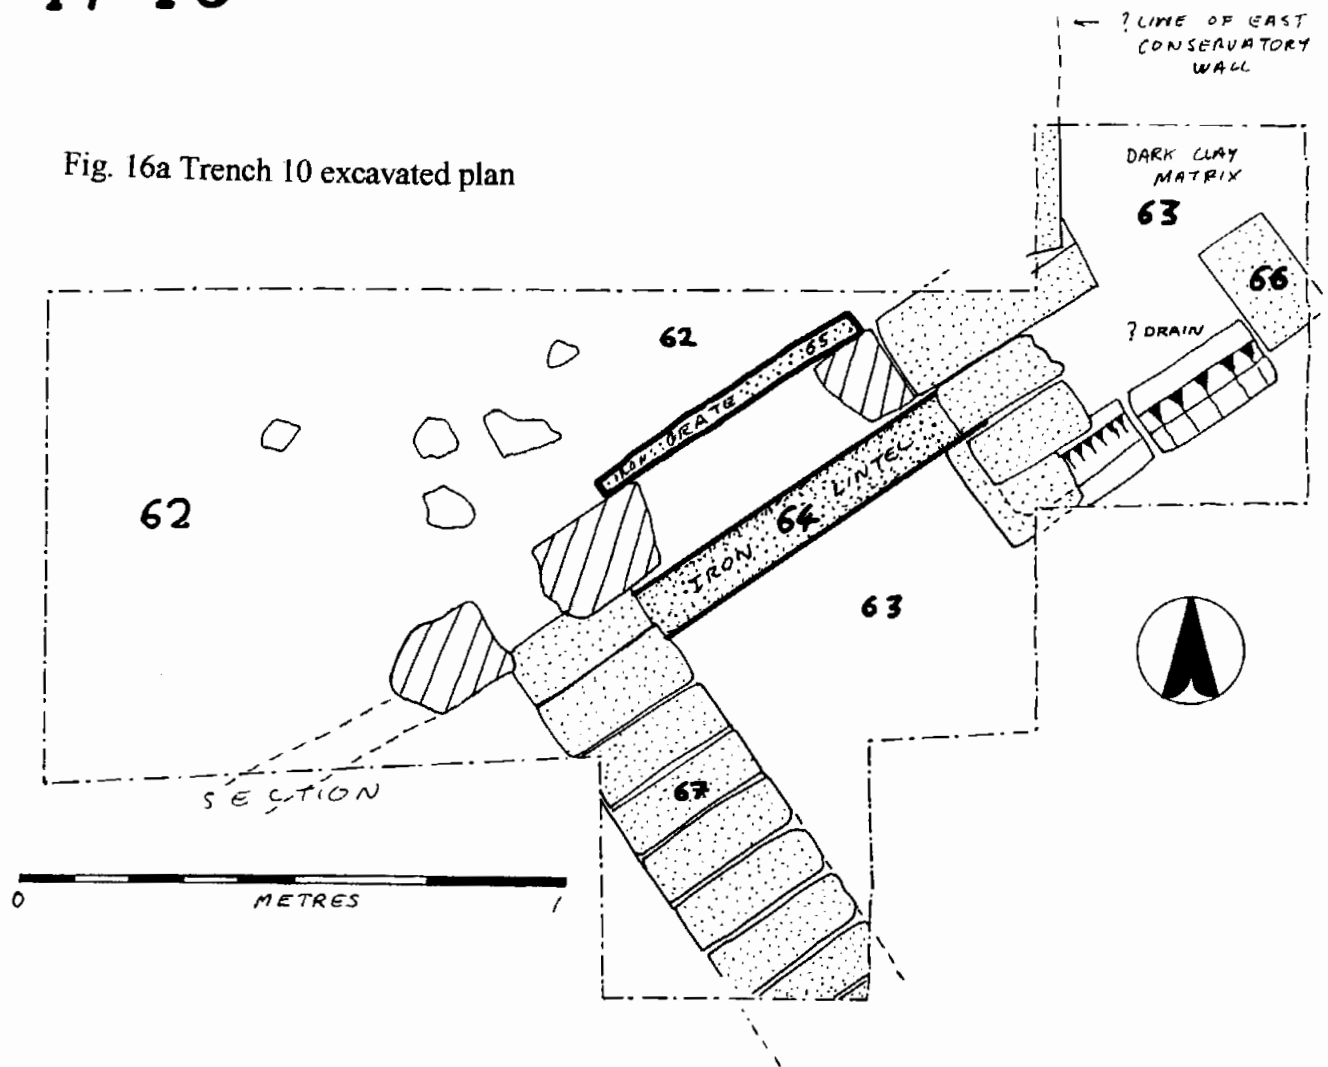
Fig. 16a Trench 10 excavated plan

A brick wall foundation [66] crossed the trench roughly south-east to north-west; A line of parallel brickwork [67] was set c1.3m to the west. An iron bar [64] was laid between [66] and [67]. Situated c0.4m to the northwest of [64] was an iron frame [65] within which were five fire bars. Near the north-eastern end of [66] there appeared to be a northward return on the line of the present east-facing conservatory wall. Brick rubble and other demolition debris covered fragmentary foundations to the south. Features [66] and [67] were abutted by a clay deposit [63], which may represent construction backfill.

4.10 Trench 10 (Fig. 16a; 16b; 17; 18)

Rather than recording the corner foundations of the demolished conservatory the excavation appeared to have exposed the stock hole for a small stove which had been made in the south-east corner. A c9" wall (c22ms), [67], ran for an indeterminate length to the south-west of the firebox, and possibly supported steps leading down from ground level. The iron lintel [64] provided support for brickwork above the firebox. Fragmentary evidence for the foundations of the conservatory were recorded; the southern wall to the west of [67], and the eastern wall to the north of [66].
