PLANNING & LISTED BUILDING APPLICATION FOR

113 ALBERT STREET
NW1 7NB

Rev. B
18/03/19

BEN SMITH ARCHITECTURE
106 Grand Union Studios, 332 Ladbrooke Grove, W10 5AD
t: 020 3735 5205 | e: mail@bensmitharchitecture.com | w: bensmitharchitecture.com

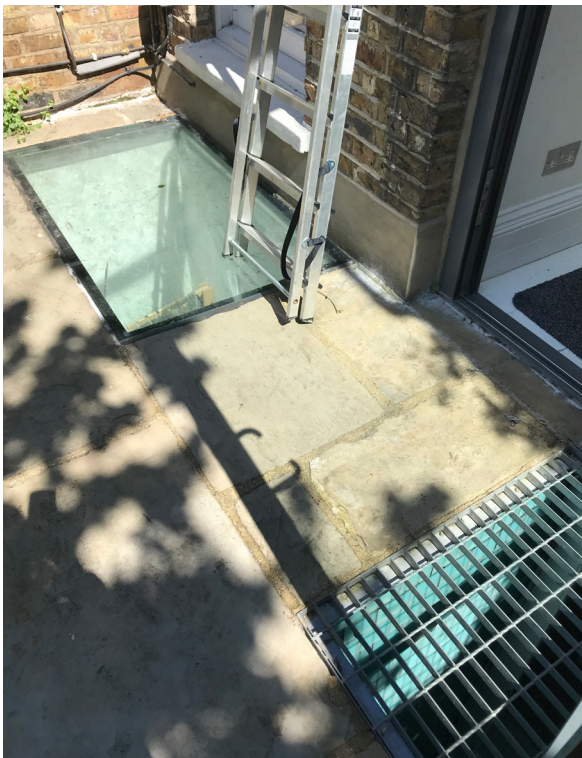
Existing rooflight and gridded lightwell cover

- one covered by a metal grille, directly outside the bi-folding doors at ground floor level that lead from the dining room into the garden
- one with a walk-on rooflight that leads to a storage room under the rear terrace.

This current configuration results in two separate small lightwells, which are not practical nor do they maximise natural daylight into the room. The metal grille located directly in front of the doors onto the terrace is in the area with heaviest footfall and makes for both an impractical and uncomfortable transition.

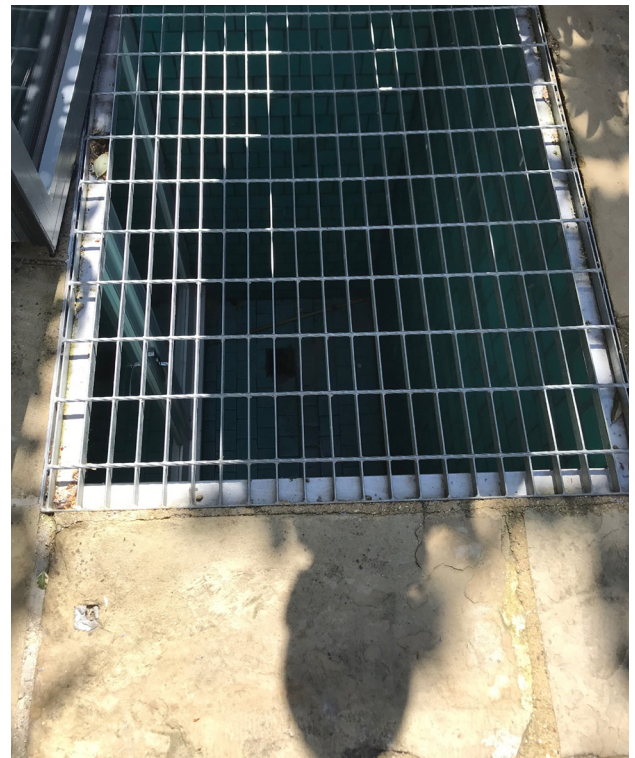
Lightwell grille cover directly outside main access to garden

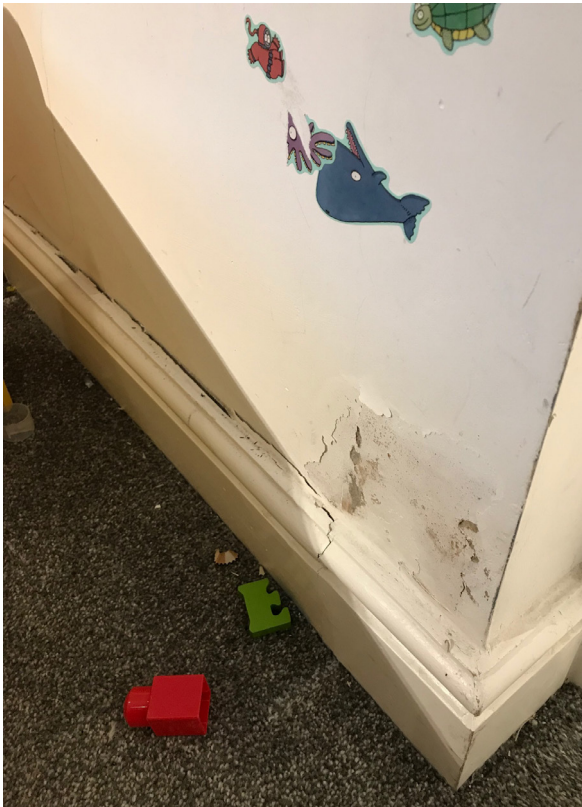
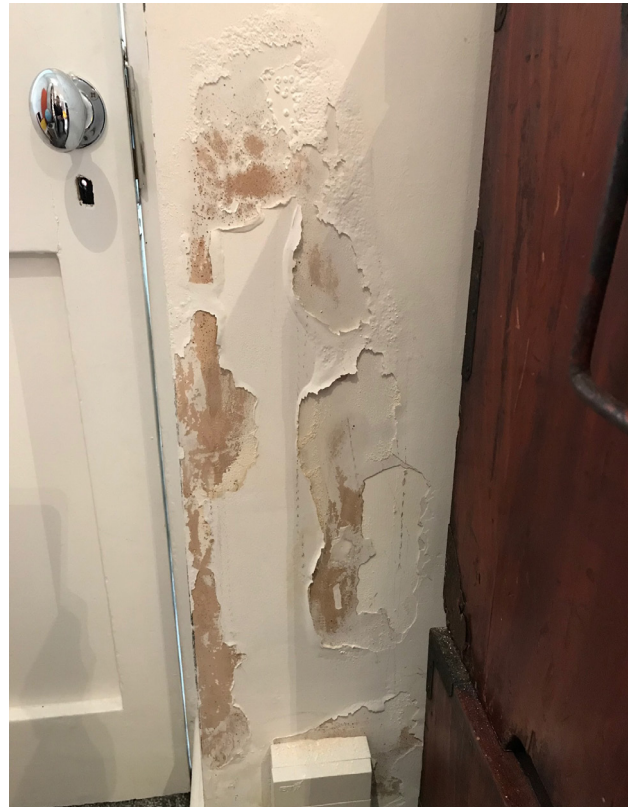
Existing damage to walls and timber-work in the front room onto the lightwell

The existing damage to the lower ground floor front room onto the lightwell is at the point where the original facade, at low level, allows water ingress into the building.

This has caused water to flow into the masonry and through the structure, and as a result the interior plaster and decorative finishes (including skirtings and architraves) are stained and damaged.

As part of the application we propose installing a ventilated dry-lining system. This requires minimal removal of the existing damaged wall lining and skirting, but allows us to install a studded waterproofing membrane and create a vented gap to allow the existing masonry to dry, and prevent damp from reaching the plasterboard and timber details.

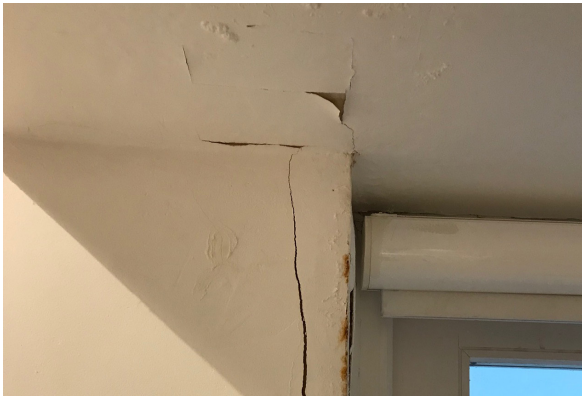
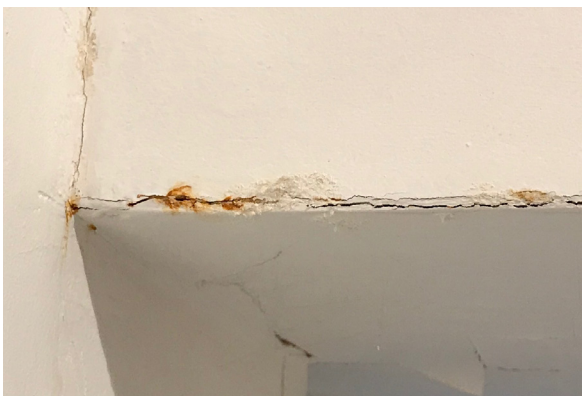
Top & bottom: water ingress into the room from above

- The current failing detailing around the lightwell, which allows water to flow through the masonry and structure into the bedroom below;
- Insufficient falls on the ground floor garden paving, which means water can collect against the rear facade; and
- The failing waterproofing system applied on the garden retaining wall in the lightwell, which is causing the wall tiles to bulge.

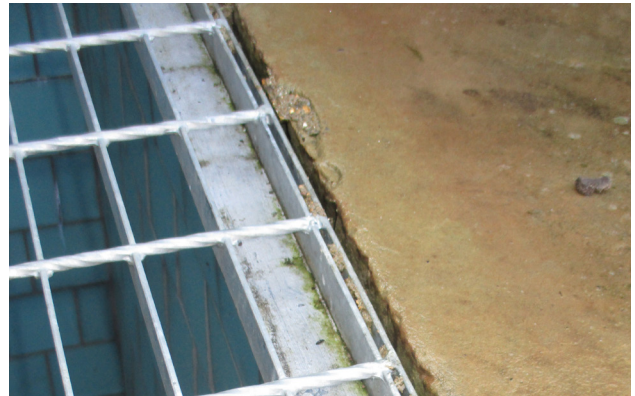
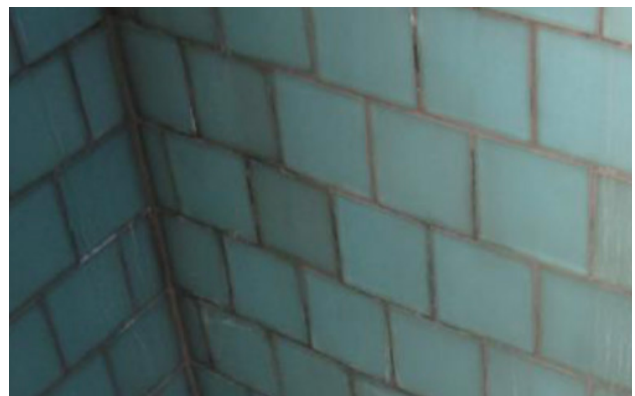
Top: Weak waterproofing point around metal grille over rear lightwell
Bottom: Bulging wall tiles in the lightwell from water pressure buildup beneath the garden

As part of the works to connect both rear lightwells, the level of the rear terrace at ground floor level will be retained, but the surface drainage would be improved to avoid water stagnating at the base of the elevation, and ensuring the surface water drains towards the rear garden instead. The new rooflights will be adequately detailed to create a safe waterproofing connection between the ground and lower ground floors, and the lightwell retaining wall itself would be treated with a lime render that allows moisture building up below the garden to evaporate through and avoid damp buildip.

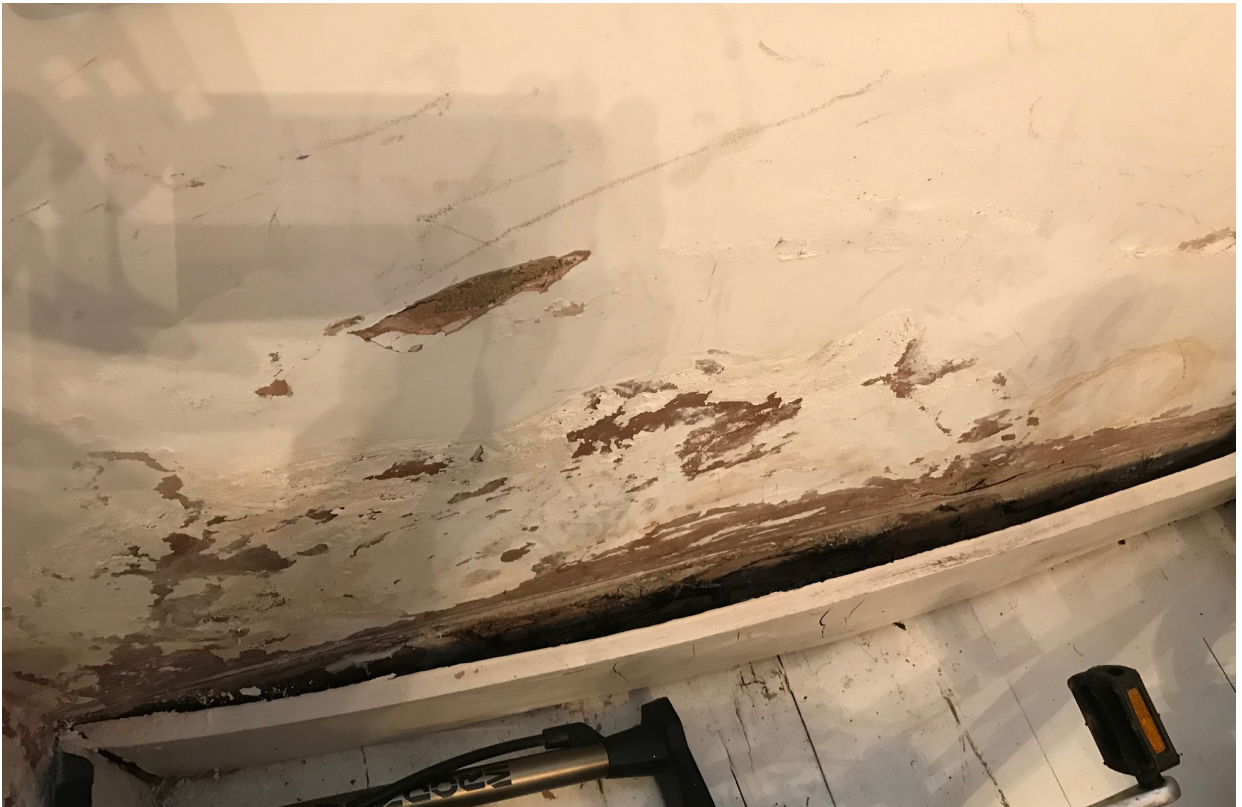
Damp damage in the cloakroom extends to the wall lining, floor finish and timberwork

As described above, the rear terrace at ground floor level currently allows water to fall towards the building and stagnate against the rear elevation. This has caused severe damp issues in the ground floor cloakroom extension (as can be seen in the photo below).

Creating slight falls in the terrace towards the garden as described above will prevent the main cause of water ingress. To mitigate any potential further damage, the works propose to clear away the damaged timber and plasterwork as required, and apply a studded waterproofing membrane up to dado-rail height only, and installing a half-height (up to dado rail) timber panelling around the room, isolated from the masonry wall. This would allow the timber to be physically separated from the walls to prevent damage, and at the same time create a vented cavity that allows the existing masonry to dry.

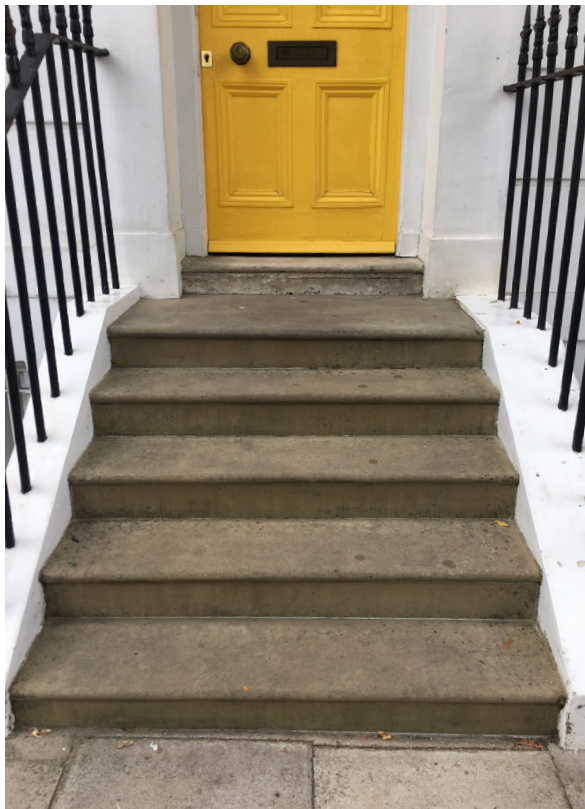
New proposed steps to raised ground floor to be clad in Portland stone to match neighbouring properties

The main access into the (raised) ground floor is via a series of steps up from street level. This arrangement is repeated along the terrace group of buildings, although the finish and treatment of these differs amongst the properties. In the case of 113 Albert Street, the steps are coated in a bituminous treatment that, as can be seen in the appended damp investigation report, shows signs of damp damage. As part of the works we propose to strip back the existing damaged asphalt and repave the treads and risers in York stone, with bull-nosed edges to the treads, to match neighbouring properties, such as no. 115. This will help enhance the overall appearance of the main access, and the terrace group in general.

The process of removing the existing asphalt may reveal the original, damaged York stone steps below. The ultimate aim is to end up with re-paved stone steps, replicating the original, and if in order to achieve this it is necessary to remove the damaged original stone and recondition the substrate to take the new stone (like-for-like) replacement, this will be carried out in a diligent and respectful manner with the Listed nature of the building.

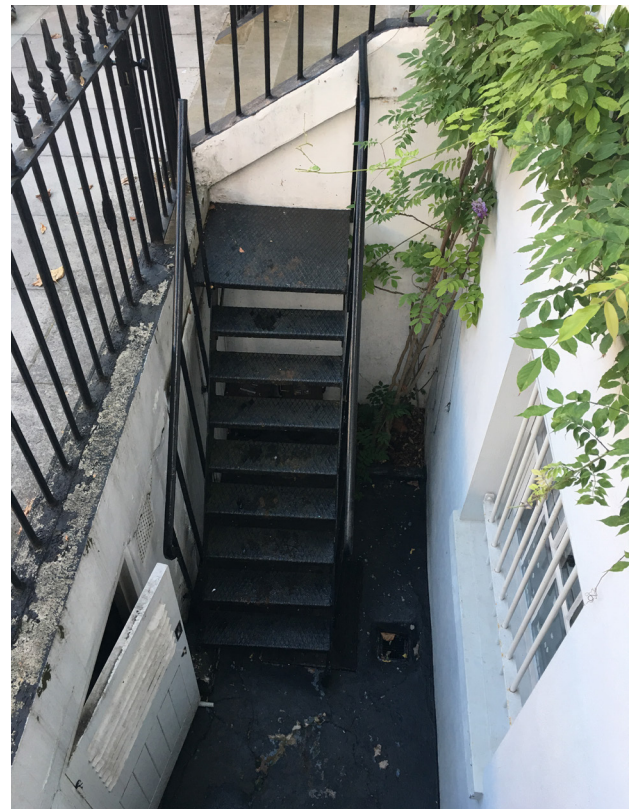
Existing steep, slippery and narrow stairs leading to front lightwell

The property has a secondary entrance via the front lightwell into the lower ground floor area. This is accessed through the railings and gate that run the length of the terrace (subsidiary feature of the Listing), and down a steep cast iron staircase.

The gate itself is only approximately 650mm wide, and the stair is not only steep but also slippery due to water collecting on the treads. The rubbish and recycling is stored in the front lightwell, away from clear view from the street, and the narrow steps therefore serve as the only route for the waste disposal removal. The current configuration with narrow, steep, slippery steps, and a narrow gate onto the street, makes maneuvering even the smallest of the council's recycling bins up to street level a hazardous activity.

To remedy this we propose to widen the existing (non-original) gate by a single finial to achieve a more comfortable (approx.) 700mm wide opening. We would then also replace the current impractical stair with a new cast iron one, in the style of the existing, but with a consistent, more gentle pitch and perforated treads (to avoid stagnating water) for ease of use. We have been liaising with a specialist metalworker to ensure we can achieve a finish for both railings/gate and stair that respect the history and fabric of the building to preserve the consistent style of the building and rest of the terrace group.
