DAYLIGHT, SUNLIGHT & OVERSHADOWING

77 Avenue Road

Produced by XCO2 for Montagu Evans

March 2018

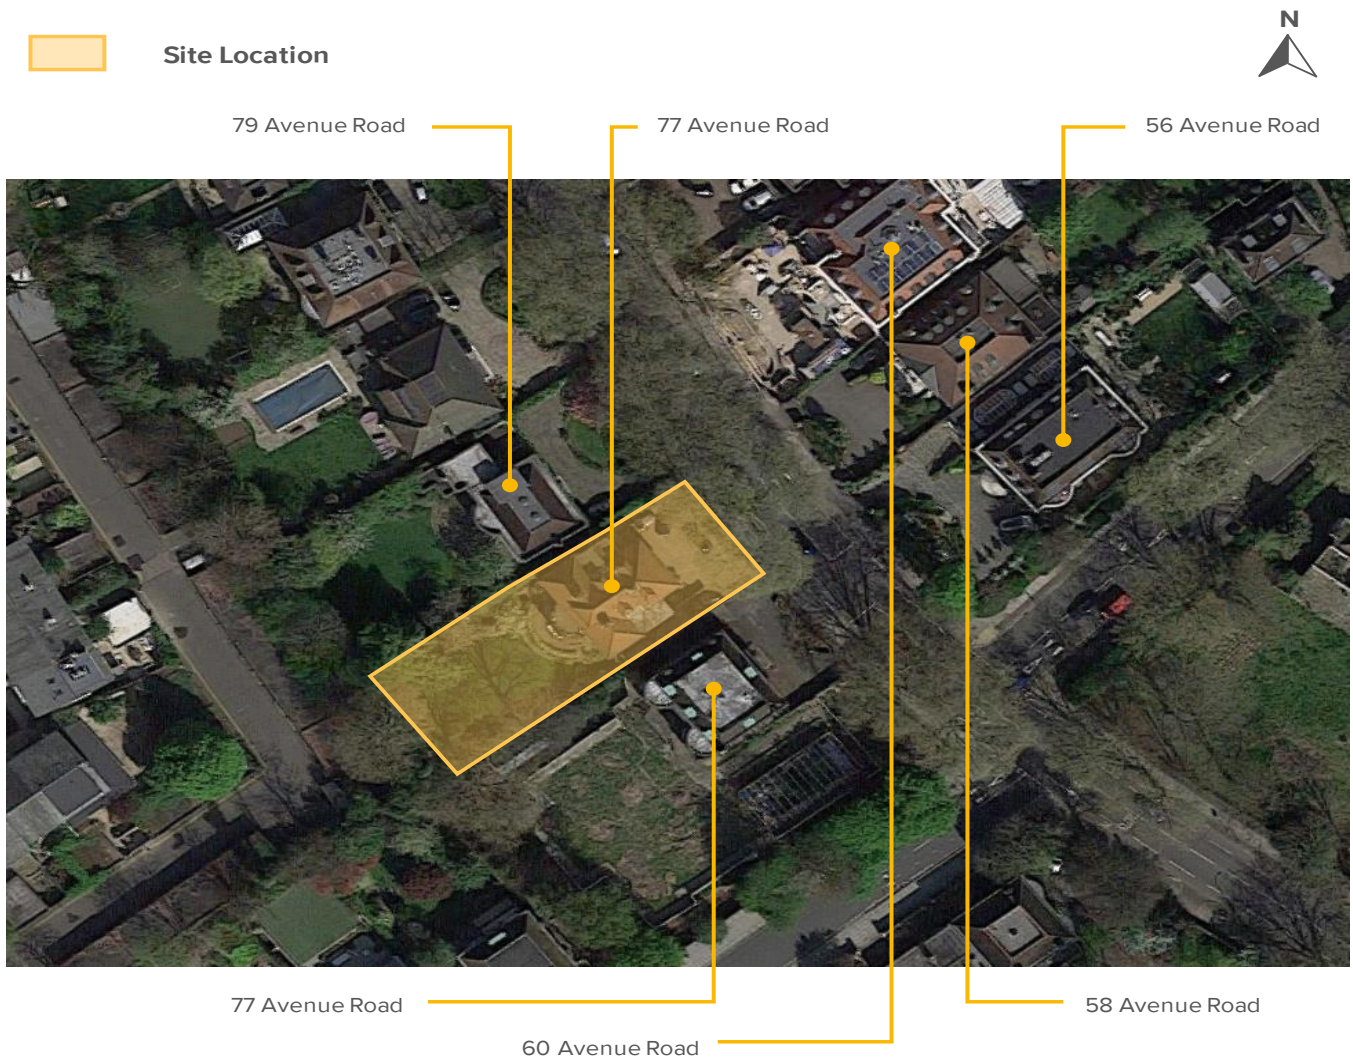
The following neighbouring buildings were tested in detail:

- 79 Avenue Road
- 75 Avenue Road
- 60 Avenue Road
- 58 Avenue Road
- 56 Avenue Road

Figure 1: Site location and neighbouring buildings assessed

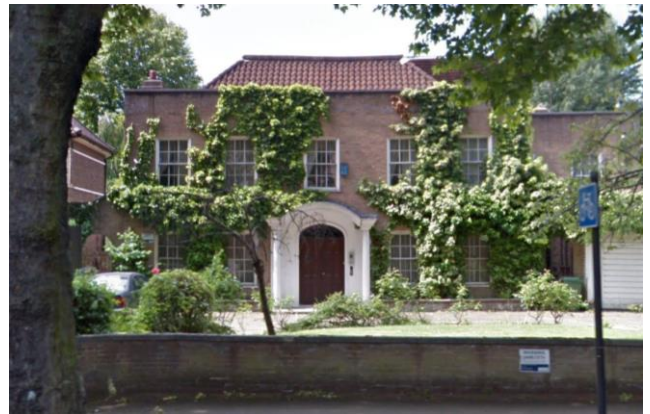
This building is located to the north west of the proposed development. Figure 2 shows potentially affected windows.

Figure 2: 79 Avenue Road windows

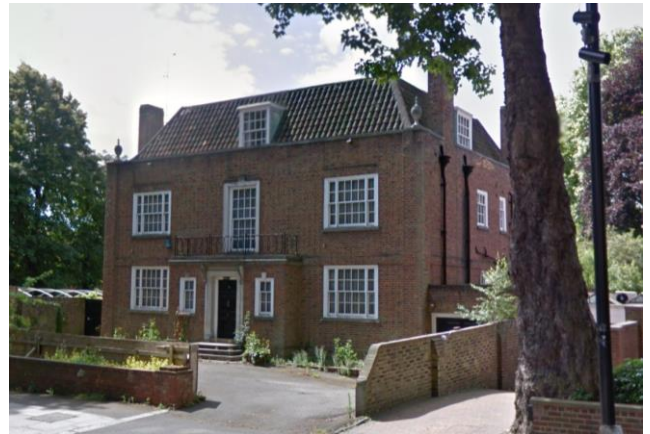
This building is located to the south of the proposed development. Figure 4 shows potentially affected windows.

Figure 4: 75 Avenue Road Windows

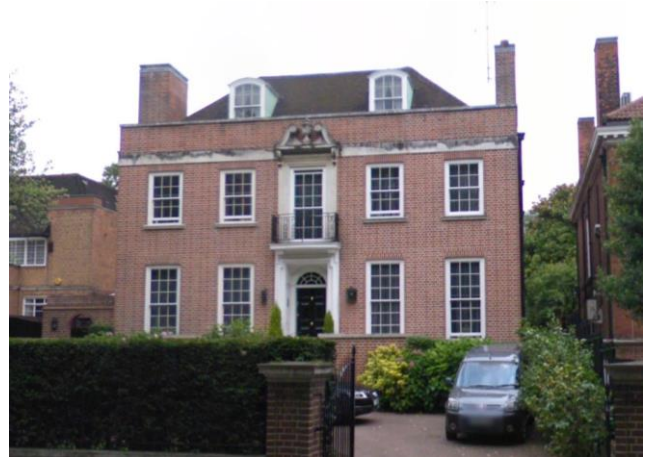
This building is located to the south of the proposed development. Figure 6 shows potentially affected windows.

Figure 6: 60 Avenue Road Windows

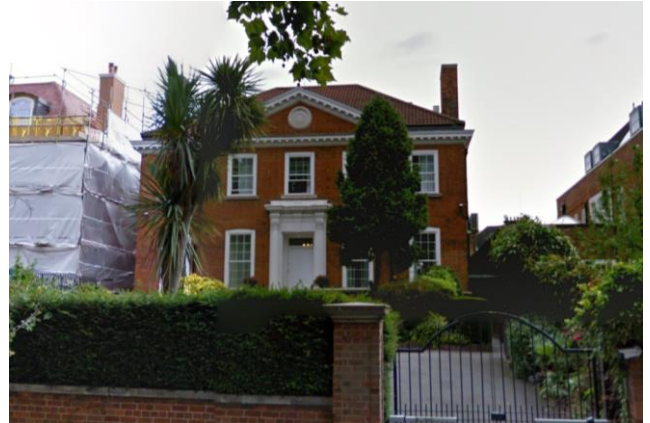
This building is located to the south of the proposed development. Figure 8 shows potentially affected windows.

Figure 8: 58 Avenue Road Windows

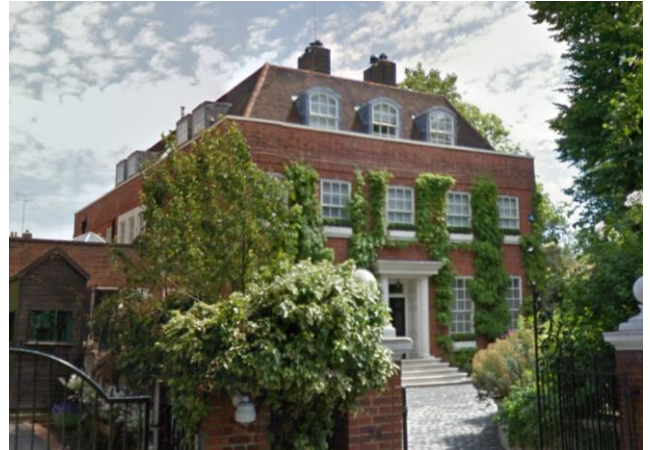
This building is located to the south of the proposed development. Figure 10 shows potentially affected windows.

Figure 10: 56 Avenue Road Windows
