Simon Pryce Arboriculture

Site: 1 - 5 Agar Grove, London, NW1 9SL

Subject: Trees and other vegetation near the building and their effects on it.
Specification for necessary or appropriate work.

Reference: 18/108

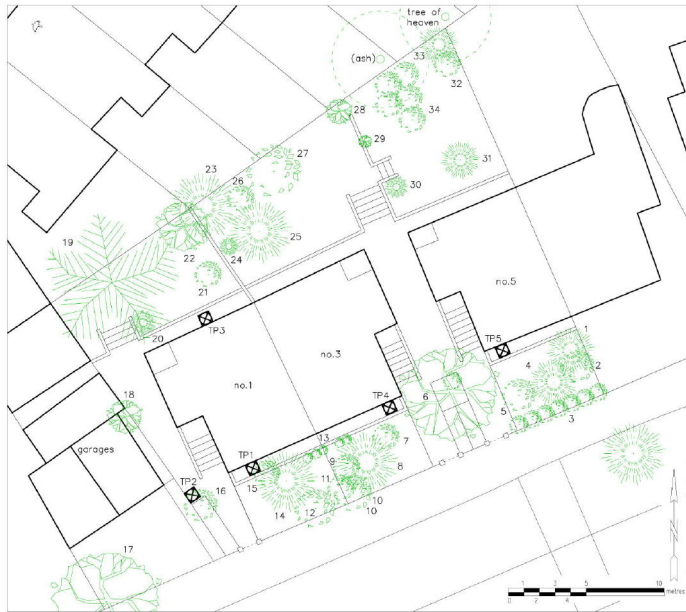
Simon Pryce Arboriculture	
Client: B&D Partnership	
Site: 1-5 Agur Grove, London, NW1 9SL	
Title: Trees and subsidence	
Date: 21 March 2019	
Ref: 18/108	Rev:
Scale: 1:200 at A4	
Original drawing: Simon Pryce on OS base plan	
Notes:	
<small> Crown Copyright 2012 Reproduced, in whole or in part, by permission without the prior permission of Ordnance Survey </small>
