**Daylight and Sunlight Study**  
**Camden Lock Hotel, 89 Chalk Farm Road, London NW1 8AR**

28 March 2019

DAYLIGHT AND SUNLIGHT STUDY  
Camden Lock Hotel, 89 Chalk Farm Road, London NW1 8AR

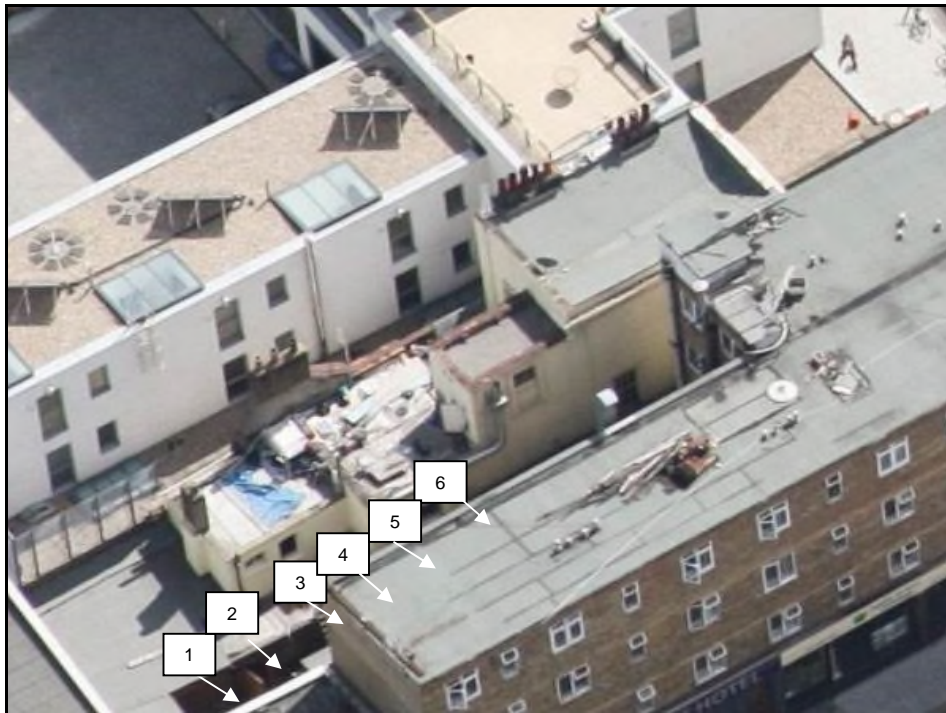
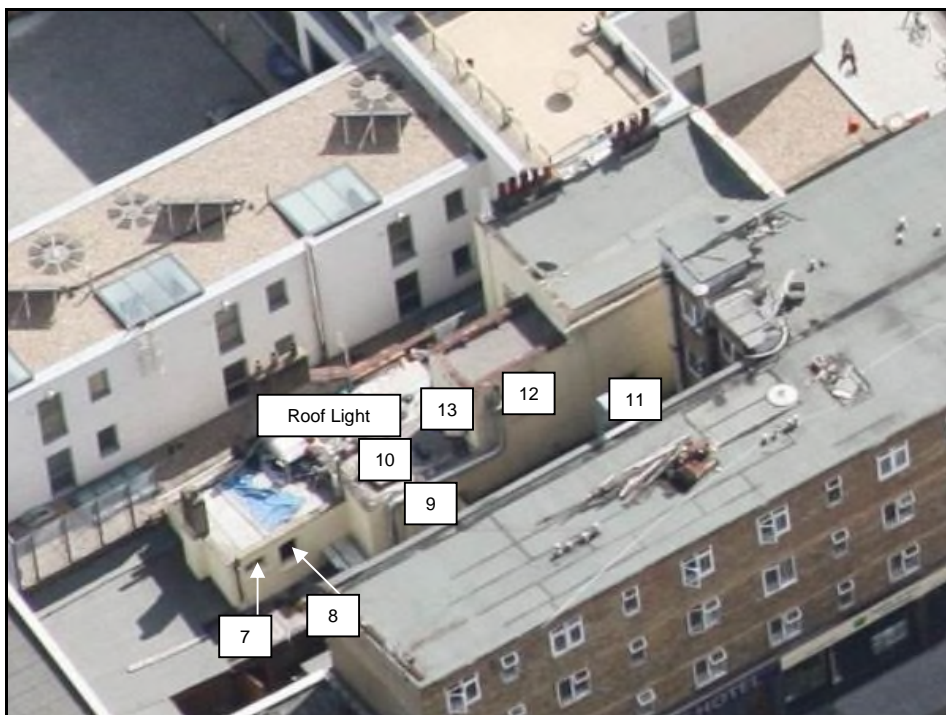
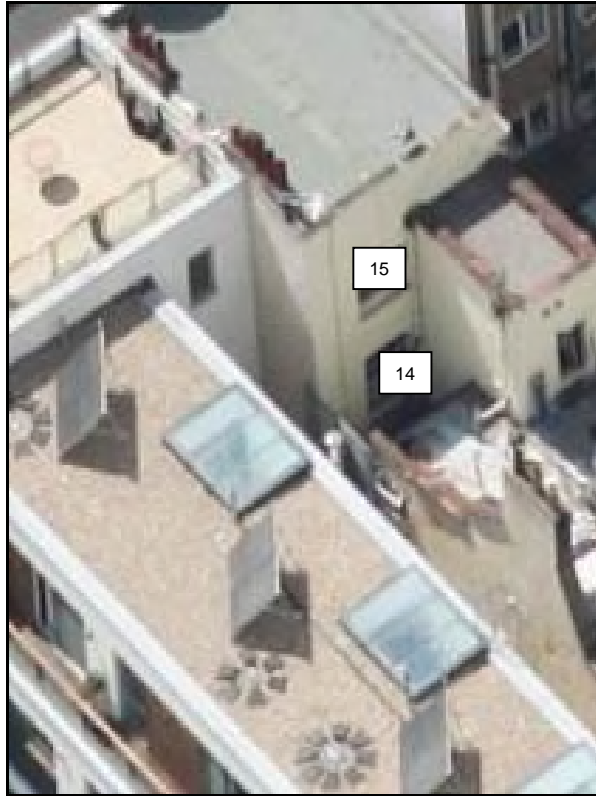
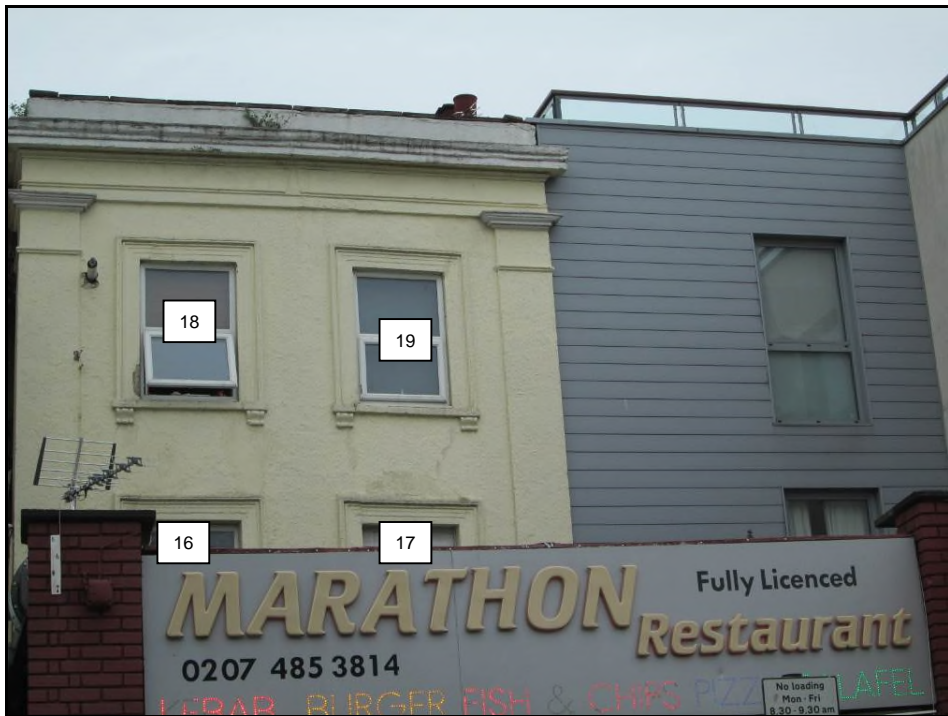
**87 Chalk Farm Road**

## Neighbouring Windows

Reference	Use Class	Vertical Sky Component			
		Before	After	Loss	Ratio
<u>87 Chalk Farm Road</u>					
Window 1	Store Room	0.1%	0.1%	0.0%	1.0
Window 2	Store Room	0.1%	0.1%	0.0%	1.0
Window 3	Store Room	0.1%	0.1%	0.0%	1.0
Window 4	Store Room	0.1%	0.1%	0.0%	1.0
Window 5	Store Room	0.1%	0.1%	0.0%	1.0
Window 6	Store Room	0.1%	0.1%	0.0%	1.0
Window 7	Domestic	17.6%	13.4%	4.2%	0.76
Window 8	Domestic	16.1%	11.8%	4.3%	0.73
Window 9	Bedroom	11.3%	6.0%	5.3%	0.53
Window 10	Bedroom	75.1%	68.3%	6.8%	0.91
Window 11	Domestic	6.4%	3.2%	3.2%	0.5
Window 12	Domestic	19.2%	8.4%	10.8%	0.44
Window 13	Domestic	33.9%	31.8%	2.1%	0.94
Window 14	Bedroom	14.8%	14.8%	0.0%	1.0
Window 15	Bedroom	26.2%	26.2%	0.0%	1.0
Window 16	Bedroom	25.5%	25.2%	0.3%	0.99
Window 17	Bedroom	28.4%	27.9%	0.5%	0.98
Window 18	Bedroom	28.5%	27.4%	1.1%	0.96
Window 19	Bedroom	32.2%	31.1%	1.1%	0.97
<u>85 to 86 Chalk Farm Road</u>					
Window 20	Bedroom	23.3%	22.9%	0.4%	0.98
