CAMDEN TOWN HALL

LENDLEASE CONSULTING (EUROPE) LTD ON BEHALF OF
LONDON BOROUGH OF CAMDEN

STRUCTURAL STATEMENT
18 APRIL 2019

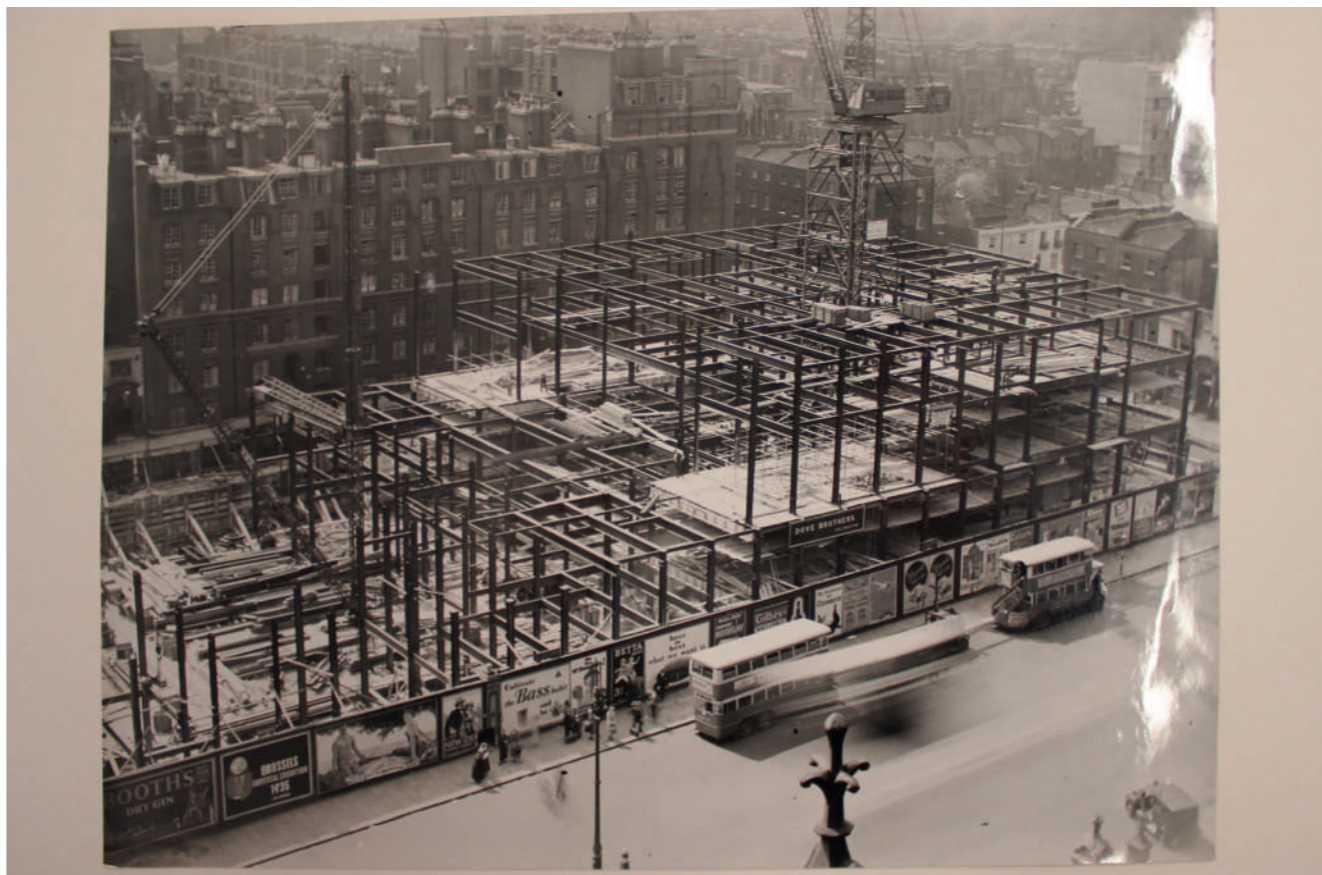
Figure 3.6 Photo taken during construction of steel frame

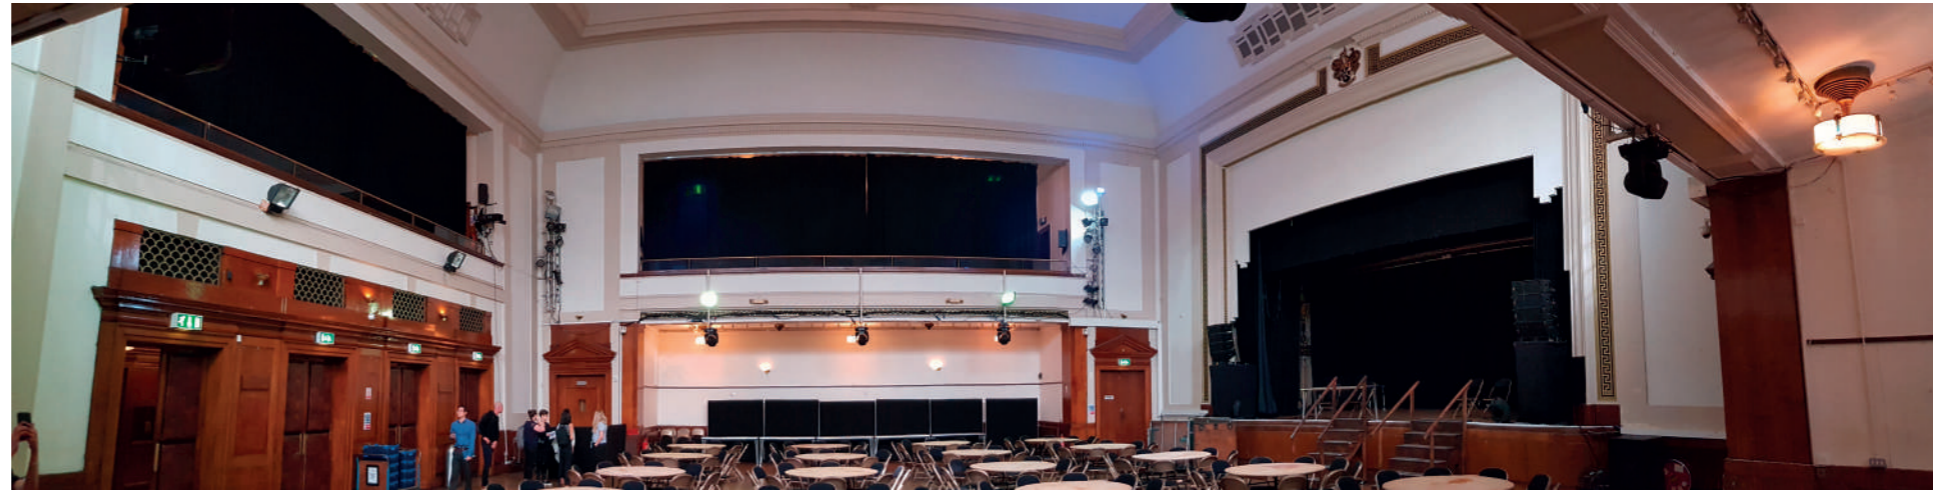
The Camden Centre (Assembly Hall) is located at the east side of the building. It is a columnless space, approximately 25m by 25m on plan and has a free height from Ground floor to Lo2. Due to its big volume a number of big transfer beams has been built along the large spans that are picking the columns from above. Due to its complex structure it is pursued from the design team to minimise as much as possible the interventions associated with the Camden Centre.

Figure 3.7 Photo of the Camden Centre

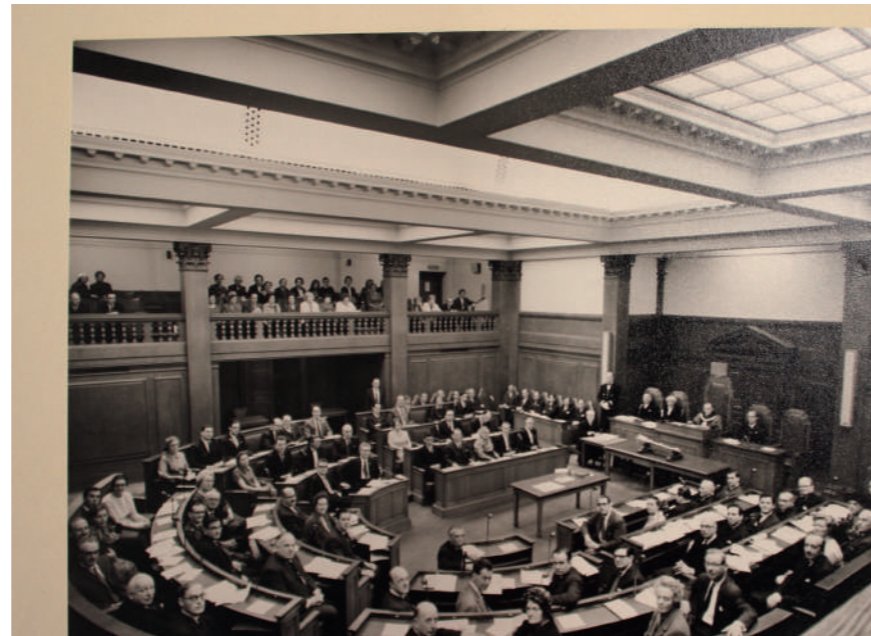
The Council Chamber is a feature of the building of special heritage significance. It is located centrally in the plan of the first floor and is approximately 15m by 15m open space. Long Span beams were built to form the geometry of the chamber roof.

Figure 3.8 Archive photo of the council chamber

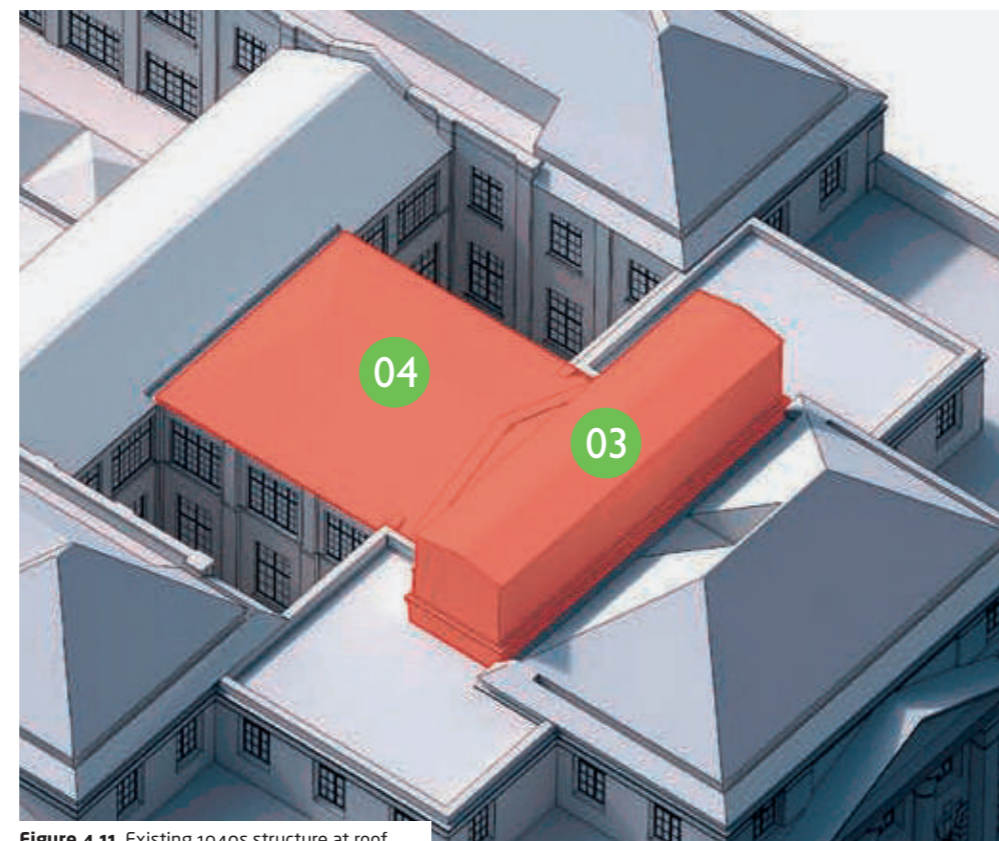
Figure 4.11 Existing 1940s structure at roof

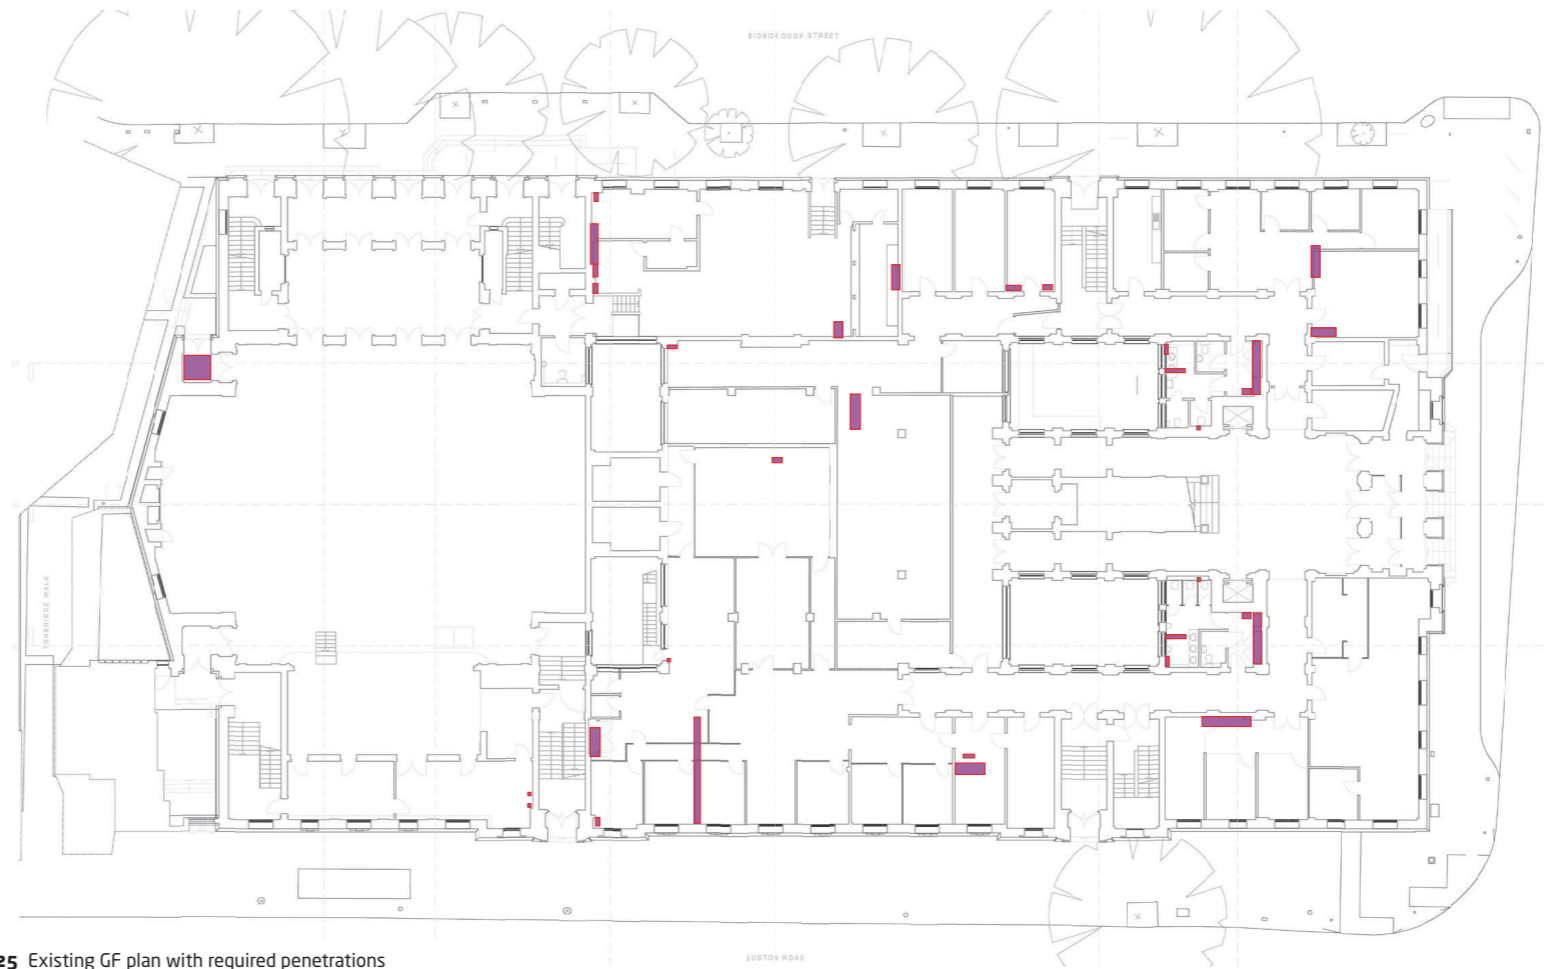
The required openings can be found in various locations across all floors of the structure as shown in Figure 4.25.

Figure 4.25 Existing GF plan with required penetrations
