Project: 1604 - 11 Prince Albert Road - PL5 application

Heritage Statement

11 Prince Albert Road is a semi-detached mid-nineteenth-century Victorian residential villa, one amongst a street of similarly styled period properties, on the northern perimeter of The Regent's Park in Camden, in the Primrose Hill Conservation Area.

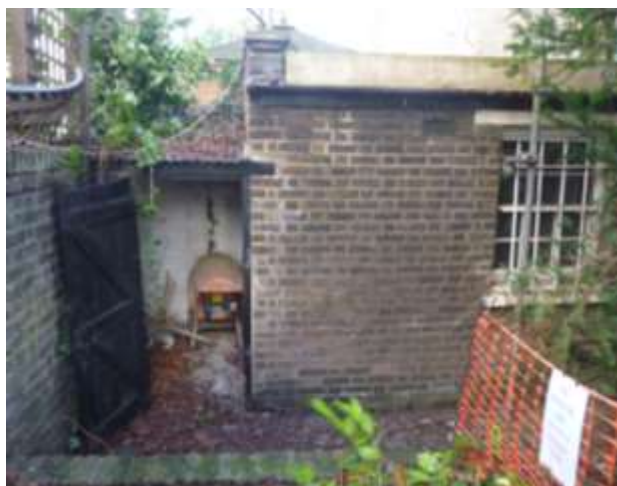
Above left: Rear outbuilding (item 1). Above right: Proposed Bin Store location (item 9) with temporary hoarding between No 10 and No 11 also visible.

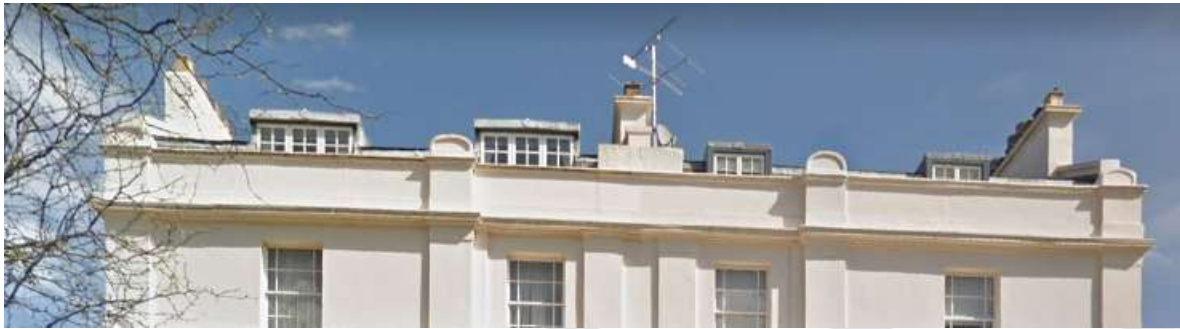
Above: Comparison of dormers on No 10 and No 11 Prince Albert Road (item 14)

15	Roof	Dormer roof; detail change to batten rolls	To reduce risk of wind uplift damage according to Lead Sheet Association technical guidance, additional batten rolls are proposed compared to existing dormer detail.	The presence of a additional batten roll on the side of each dormer is not considered unduly harmful. The dormers on the adjoining property do not match this property so there is no loss of symmetry – see photo page 10.
16	Roof	Existing closet wing failing curved asphalt roof renewed in lead as previously permitted	Existing asphalt has reached the end of its life	Visual improvement.
17	Roof	Existing rear extension failing asphalt roof renewed in lead as previously permitted	Existing asphalt has reached the end of its life	Visual improvement.
18	Roof	New cowls to flues and chimney pot repair works. Cowls to be painted to match the chimney pots.	To prevent moisture ingress into unused flues, whilst avoiding permanently sealing those routes, as they could prove useful in the future.	Reversible intervention, minimal aesthetic impact at high level. Benefit to avoiding water ingress to inaccessible parts of the fabric.

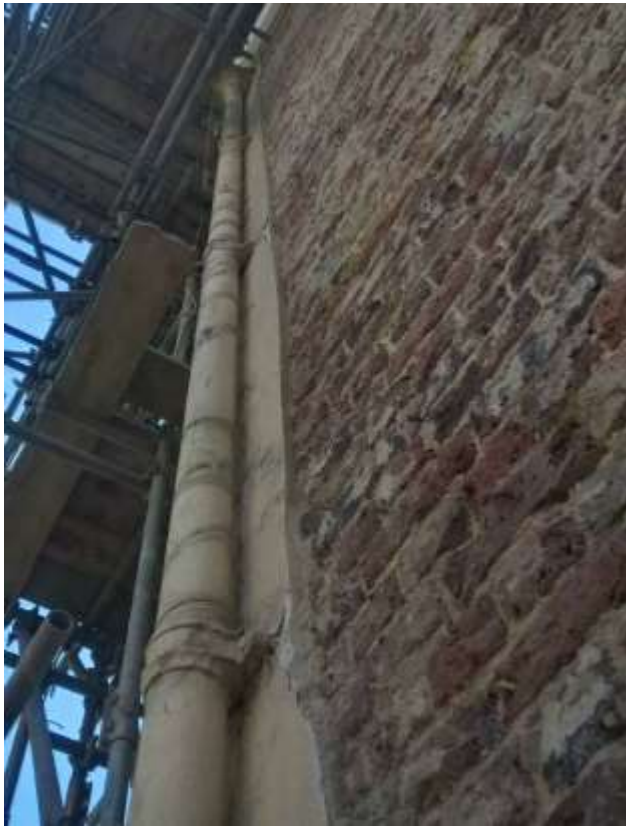
Above: modern 'Timesaver' rainwater pipe proposed for removal (item 13)
