AECOM Aldgate Tower 2 Leman Street London, E1 8FA

WEST HAMPSTEAD COTTAGES.
TYPICAL REPAIR DETAILS

WHC-ACM-XX-XX-DE-SE-0001

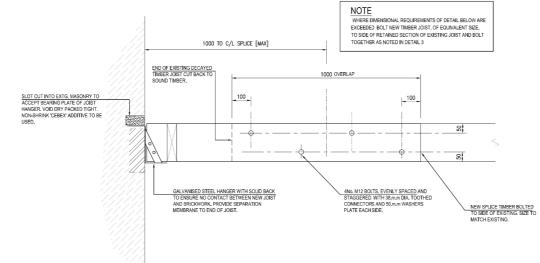
TYPICAL FLOOR JOIST SUPPORT DETAIL IN EXTG. MASONRY WALLS.

DETAIL 1 1:10

TYPICAL TIMBER JOIST EXTENSION DETAIL WHERE EXISTING JOIST CUT BACK DUE TO ROT

DETAIL 2 1:10

NEW TIMBER TRIMMER SHOWING **BOLTING REQUIREMENTS**

DETAIL 3 1:10

TYPICAL EXISTING TIMBER JOIST NOTCH REPAIR DETAILS DETAIL 4 1:10

VERTICAL RESTRAINT DETAIL TO **EXISTING EXTERNAL MASONRY** DETAIL 5 1:10
