**PRELIMINARY STRUCTURAL
ENGINEERING ASSESSMENT
FOR NEW BASEMENT
AT**

4b Hampstead Hill Gardens

REF: 218136 - SEPTEMBER 2018

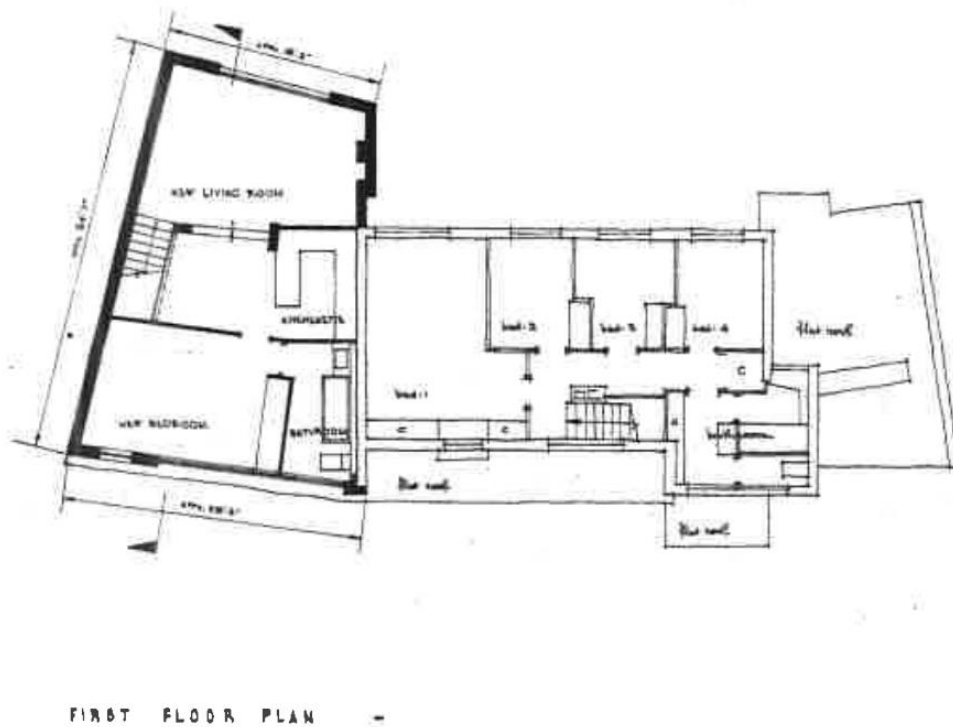
- 2.1 This is a semi detached property with 4b forming the left hand end of the dwelling noted in black hatching below. 4a is the neighbouring property and is to the right of the hatched 4b section.

Compiled plan of original dwelling and extended garage to the left hand end. Blue hatch denotes party wall.

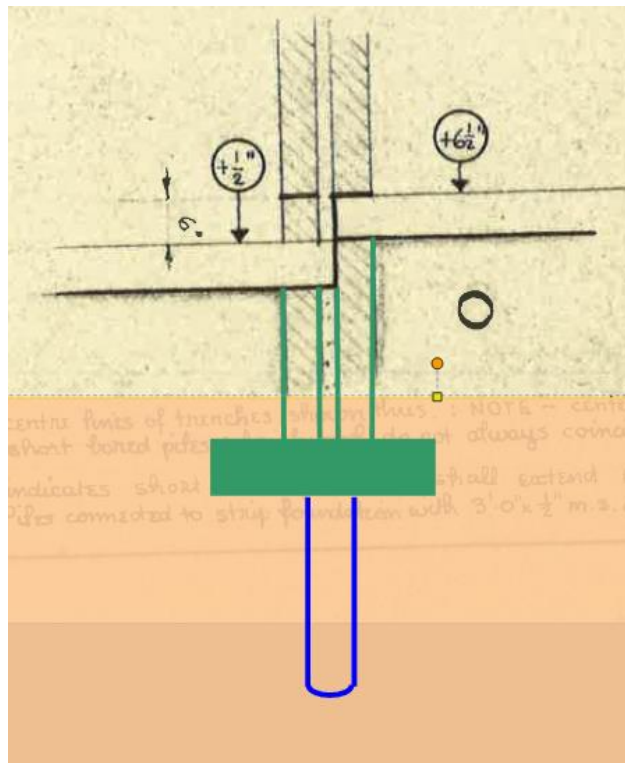
Section through party wall

- 2.2 The building is formed using cavity masonry walls and timber floors and roof. There is a shared party wall between 4a and 4b.
- 2.3 Foundation details to the party walls have been retrieved from the record drawings. They show floor slabs built in to a cavity masonry wall. The drawings then note a piled trench set down 850mm BGL which is approximately 825mm wide x 225mm deep with short bored piles below extending to 2.35m BGL.

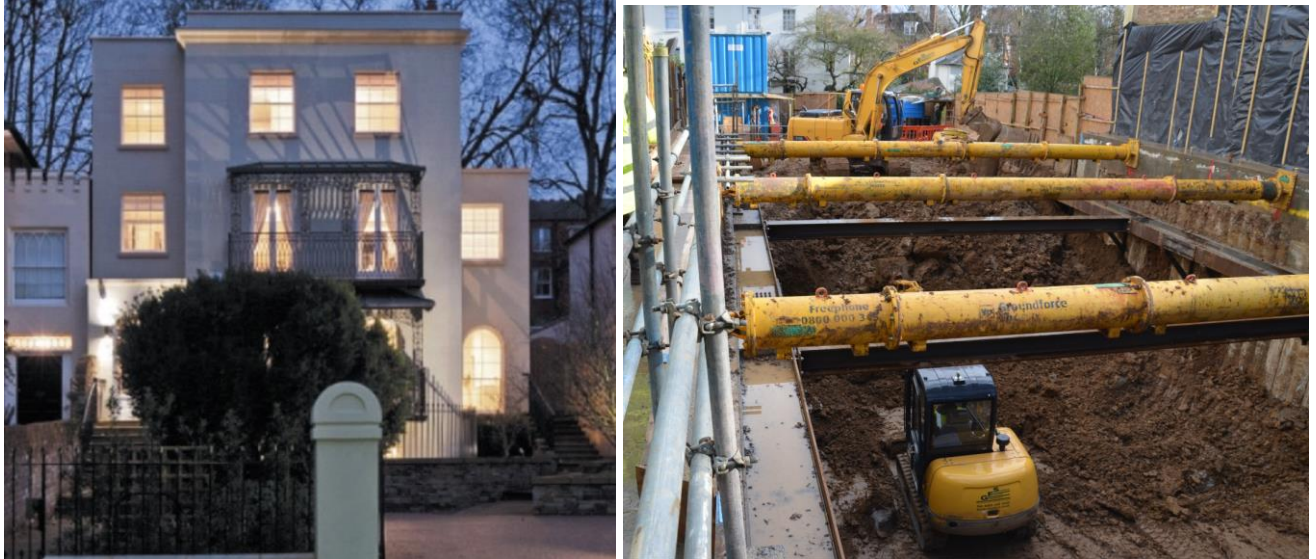
9 Downshire Hill, Hampstead - the re-construction of a dwelling including a double basement and 3 upper floors.

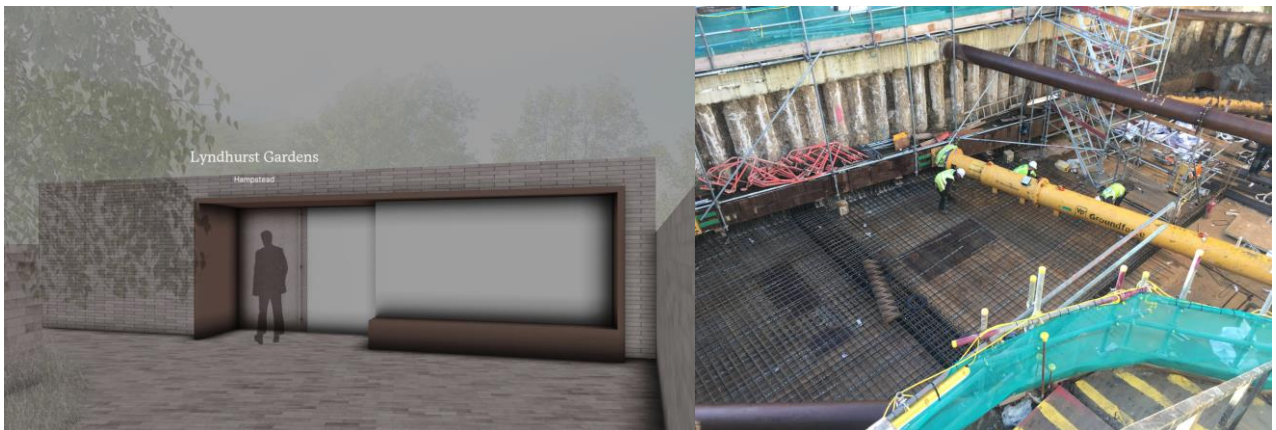
16 Lyndhurst Gardens, Belsize Park - the re-construction of a dwelling including a double basement and 1 upper floor.
