REV No.	DATE	REMARKS	I.D.CUTHBERT MCIAT ACIOB Chartered Architectural Technologist 6, Burgess Field, Chelmsford, Essex CM2 6UE Tel: 01245-450802 iancuthbert@blueyonder.co.uk	Scale: 1:50 (at A3 print)	14A, PATSHULL ROAD, KENTISH TOWN, LONDON NW5 REPLACEMENT FRENCH DOORS IN REAR ELEVATION	drawing no:	482:60 B
			March 2019

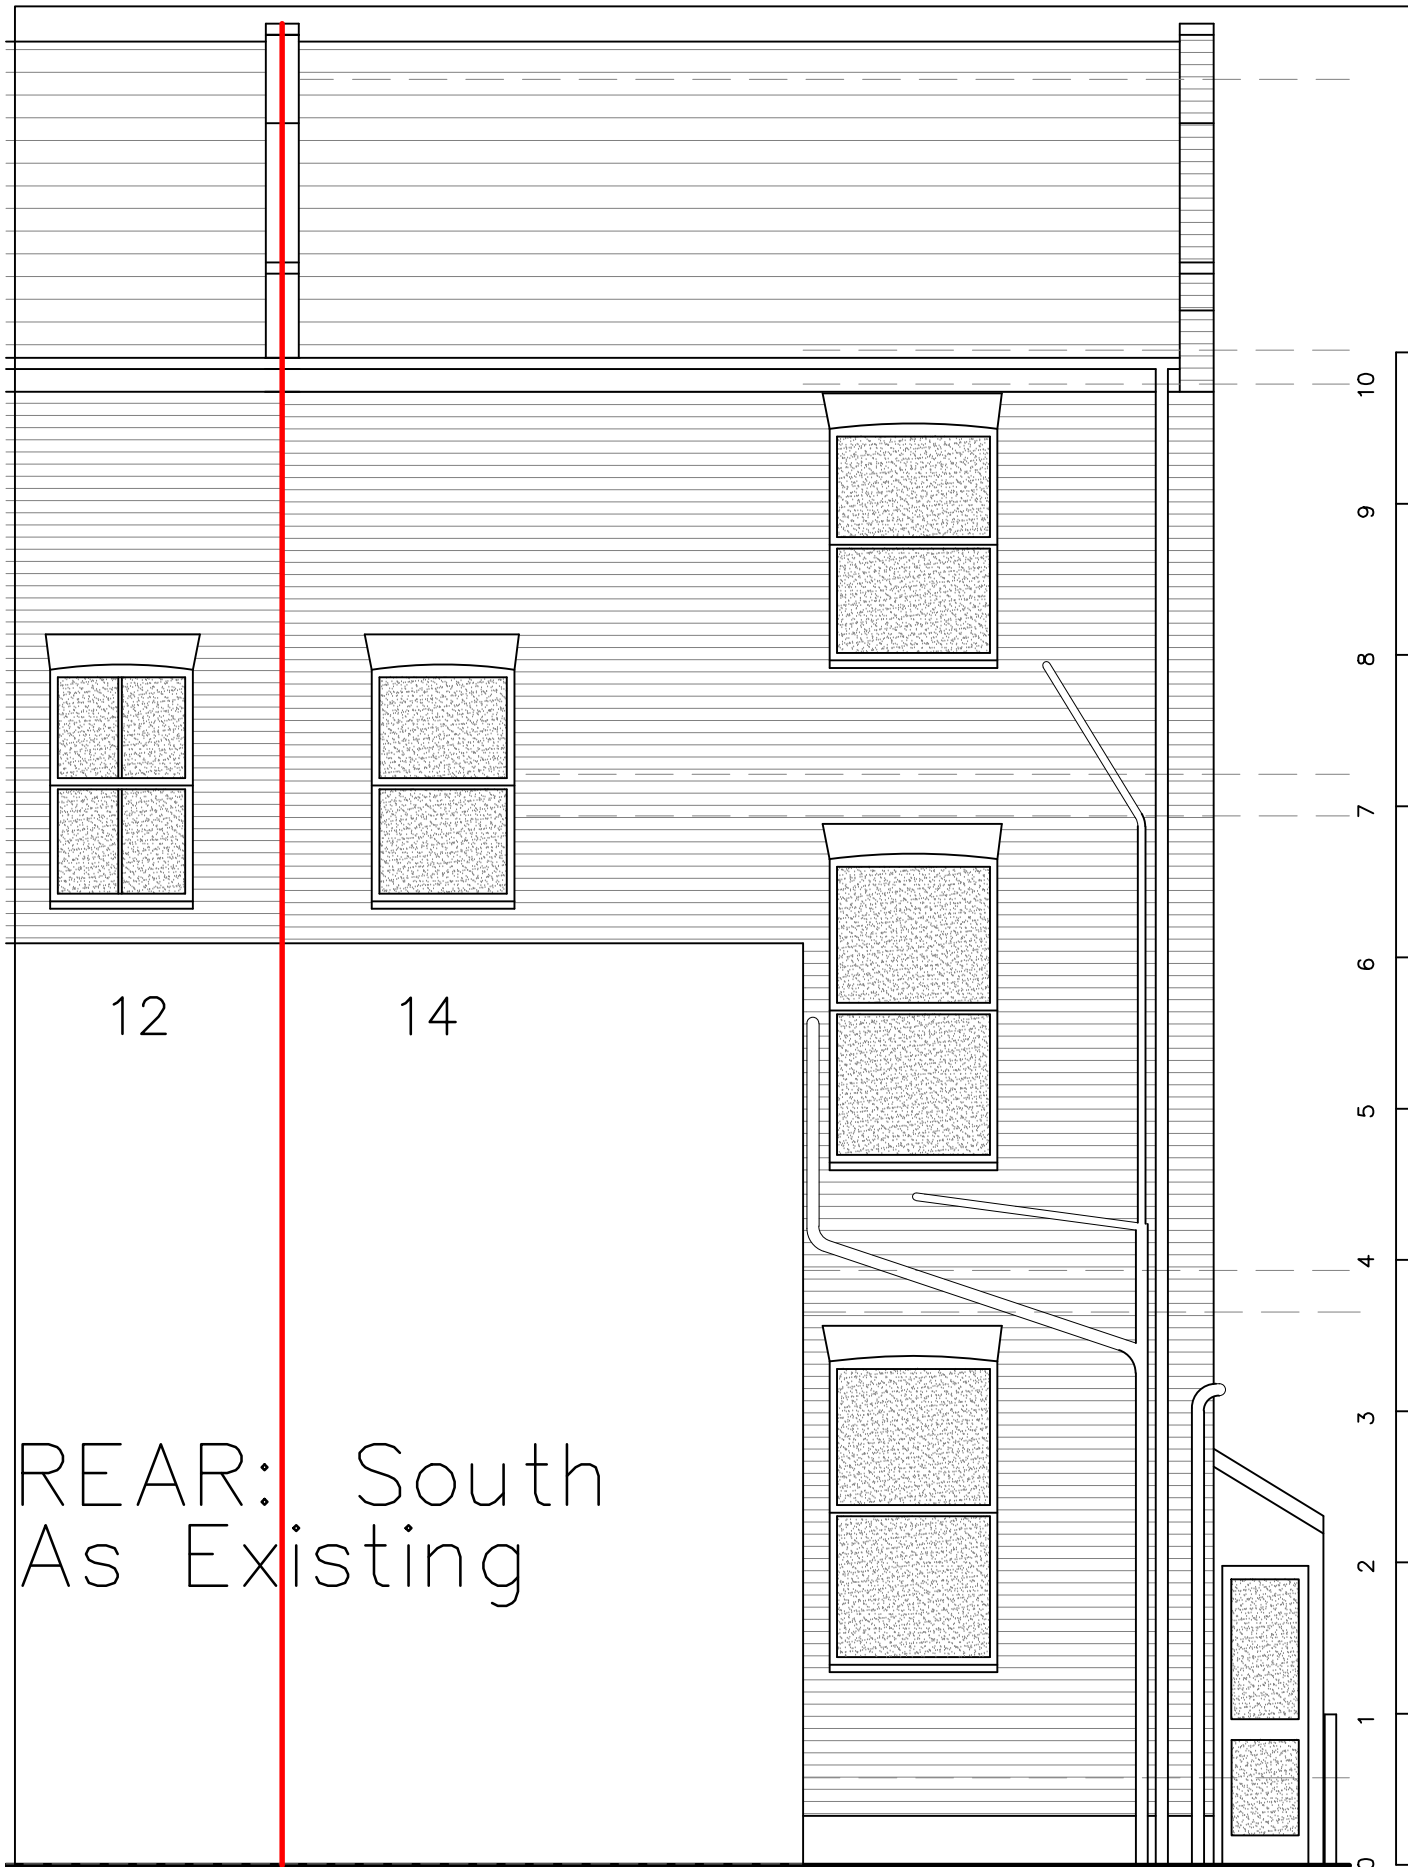
REAR: South
As Existing

Existing covered passage: 215mm brick wall on the boundary and slate covered roof.
