METHOD STATEMENT

Dismantlement & Reinstatement of Railings, Stone and Brickwork

Garden Railings to Gloucester Gate Lodge – Application for Listed Building Consent

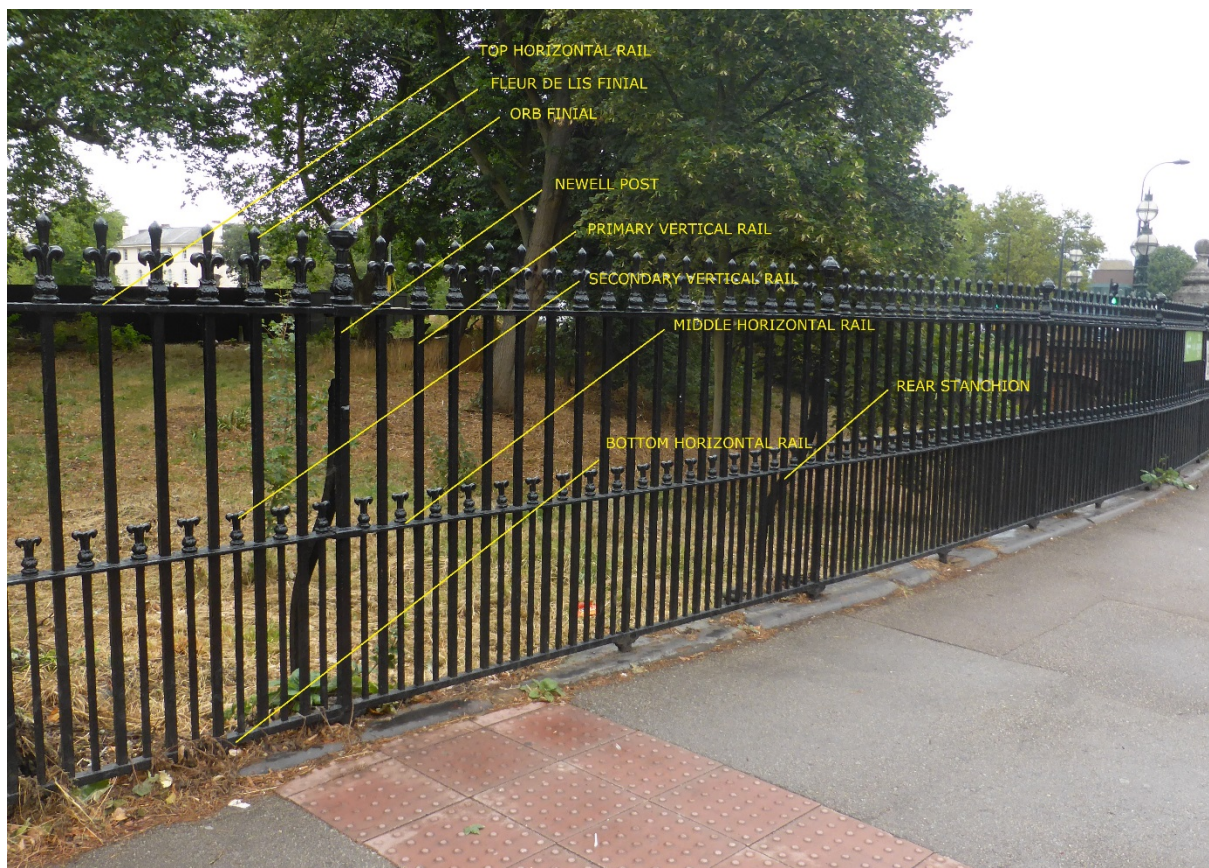
The railings construction can be identified by (which corresponds with the mark-up below):

- Primary vertical rails
- Secondary vertical rails
- Top horizontal rail
- Middle horizontal rail
- Bottom horizontal rail
- Newell post
- Rear Stanchion

Originally Victorian and Edwardian railings were made by casting iron in sand moulds, linked by wrought iron horizontals and were finished with a cast decorative finial. The railings that run around the perimeter of the park currently look to date from the early 20th century, seemingly confirming research which suggests the originals were removed as part of the war effort. The current railings are thought to be constructed from both cast iron and mild steel set into York sandstone coping stones on top of a brickwork base. In this case, each individual rail has a fleur des lis to the top and each stanchion post an orb.
