Project: **St Giles Circus**

Drawing Title:  
**No. 20 Denmark Street/No. 16 Denmark Place Proposed Rear yard Elevations**

**1793PL017-05**

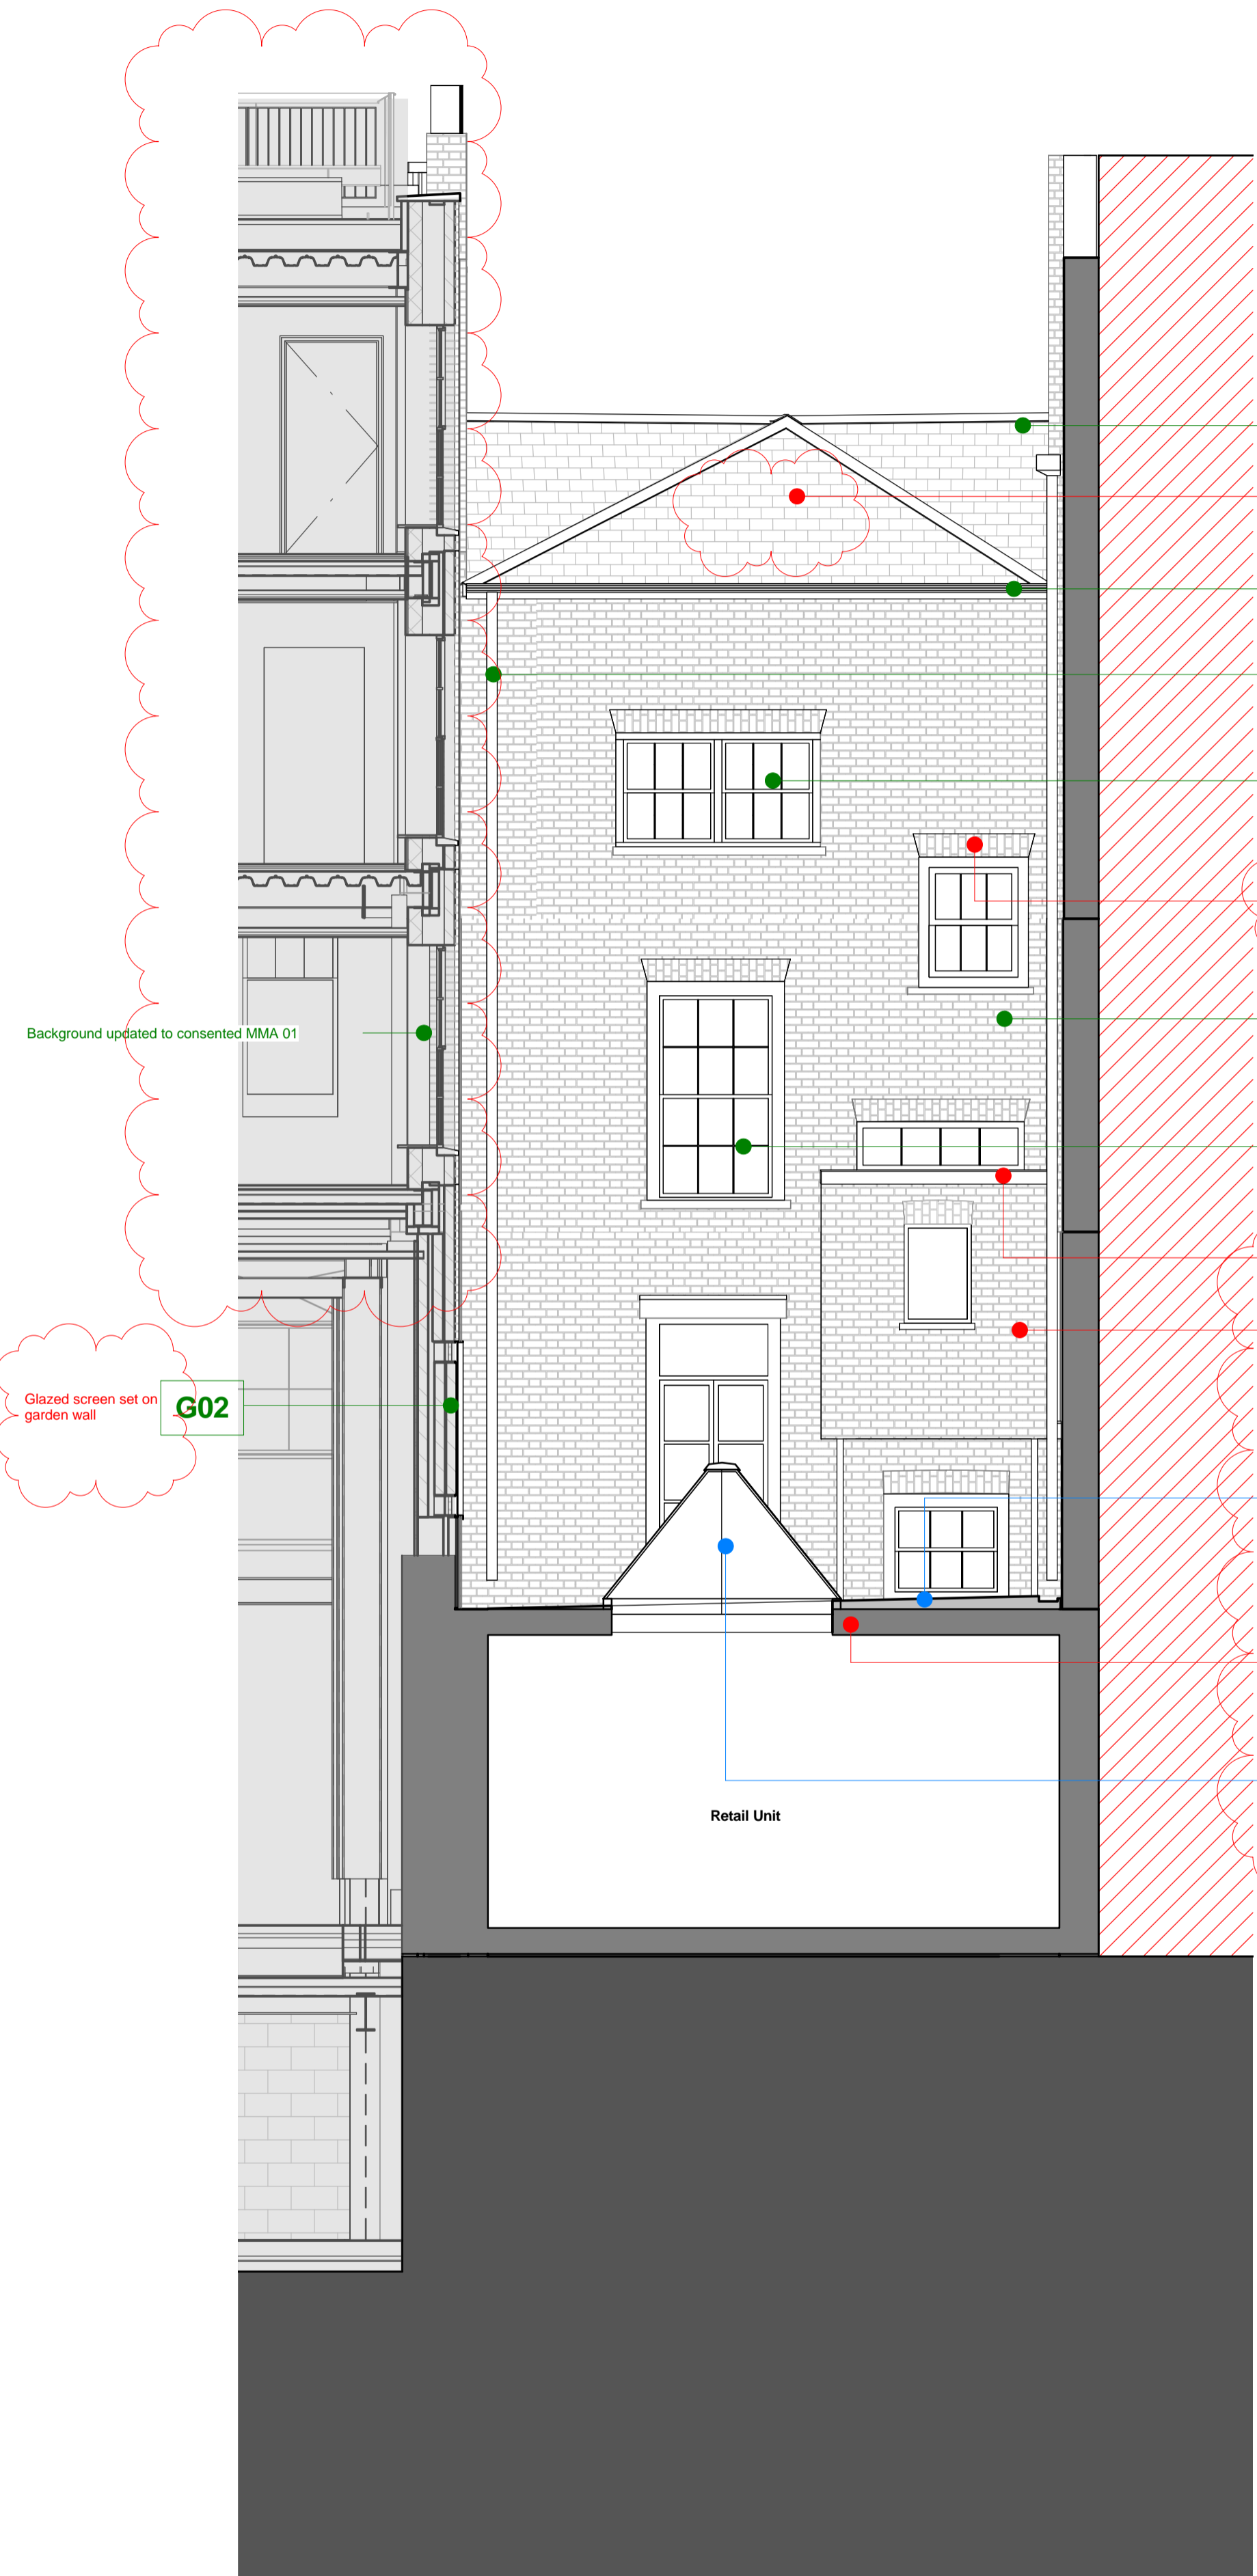
- RF01** Roof tiles removed - replaced with reclaimed natural slate tiles. New rolled lead ridge and flashings.
- Rooflight removed
- IW02** New period cast iron gutter

- IW01** New period cast iron downpipe
- W09** Existing sash box surrounds carefully repaired and refurbished where possible. New sash boxes to match existing where required.  
New sliding sash casements throughout.

- B13** Lintols water washed by hand, pointing carefully raked out, masonry repaired where required with matching reclaimed bricks.  
Repointing in lime mortar with flush joints.

- B10** Existing brickwork to be water washed by hand, pointing to be carefully raked out, masonry repaired where required with matching reclaimed bricks.  
Repointing in lime mortar with flush joints.

- W09** Existing sash box surrounds carefully repaired and refurbished where possible. New sash boxes to match existing where required.  
New sliding sash casements throughout.

- New standing seam rolled lead roof
- WC block rebuilt to match existing - Refer to Structural Engineers Details also.
- RF11** Roof relined and finished with timber decking

- Trimming steel to Structural Engineers details  
Existing joists removed and set aside for reuse following steel installation  
New plasterboard ceiling with insulation between joists.

- W13** Lantern rooflight replaced to match existing

- Background updated to consented MMA 01
- C07** New stone coping to replace precast concrete copings
- B10** Existing brickwork to be water washed by hand, pointing to be carefully raked out, masonry repaired where required with matching reclaimed bricks.  
Repointing in lime mortar with flush joints.
- W09** Existing sash box surrounds carefully repaired and refurbished where possible. New sash boxes to match existing where required.  
New sliding sash casements throughout.
- G02** New glazed screen set onto former garden
- RF11** Roof relined and finished with timber decking
- Trimming steel to Structural Engineers details  
Existing joists removed and set aside for reuse following steel installation  
New plasterboard ceiling with insulation between joists.
- W13** Lantern rooflight replaced to match existing
