REMEDIATION STRATEGY AND VERIFICATION PLAN

PROPOSED DEVELOPMENT AT
138-140 HIGHGATE ROAD, HIGHGATE, LONDON, NW5 1PB

Report Title:	Remedial Strategy 8	& Verification Plan for	138-140 High	gate Road.	Highgate, London

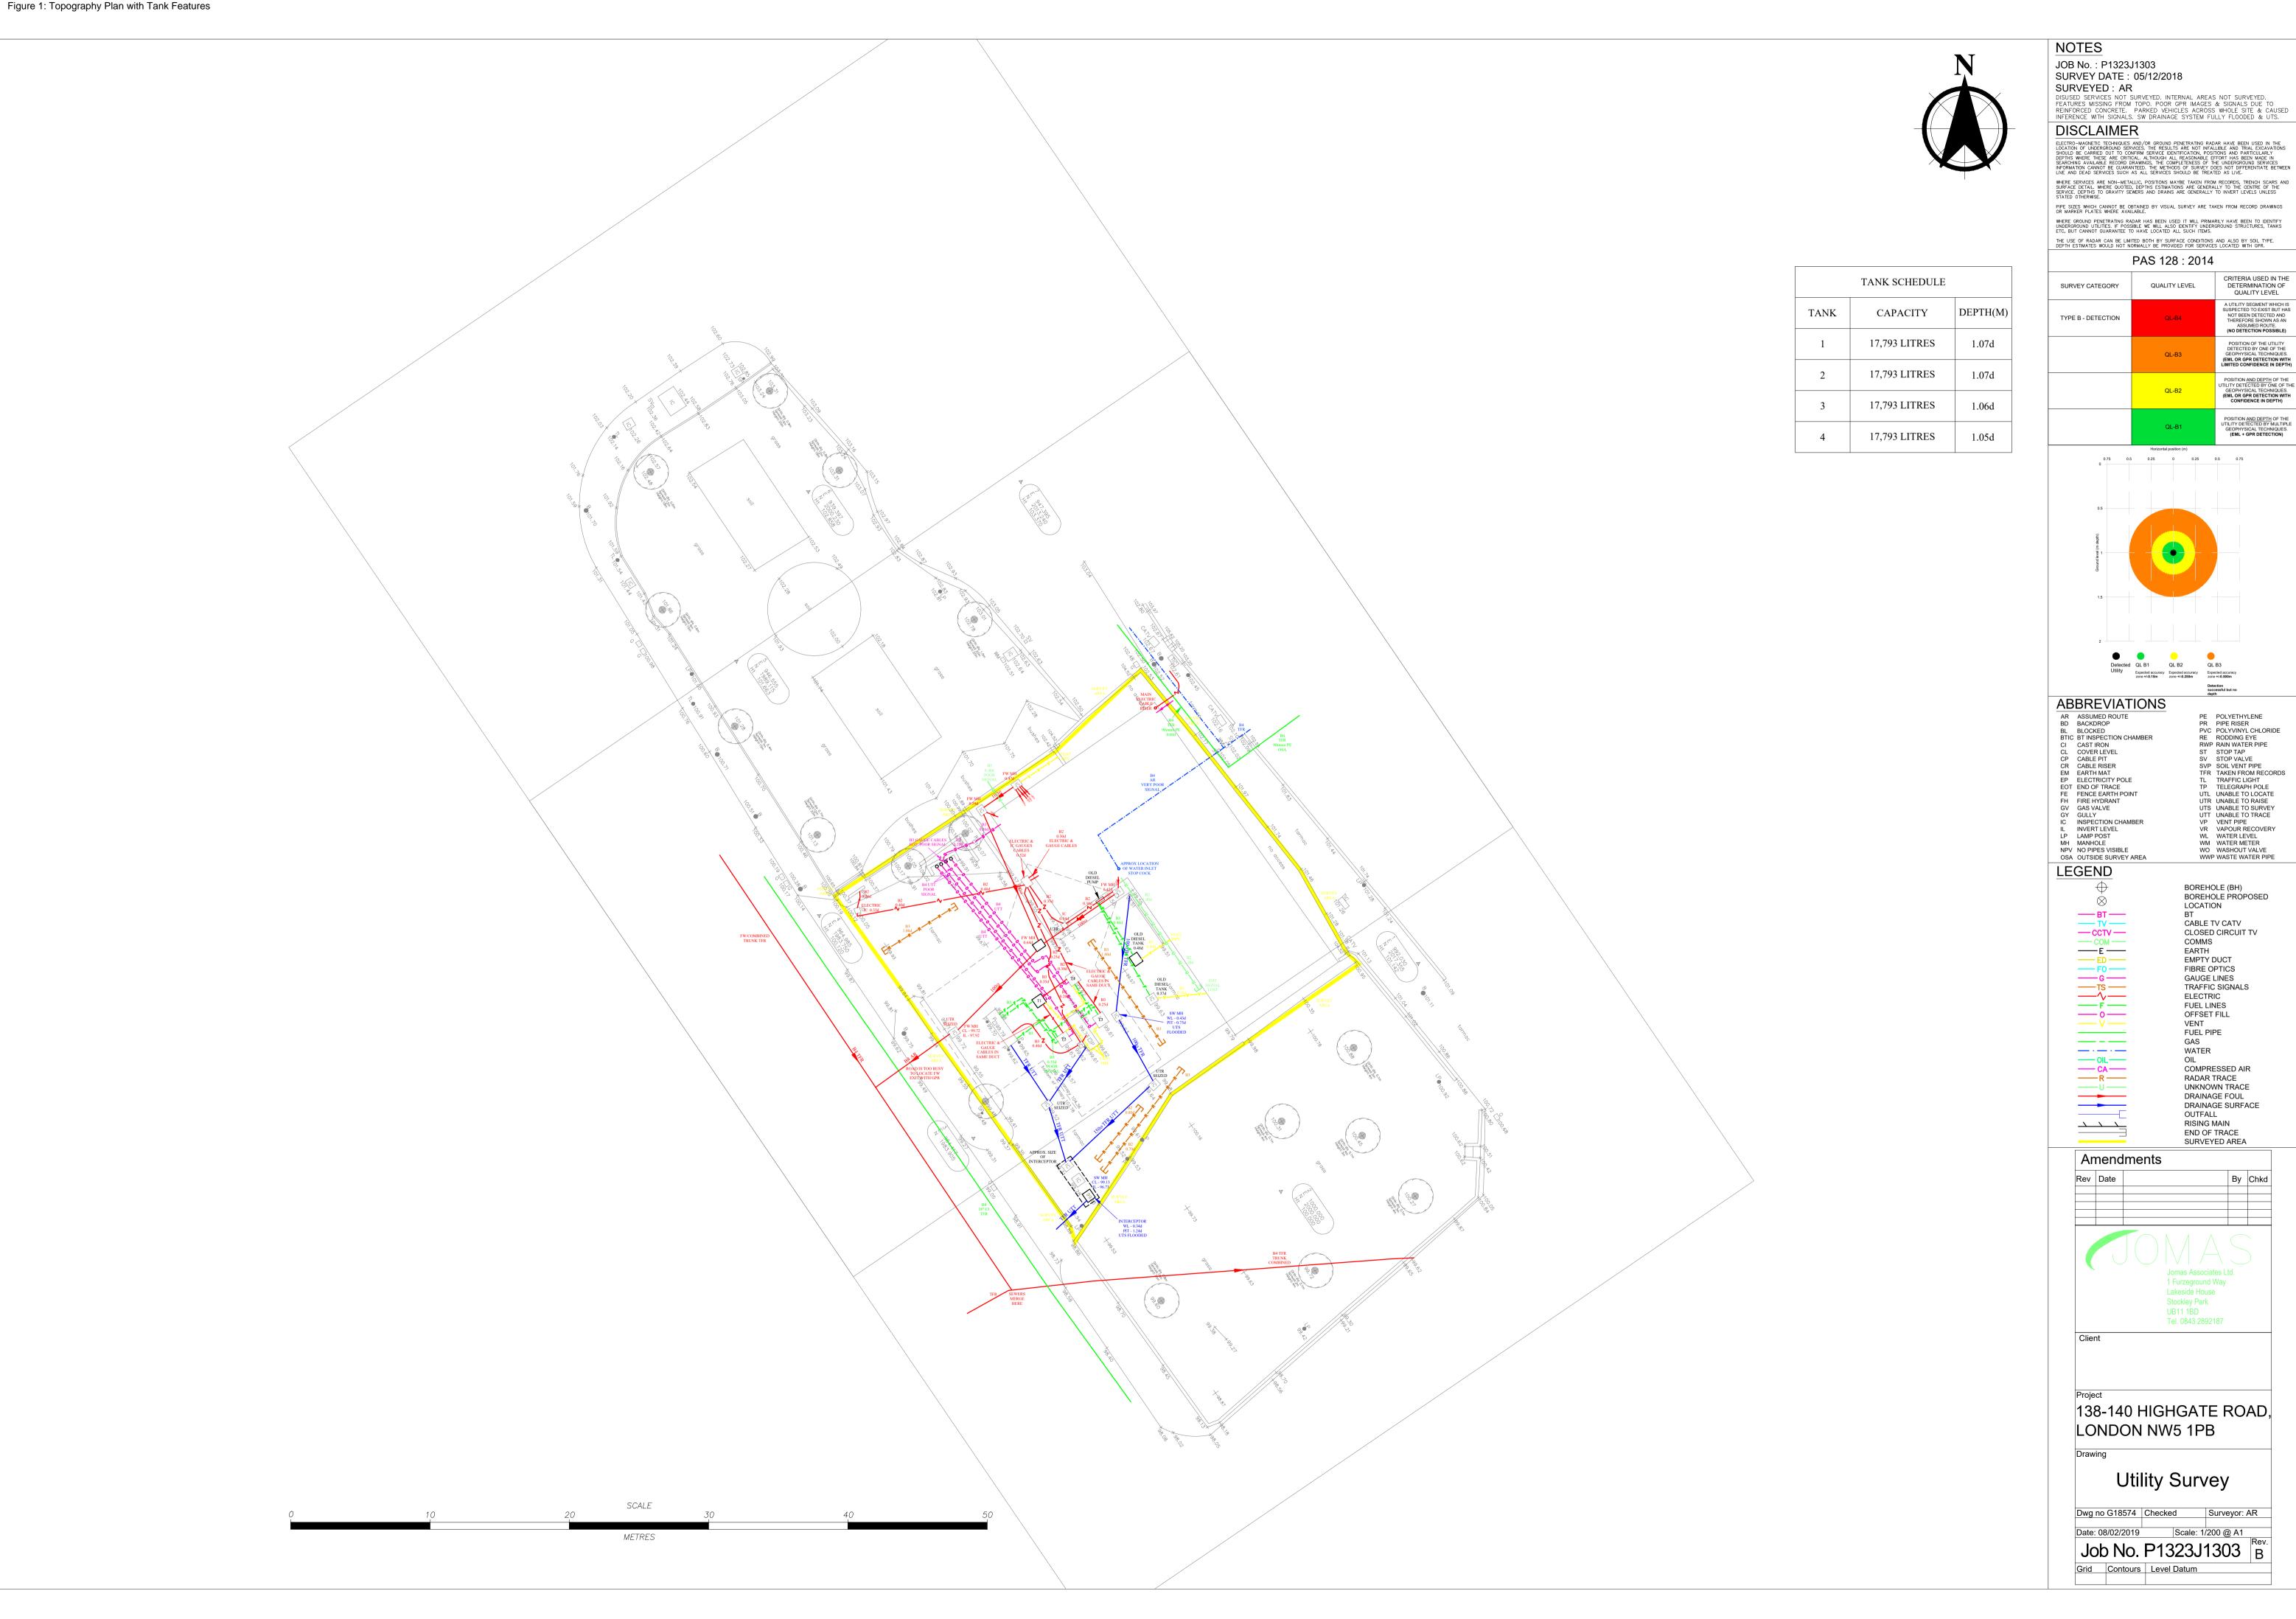
Utility Survey

SURVEY DATE: 05/12/2018

PIPE SIZES WHICH CANNOT BE OBTAINED BY VISUAL SURVEY ARE TAKEN FROM RECORD DRAWINGS OR MARKER PLATES WHERE AVAILABLE.

Dwg no G18574 Checked Surveyor: AR Date: 08/02/2019 | Scale: 1/200 @ A1 Job No. P1323J1303 B

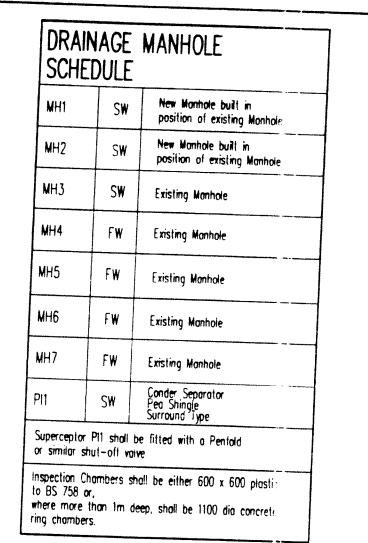
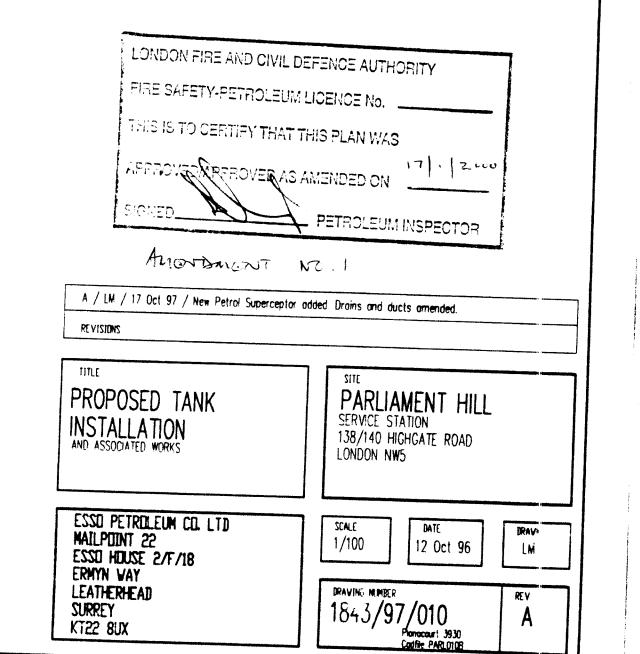
Electric ducts 100 and 150m
→ Tank Gauge Duct 100mm

PROP(osed ne	W TANK	S Do	ouble skinned steel co	nstruction
Tank No	Capacity Litres	95 % Capacity Litr e s	Grade	Pump No	Pump t ype
T1	18,260	TBA	ULP 95	P 2	Highline 2
T2	18, <i>2</i> 60	TBA	4*	P 1, 2, and 4	Highline 2
T3	18,260	TBA	ULP 98	P 3	Highline 2
T4	18,260	TBA	ULP 95	P 1 and 4	Highline 2

PIPEWORK LEG	GEND
	100mm Offset Fills UPP pipes.
<u> </u>	 63mm Suction pipes, flexible lined UPP 90mm Stage 1 Tank vent pipes, rigid UPP lined Manifolded underground using Emco Wheaton vent T valves
Ow.	— 63mm Stage 2 Vapour return pipes, rigid UPP, lined installed for future use
OW _	Tank Observation Well
*	Tank gauge duct 100mm

- 3.7.5 I enclose a copy of the Licensed Drawing for this site (Drawing Number 1843/97/010A) dated 12 October 1996, indicating the location of the tank farm. The current set of tanks designated T1-T4 directly replaced 4 previous tanks of the same size dating back to 1969.

- 3.7.6 A second plan is enclosed (1436/CS140/21) dated 20 July 1972 which shows the positions of the 2 tanks in the table above, installed in 1959 and currently being used for kerosene/diesel storage (in addition to the 4 replaced tanks)."
