# **Condition 4e - Conservation Rooflights**

#### **Condition 4E - Conservation Rooflights**

### Condition 4e states the following:

Details, including manufacturer's specification and detailed section drawings at a scale of 1:10, of all proposed conservation rooflights.

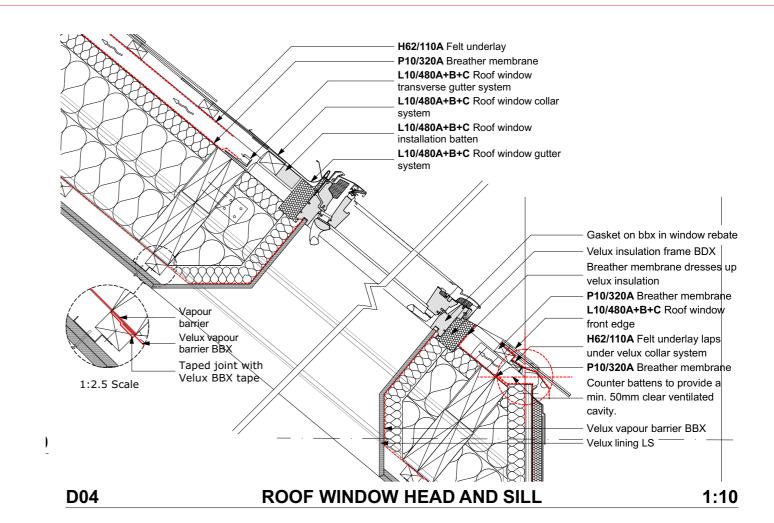
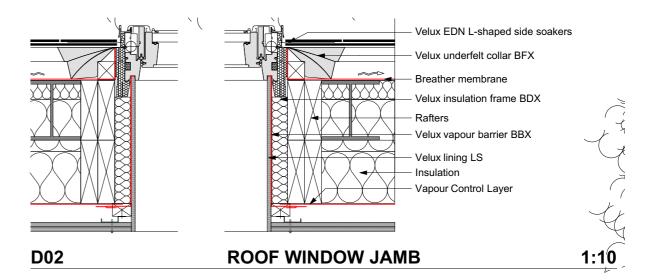
### **Conservation Rooflight Windows - Specification**

Manufacturer: VELUX Company Ltd.
Product reference: GGL centre-pivot roof window,
INTEGRA® electric, CONSERVATION STYLE with
recessed flashing & fittings.

- Roof pitch: 40.
- Window Code: GGL UK08.
- Finishes: Internal frame and sash: White Painted.
- External cladding: Grey aluminium; colour reference NCS S-7500-N Code 0.
- Glazing: 7021U.
- Blinds, Awning and Shutter:
- Type: DML Blackout blind.
- Operation: Electrical.
- Energy efficiency installation collars: Insulation Collar – Code BDX 2000.
- Flashing: EDN.
- Internal lining framing kit: LSG 1000.

BPD-LDW-WH-ZZ-DR-A-303001 ROOF DETAILS - SHEET 1\_C1.pdf 1:10 detail of roof window head & cill.

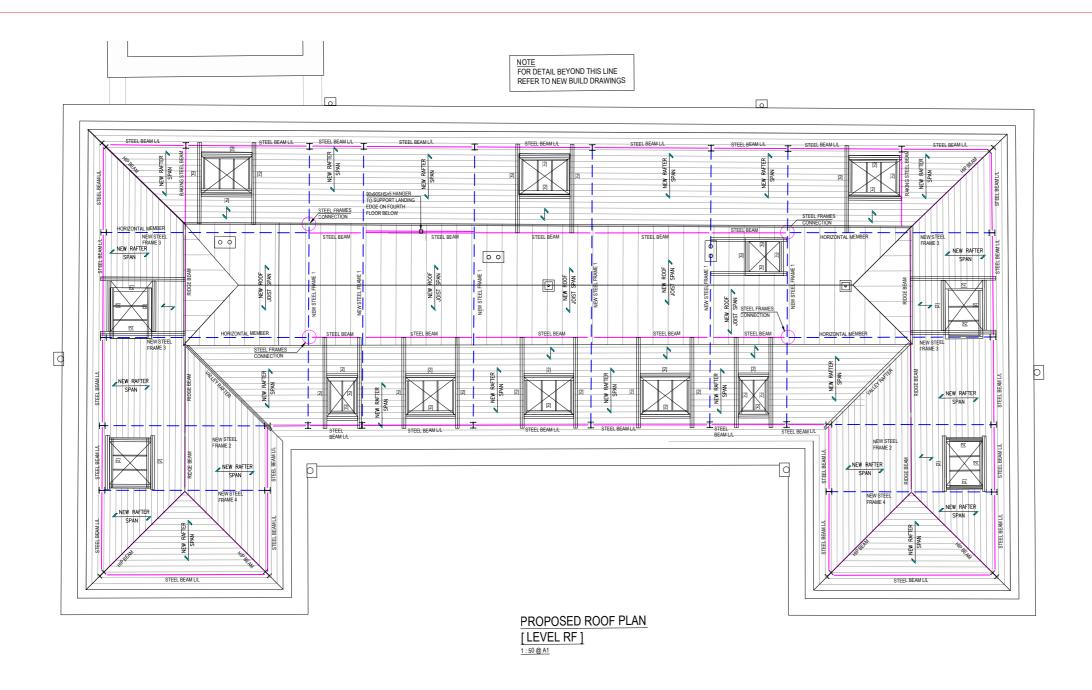
# Condition 4e - Conservation Rooflight Windows Location

NOTE.
FOR TYPICAL DETAILS AND DETAILS OF STEEL FRAMES REFER TO DRG. Nos.
MHA-ACM-XY-XY-DE-S-00001 TO 00003.
MHA-ACM-WH-XX-DE-S-00001 TO 00003.

Structural Engineer drawing MHA-ACM-WH-R1-DR-S-00001.pdf. 1:50 drawing showing rooflight window locations.

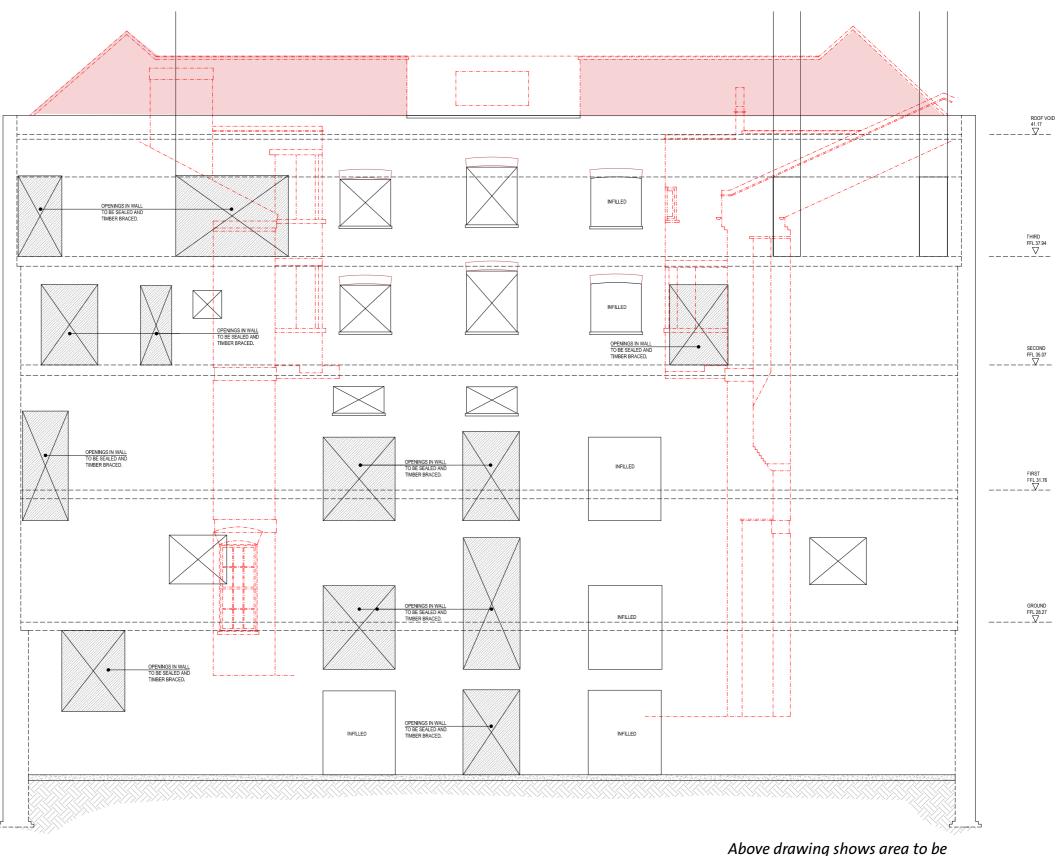
<u>SECTION B - B</u> (EXTERNAL WORKHOUSE WALL SHOWING TEMPORARY INFILL TO EXISTING OPENINGS)

NOTE.
FOR LOCATION OF SECTION B - B
REFER TO DRAWING MHA-ACM-WH-XX-DE-S-00006

Above drawing shows area to be demolished and areas to be temporary covered before rear elevation is reclad in brick. See drawing MHA-ACM-WH-XX-DE-S-00008.pdf for extent of area to be rebuilt in brick.

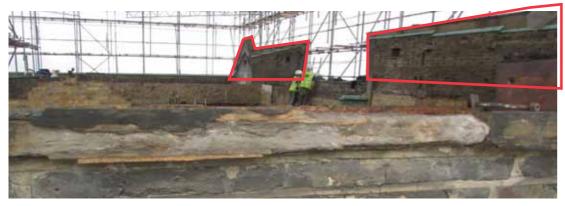
Photo 01 Existing high level parapet wall to be lowered to match existing parapet level to south, north & west facades. The above photo shows the existing York stone copings are largely degraded on the sky surface. Virtually all the copings are delaminating laterally along bedding planes leaving the whole unit friable.

- 1. Existing high level rear parapet (above 4th level ceiling) wall to be lowered to match adjoining parapet level as per the North & South Facade. (Shown on adjoining elevation highlighted in red). See adjoining photo.
- 2. Existing rear parapet to be lowered and demolished by hand removal.
- 3. Existing York stone copings are largely degraded on the sky surface. Virtually all the copings are delaminating laterally along bedding planes leaving the whole unit friable. New Stone coping to replace existing. Stone Profile to match existing.
- 4. Rear elevation as per previous conditions 5 the outer brick skin will be replaced with reclaimed bricks.

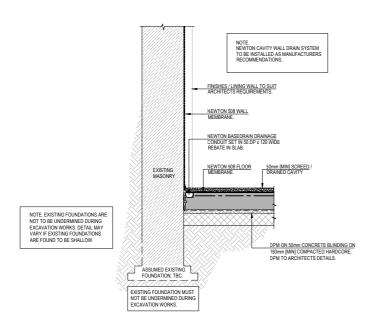
TYPICAL BASEMENT DRAIN CAVITY DETAIL

Please refer to Aecom drawing MHA-ACM-WH-XX-DE-S-00005 for 1:20 details.

- proposed new basement area replacing basement vault.
- Typical basement drain cavity detail
- Typical vent detail in external wall
- Formation of service void in existing steel floor beam.

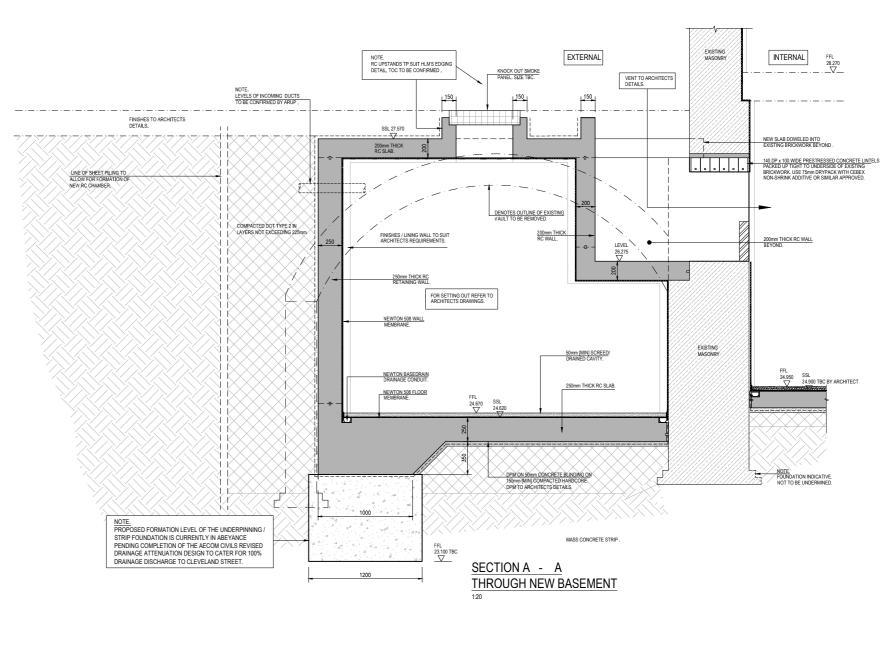
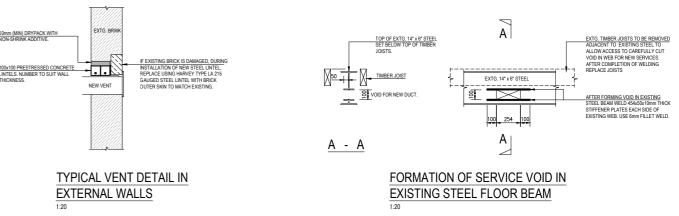
Details show the following:
