ARBORICULTURAL ASSESSMENT REPORT

For:	Client:	Oriel Services Limited
	Insurer:	Zurich Commercial Broker
Site:	Policyholder:	T Tasou, P Tasou, P Tascou and A Tascou
	Risk Address:	9 Woodchurch Road, London, NW6 3PL
Refs:	PRI Ref:	[REDACTED]
	Client Ref:	[REDACTED]
	Insurer Ref:	20-50-305636

Arborist Name:	Tom Peppiatt	Date:	29/08/2019
QC:	Margaret MacQueen	Date:	19/09/2019

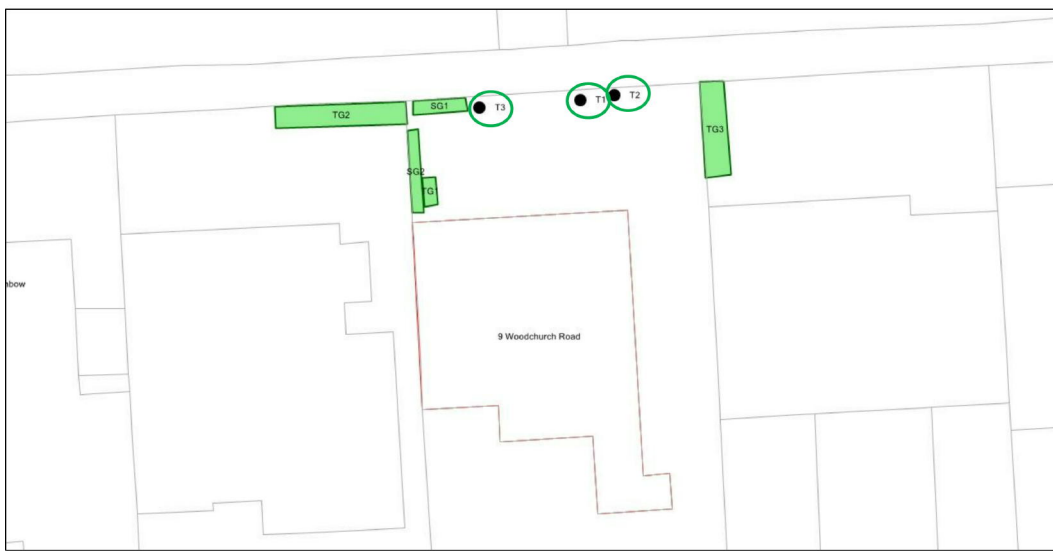
7.0 APPENDIX 2: SITE PLAN

Location:	9 Woodchurch Road, London, NW6 3PL
Job Ref:	[REDACTED]
Survey Date:	29/09/2019 - NTS
By Property Risk Inspection - Insurance Services	
Crown copyright 2016. License number [REDACTED]
