THE DIOCESE OF LONDON

ST PETERS VICARAGE, 53 BELZISE SQUARE,
LONDON, NW3 4HY

FULL CONSTRUCTION MANAGEMENT PLAN

October 2019

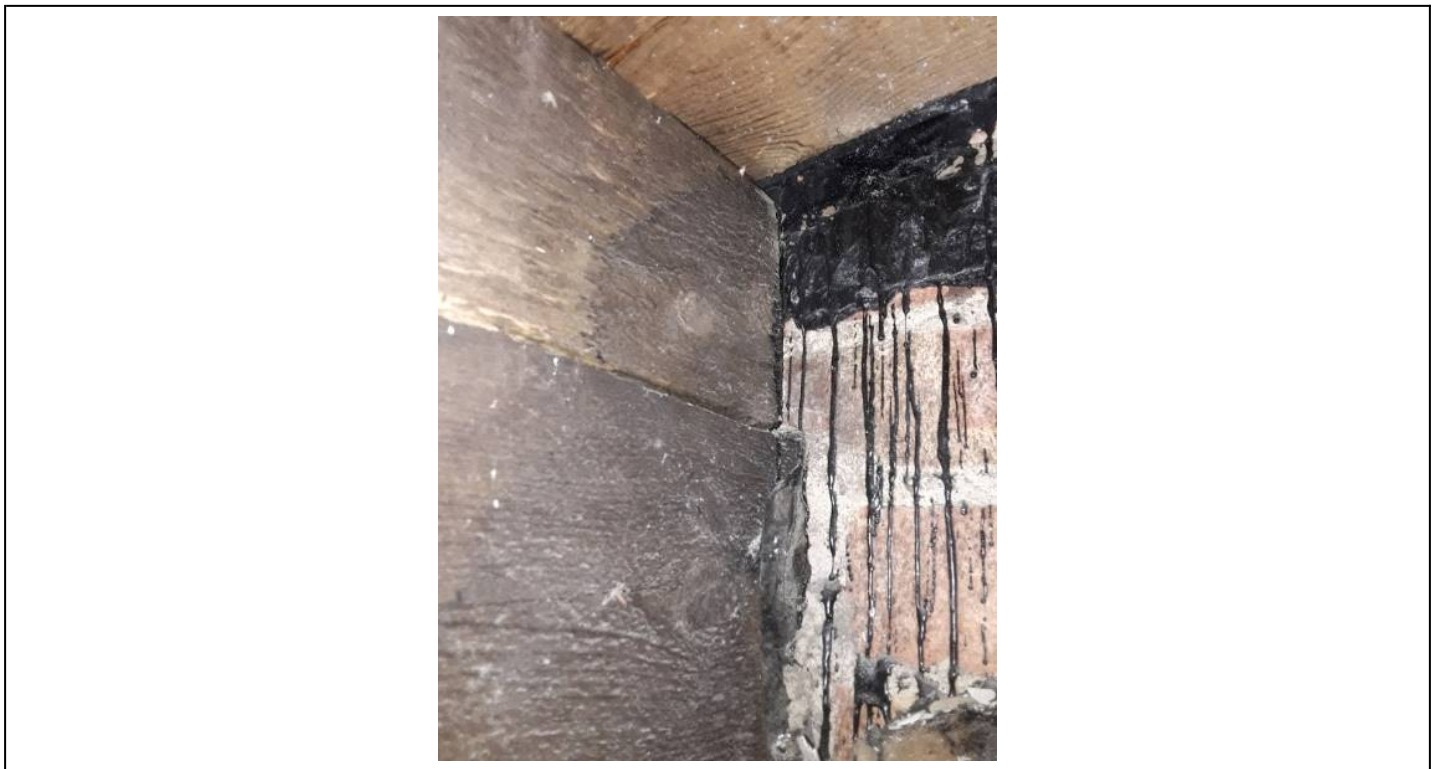
Item Number:	1 Ref Item: N/A	Sample Reference	AM001068
Item Description:	Damp proof course to timber framework passing through the brick walls within the ceiling void	Approx. Quantity:	N/A
Position:	Ceiling void	Identification:	Identified
Item Material:	N/A	Asbestos Present:	No Asbestos Detected

Total Assessment:	N/A	N/A
Sample notes:	N/A	
Comments:	Identified to all timber framework on 1st floor within rooms.	
Recommendation:	No further action required	Timescale: N/A

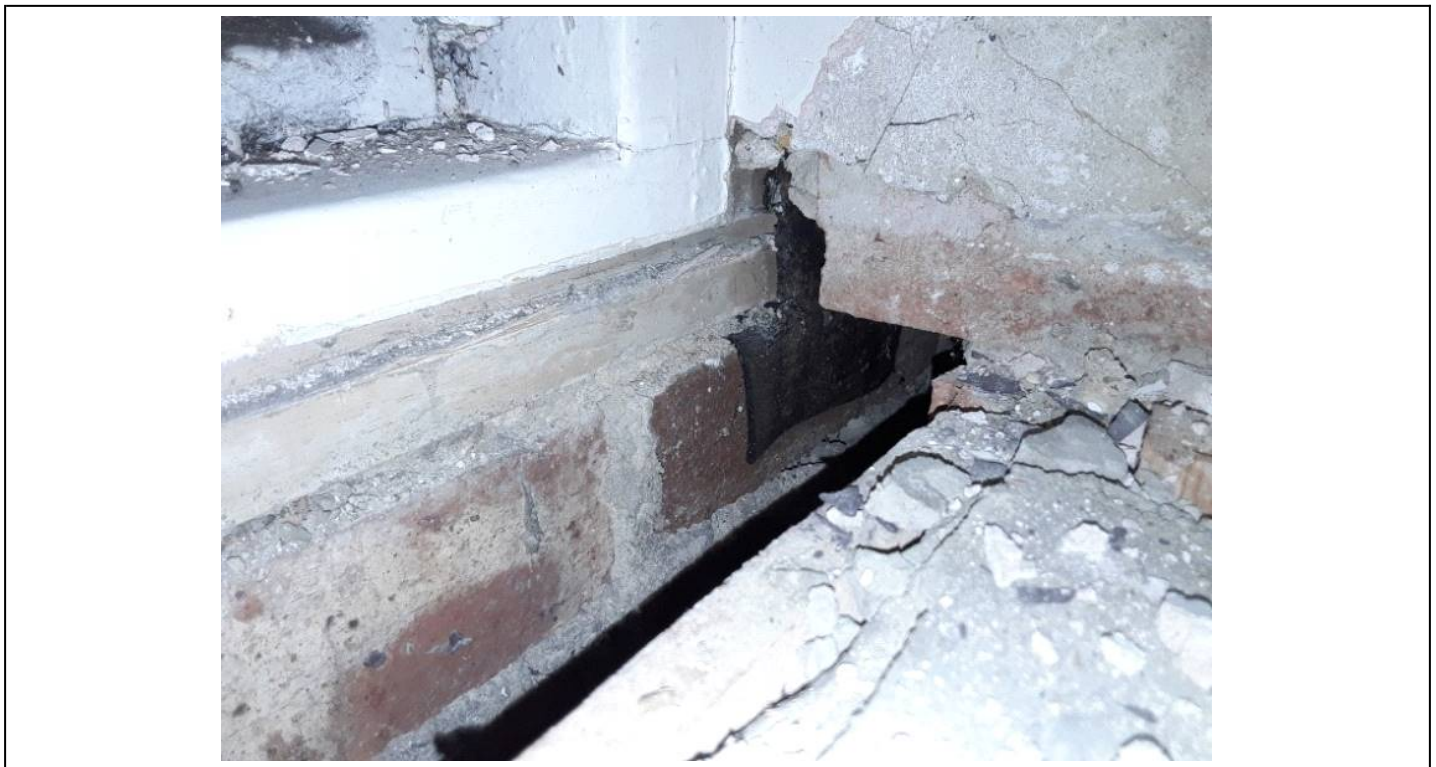
Item Number:	9 Ref Item: 1	Sample Reference	AS/ AM001068
Item Description:	Damp proof course to timber framework passing through the brick walls within the ceiling void	Approx. Quantity:	N/A
Position:	Ceiling void	Identification:	Strongly Presumed
Item Material:	N/A	Asbestos Present:	No Asbestos Detected

Total Assessment:	N/A	N/A	
Sample notes:	N/A		
Comments:	Identified to all timber framework on 1st floor within rooms.		
Recommendation:	No further action required	Timescale	N/A

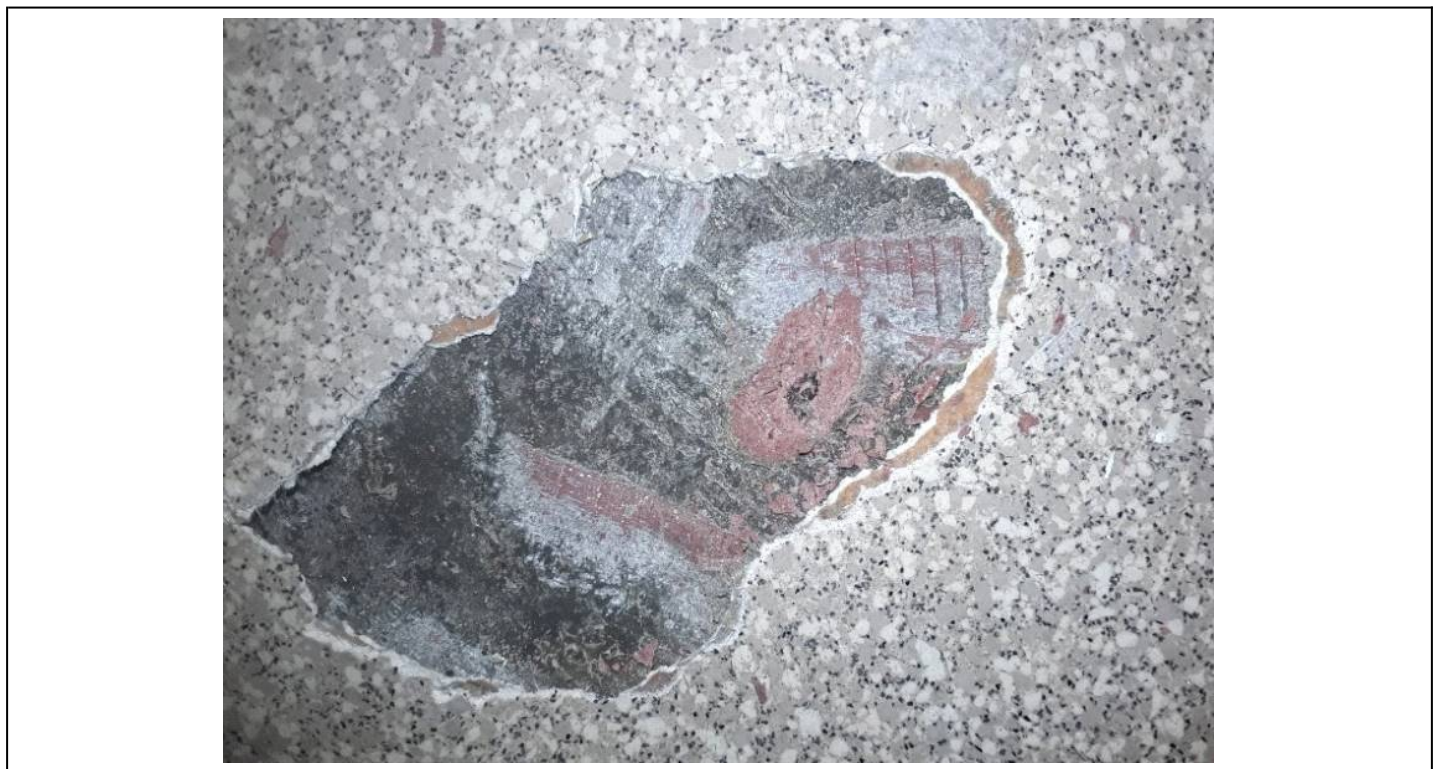
Item Number:	11 Ref Item: N/A	Sample Reference	AM001075
Item Description:	Vinyl tiles to the floor	Approx. Quantity:	15m ²
Position:	Floor	Identification:	Identified
Item Material:	Vinyl Floor tiles	Asbestos Present:	Chrysotile

MATERIAL ASSESSMENT (MA)		ACCESSIBILITY	
Product Type:	1	Easy	
Damage:	1		
Treatment:	0		
Asbestos Type:	1		
MA Score:	3

Total Assessment:	3	Low	
Sample notes:	N/A		
Comments:	Below the vinyl.		
Recommendation:	Remove under Controlled Conditions	Timescale	12 Months

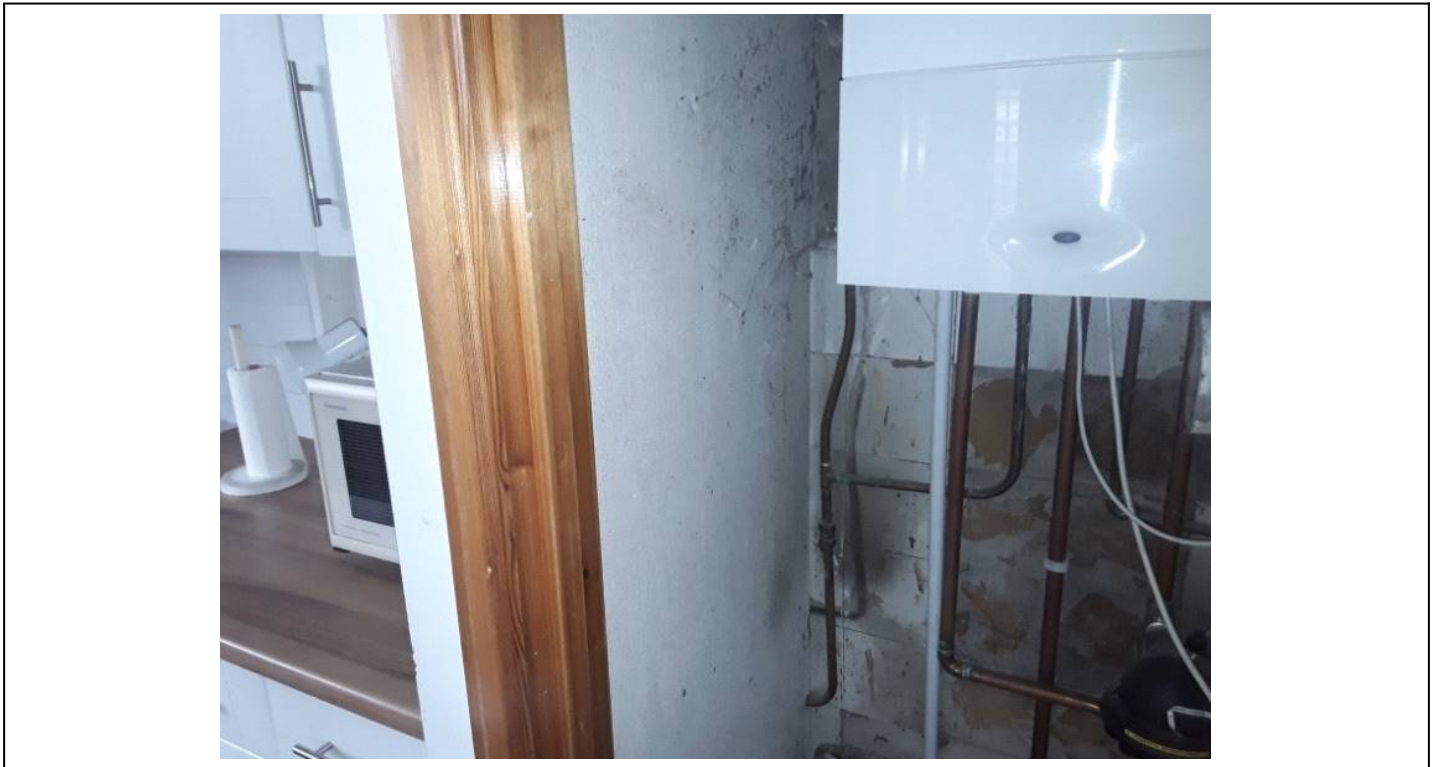
Item Number:	15 Ref Item: N/A	Sample Reference	AM001078
Item Description:	Board wall within cupboard	Approx. Quantity:	N/A
Position:	Wall	Identification:	Identified
Item Material:	N/A	Asbestos Present:	No Asbestos Detected

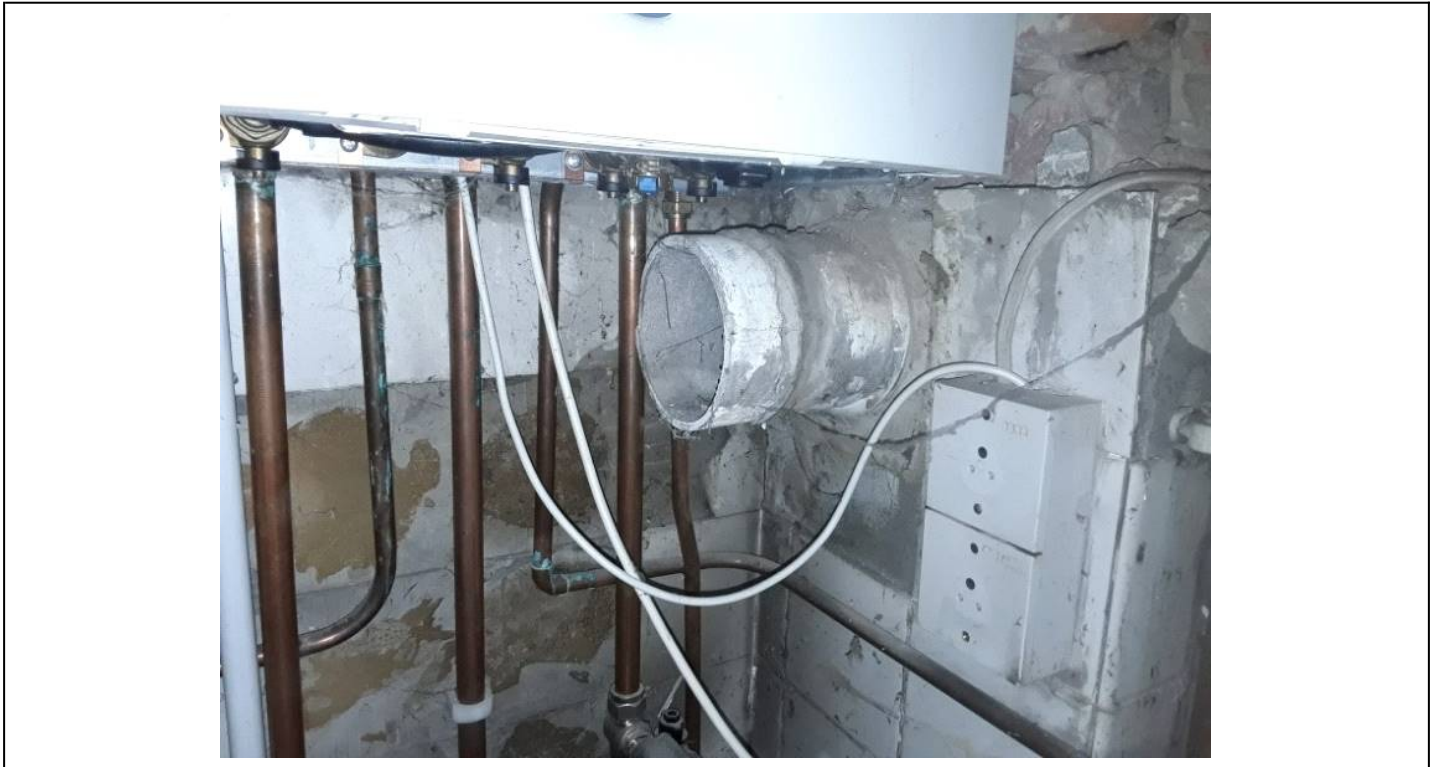
Item Number:	16 Ref Item: N/A	Sample Reference	AM001080
Item Description:	Redundant cement flue passing through wall	Approx. Quantity:	0.2lm
Position:	Flue	Identification:	Identified
Item Material:	Asbestos Cement	Asbestos Present:	Chrysotile

MATERIAL ASSESSMENT (MA)		ACCESSIBILITY	
Product Type:	1	Easy	
Damage:	1		
Treatment:	1		
Asbestos Type:	1		
MA Score:	4

Total Assessment:	4	Low	
Sample notes:	N/A		
Comments:	No comments		
Recommendation:	Remove under Controlled Conditions	Timescale	12 Months

Item No.	Building	Floor/ Room No	Room Description	Item Description	Type of Asbestos	Total Assessment	Action
16	St Peter's, Belsize Park	Ground Floor/1	Kitchen	Redundant cement flue passing through wall	Chrysotile	Very Low Risk	Remove under Controlled Conditions
27	St Peter's, Belsize Park	Ground Floor/4	WC	Screed to the floor	Chrysotile	Very Low Risk	Remove under Controlled Conditions
5	St Peter's, Belsize Park	1st Floor/4	Bedroom 3	Damp proof course within the window cavity	Chrysotile	Very Low Risk	Remove under Controlled Conditions
6 Refer: 5	St Peter's, Belsize Park	1st Floor/6	Bedroom 5	Damp proof course within part of the window cavity	Chrysotile	Very Low Risk	Remove under Controlled Conditions
8 Refer: 5	St Peter's, Belsize Park	1st Floor/7	WC	Damp proof course within the window cavity	Chrysotile	Very Low Risk	Remove under Controlled Conditions
11	St Peter's, Belsize Park	Ground Floor/1	Kitchen	Vinyl tiles to the floor	Chrysotile	Very Low Risk	Remove under Controlled Conditions

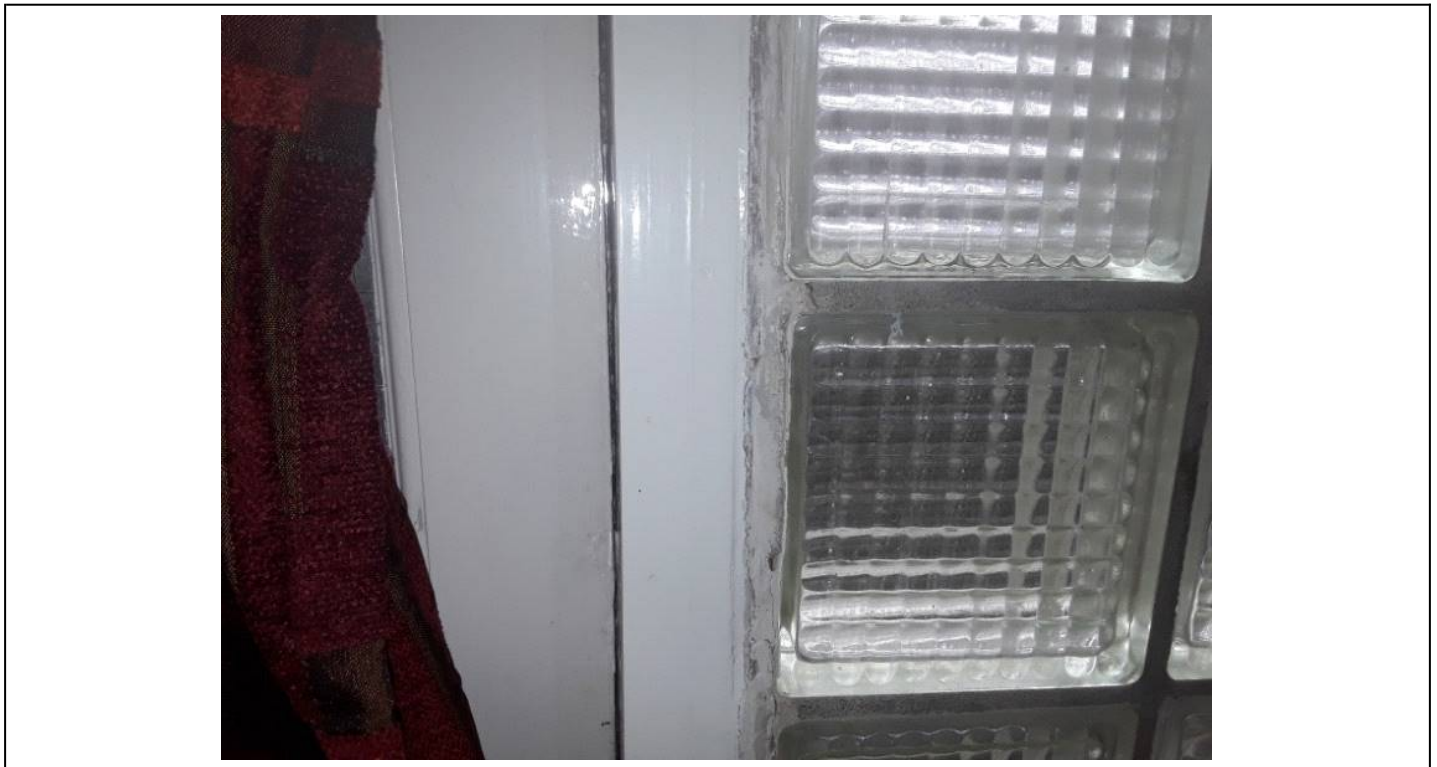
Item Number:	17 Ref Item: N/A	Sample Reference	AM001079
Item Description:	Mastic to glass of rear door surrounds	Approx. Quantity:	N/A
Position:	Glass	Identification:	Identified
Item Material:	N/A	Asbestos Present:	No Asbestos Detected

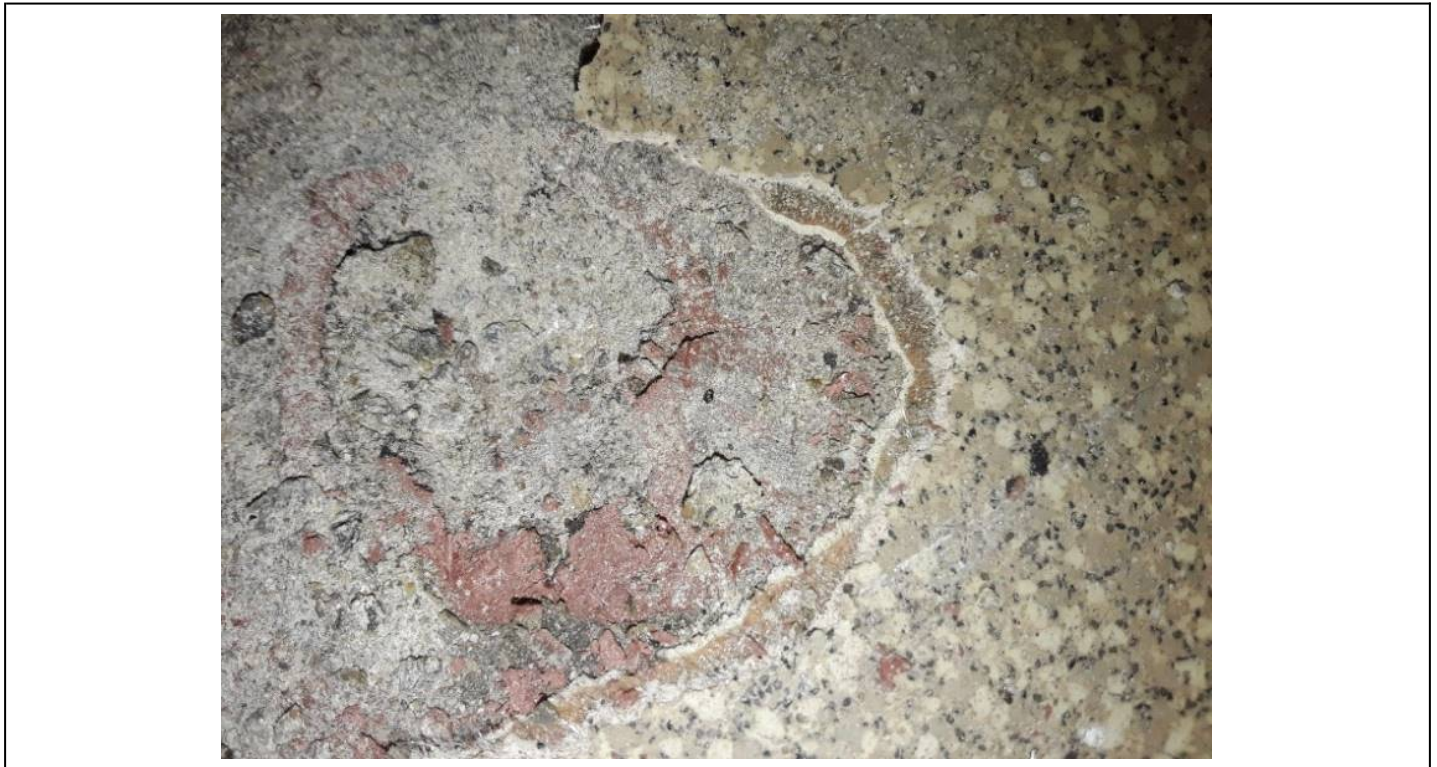
Item Number:	18 Ref Item: N/A	Sample Reference	AM001081
Item Description:	Bitumen below vinyl tiles	Approx. Quantity:	15m ²
Position:	Floor	Identification:	Identified
Item Material:	Vinyl Floor tiles	Asbestos Present:	Chrysotile

MATERIAL ASSESSMENT (MA)		ACCESSIBILITY	
Product Type:	1	Easy	
Damage:	1		
Treatment:	0		
Asbestos Type:	1		
MA Score:	3

Total Assessment:	3	Low	
Sample notes:	N/A		
Comments:	Asbestos found in both vinyl and bitumen		
Recommendation:	Remove under Controlled Conditions	Timescale	12 Months

18	St Peter's, Belsize Park	Ground Floor/1	Kitchen	Bitumen below vinyl tiles	Chrysotile	Very Low Risk	Remove under Controlled Conditions
19	St Peter's, Belsize Park	Ground Floor/2	Open Lounge and Dining Area	Vinyl tiles to the floor	Chrysotile	Very Low Risk	Remove under Controlled Conditions

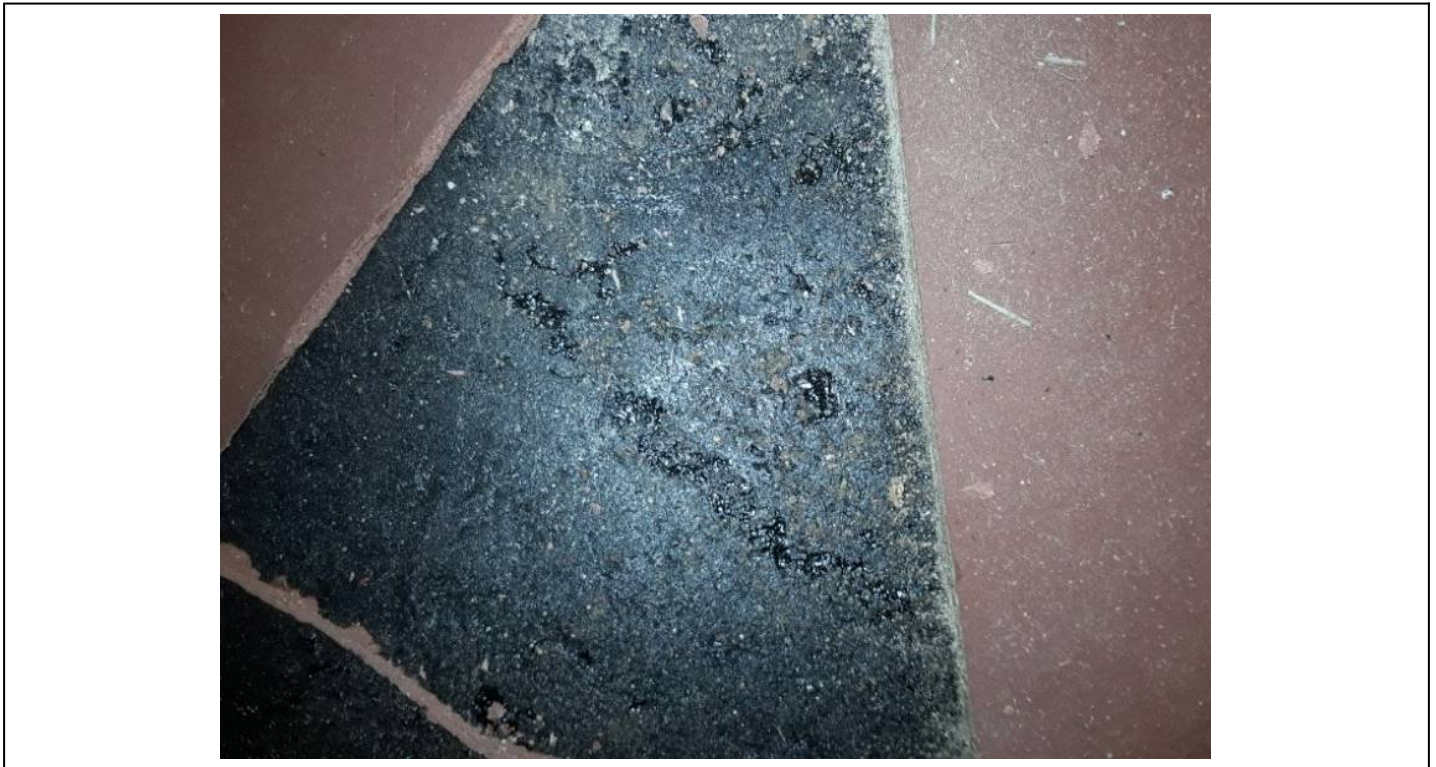
Item Number:	20 Ref Item: N/A	Sample Reference	AM001083
Item Description:	Bitumen adhesive below vinyl tiles	Approx. Quantity:	40m ²
Position:	Floor	Identification:	Identified
Item Material:	Reinforced Composite	Asbestos Present:	Chrysotile

MATERIAL ASSESSMENT (MA)		ACCESSIBILITY	
Product Type:	1	Easy	
Damage:	1		
Treatment:	0		
Asbestos Type:	1		
MA Score:	3

Total Assessment:	3	Low	
Sample notes:	N/A		
Comments:	No commentsn		
Recommendation:	Remove under Controlled Conditions	Timescale	12 Months

Item No.	Building	Floor/ Room No	Room Description	Item Description	Type of Asbestos	Total Assessment	Action
20	St Peter's, Belsize Park	Ground Floor/2	Open Lounge and Dining Area	Bitumen adhesive below vinyl tiles	Chrysotile	Very Low Risk	Remove under Controlled Conditions
23 Refer: 19	St Peter's, Belsize Park	Ground Floor/3	Play Room	Vinyl tiles to the floor	Chrysotile	Very Low Risk	Remove under Controlled Conditions
24 Refer: 20	St Peter's, Belsize Park	Ground Floor/3	Play Room	Bitumen adhesive below vinyl tiles	Chrysotile	Very Low Risk	Remove under Controlled Conditions
29	St Peter's, Belsize Park	Ground Floor/6	Hallway	Vinyl tiles to the floor	Chrysotile	Very Low Risk	Remove under Controlled Conditions
30	St Peter's, Belsize Park	Ground Floor/6	Hallway	Bitumen adhesive below vinyl tiles	Chrysotile	Very Low Risk	Remove under Controlled Conditions
34	St Peter's, Belsize Park	External/1	External	Putty to glass surrounding rear door	Chrysotile	Very Low Risk	Remove under Controlled Conditions

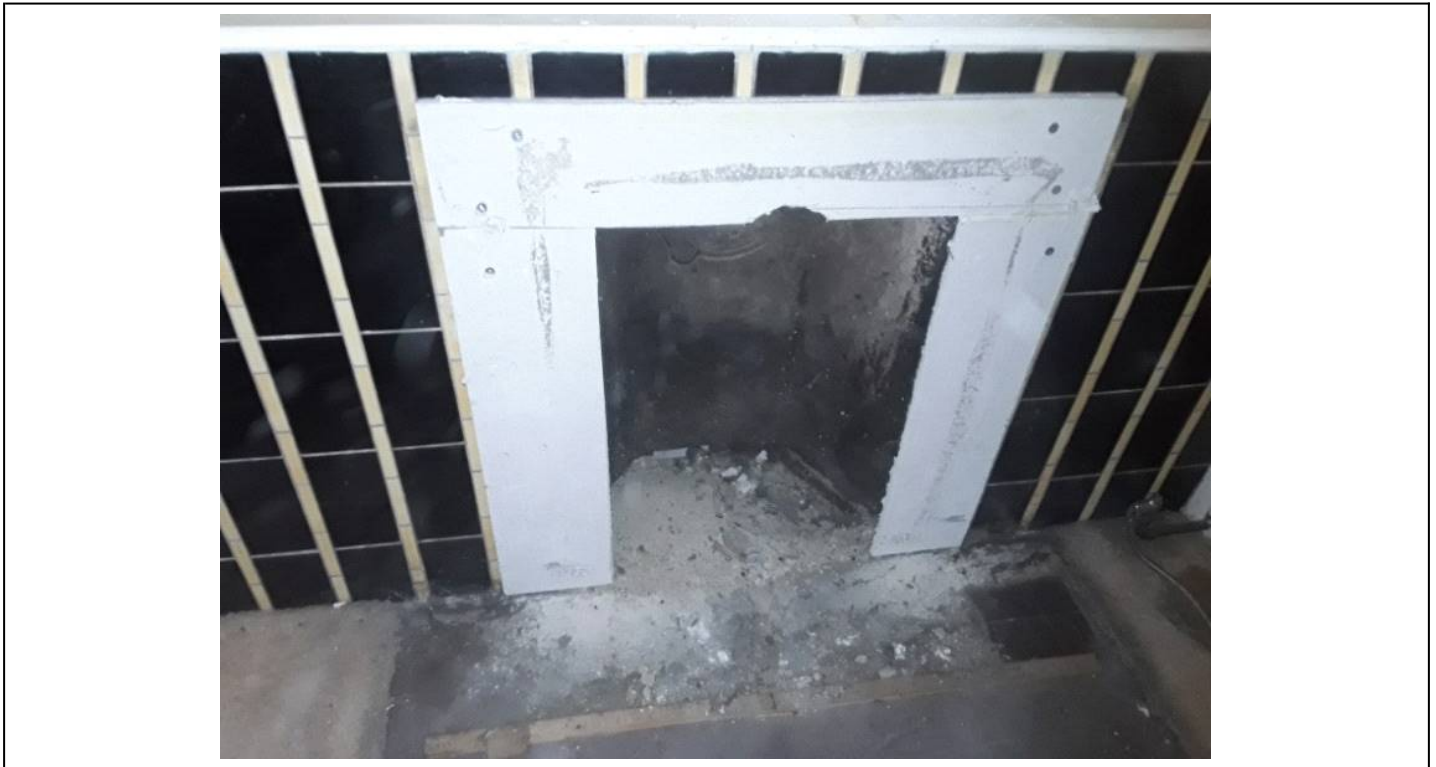
Item Number:	21 Ref Item: N/A	Sample Reference	AM001084
Item Description:	Board infills rear of fireplace	Approx. Quantity:	N/A
Position:	Fireplace	Identification:	Identified
Item Material:	N/A	Asbestos Present:	No Asbestos Detected

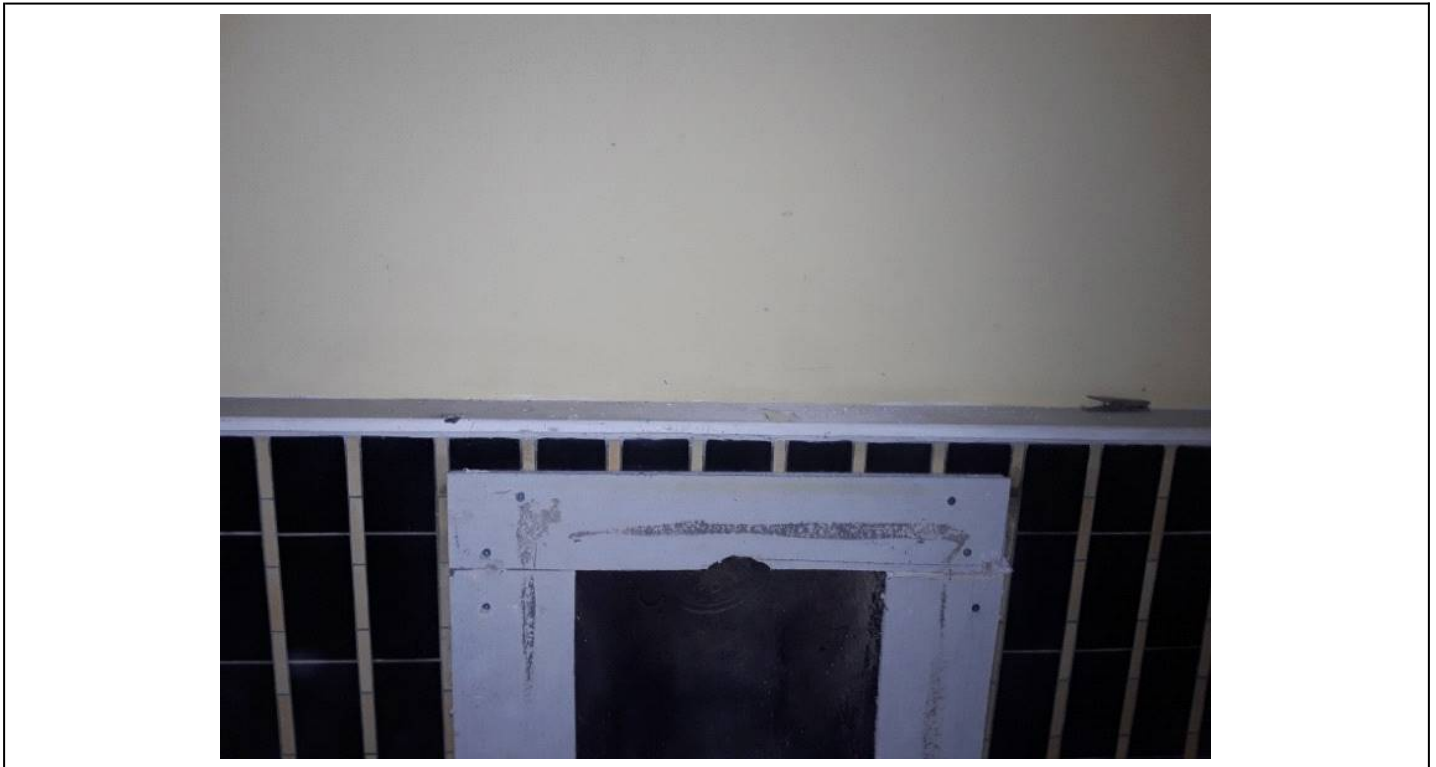
Item Number:	22 Ref Item: N/A	Sample Reference	AM001085
Item Description:	Bakerlite sill to fireplace	Approx. Quantity:	N/A
Position:	Fireplace	Identification:	Identified
Item Material:	N/A	Asbestos Present:	No Asbestos Detected

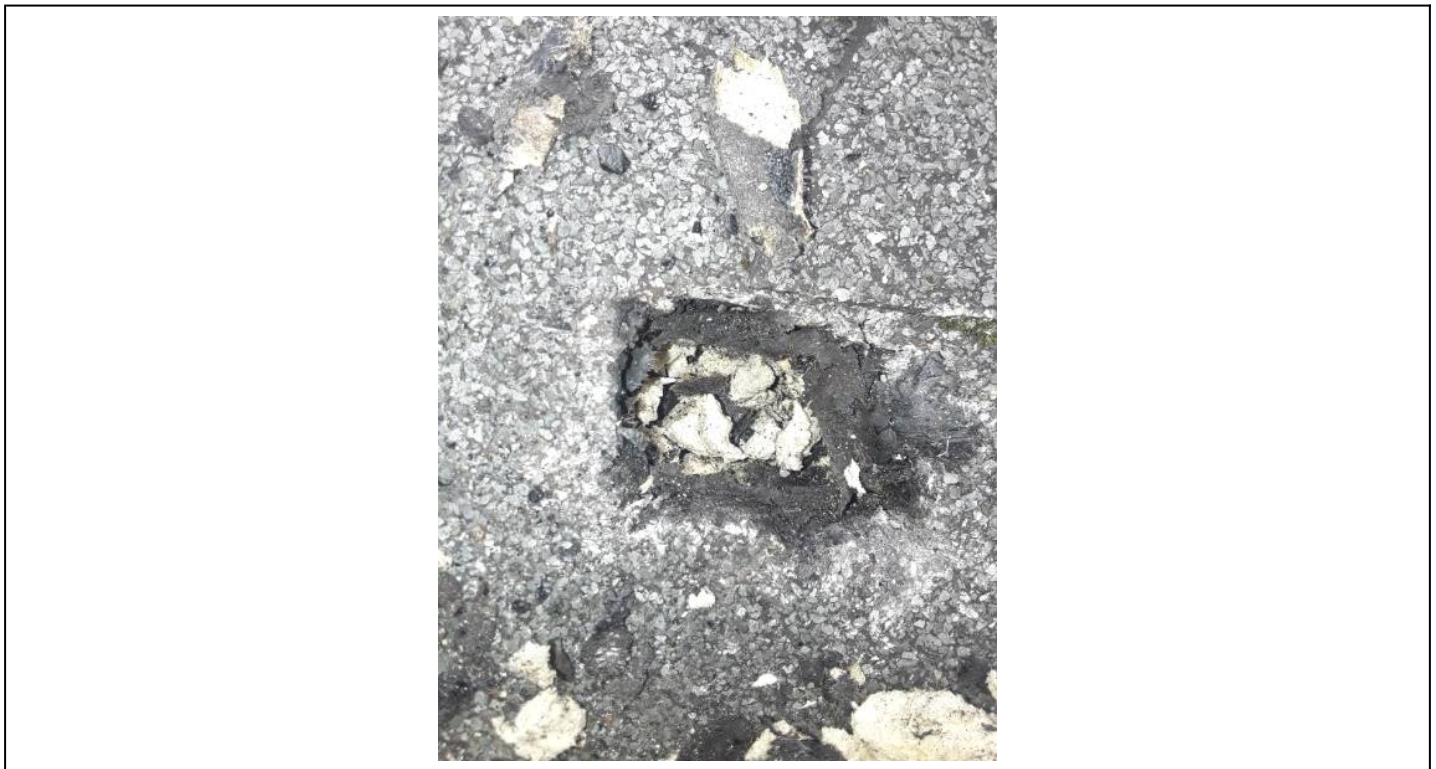
Item Number:	31 Ref Item: N/A	Sample Reference	AM001091
Item Description:	Bitumen felt to the flat roof	Approx. Quantity:	N/A
Position:	Roof area	Identification:	Identified
Item Material:	N/A	Asbestos Present:	No Asbestos Detected

Total Assessment:	N/A	N/A	
Sample notes:	N/A		
Comments:	Below the asphalt.		
Recommendation:	No further action required	Timescale	N/A

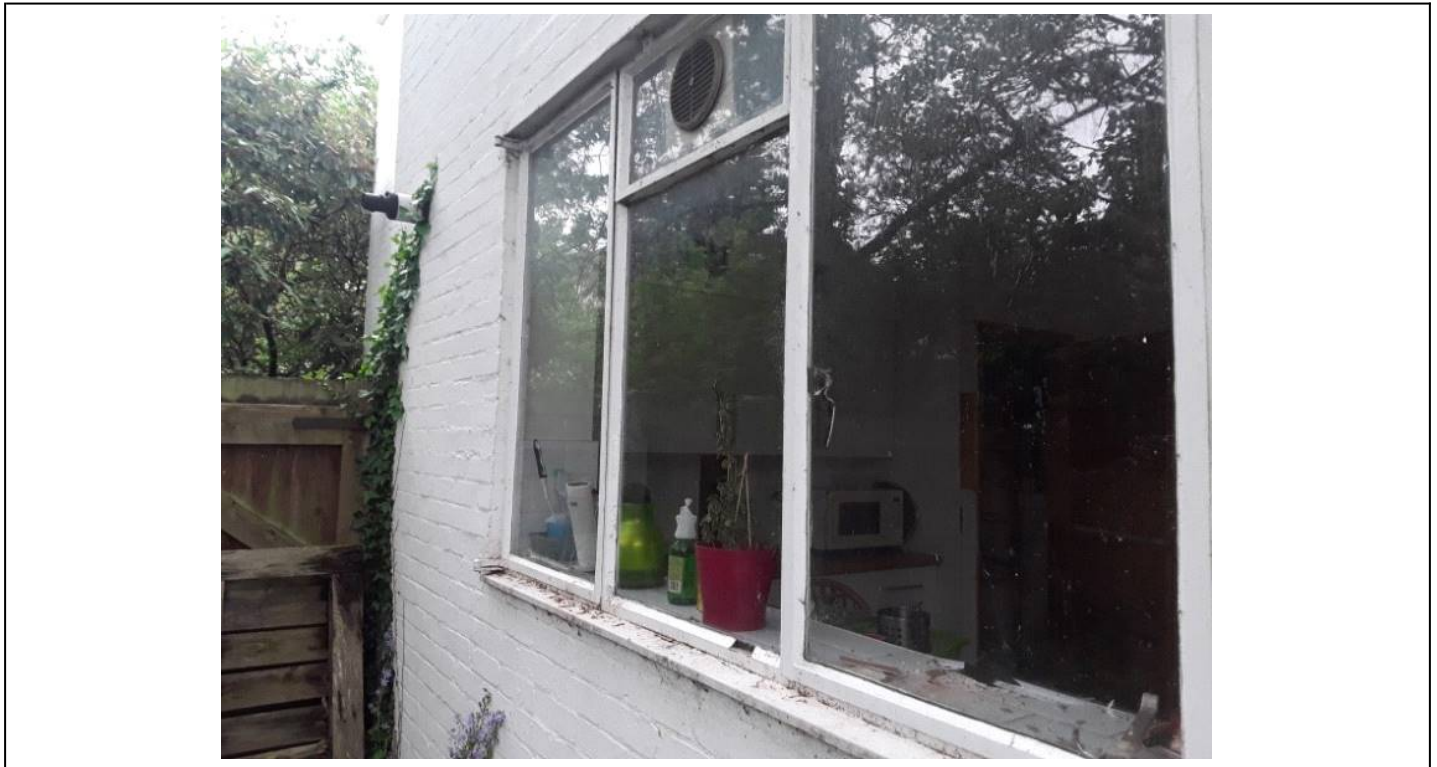
Item Number:	33 Ref Item: N/A	Sample Reference	AM001092
Item Description:	Putty to metal framed windows	Approx. Quantity:	N/A
Position:	Windows	Identification:	Identified
Item Material:	N/A	Asbestos Present:	No Asbestos Detected

Total Assessment:	N/A	N/A	
Sample notes:	N/A		
Comments:	Identified throughout property		
Recommendation:	No further action required	Timescale	N/A
