Rev	Date	Notes	Architect	Contact	Project	Drawing Title	Drawing Status	Job	Drawing No	Rev
A	25.04.2019	First issue.	ROBERT LOADER	t: 0794 880 1144	Primrose Hill School	BASEMENT WINDOWS	INFORMATION	PHS	101	A
	18.10.2019	Revised to include single glazing, as requested by the Planners	RIBA ARB	e: studio@gordenrow	London NW1	PLAN, SECTION & ELEVATION	PROPOSED			
NOTES 1. Where applicable, this drawing is to be read in conjunction with specification 2. All dimensions to be checked on site prior to commencement of works. Contractor to report back any discrepancies with site dimensions.

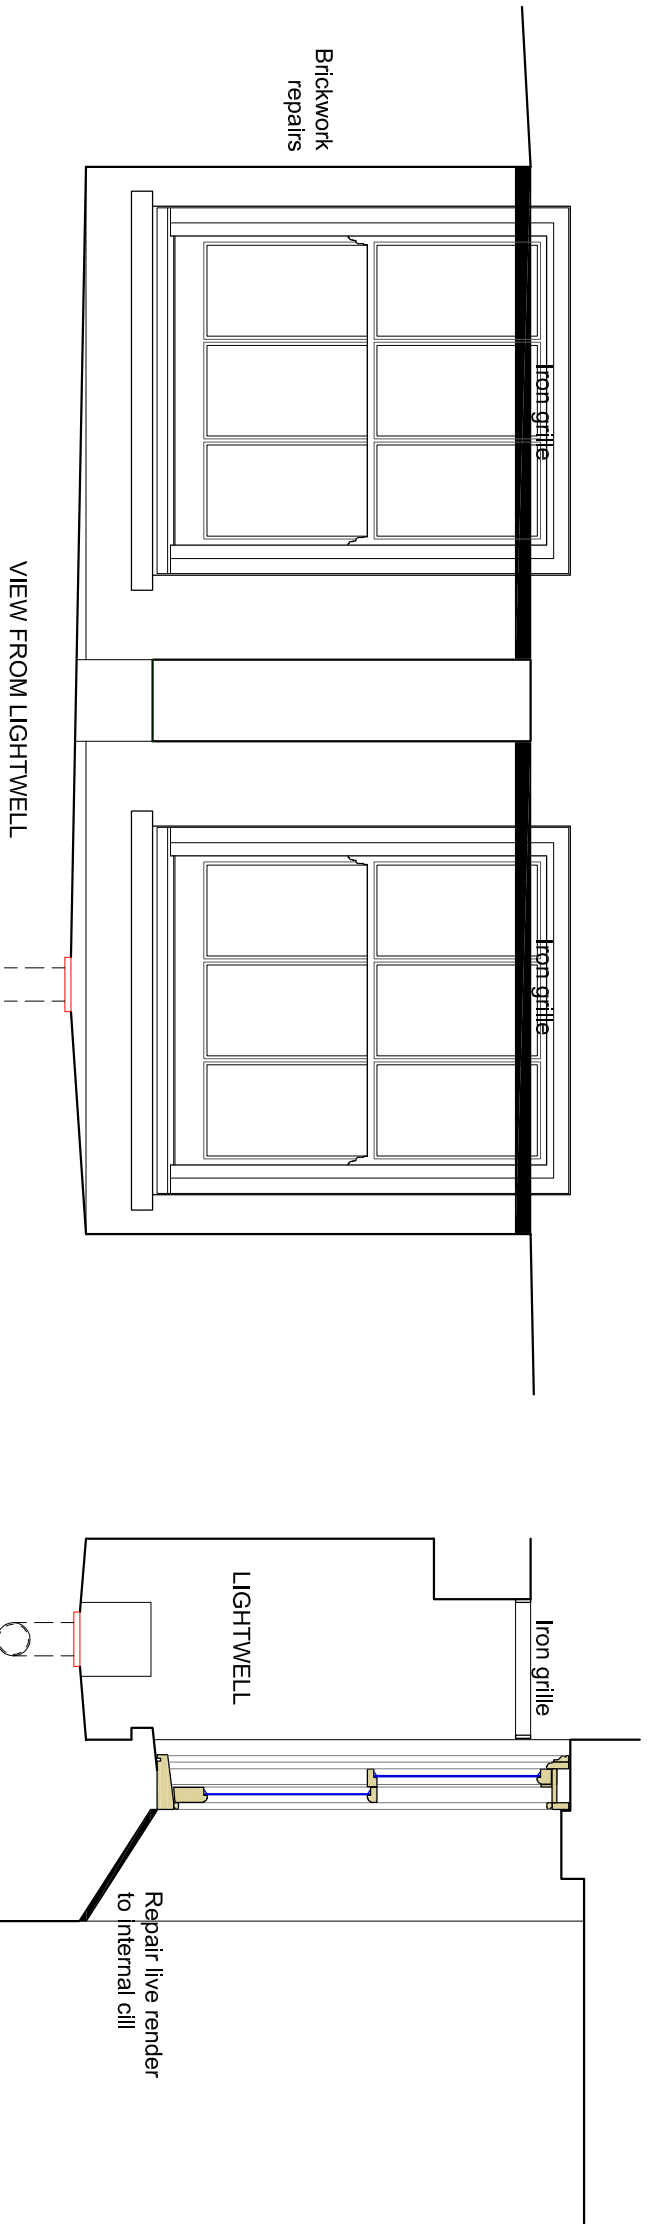
Repair live render to internal cill

Painted 50x22mm timber ogee architraves all round

- Steam clean external lightwell brickwork with Doff cleaning equipment to manufacturer's recommendations.
- Brickwork repairs to SE's specification if required.
- CCTV Survey drain connection and clear if required.
- Replace broken gully.
- Repair live render to internal cill.

- New 50mm thick sash windows from Accoya timber with factory-applied paint finish.
- Internal and external ovolo mouldings and profiles and timber component sizes: to match existing adjacent sash windows.
- Single-glazing units. Putty glazing, protect DGU seals from oils.
- Recessed weatherstripping all round sashes and sash beads.
- Recessed drips to cill and base of lower sash.
- Painted 50x22mm timber ogee external architraves: to match existing adjacent sash windows.
