AKERA ENGINEERS

**18A FROGNAL GARDENS
LONDON NW3 6XA**

BASEMENT IMPACT ASSESSMENT

**PROPOSED DEVELOPMENT AT
18 A FROGNAL GARDENS, LONDON NW3 6XA**

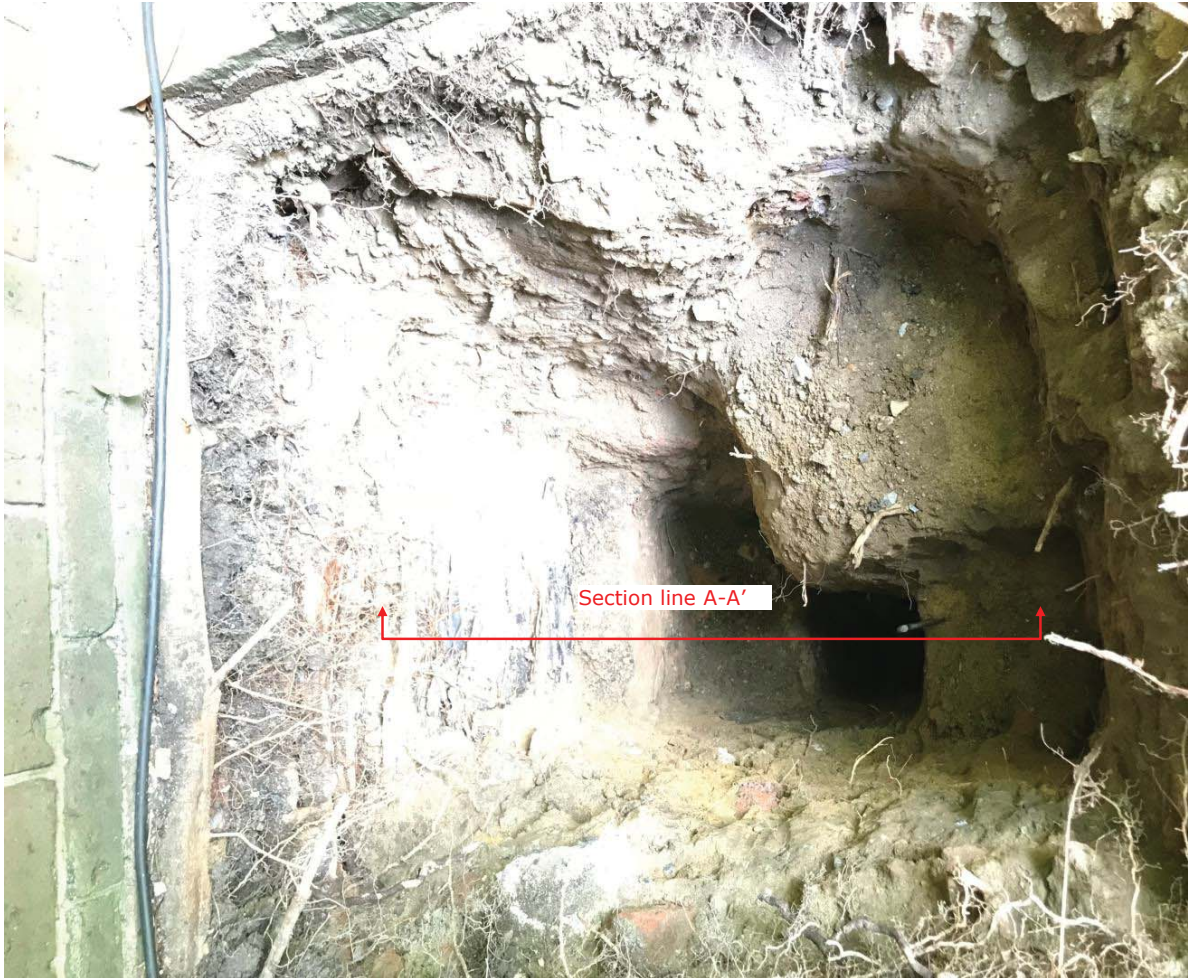
PHOTOGRAPHS

Date:	08/08/19	Groundwater details	Samples
Equipment:	Hand excavation	• Dry	1.00m to 2.00m E
Stability:	Stable		
Remarks:		Logged by: SC

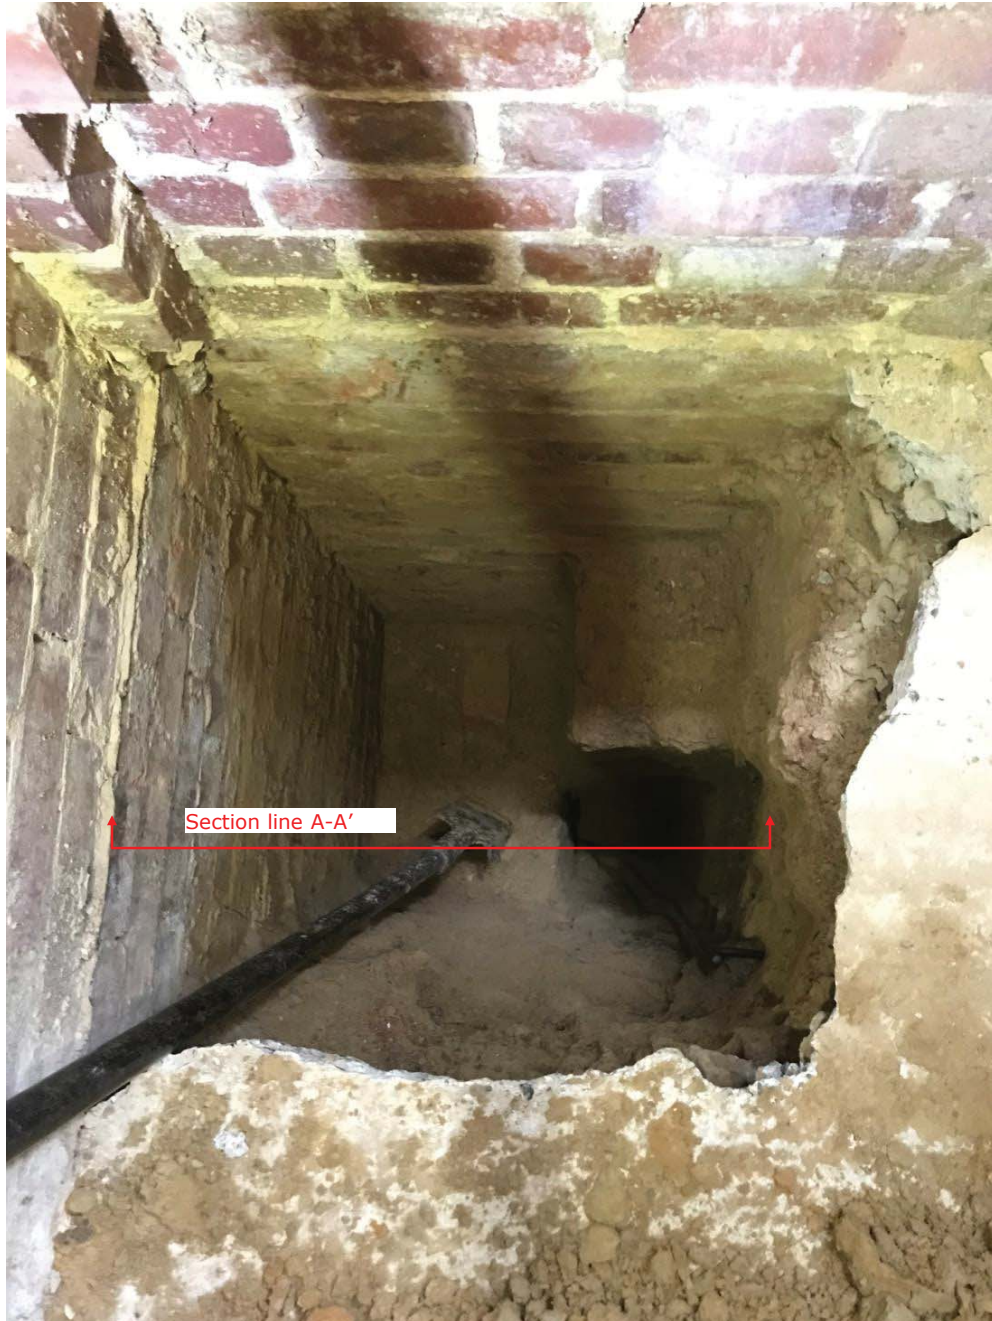
PHOTOGRAPHS

Date:	08/08/19	Groundwater details	Samples
Equipment:	Hand excavation	• Dry	1.00m to 2.00m E
Stability:	Stable		
Remarks:			Logged by: SC

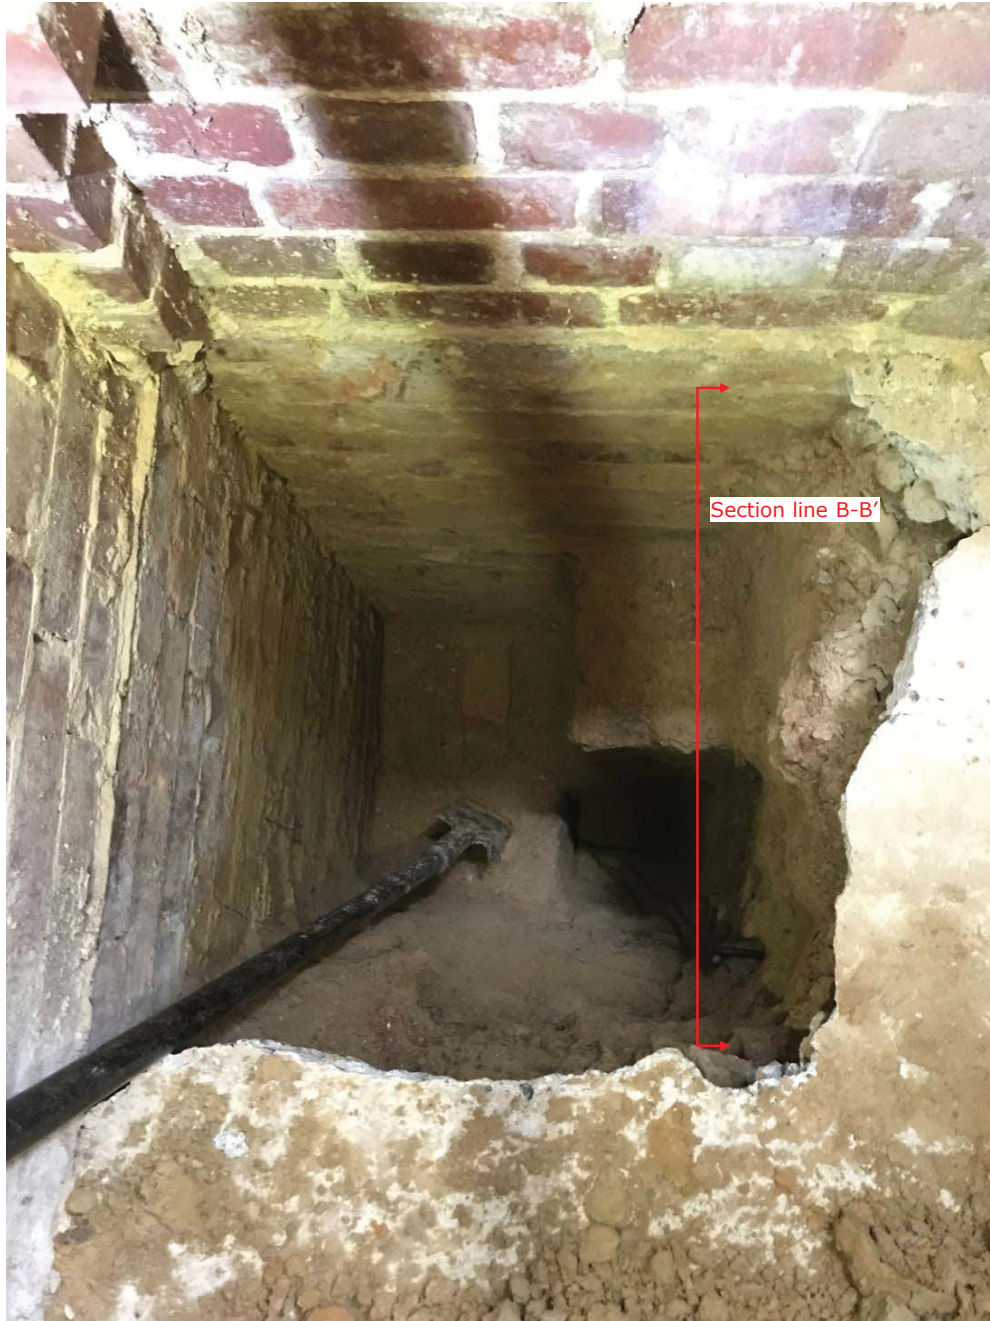
PHOTOGRAPHS

Date:	08/08/19	Groundwater details	Samples
Equipment:	Hand excavation	• Dry	1.00m to 2.00m E
Stability:	Stable		
Remarks:			Logged by: SC

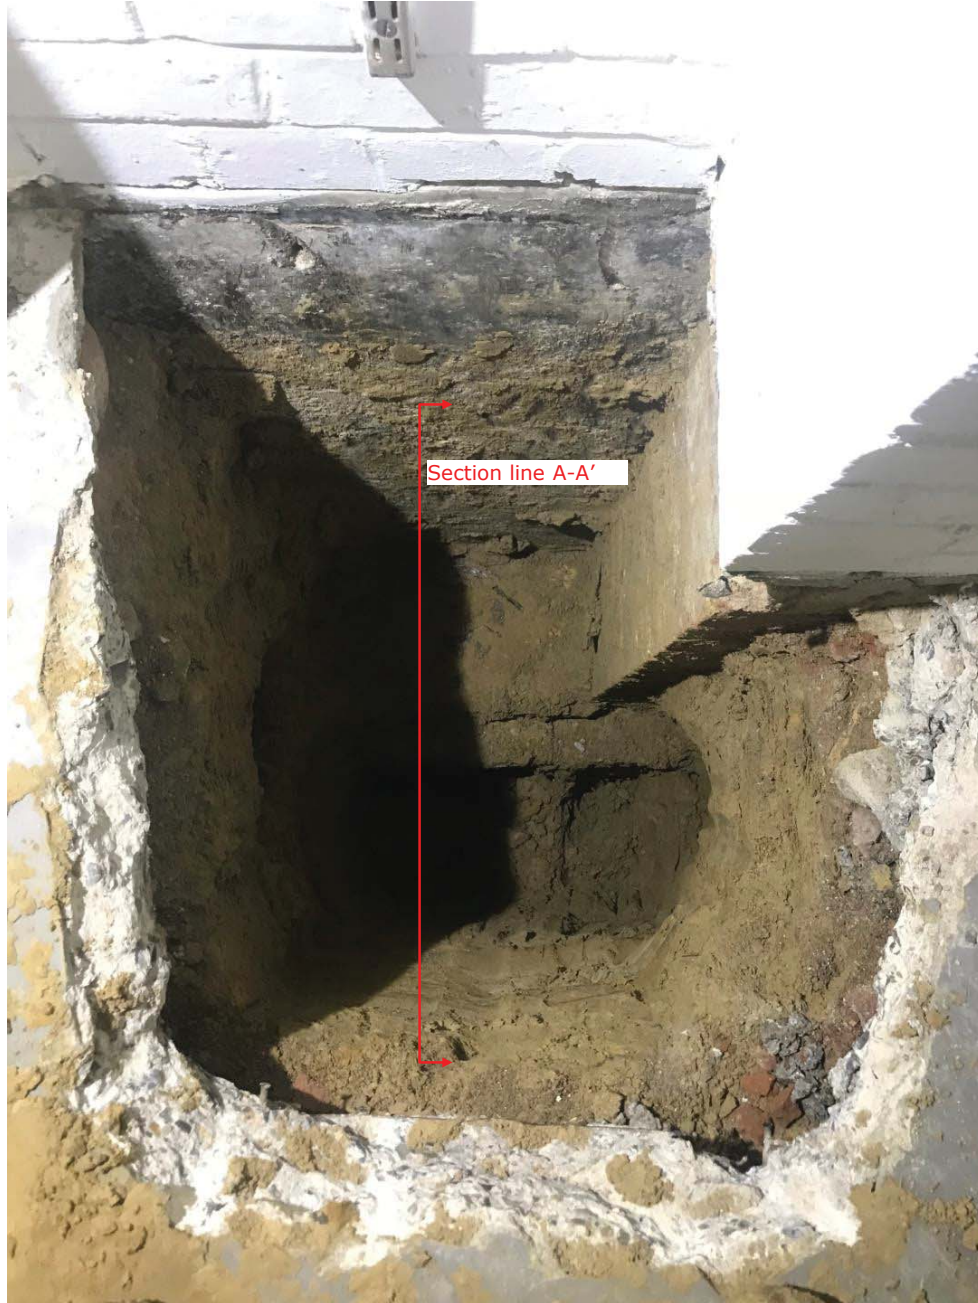
PHOTOGRAPHS

Date:	09/08/19	Groundwater details	Samples
Equipment:	Hand excavation	• Dry	1.50m E
Stability:	Stable		
Remarks:	Unable to progress further due to concrete and pipe obstructions		Logged by: SC
