Camden Town Conservation Area Advisory Committee

Comments on proposed alterations to 3a, Camden Road 20.10.19

Planning Application ref. 2019/3693/P

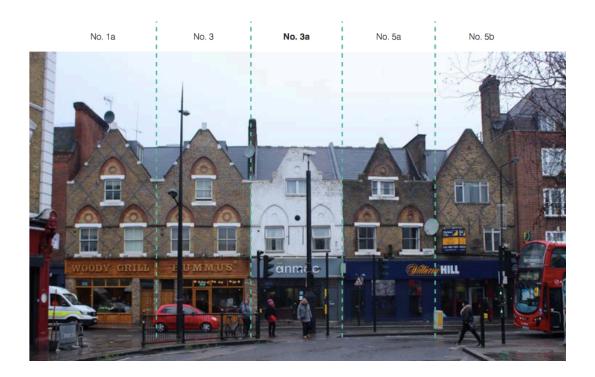
The Design and Access Statement confuses the numbering of the buildings in the terrace, referring them as "1a, 3, 3a, 5a and 5b". This should read 1a, 3, 3a, 5 and 5a, as it shows on the OS map and the application drawings.

It is not clear why the author of the report should do this, as the location plan submitted with the application gives the numbers correctly. It is possibly because the actual numbers on the door are misleading.

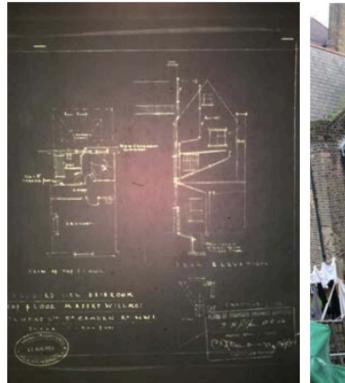
Rear elevation of 5a Camden Rd from 1954

The above 1954 drawing is of no. 5a

Current rear elevation - 5a Caranden Al

This building is no. 5, not 5a

Page 12 of the report makes the case for the rear elevation of no. 5 Camden Road (to the immediate right of the application site) not being original. The report says that the 1954 drawings of no. 5a show the elevations of no. 5:

"It is evident from looking at the drawing from 1954 that the current rear facade at 5a Camden Road is not original. The window order has changed, as well as the roof structure."

This is plainly erroneous. These elevations are of the building at the right-hand end of the terrace (it shows the neighbouring 1930s block of flats). The front elevation of this building is modern, maybe rebuilt after sustaining bomb-damage, and is an approximation of the design of nos. 1a and 3, without the blind arches over the windows or the stone dressings, although an attempt has been made to match the diagonal brick pattern.

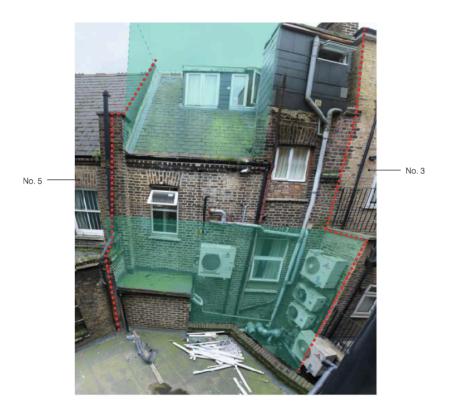
The photo of the rear of no. 3a correctly labels the neighbouring building as no. 5.

The existing rear elevation of no. 5a is not shown.
