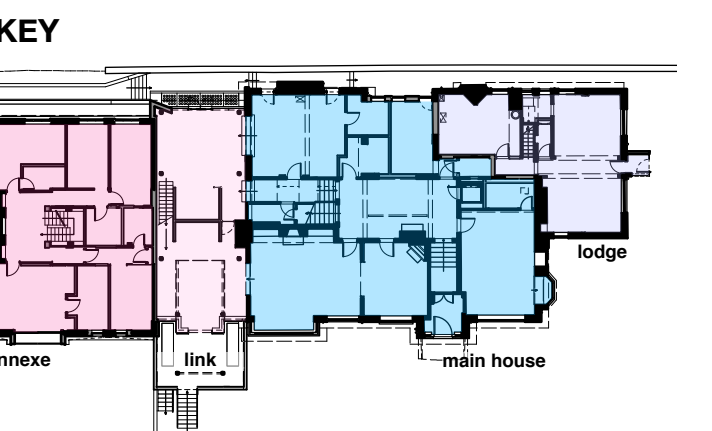
new doorway formed, to reflect and match exactly existing doorway to guest bedroom. architraves in section and pattern and door seating to follow original design exactly

new infill wall panel to replace removed reception screen and desk

new extension formed in lightweight construction. insulated timber frame walls finished with bronzed coloured sheeting, site formed, with standing seam

existing lift and plant is removed. new platform lift is smaller and allows space for a service riser. see drawings 4501 and 4502

existing cornices are retained and protected. new sections for to and reflect to match the original exactly glazed screen to full height with supporting structure in bronze anodised aluminum. screen appears frameless when viewed from outside with invisible recessed edge frame and silicon jointing

circular pavement roof lights to filter natural light into the cinema room below

existing cornices retained and protected. new sections to match exactly, following the downstand beams, and tracing the original room layout

new entrance porch, formed in glass and insulated timber frames fitted with bronze coloured metal skin with standing seams

non original handrails are removed from paneling, repair damage created by the fixings and refurbish joinery

existing cabinetry retained and protected. restore joinery and ironmongery where necessary.

archway is carefully re-opened, existing joinery is retained and must be protected. opening is fitted with new bi-folding double panelled doors. please refer to drawing no 4200 for details

flush walk on glass roof lights
