Tree survey plan SHA 681 TSP

Sharon Hosegood
ASSOCIATES

ARBORICULTURAL IMPACT ASSESSMENT REPORT
BS 5837:2012 'Trees in relation to design, demolition and construction.
Recommendations'

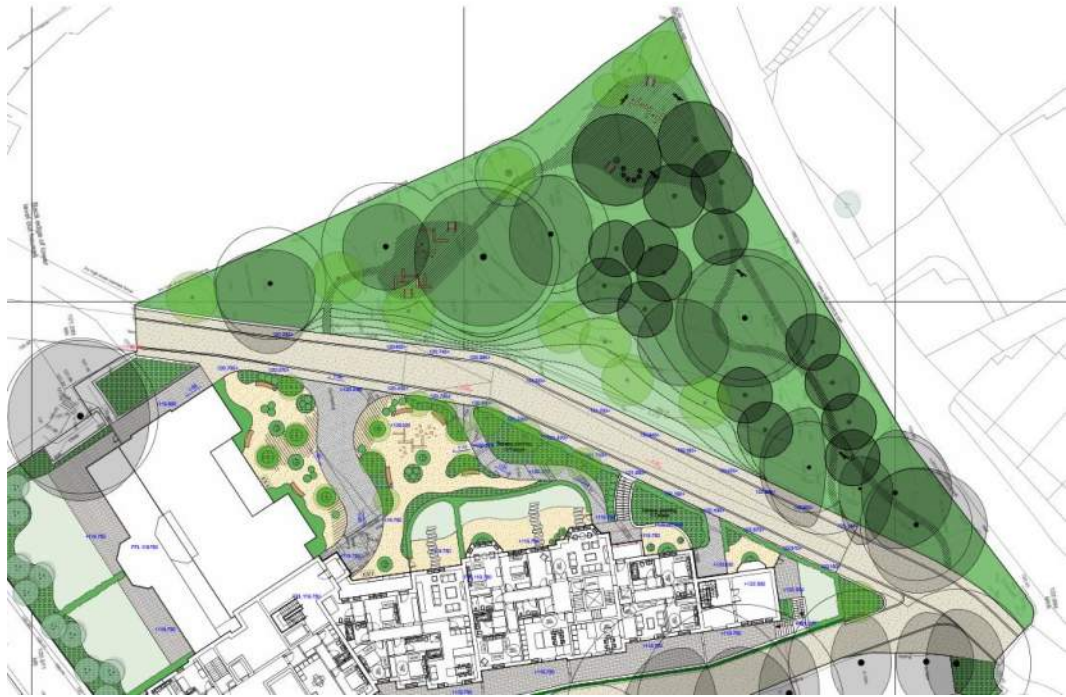
Plan 5 - extract from Landscape General arrangement plan by Planit E Ltd drawing number 1926-PLA-00-GF-DR-L-0001 Rev P01. Do not scale, north is vertical.

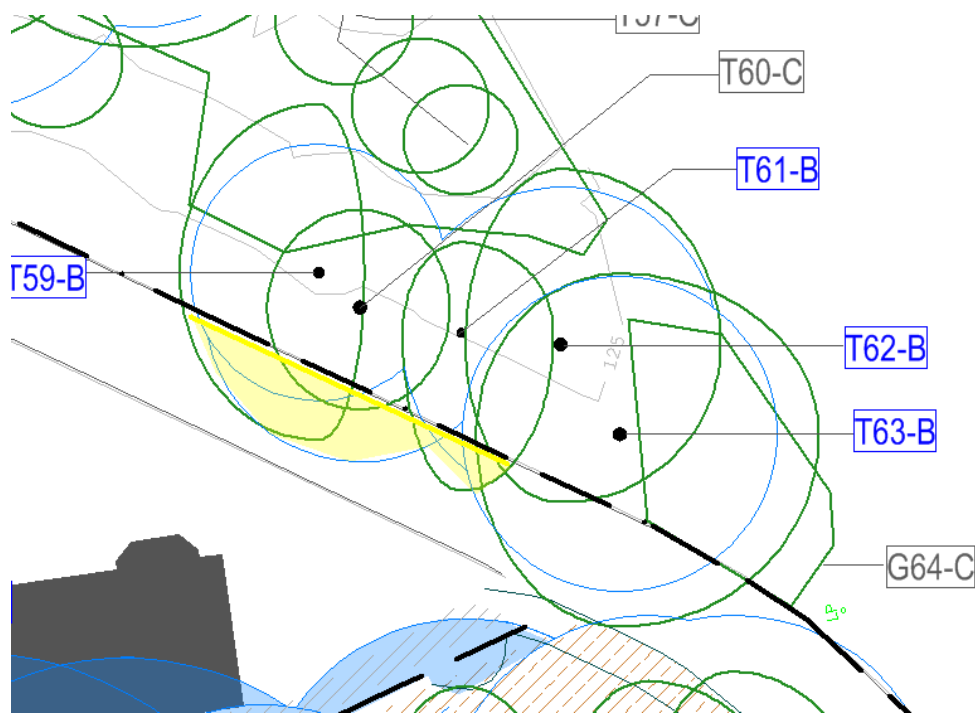
Plan 6 – extract from SHA 681 TPP2 – yellow area is the area for root pruning by the arboriculturist to allow for the excavation for a sloping level including the construction make up of the road. Do not scale. North is vertical.

6.8.5 Spedan Close will need to be lowered within the root protection area of T59 - T61 yew.

A TreeRadar survey was conducted by TreeRadar UK in September 2019. The results showed that *'Roots are found in very low rooting densities throughout the scan lines, with the majority of the roots found in an unevenly distributed band between 35-50cm deep and few deeper. This shallow rooting pattern indicates adventitious roots, growing to exploit the condensation layer beneath the surface, rather than larger structural roots. Again a very large number of non-root reflectors and services were found within the data.'*

Given the data, I am content the impact on the trees structure and vitality will be negligible. A full method statement for the root pruning will be produced post planning, but the principle is one of root pruning and facing back with plastic sheeting and hessian. The edge of the drive would need to be retained to prevent the bank from slipping, and the detail of this will also form part of the method statement.

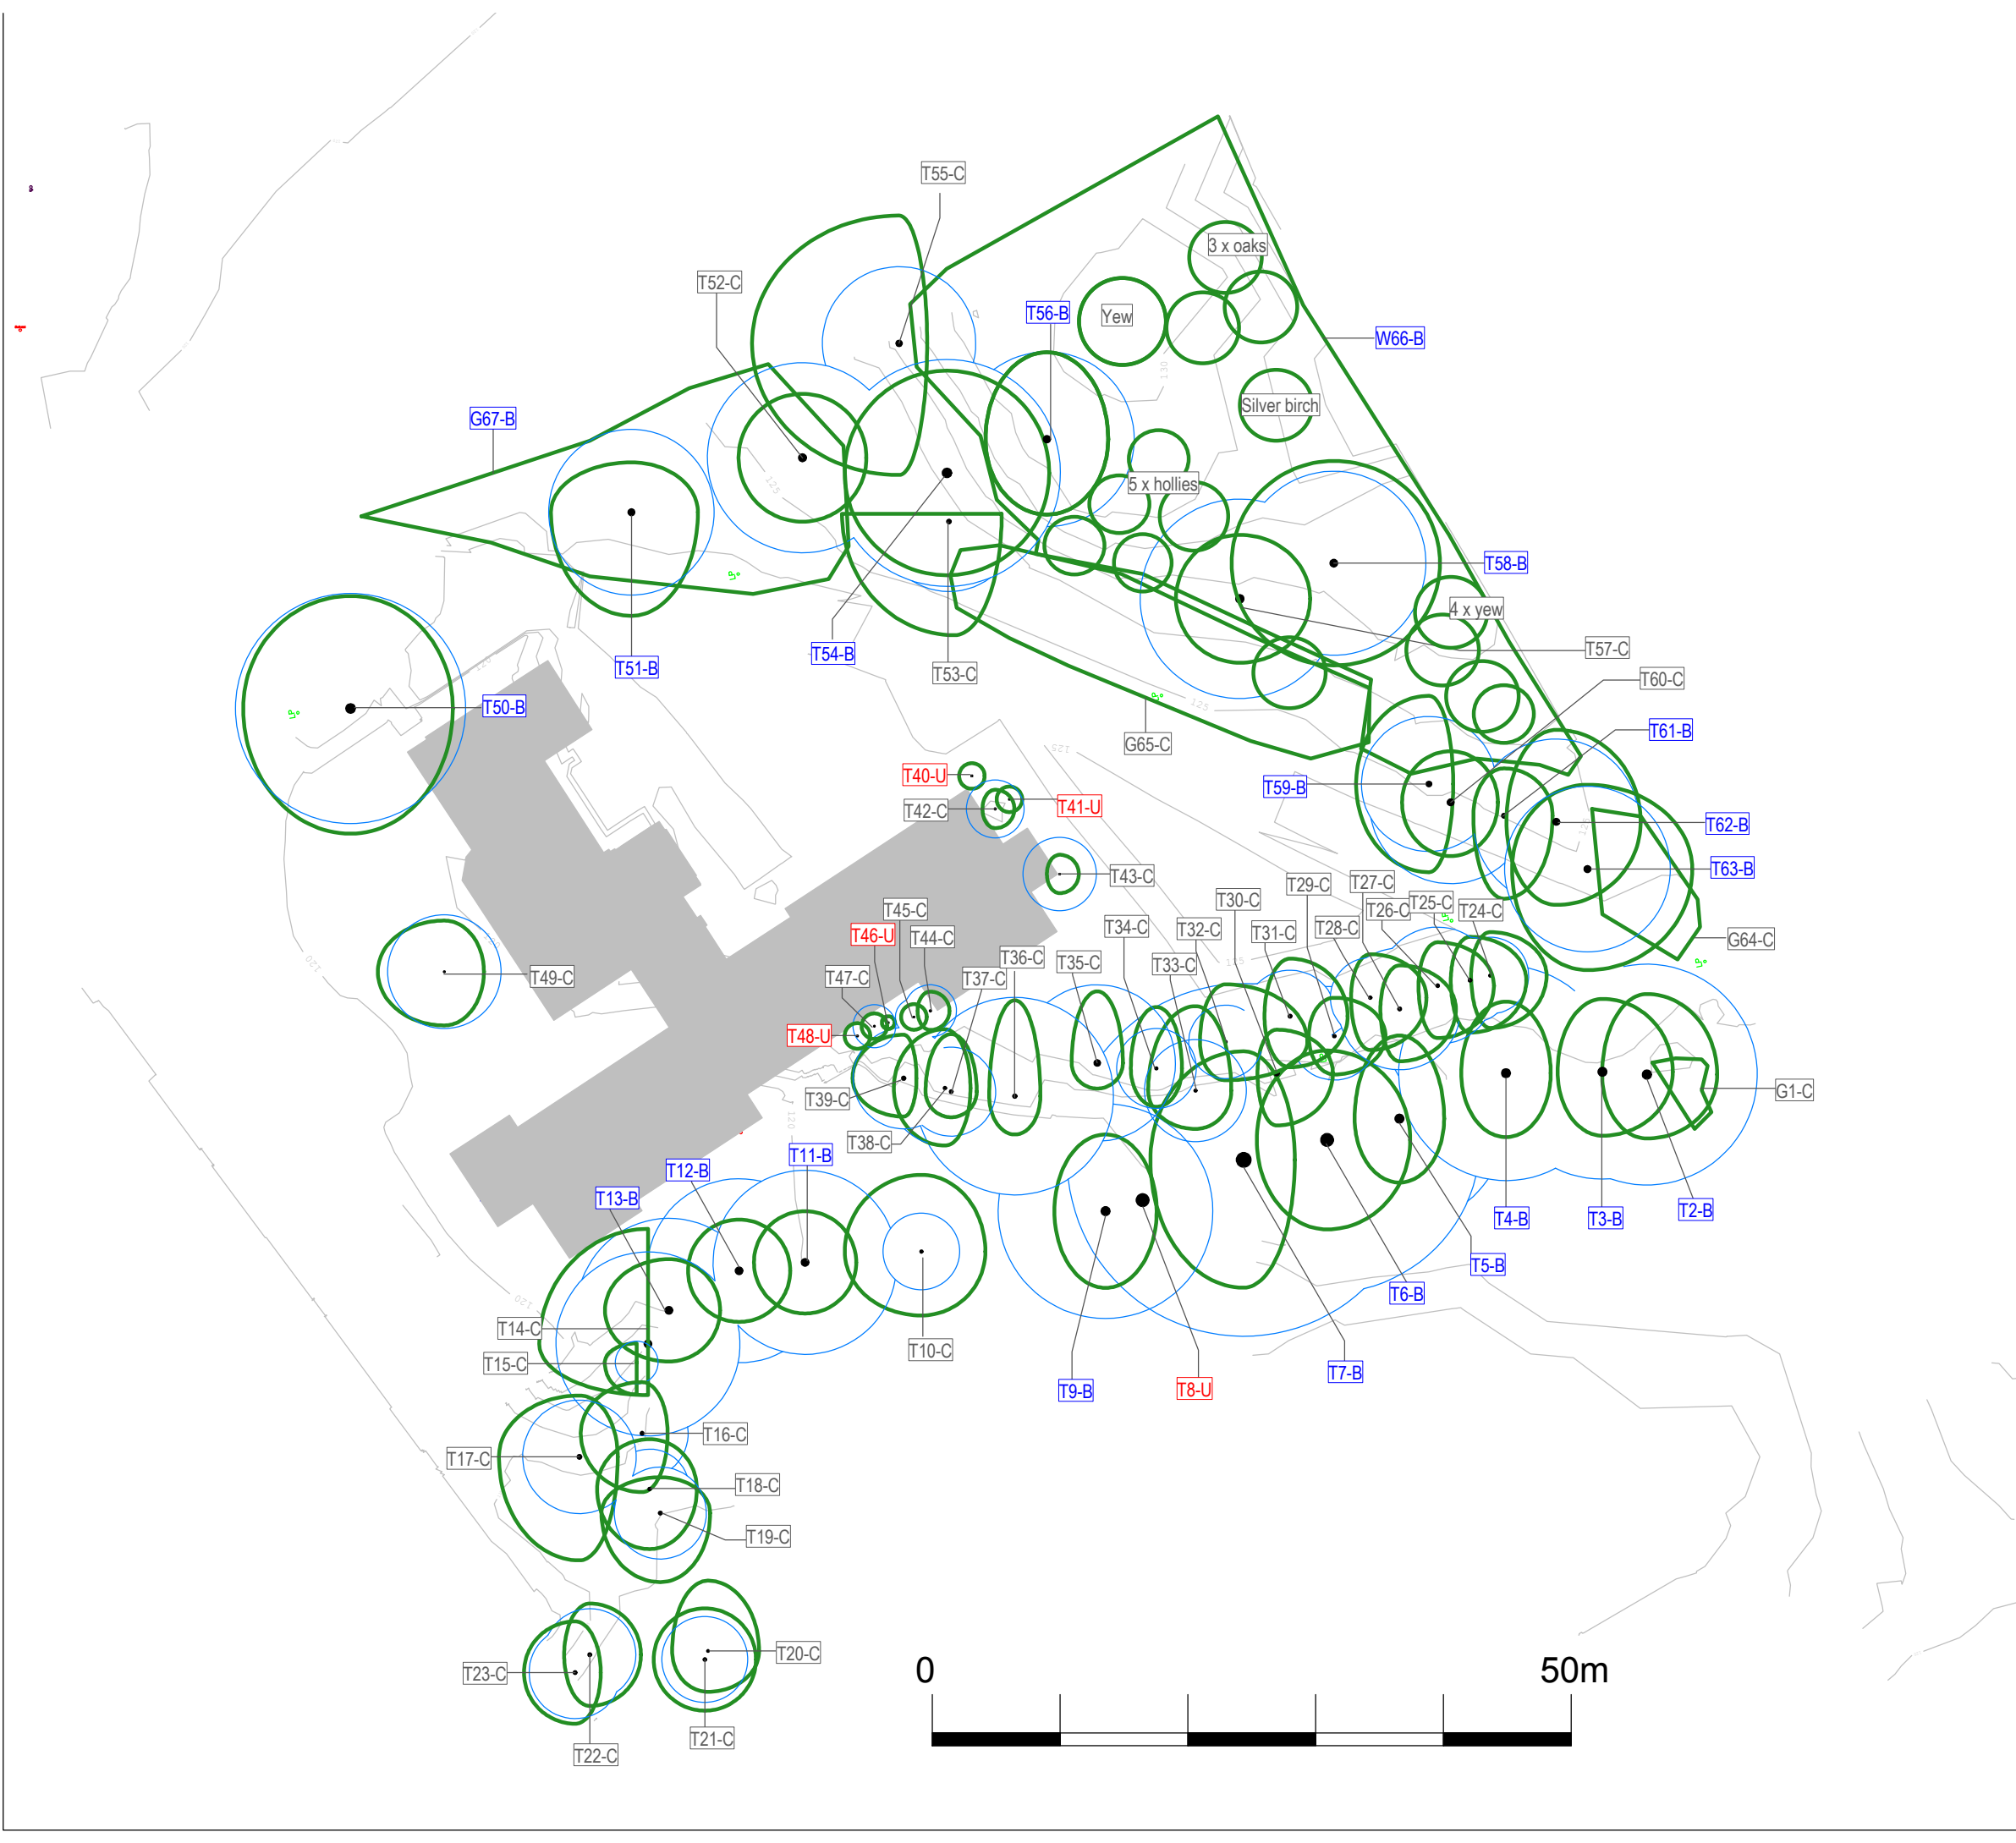
- T1-B Category B - moderate quality and value
- T1-C Category C - low quality and value
- T1-U Category U - unsuitable for retention
- Crown spread
- RPA - root protection area as defined by Table 2 BS 5837:2012
- Group/Woodland

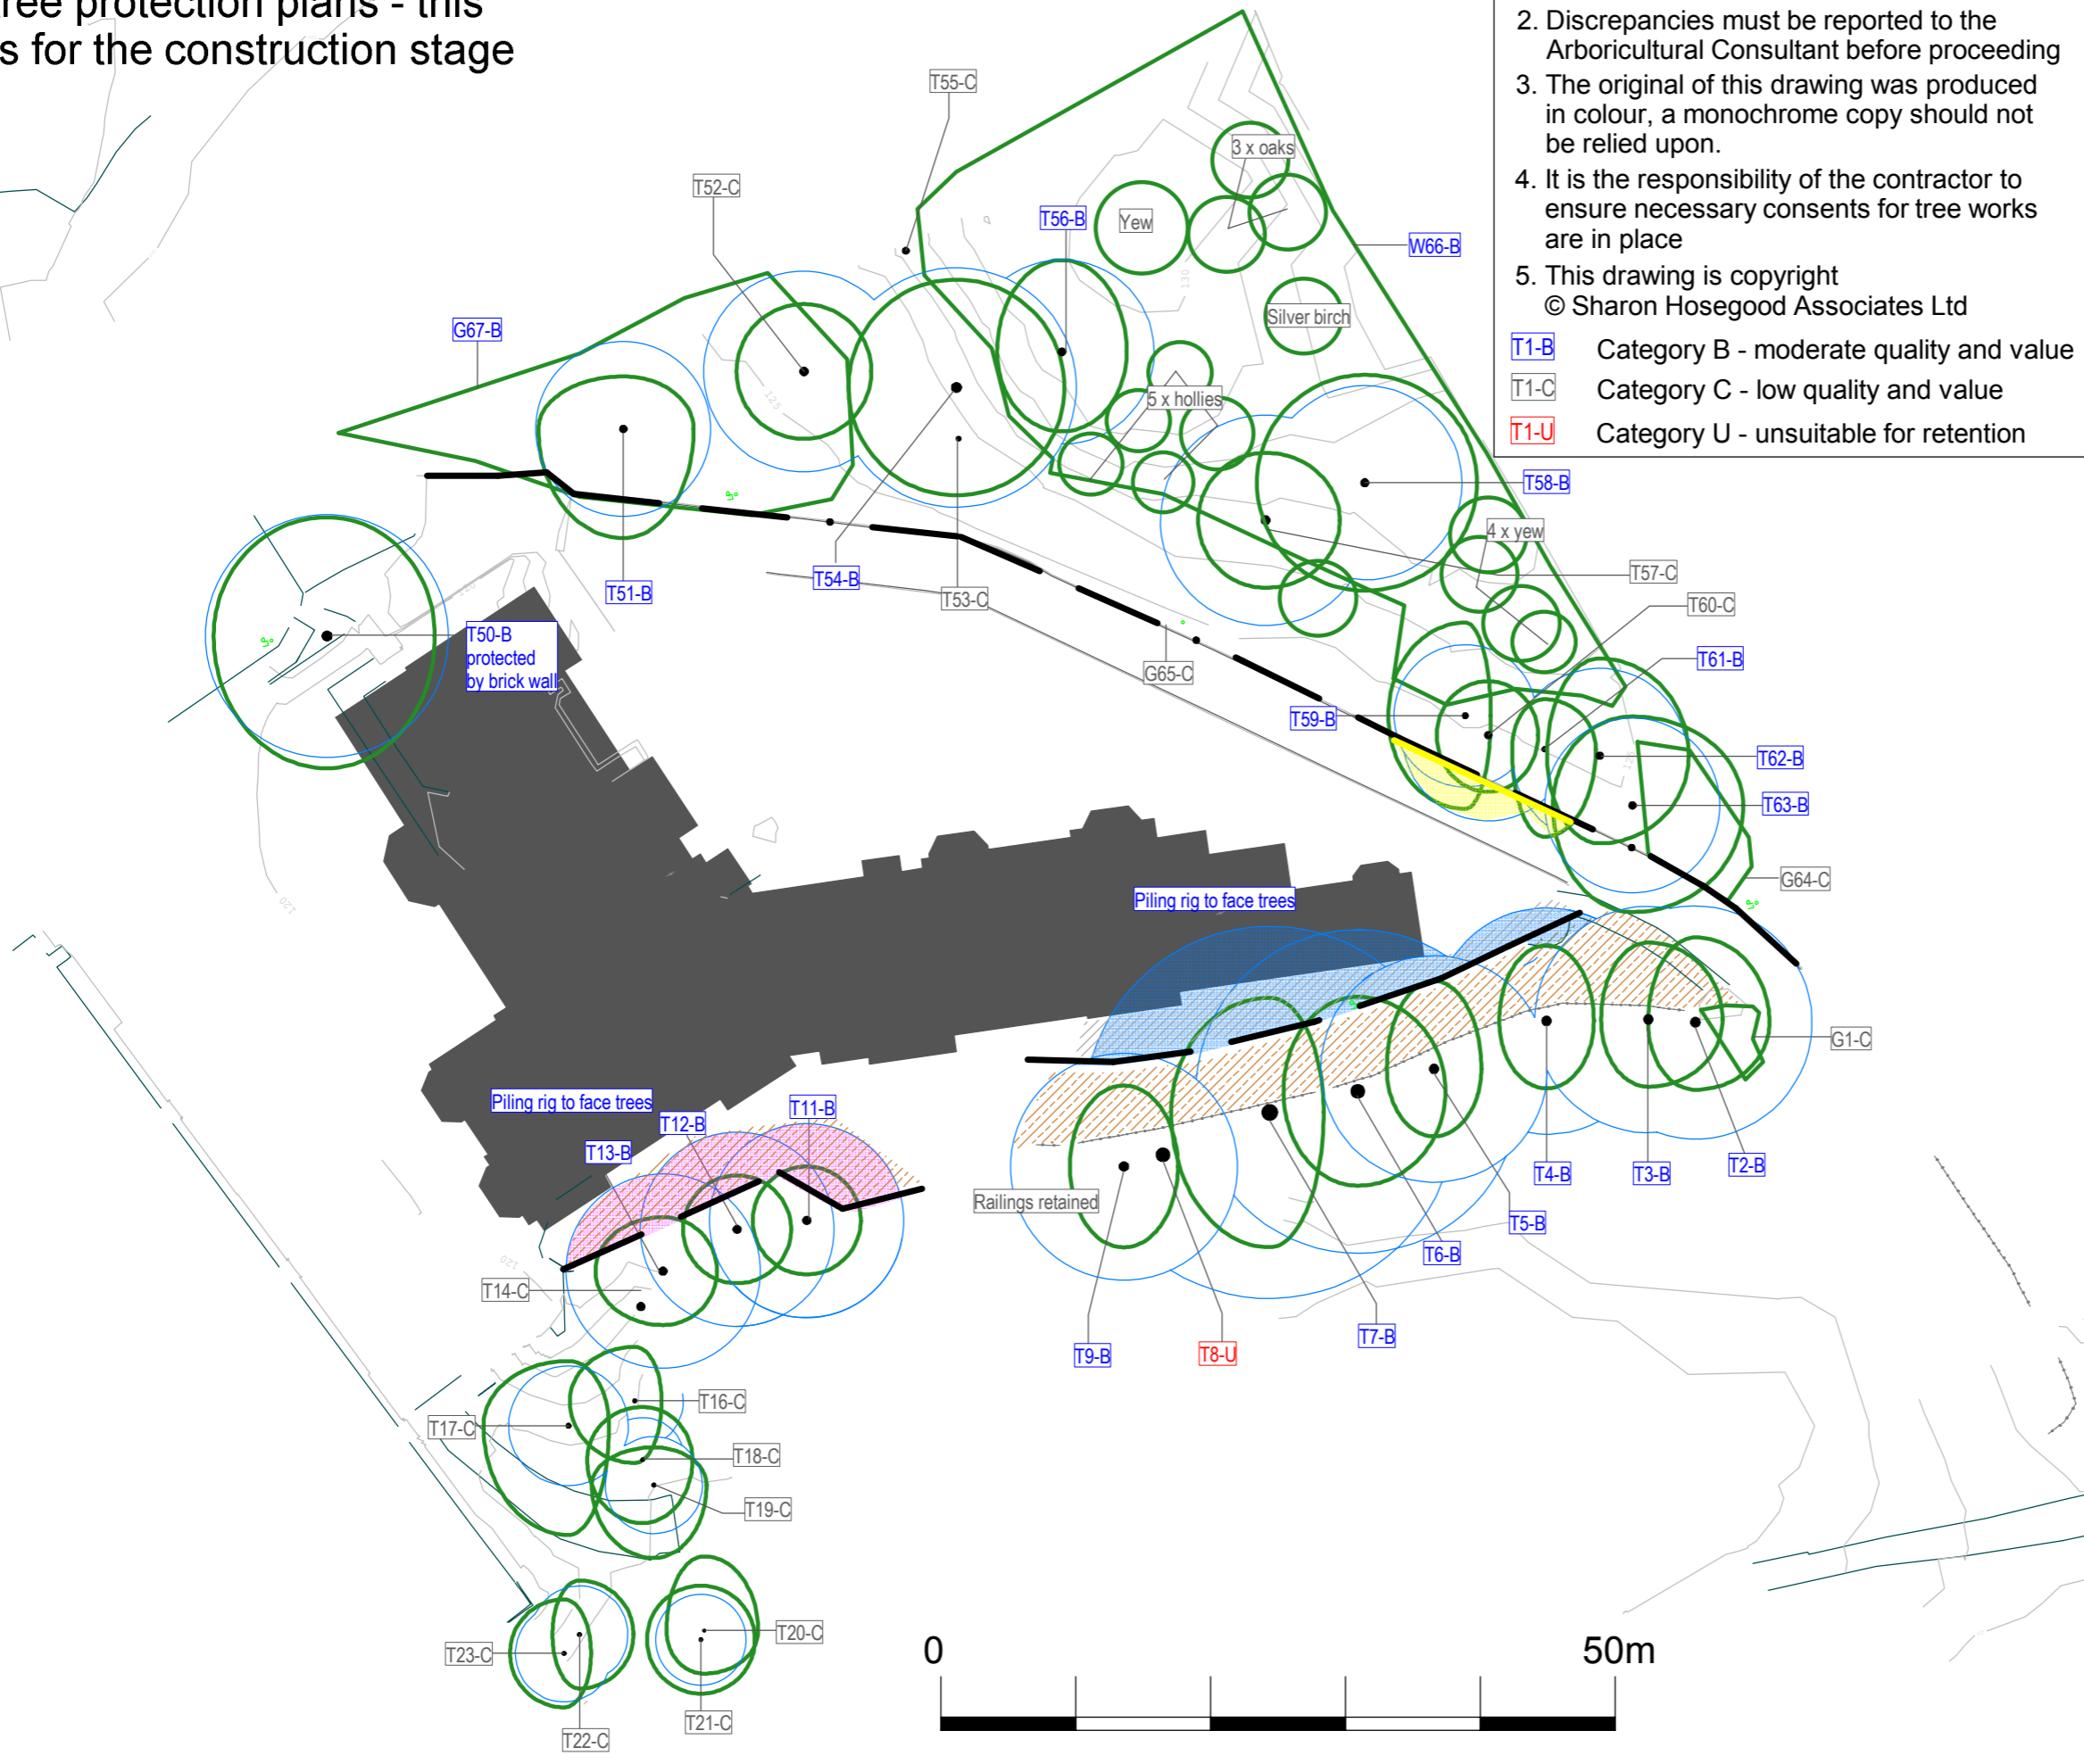
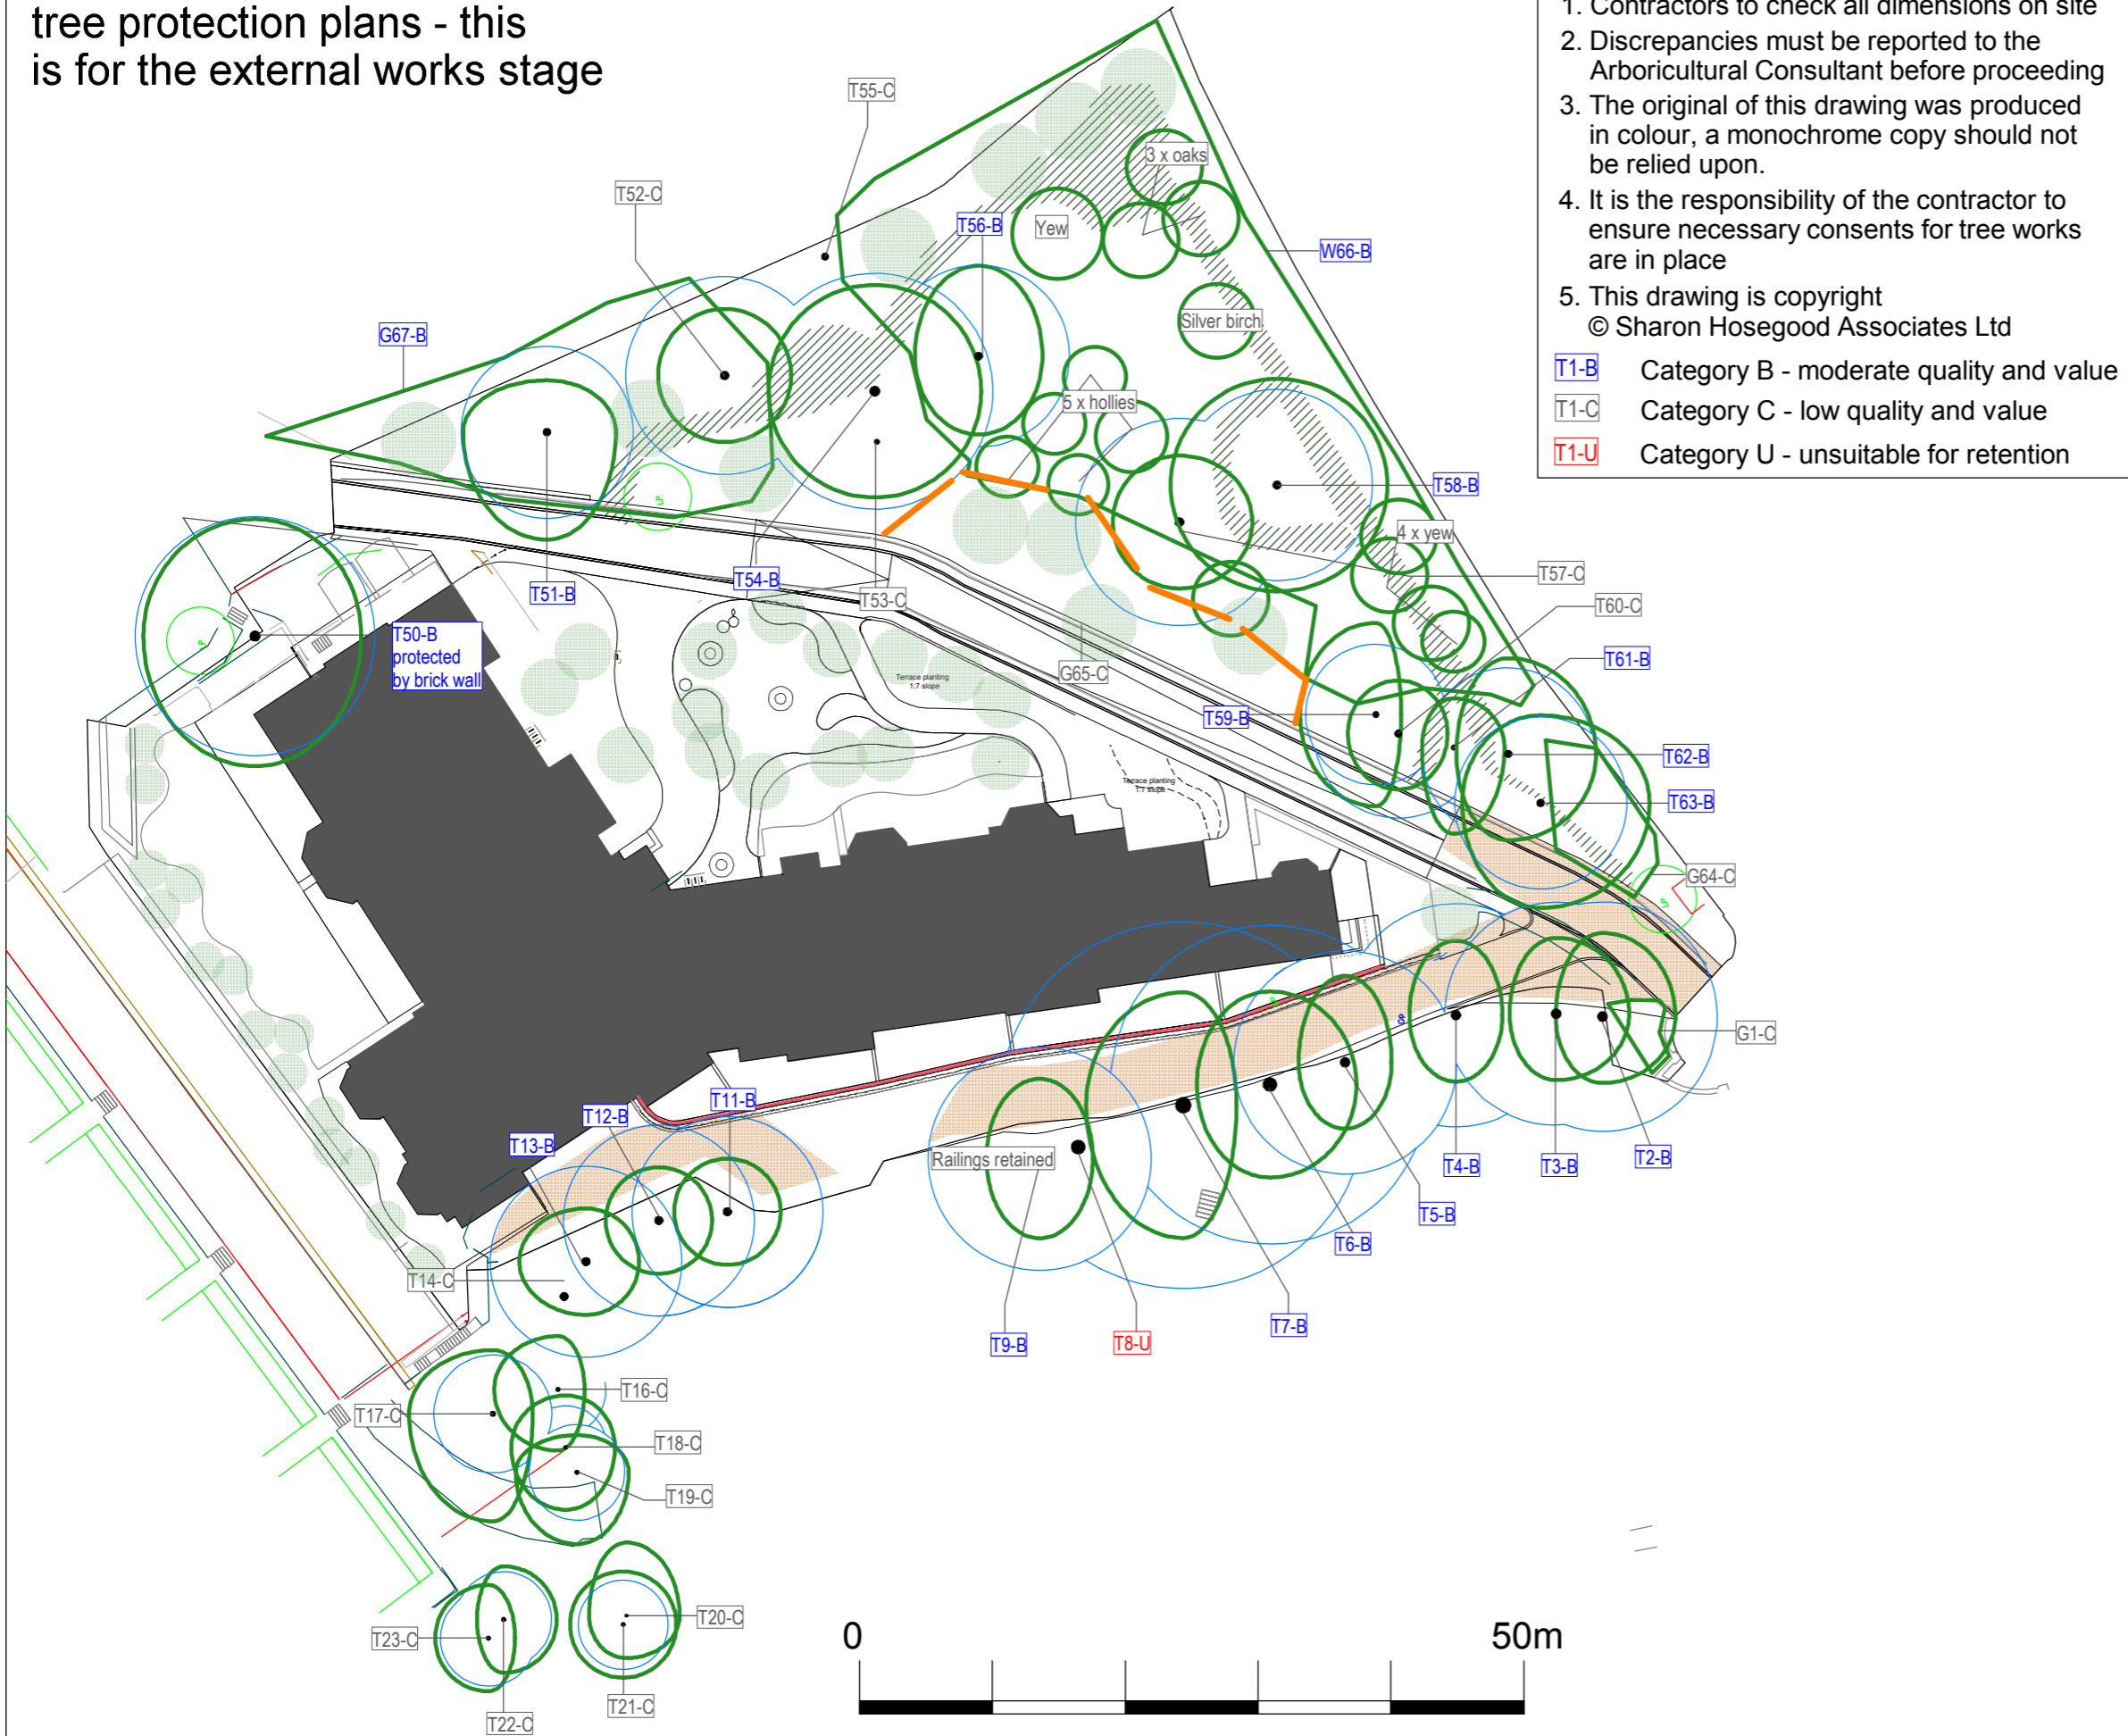
SMD-H	SMD-H
Date	Drawing Number	Scale	Drawing Status
6.12.19	SHA 681 TPP2	1:500@A3	For Issue
Revision

This is the third of three tree protection plans - this is for the external works stage

- Tree to be retained
- RPA - root protection area as defined by Table 2 BS 5837:2012
- Woodland to be retained and managed
- Tree protection fencing comprising orange mesh fencing supported by metal pins every 1m
The change in level within this area will be supervised by the arboriculturist
- Informal path created by using the wood chip from the tree surgery, and the suitable branches are edging. Depth and exact location to be determined by the landscape architect.
- Informal play will be installed in accordance with the method statement
- Area for method statement for top dressing of existing hard surface with Resin Bound Gravel

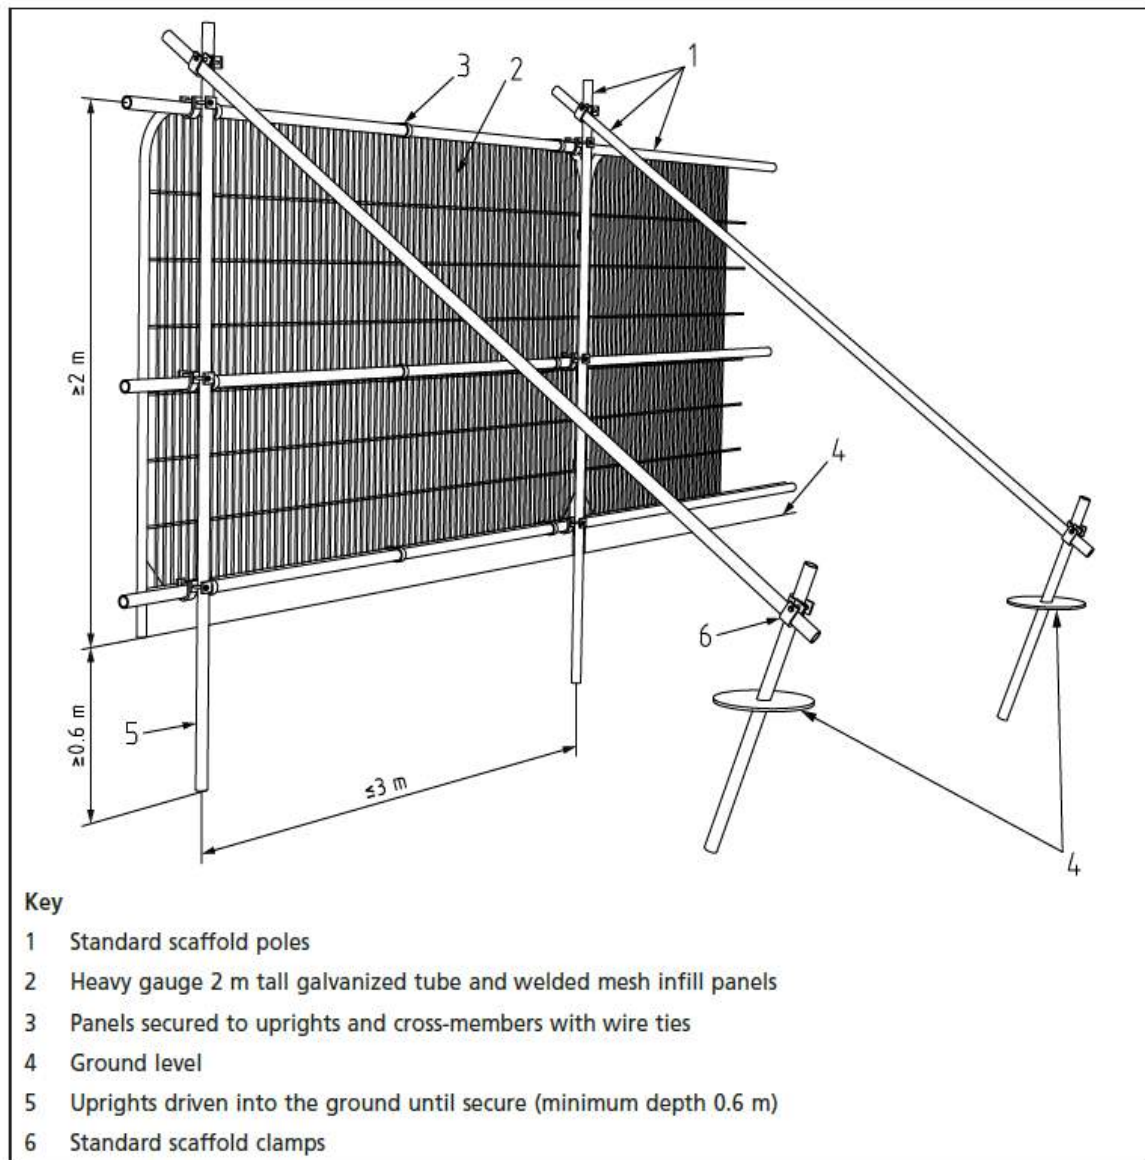
Figure 2 Default specification for protective barrier

Tree protection fencing specification from BS 5837:2012 Figure 2

The default specification is shown above at Figure 2. Care should be taken when locating the vertical poles to avoid underground services and structural roots. Where it is not possible to drive a pole into the ground, for example on hard surfacing, figure 3 overleaf, applies.

The location for the tree protection fencing is shown on the tree protection plan delineated by a black dashed line. The location of the fencing is out the outer edge of the root protection area and the dimensions from fixed points are shown on the drawings. All weather signs should be affixed to the barriers, no more than 12m apart.

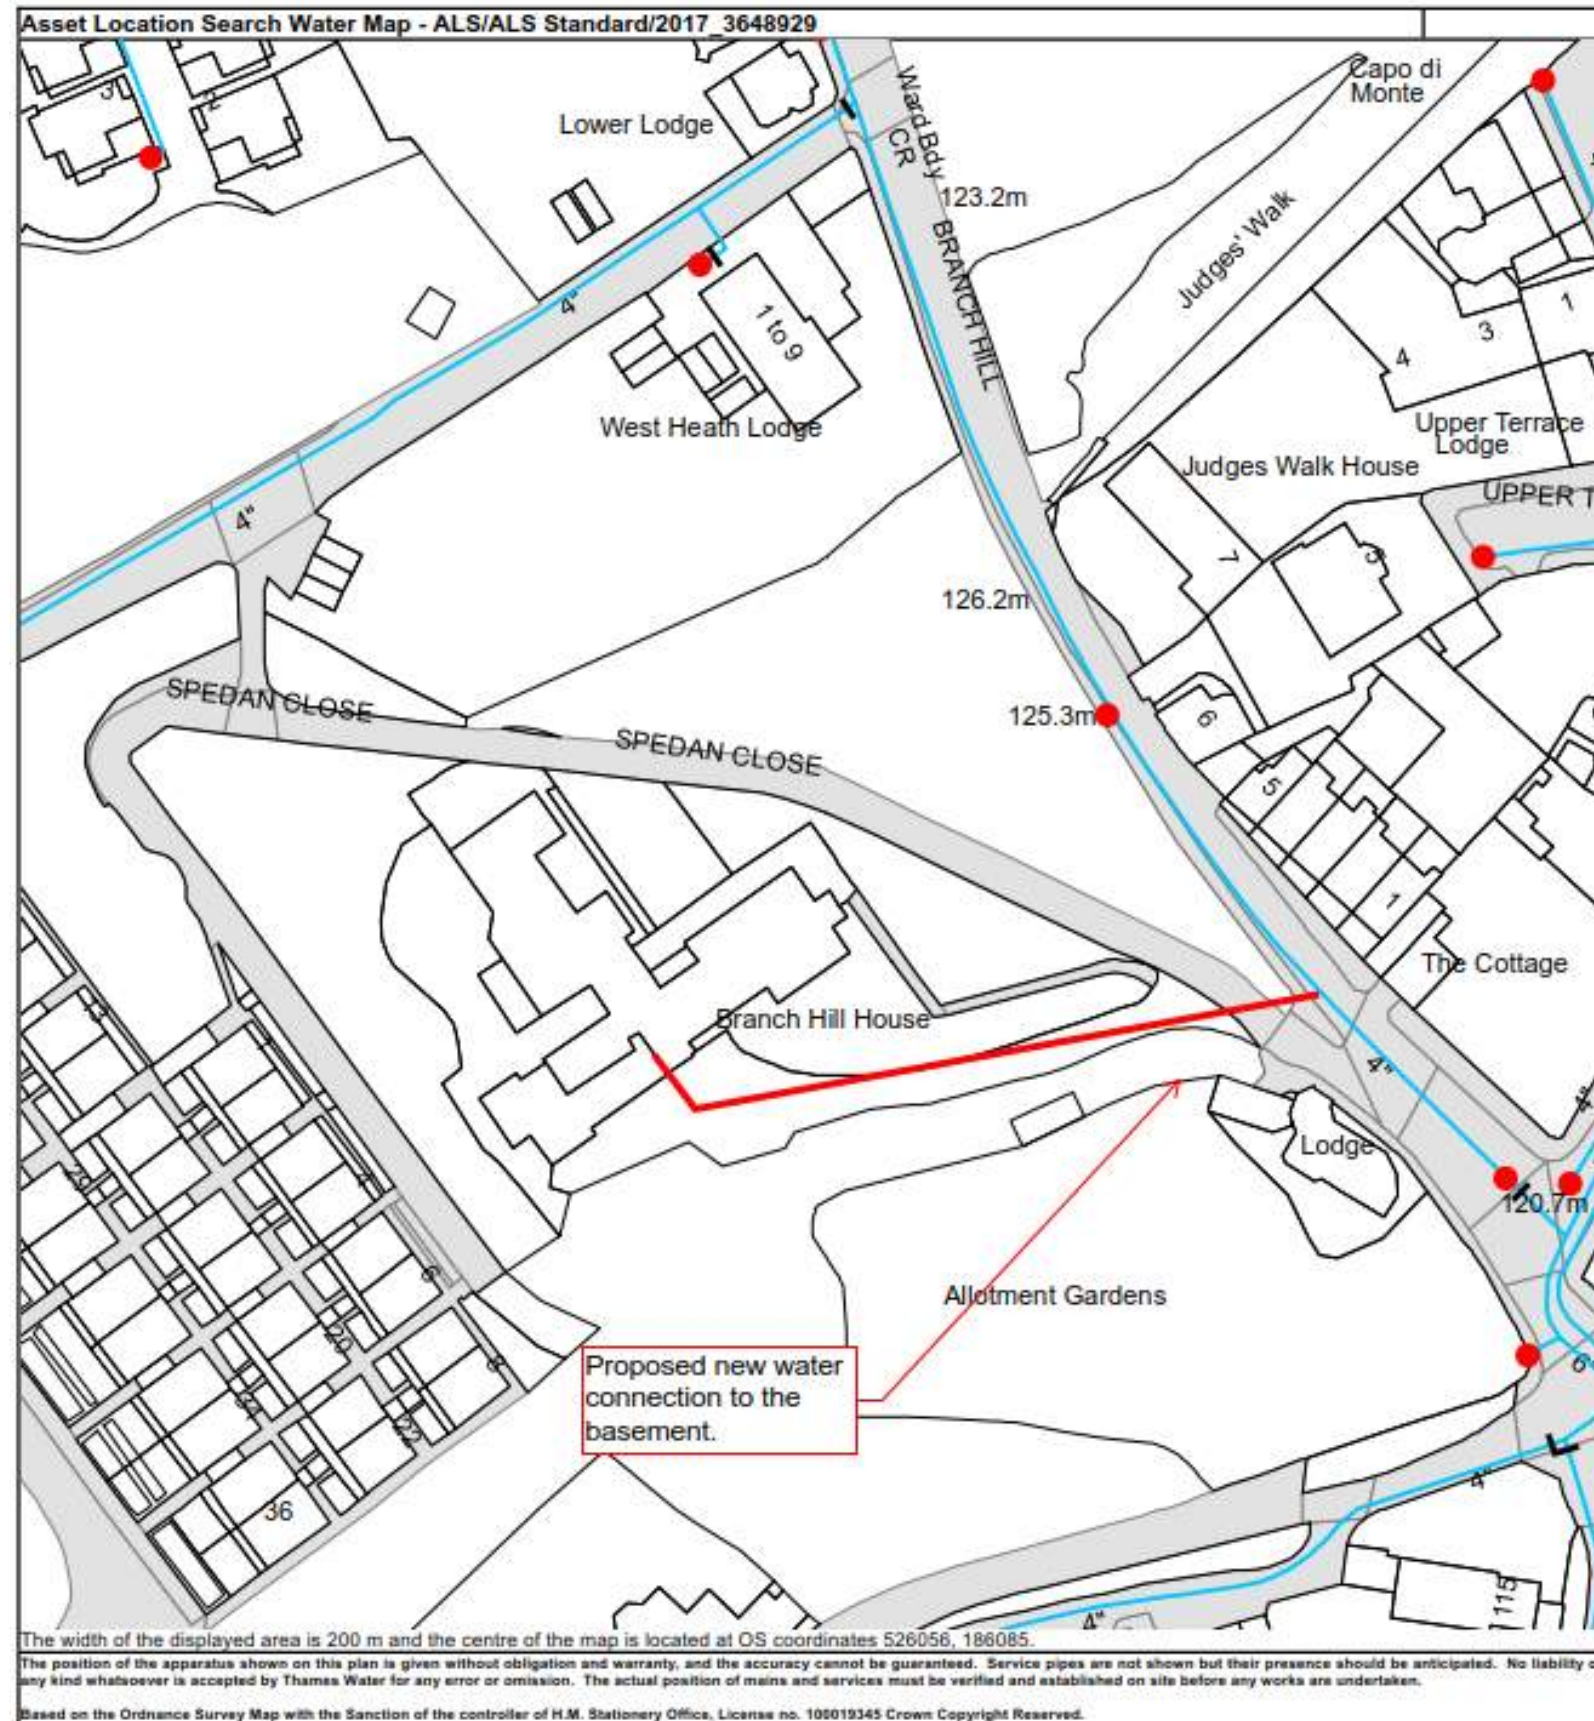
We are in contact with Thames Water to provide a new connection with a new meter for 8.8 l/s water flow. Thames Water provided a water map which shows the site is close to a 4-inch main water pipe as shown below, however, due to the height of the building, a booster pump with a 5 m³ break tank will be required.

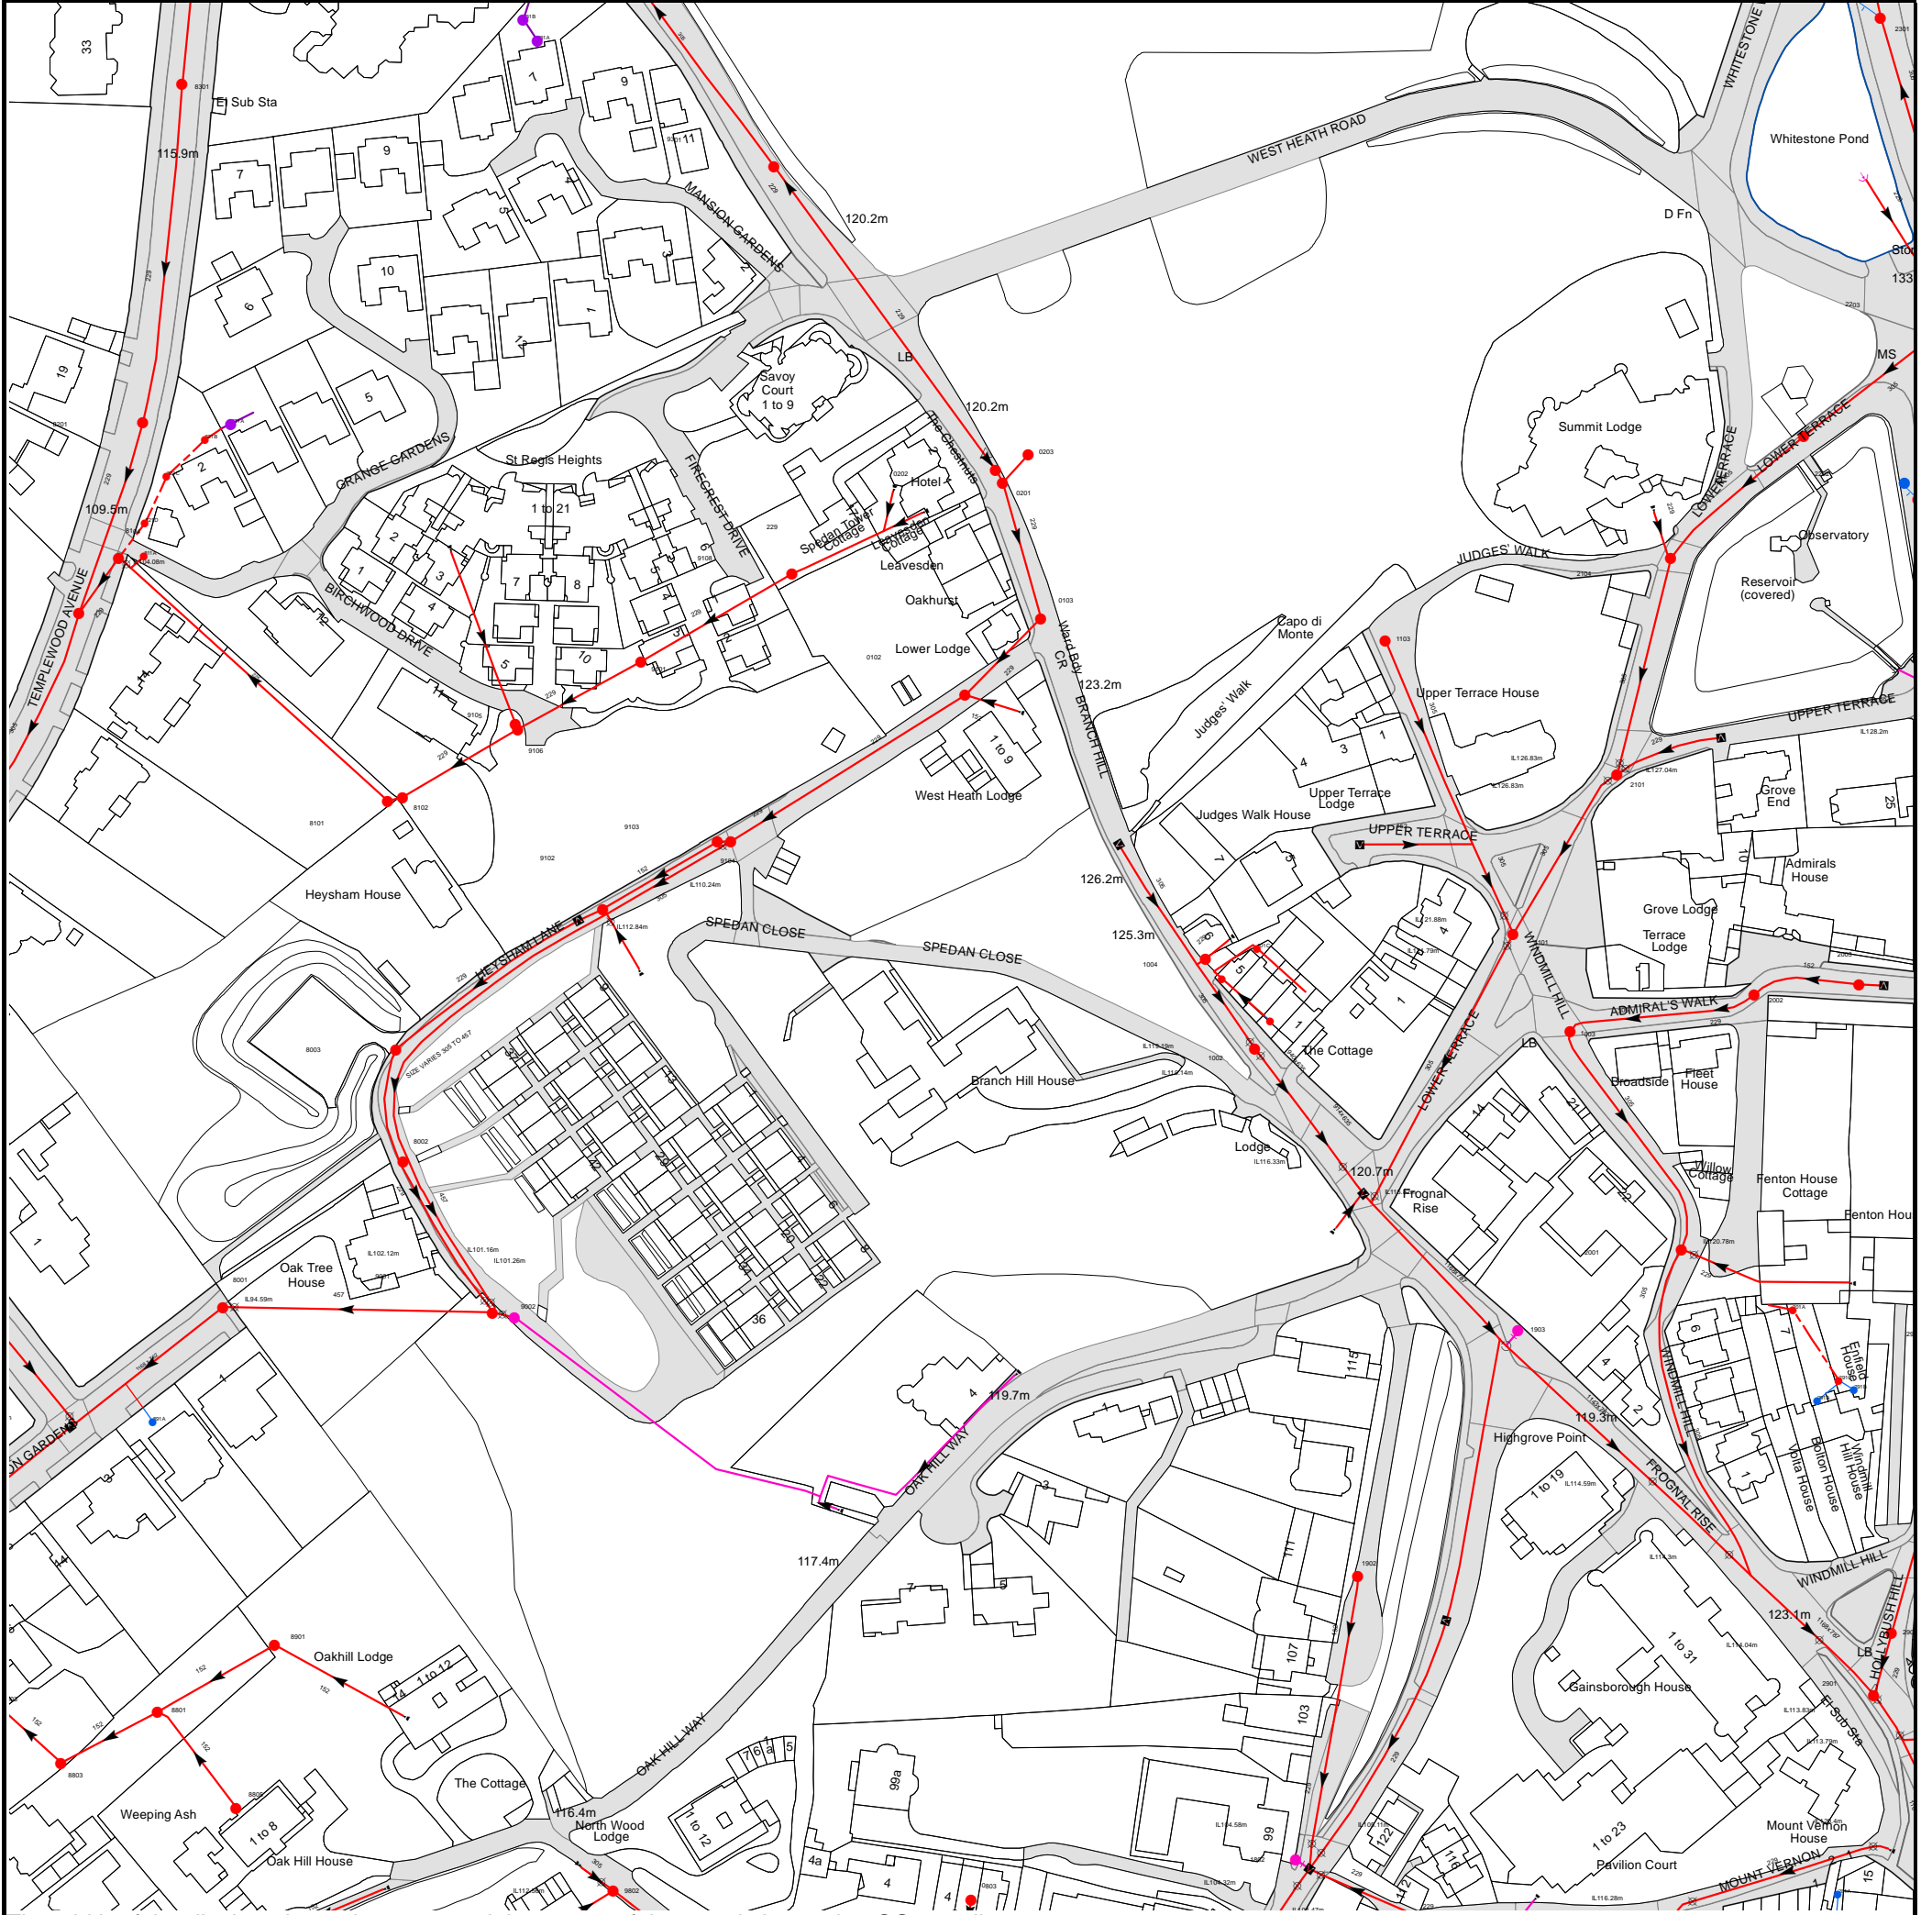
Asset Location Search Sewer Map - ALS/ALS Standard/2019_3956905

The width of the displayed area is 500 m and the centre of the map is located at OS coordinates 526042,186095
