BASEMENT IMPACT ASSESSMENT  
BRANCH HILL HOUSE  
ALMAX GROUP  
05 December 2019

BASEMENT IMPACT ASSESSMENT  
BRANCH HILL HOUSE  
ALMAX GROUP

05 December 2019

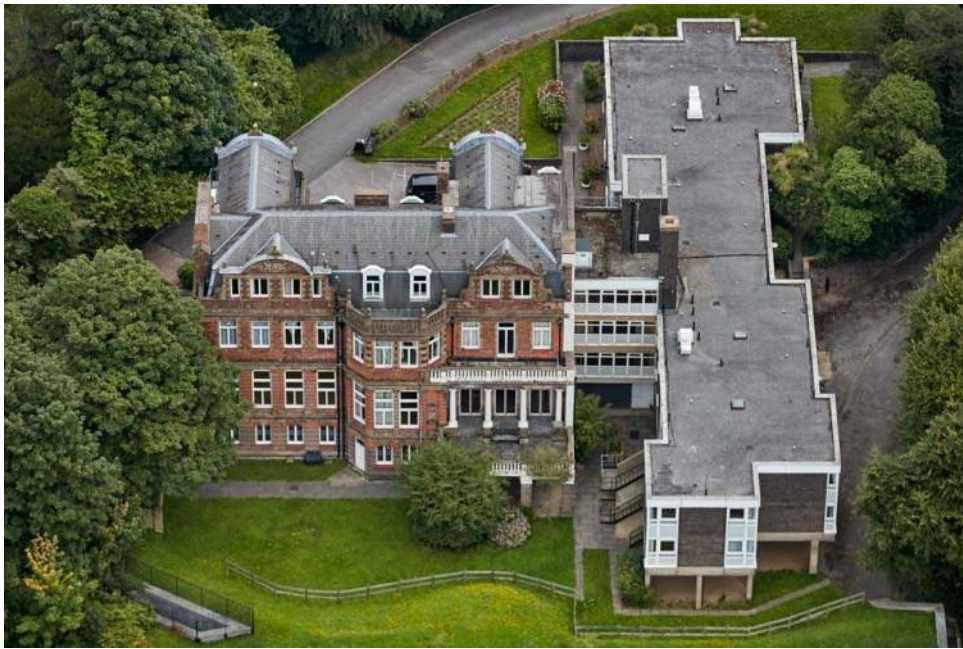
Figure 2 - Branch Hill Manor House (left) with abutting Residential Structure (right)

The current site arrangement comprises a 3-storey (+1 storey basement) residential manor house constructed circa 1860s, with an abutting 2-storey residential block constructed circa 1960s. The site has formerly been used as a residential facility for senior citizens but is currently occupied by building guardians. The site is set back from the main Branch Hill road, with access via a driveway (Spedan Close). At the rear of the building's plot (south-western end), a car park basement is embedded underneath the garden.

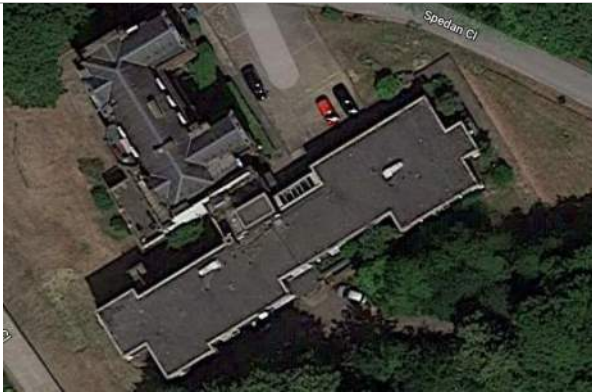
Figure 3 - Existing Site Footprint

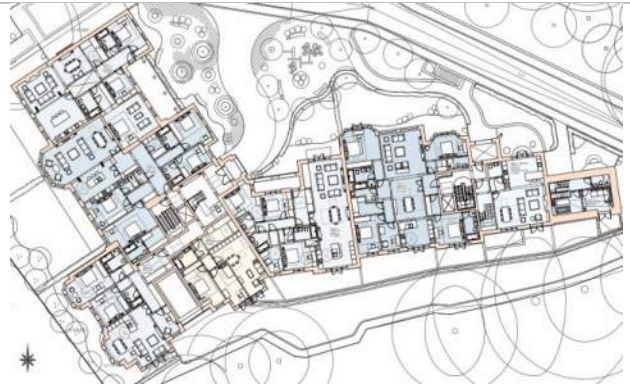
Figure 4 - Proposed Site Footprint

The proposed development comprises the construction of a new 3-5-storey block of residential dwellings with a single storey basement. The existing residential 1960s structure will be demolished, with the new development occupying the footprint of this site, abutting the original Branch Hill Manor House, which is to be preserved and renovated.

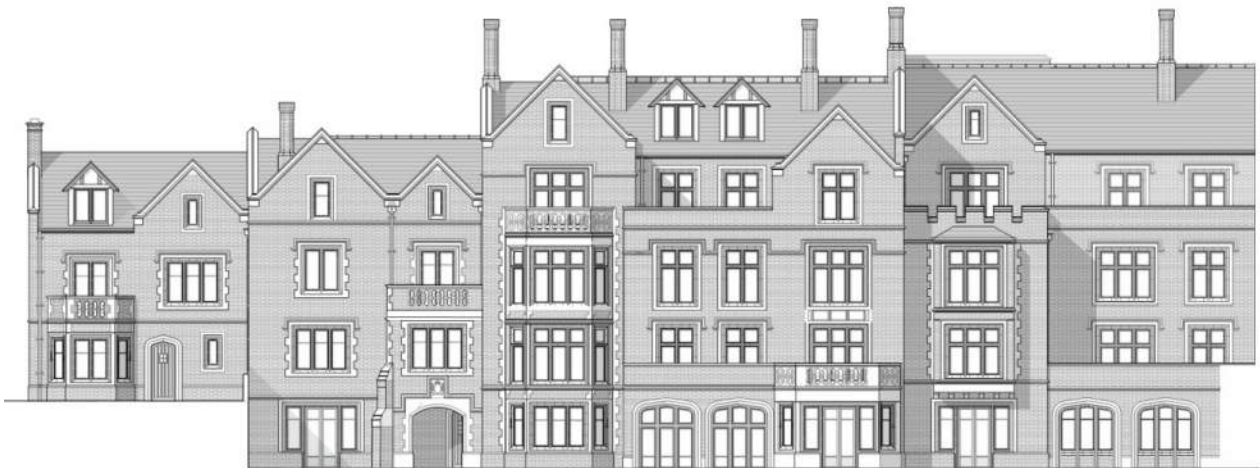
Figure 5 - Proposed North Elevation

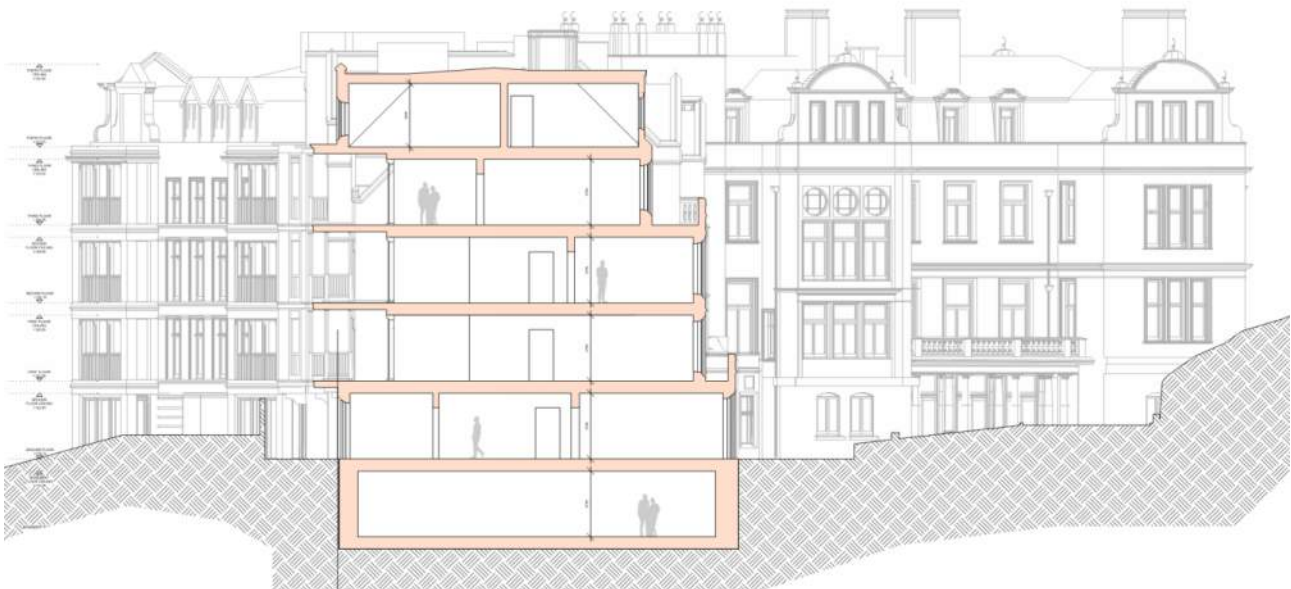
Figure 6 - Proposed Section with Basement

The proposed single storey below ground basement is to be constructed immediately adjacent to the existing 4 storey red bricked Victorian Branch Hill House which is understood to date from the 1860's. The basement will extend below the depth of the existing footings to the House which have been exposed and found to consist of shallow corbelled brick footings on concrete strip footings. Prior to constructing the basement, the existing footings are to be underpinned down to the new basement level. This is to be achieved by traditional reinforced concrete pin underpinning. Due to the depth of underpinning required, the underpinning will be undertaken in stages to get down to formation depth for the new basement. Prior to the underpinning being undertaken, a temporary shoring frame will be provided to laterally restrain the party gable wall to Branch Hill House during the construction stage. Temporary propping will also be provided to laterally restrain the underpinning pits as the underpinning progresses down to the new basement level. The props will be restrained against temporary concrete thrust blocks cast into the base of the basement.

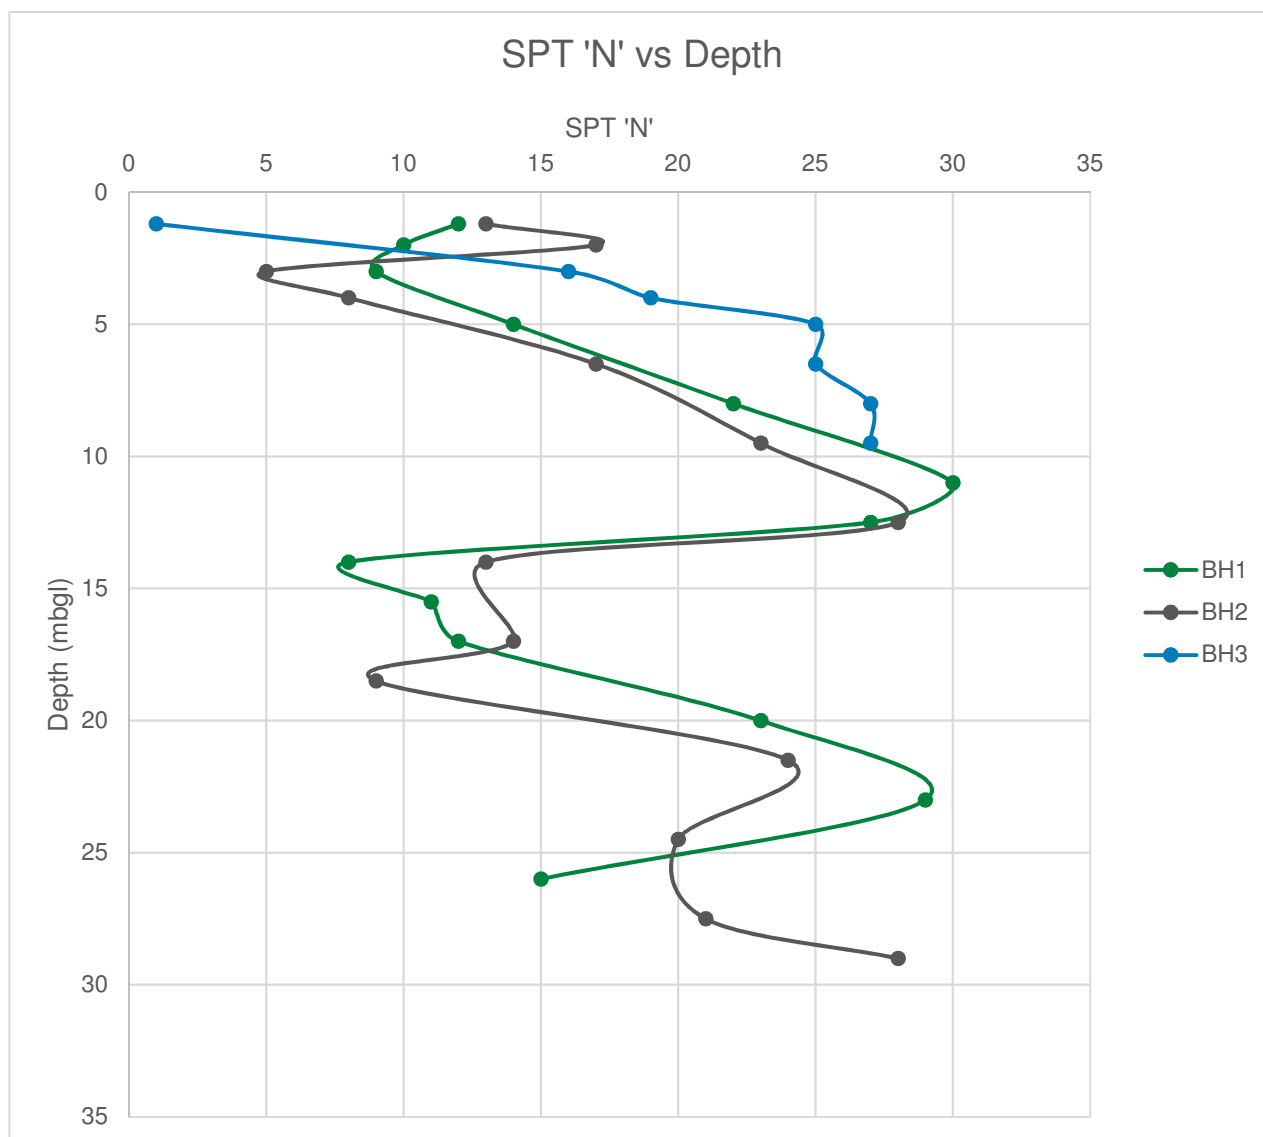
Graph 6.1: SPT 'N' Value Distribution

BH No.	Depth (mbgl)	Strata	SPT 'N' Value	Main Constituent
BH01	1.2	Bagshot Formation	12	CLAY
	2.0		10	
	3.0		9	
	5.0		14	
	8.0		22	
	11.0		30	
	12.5	Claygate Member	27	SAND
	14.0		8	CLAY
	15.5		11	SAND
	17.0		12	SAND
	20.0		23	CLAY
	23.0		29	SAND
BH02	26.0		15	CLAY
	1.2	Bagshot Formation	13	SAND
	2.0		17	
	3.0		5	
	4.0		8	
	6.5		17	
	9.5		23	
	12.5		28	
	14.0		13	
	17.0	Claygate Member	14	CLAY
	18.5		9	
	21.5		24	
	24.5		20	
	27.5		21	SAND
	29		28	
BH03	1.2	Bagshot Formation	15	CLAY
	3.0	Bagshot Formation	16	
	4.0	Claygate Member	19	SAND
	5.0		25	
	6.5		25	
	8.0		27	
	9.5		27

Table 6.1: SPT 'N' Value Distribution

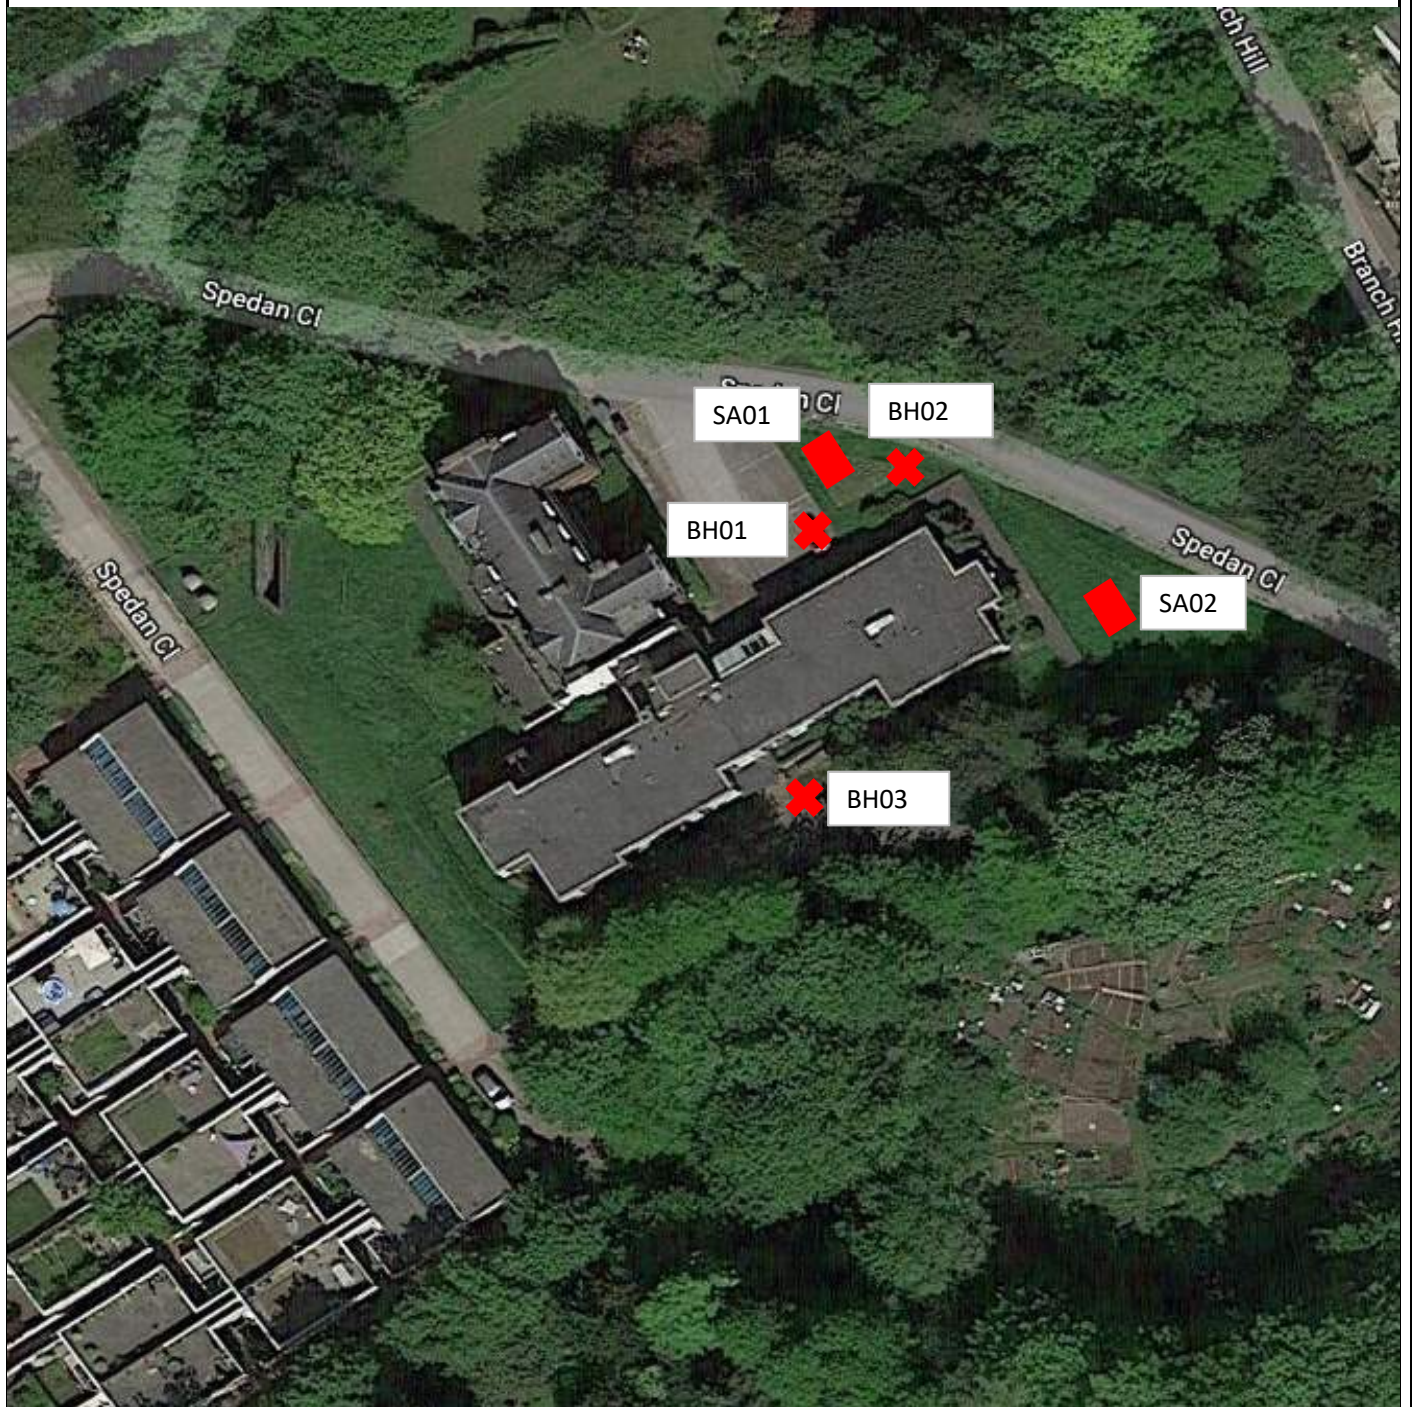
## FIGURE 3 – TEST LOCATION PLAN

PROJECT		Branch Hill House		DRAWING				5008338-03								
<div>RIDGE</div> <div>PARTNERSHIP HOUSE TEL: 01962 834400</div> <div>MOORSIDE ROAD FAX: 01993 815001</div> <div>WINCHESTER</div> <div>HAMPSHIRE, SO23 7RX www.ridge.co.uk</div> <div>Also at Reading, Bristol, London &amp; Leicester</div>	CLIENT			Almax			SCALE		DATE				DRAWN BY		CHECKED BY	
							NTS		25/07/2019				PB		RJH	
							TITLE									
							EXPLORATORY HOLE LOCATION PLAN									
										REV

The Site Investigation scope was devised by Ridge and agreed by the Client. The scope of works was to include advancing intrusive locations to assist with the geotechnical design. This was to be achieved with the completion of boreholes to assess the nature of the underlying soils and groundwater conditions, the completion of soakage testing to inform soakaway design, along with specified in-situ testing and sample collection. A site investigation plan is appended to Figure 3

The following soil conditions were encountered during the investigation works. Please refer to the Borehole Logs included within Appendix 2 for a more detailed description. The layout of the exploratory positions is presented in Figure 3.

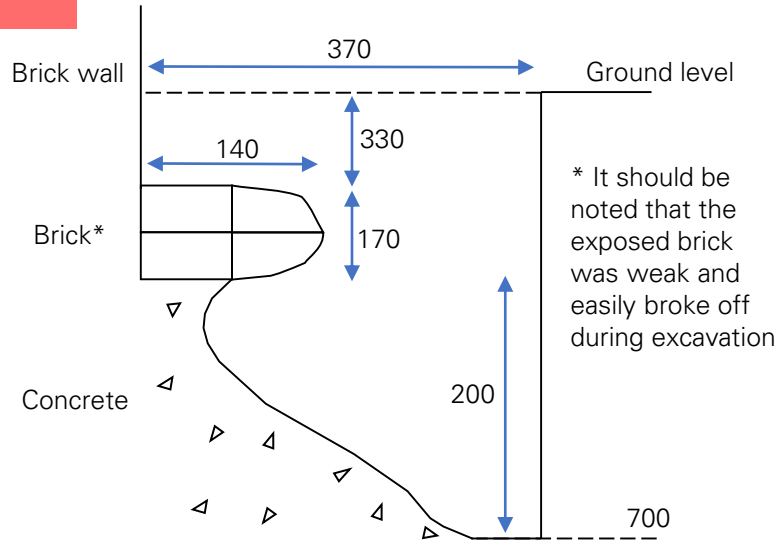
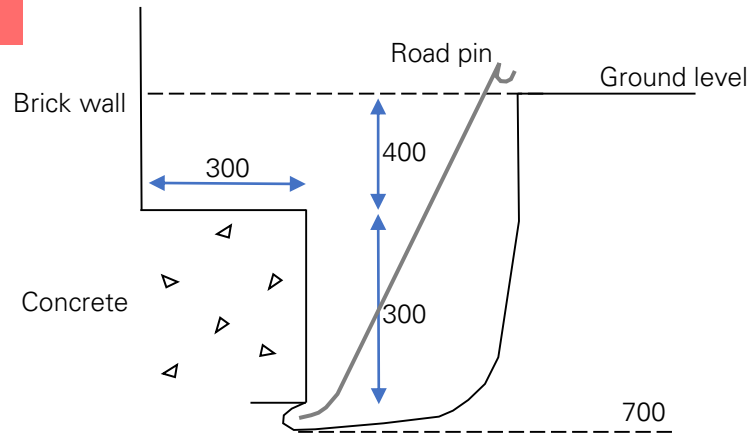
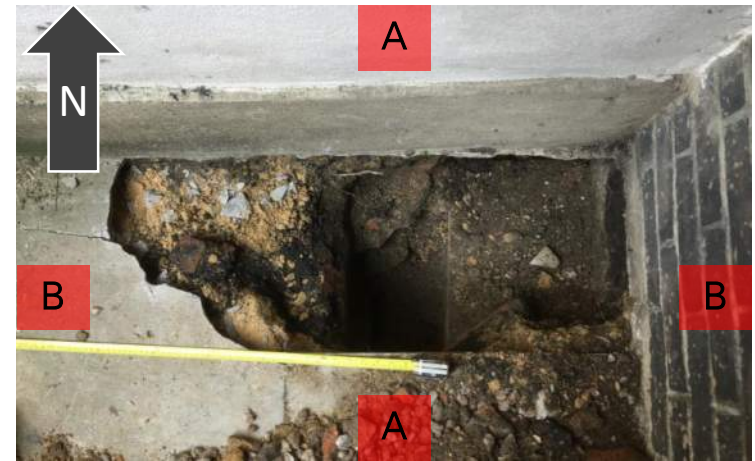
Project:	Branch Hill House			Title:	TP1a – Foundation Pit	
Job Number:	5008338	Client:	Almax Group Ltd	Ridge and Partners LLP  TEL: 01962 834300 www.ridge.co.uk	Partnership House Moorside Road Winchester Hampshire SO23 7RX	 
Drawing:	5008338-01-TP1a	Revision:	-			
Drawn:	RG	Date:	April 2019			
Checked by:	RJH	Scale:	NTS

**A-A**

**B-B**

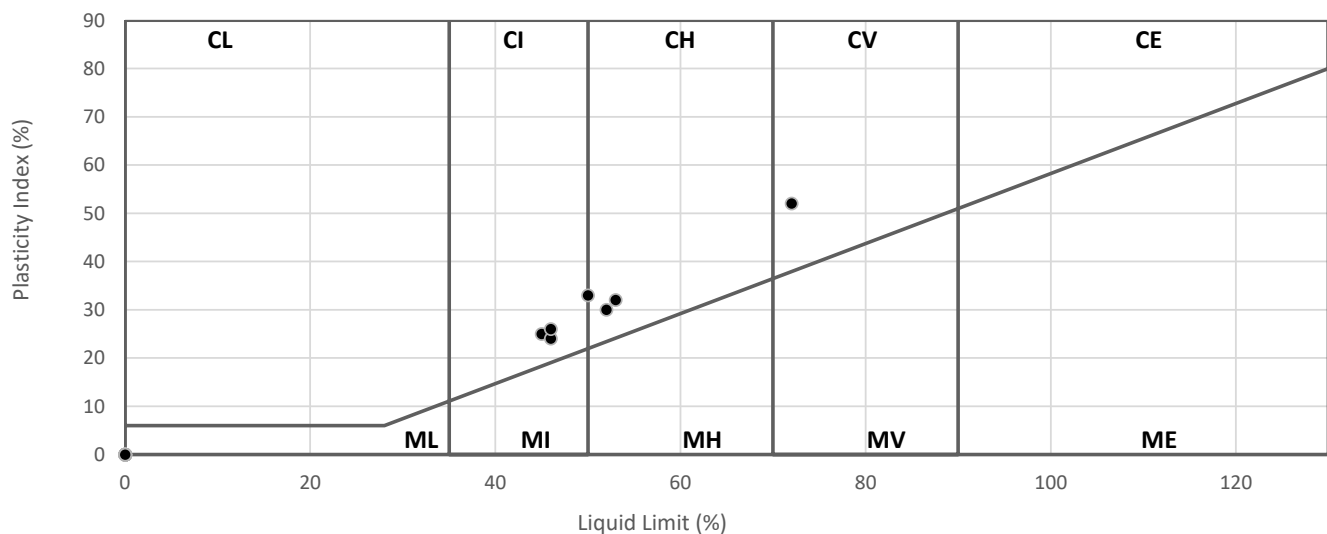
### PLASTICITY CHART FOR CASAGRANDE CLASSIFICATION BS 5930:1999+A2:2010

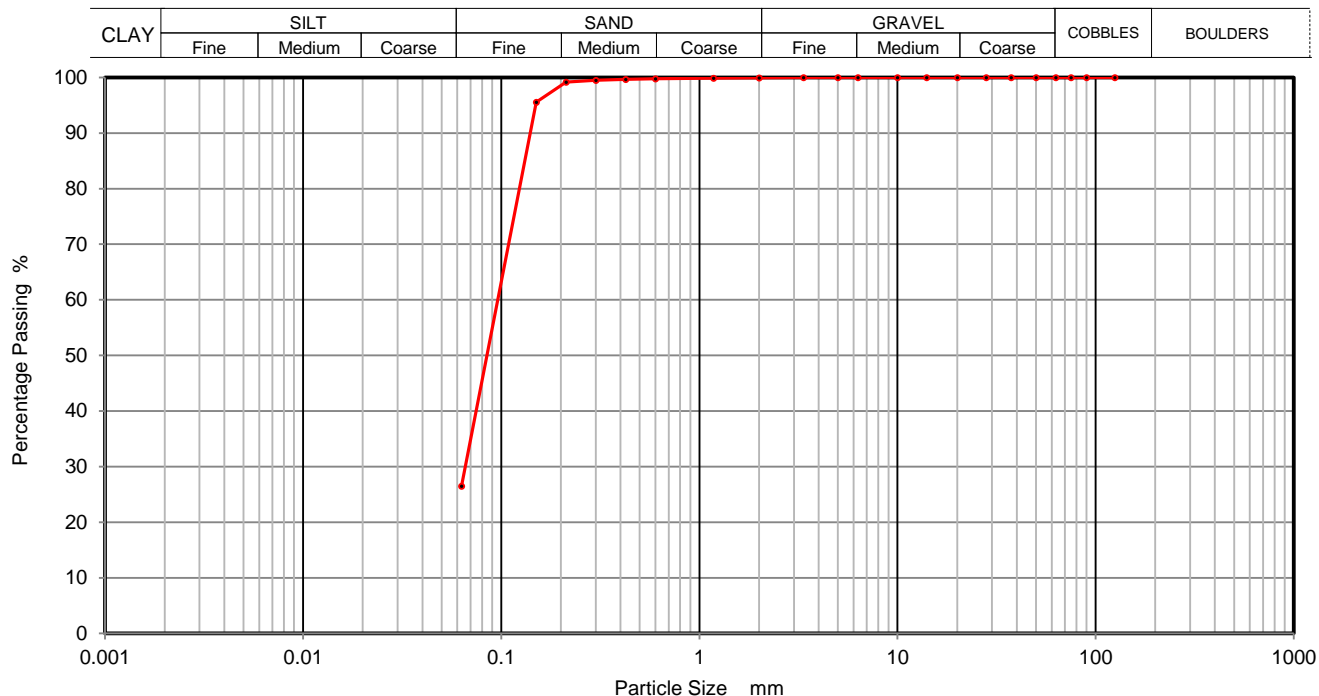
Sieving		Sedimentation	
Particle Size mm	% Passing	Particle Size mm	% Passing
125	100		
90	100		
75	100		
63	100		
50	100		
37.5	100		
28	100		
20	100		
14	100		
10	100		
6.3	100		
5	100		
3.35	100		
2	100		
1.18	100		
0.6	100		
0.425	100		
0.3	99		
0.212	99		
0.15	96		
0.063	26

Sample Proportions	% dry mass
Cobbles	0
Gravel	0
Sand	74
Silt and Clay	26

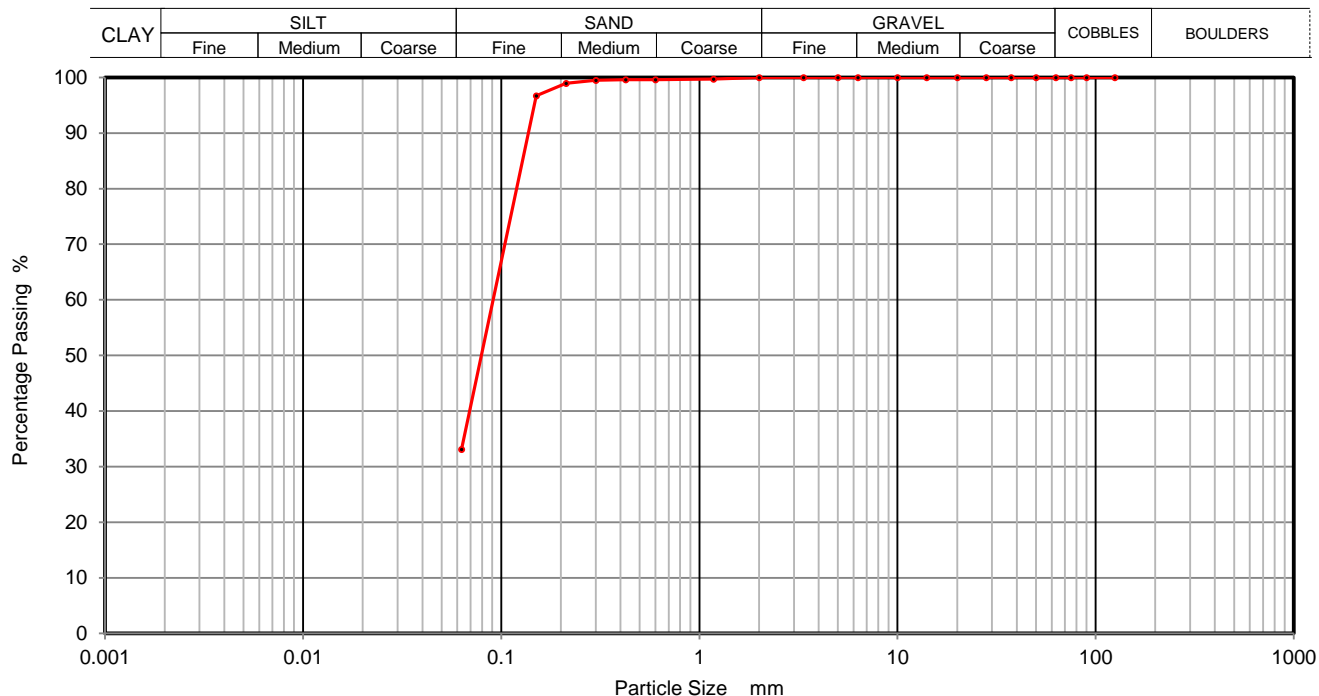
Sieving		Sedimentation	
Particle Size mm	% Passing	Particle Size mm	% Passing
125	100		
90	100		
75	100		
63	100		
50	100		
37.5	100		
28	100		
20	100		
14	100		
10	100		
6.3	100		
5	100		
3.35	100		
2	100		
1.18	100		
0.6	100		
0.425	100		
0.3	99		
0.212	99		
0.15	97		
0.063	33

Sample Proportions	% dry mass
Cobbles	0
Gravel	0
Sand	67
Silt and Clay	33

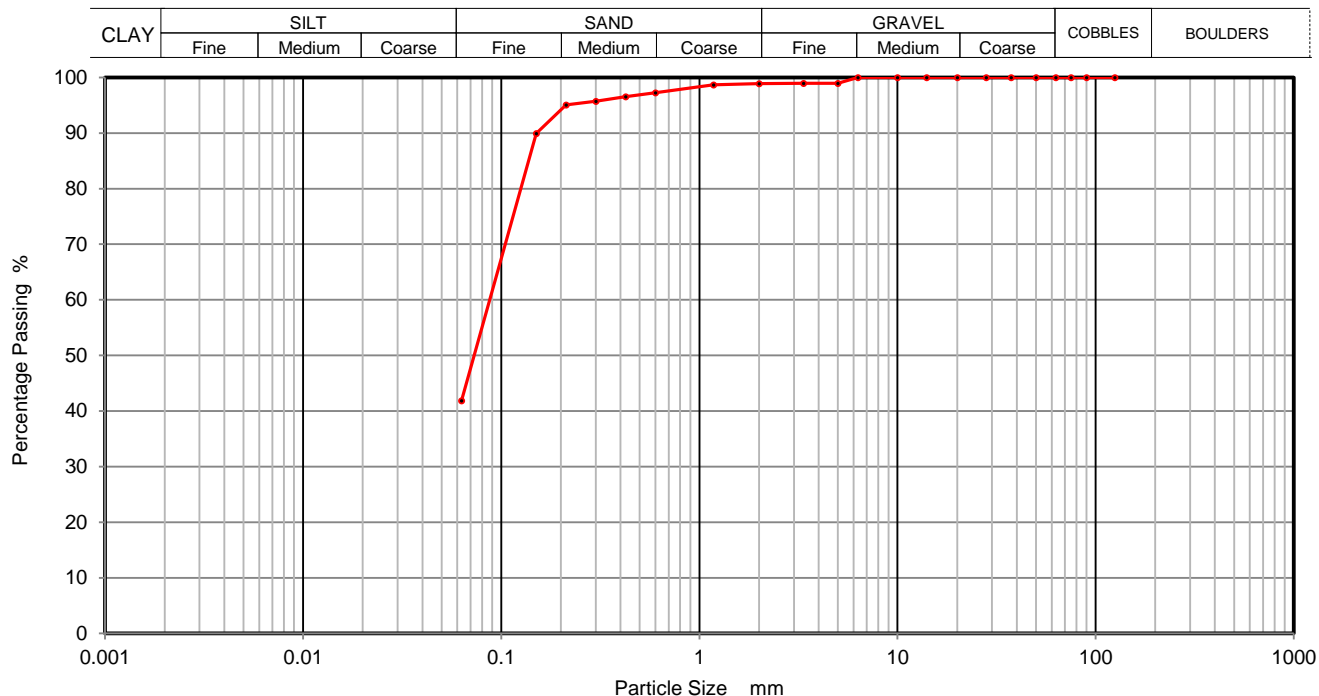
Sieving		Sedimentation	
Particle Size mm	% Passing	Particle Size mm	% Passing
125	100		
90	100		
75	100		
63	100		
50	100		
37.5	100		
28	100		
20	100		
14	100		
10	100		
6.3	100		
5	99		
3.35	99		
2	99		
1.18	99		
0.6	97		
0.425	97		
0.3	96		
0.212	95		
0.15	90		
0.063	42

Sample Proportions	% dry mass
Cobbles	0
Gravel	1
Sand	57
Silt and Clay	42

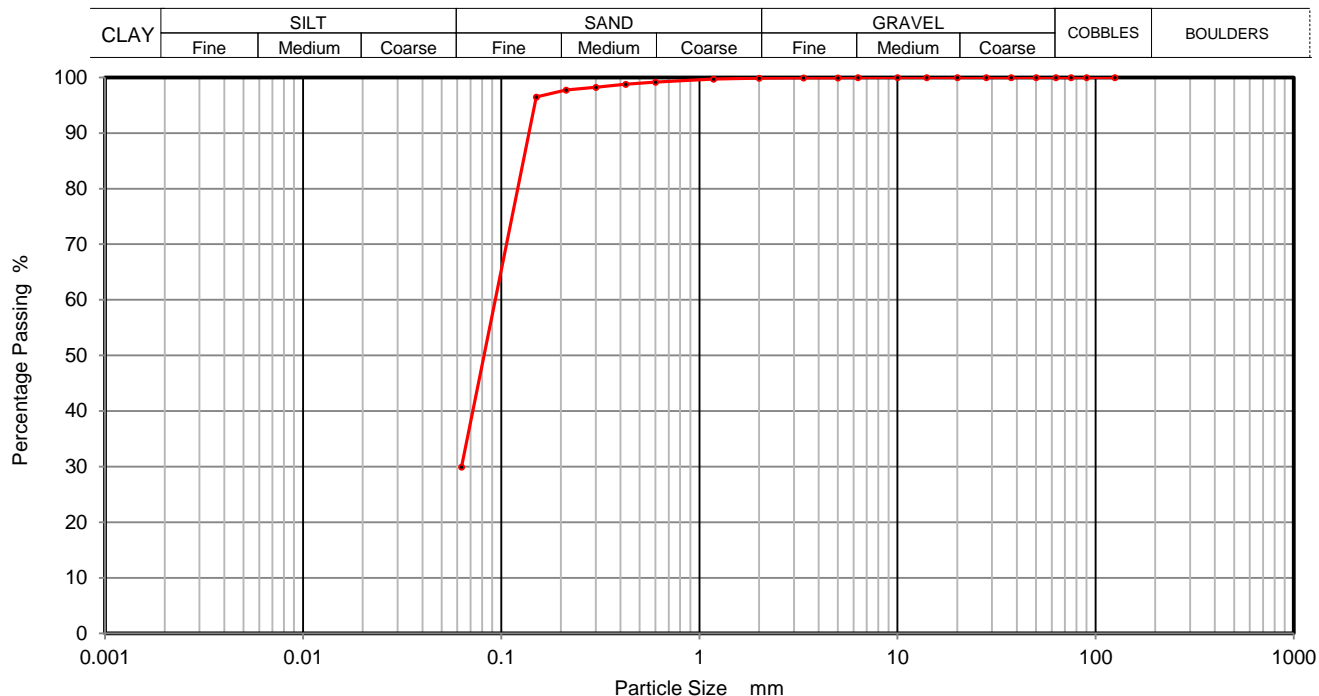
Sieving		Sedimentation	
Particle Size mm	% Passing	Particle Size mm	% Passing
125	100		
90	100		
75	100		
63	100		
50	100		
37.5	100		
28	100		
20	100		
14	100		
10	100		
6.3	100		
5	100		
3.35	100		
2	100		
1.18	100		
0.6	99		
0.425	99		
0.3	98		
0.212	98		
0.15	96		
0.063	30

Sample Proportions	% dry mass
Cobbles	0
Gravel	0
Sand	70
Silt and Clay	30

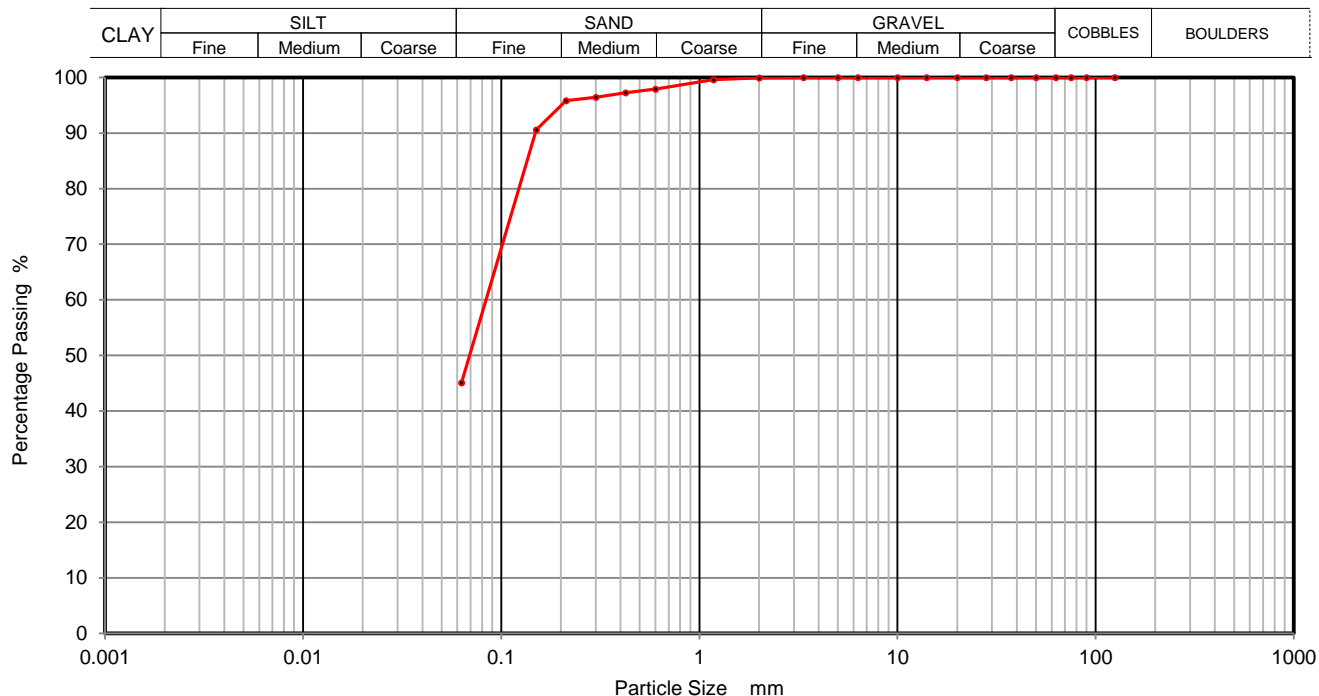
Sieving		Sedimentation	
Particle Size mm	% Passing	Particle Size mm	% Passing
125	100		
90	100		
75	100		
63	100		
50	100		
37.5	100		
28	100		
20	100		
14	100		
10	100		
6.3	100		
5	100		
3.35	100		
2	100		
1.18	100		
0.6	98		
0.425	97		
0.3	96		
0.212	96		
0.15	91		
0.063	45

Sample Proportions	% dry mass
Cobbles	0
Gravel	0
Sand	55
Silt and Clay	45

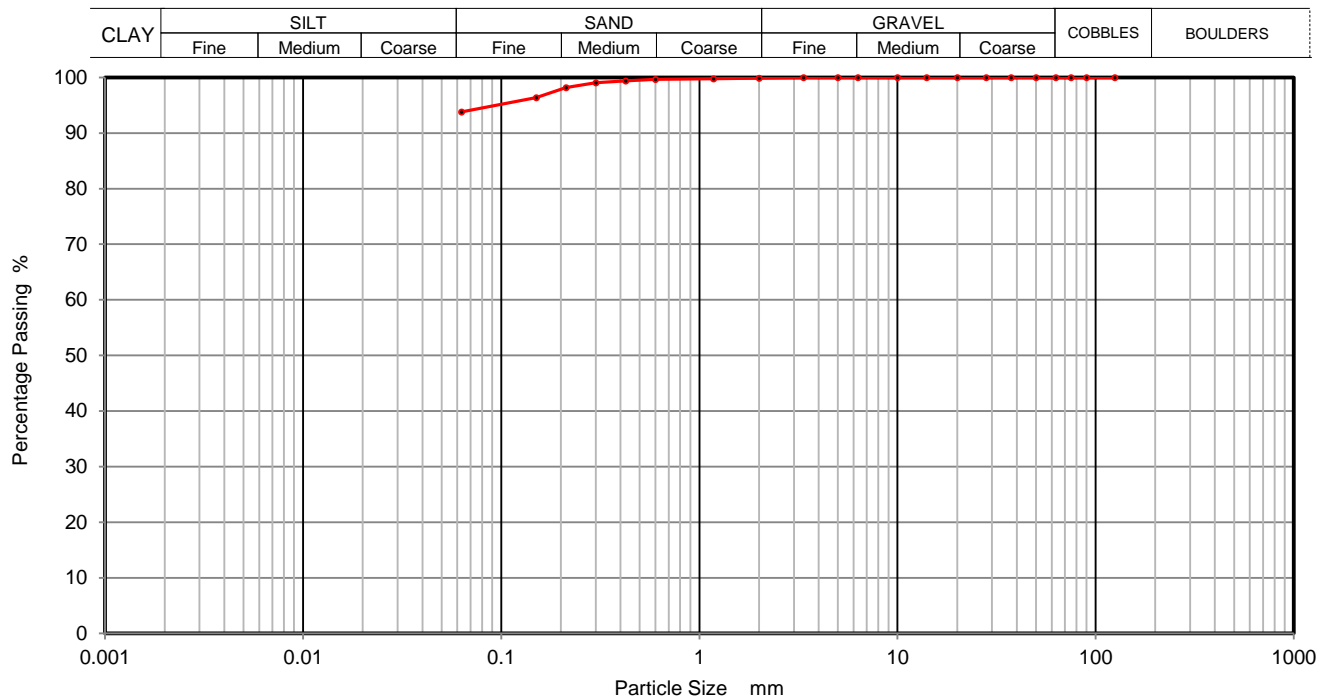
Sieving		Sedimentation	
Particle Size mm	% Passing	Particle Size mm	% Passing
125	100		
90	100		
75	100		
63	100		
50	100		
37.5	100		
28	100		
20	100		
14	100		
10	100		
6.3	100		
5	100		
3.35	100		
2	100		
1.18	100		
0.6	100		
0.425	99		
0.3	99		
0.212	98		
0.15	96		
0.063	94

Sample Proportions	% dry mass
Cobbles	0
Gravel	0
Sand	6
Silt and Clay	94

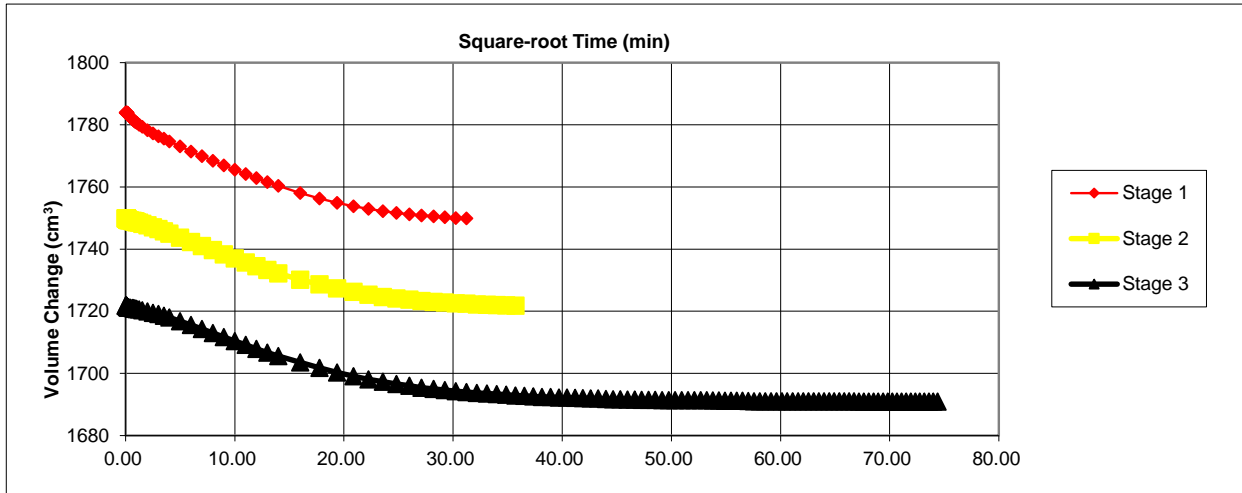
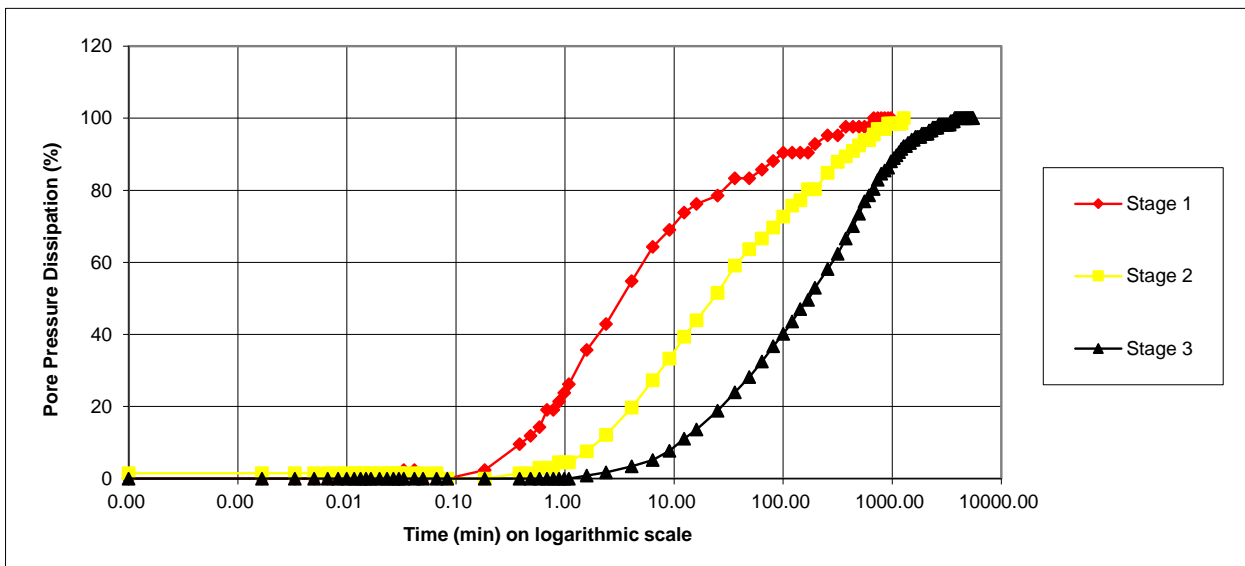
## Consolidation Stage

Borehole	BH01
Sample No.	
Depth	4.00-4.45
Date	29/05/2019

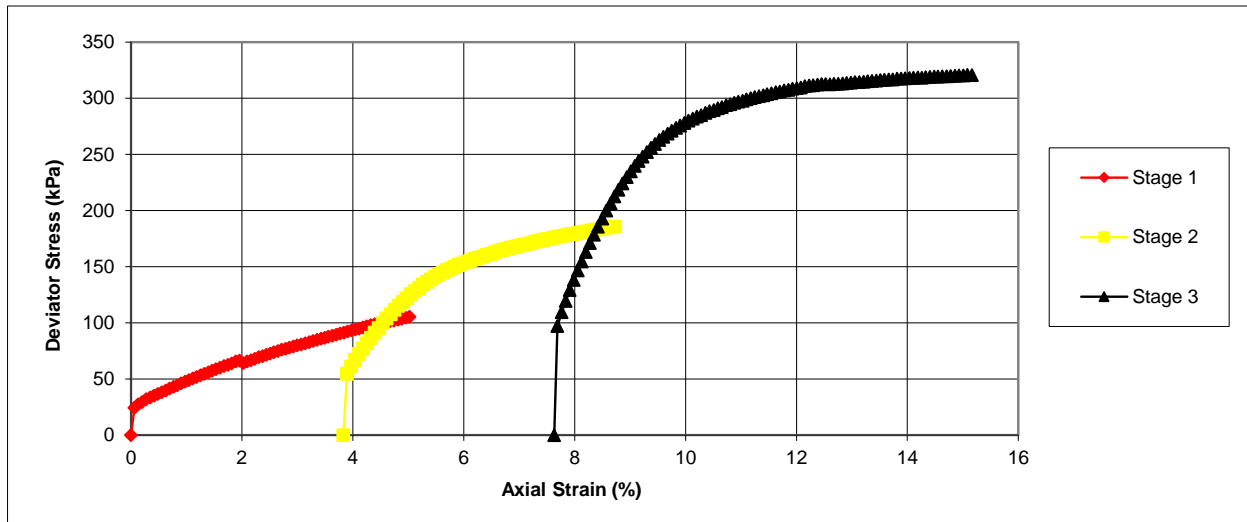
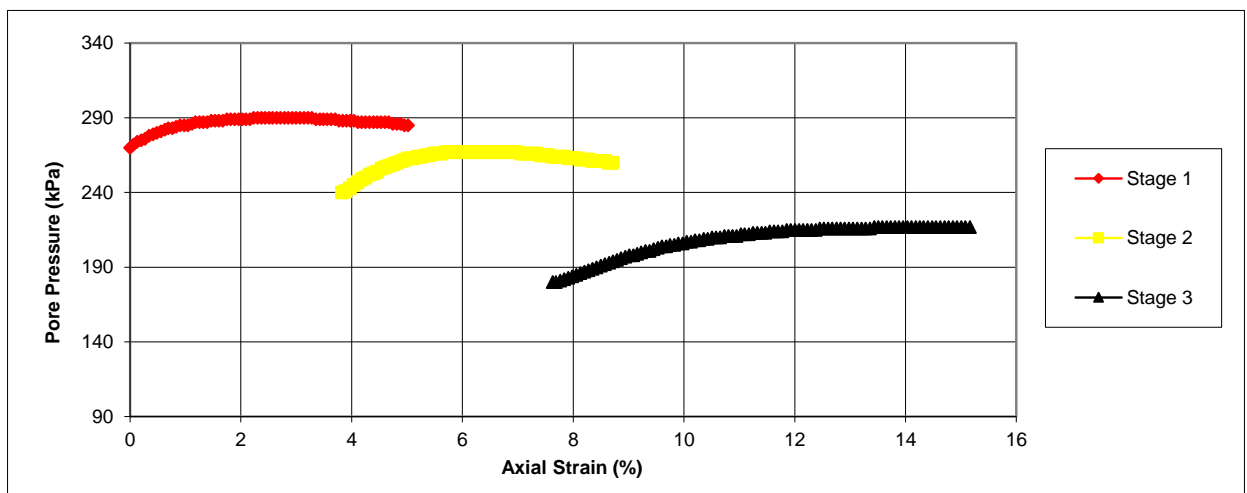
## Shearing Stage

Borehole	BH01
Sample No.	
Depth	4.00-4.45
Date	29/05/2019

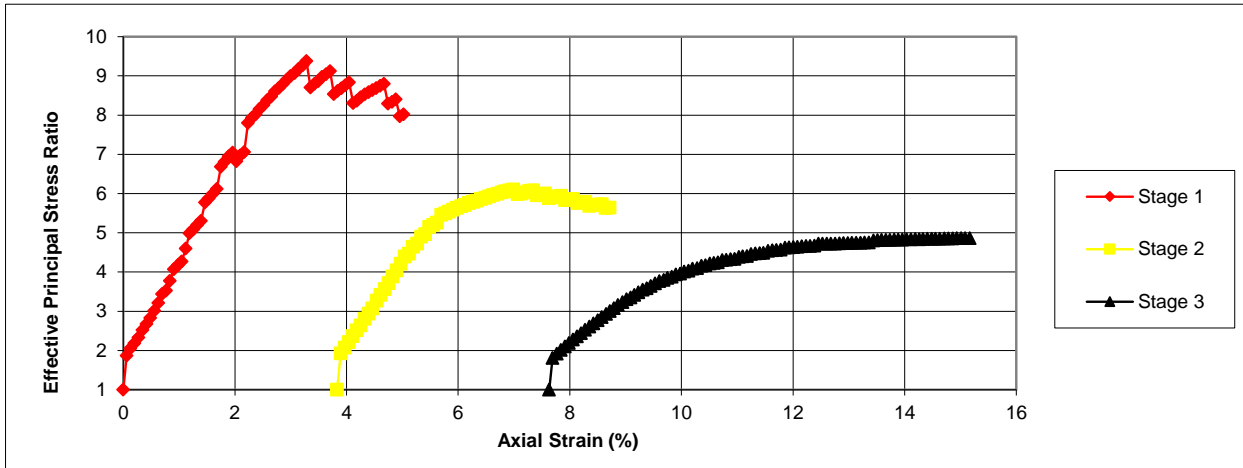
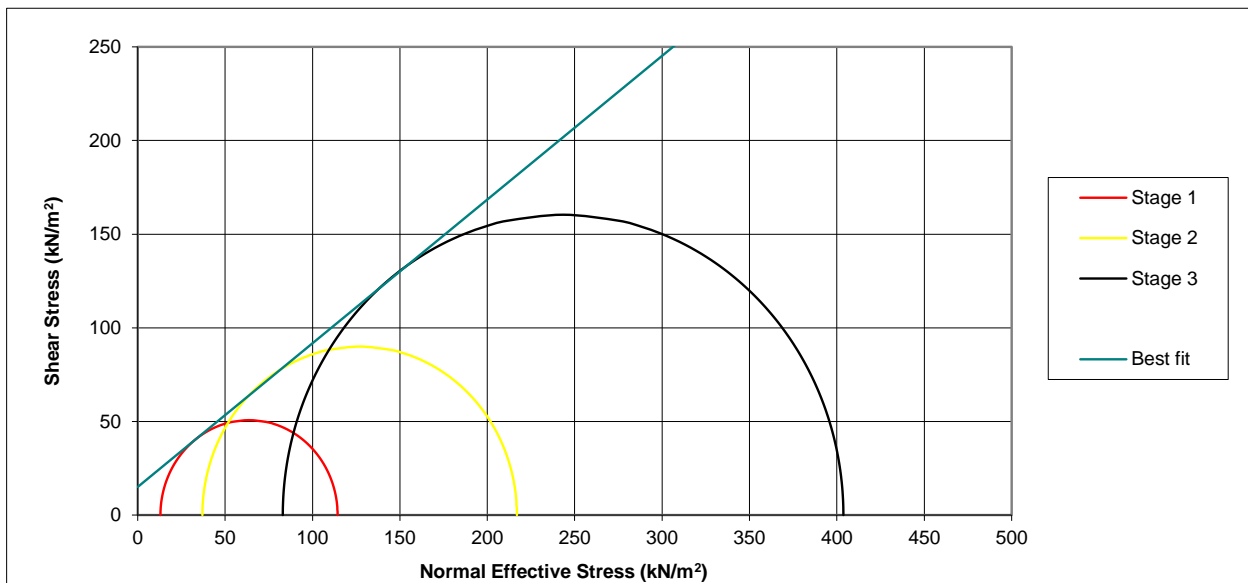
## Shearing Stage

Borehole	BH01
Sample No.	
Depth	4.00-4.45
Date	29/05/2019

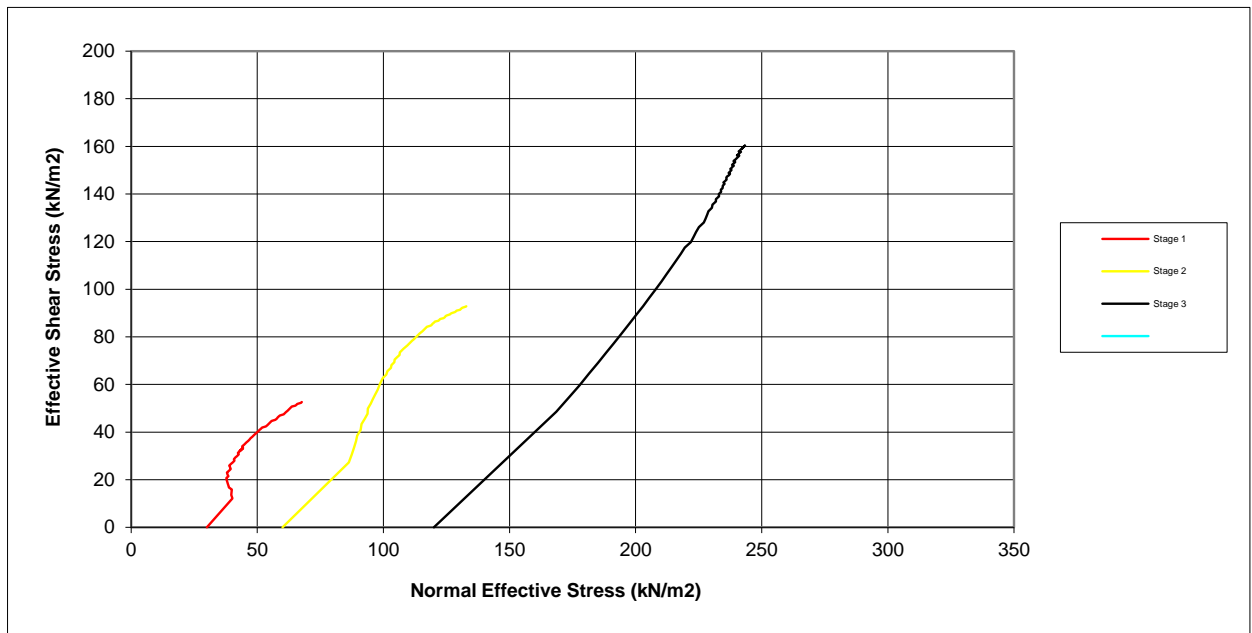
## Shearing Stage

Borehole	BH01
Sample No.	
Depth	4.00-4.45
Date	29/05/2019

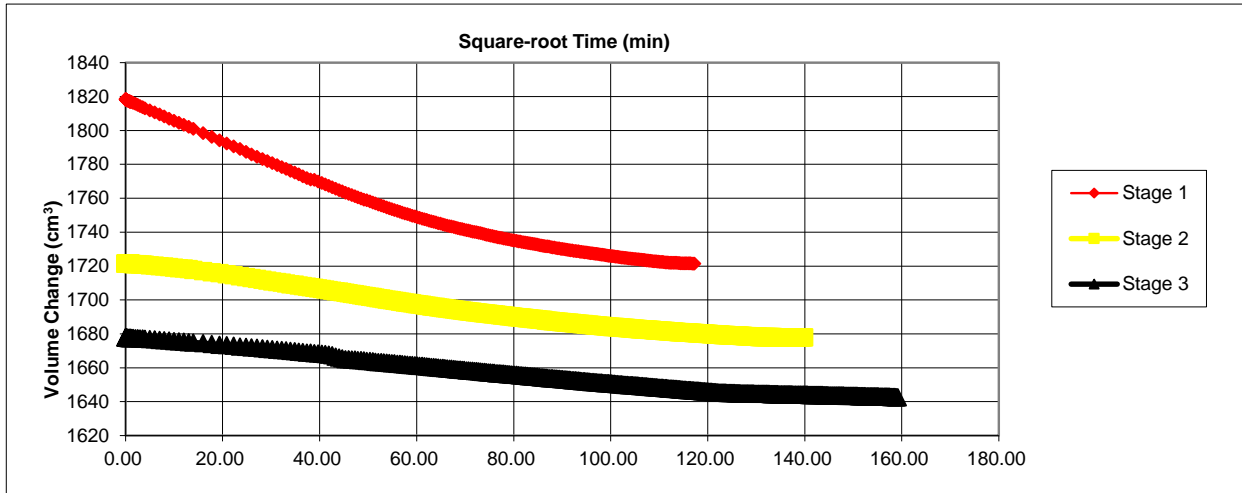
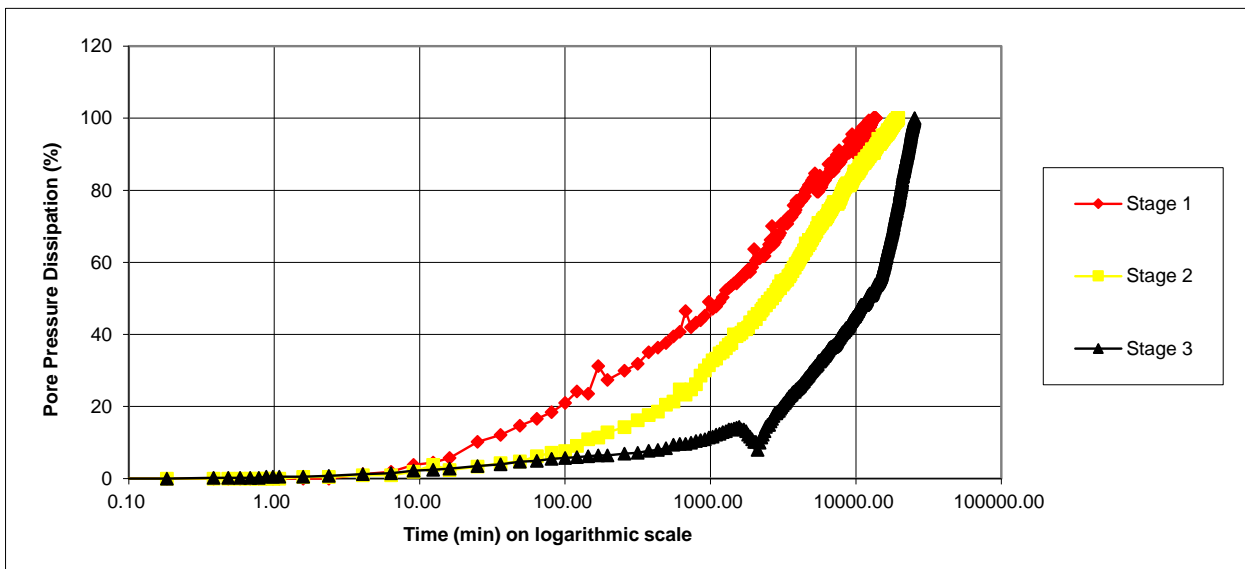
Borehole	BH01
Sample No.	
Depth	18.50-18.95
Date	29/05/2019

## Consolidation Stage

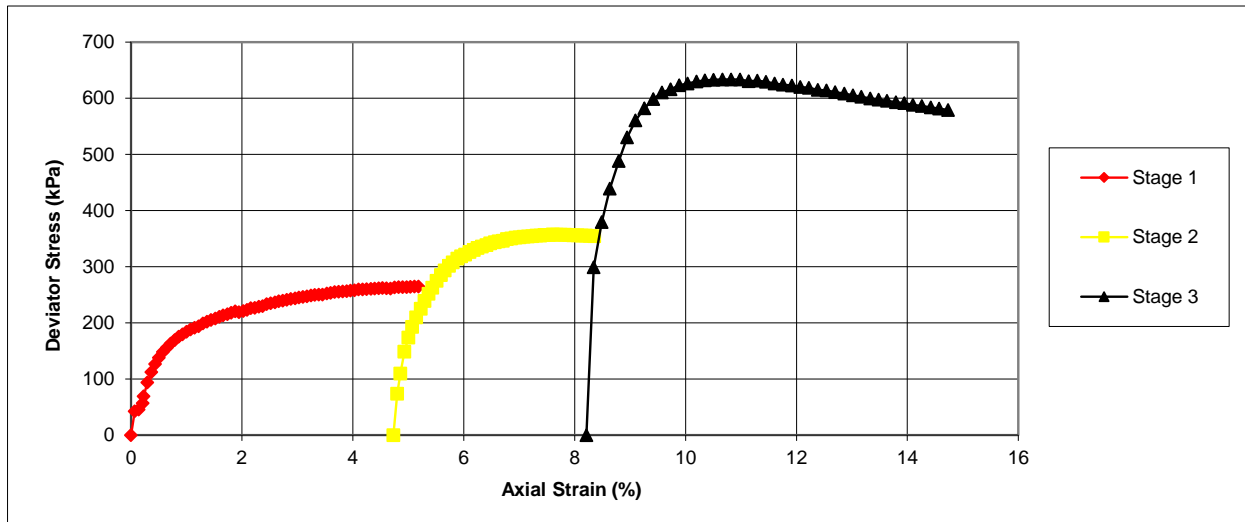
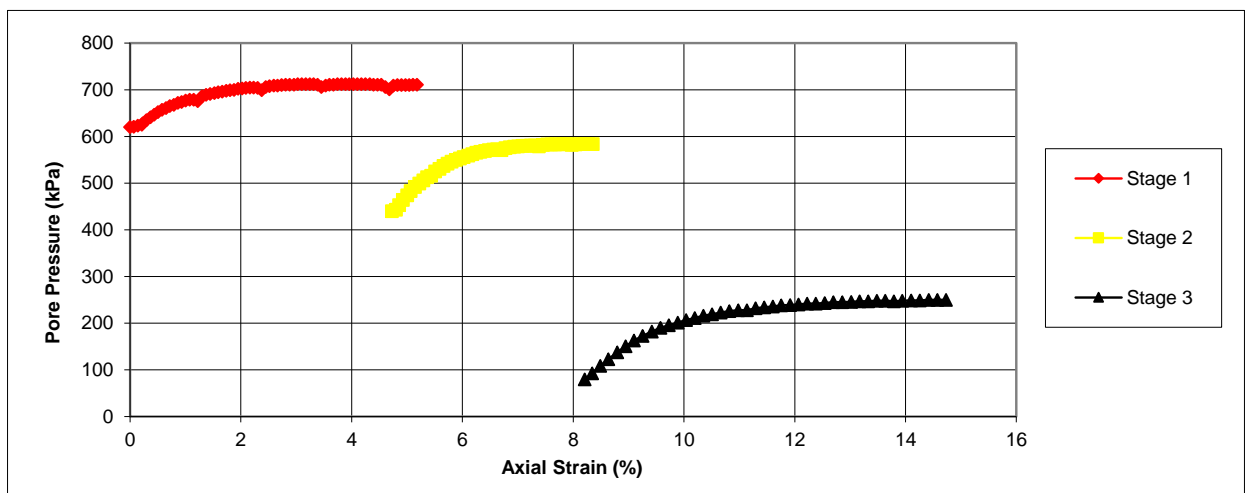
Borehole	BH01
Sample No.	
Depth	18.50-18.95
Date	29/05/2019

## Shearing Stage
