BASEMENT IMPACT ASSESSMENT  
BRANCH HILL HOUSE  
ALMAX GROUP  
05 December 2019

BASEMENT IMPACT ASSESSMENT  
BRANCH HILL HOUSE  
ALMAX GROUP

05 December 2019

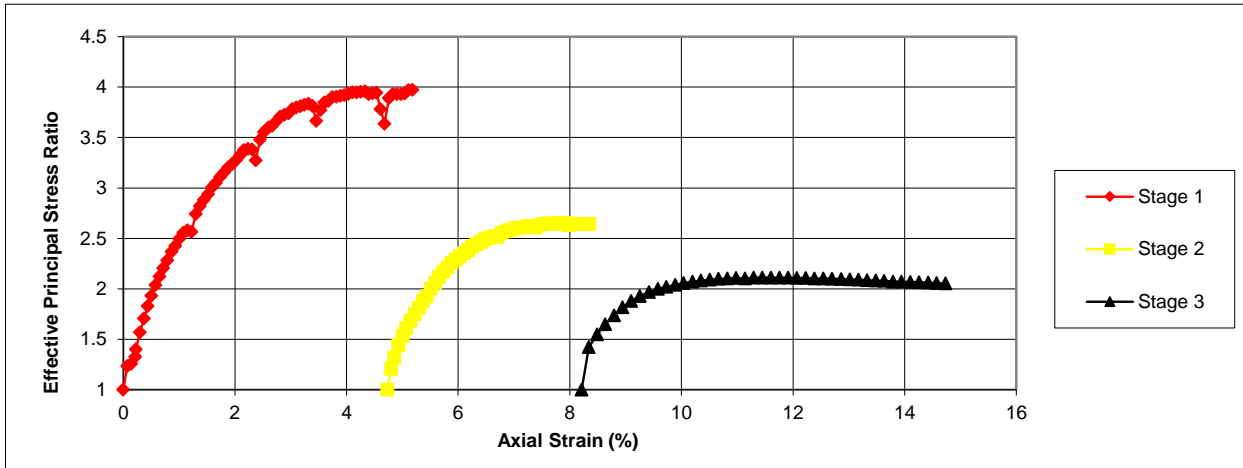
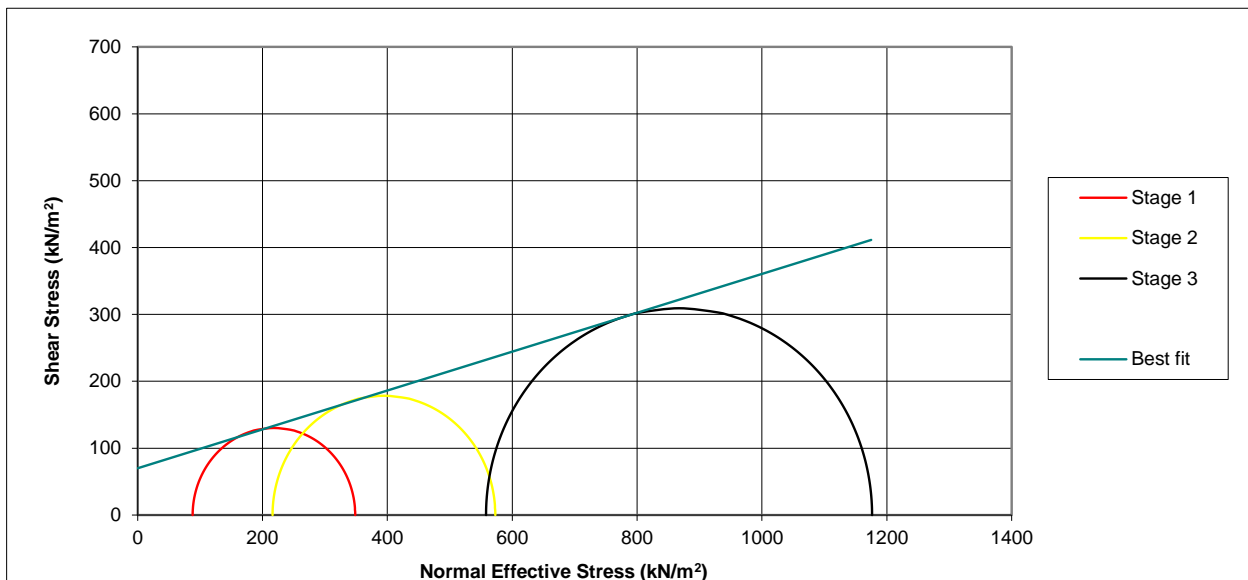
Borehole	BH01
Sample No.	
Depth	18.50-18.95
Date	29/05/2019

## Shearing Stage

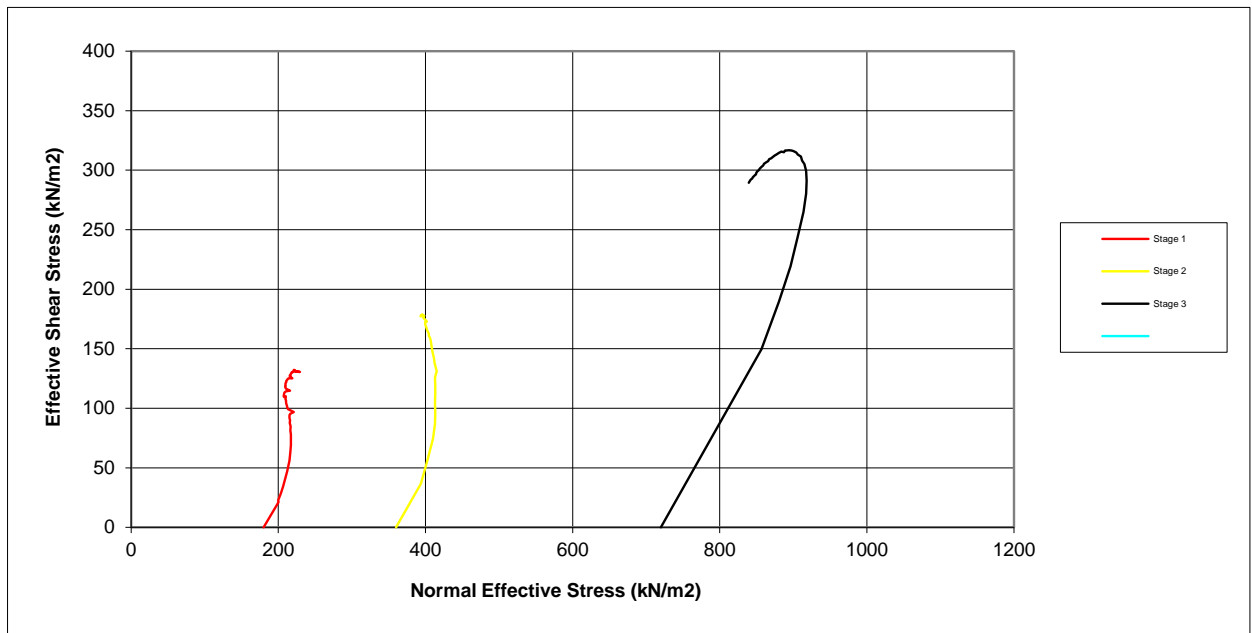
Borehole	BH01
Sample No.	
Depth	18.50-18.95
Date	29/05/2019

## Shearing Stage

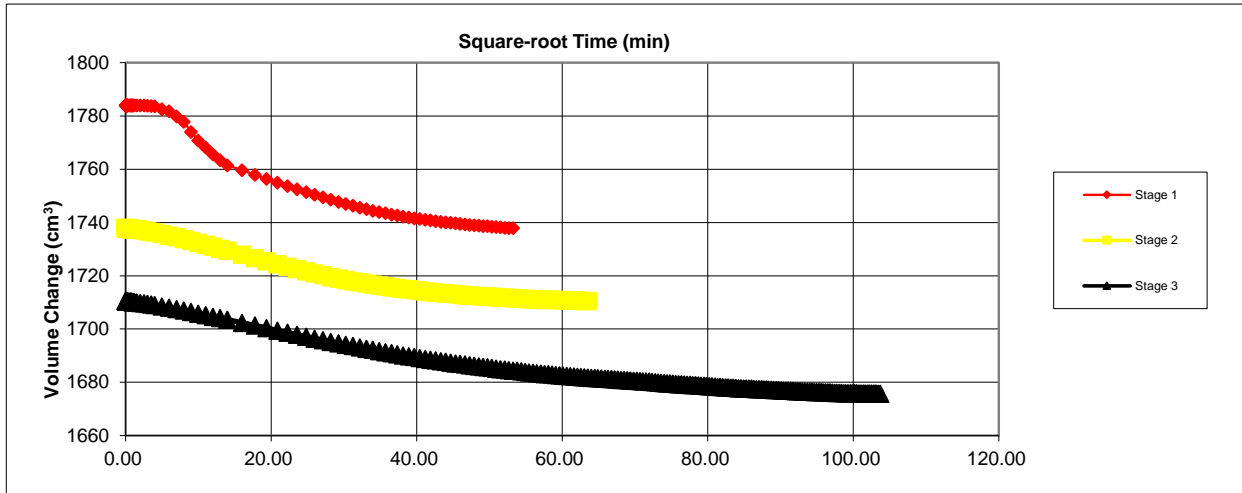
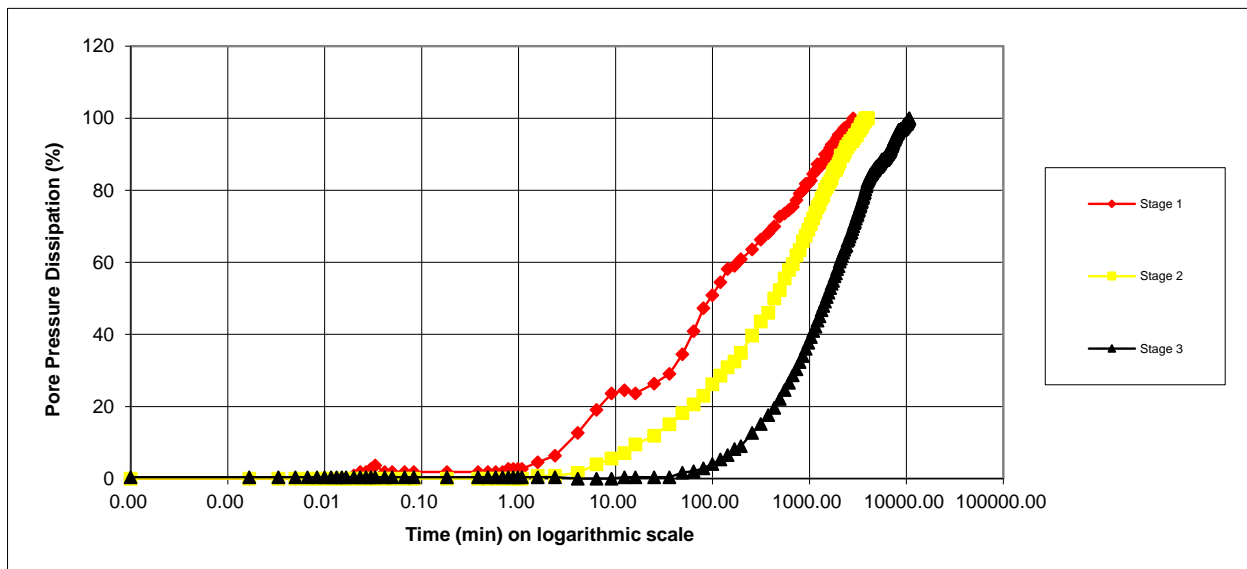
Borehole		BH01
Sample No.		
Depth	from(m)	21.50
Depth	to(m)	21.95

## Consolidation Stage

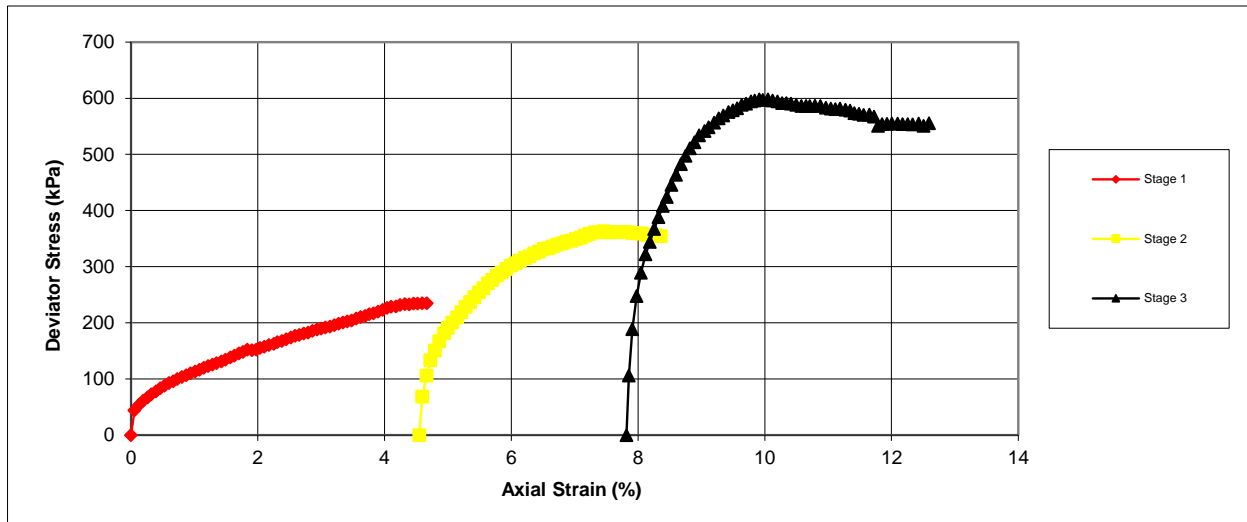
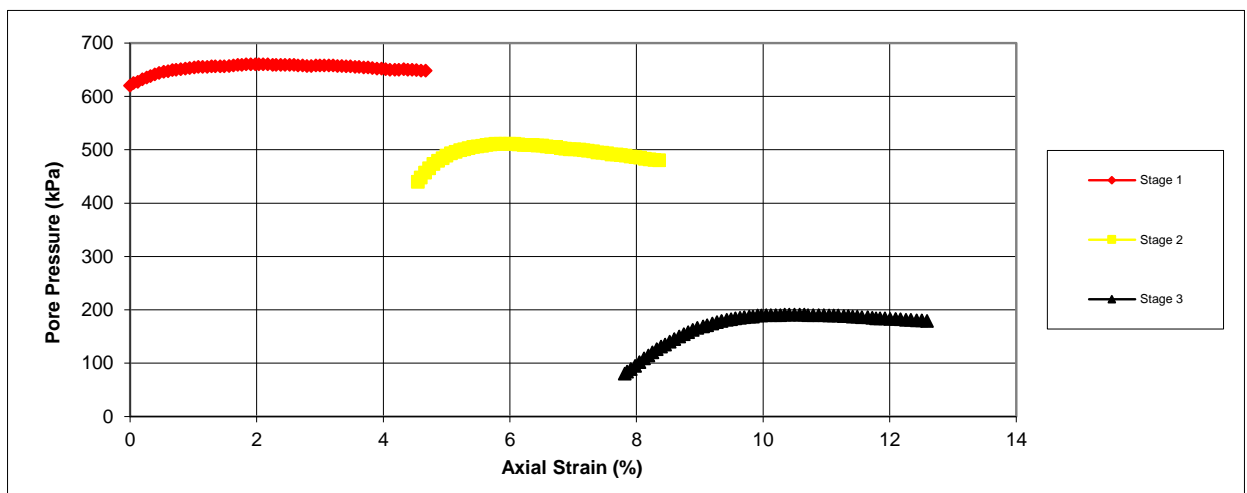
Borehole		BH01
Sample No.		
Depth	from(m)	21.50
Depth	to(m)	21.95

## Shearing Stage

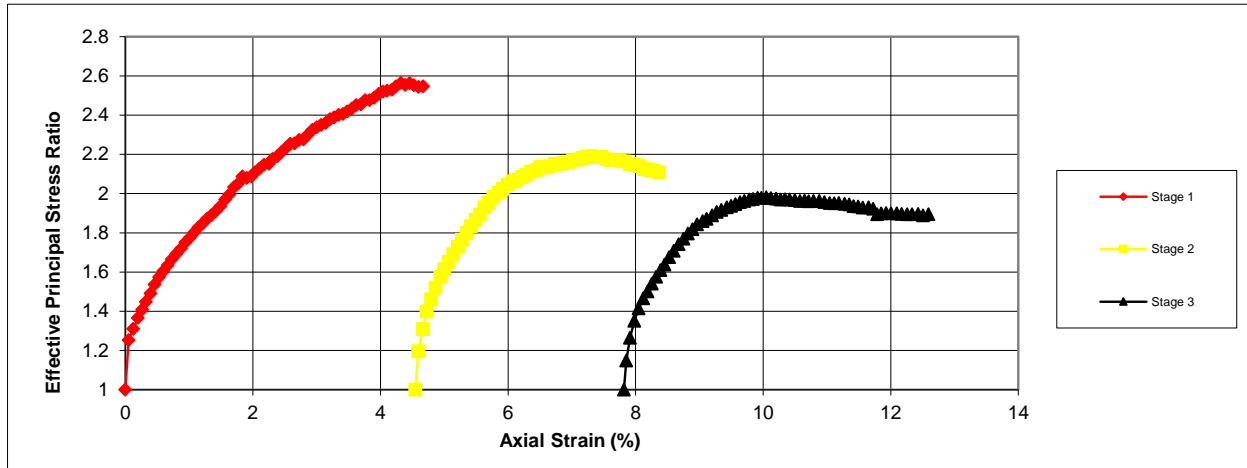
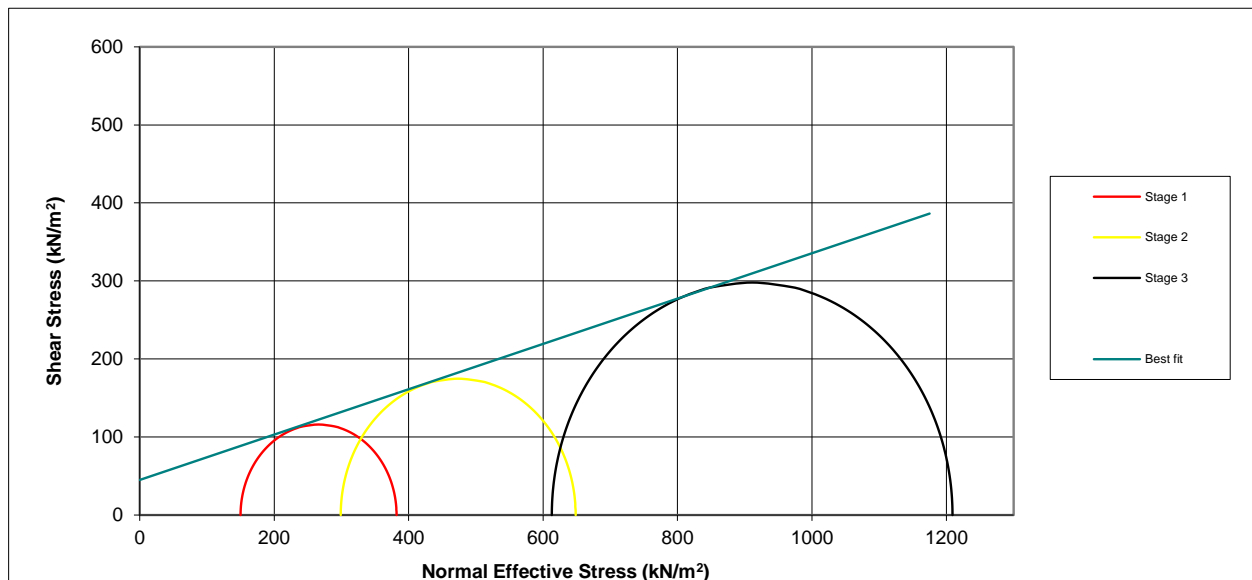
Borehole		BH01
Sample No.		
Depth	from(m)	21.50
Depth	to(m)	21.95

## Shearing Stage

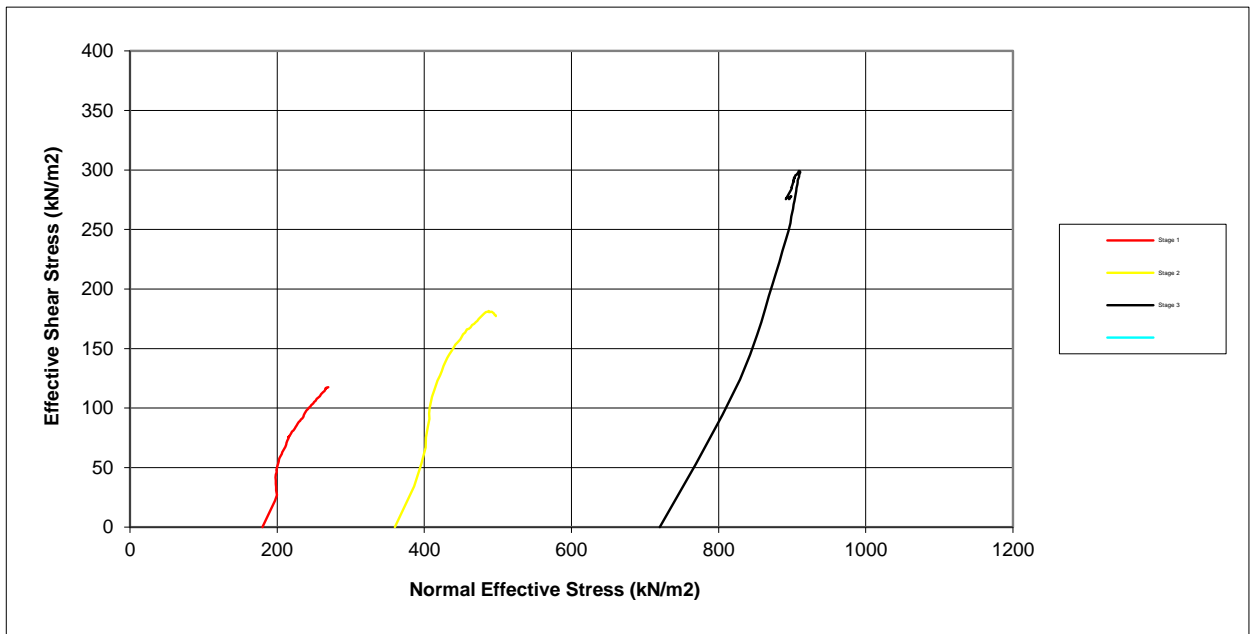
Borehole		BH01
Sample No.		
Depth	from(m)	21.50
Depth	to(m)	21.95

## Shearing Stage

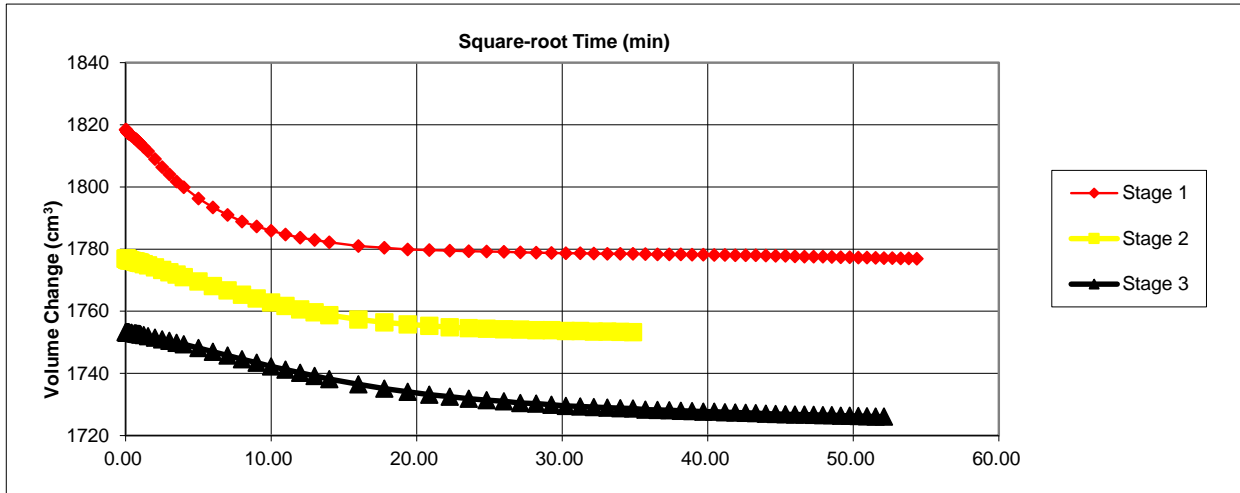
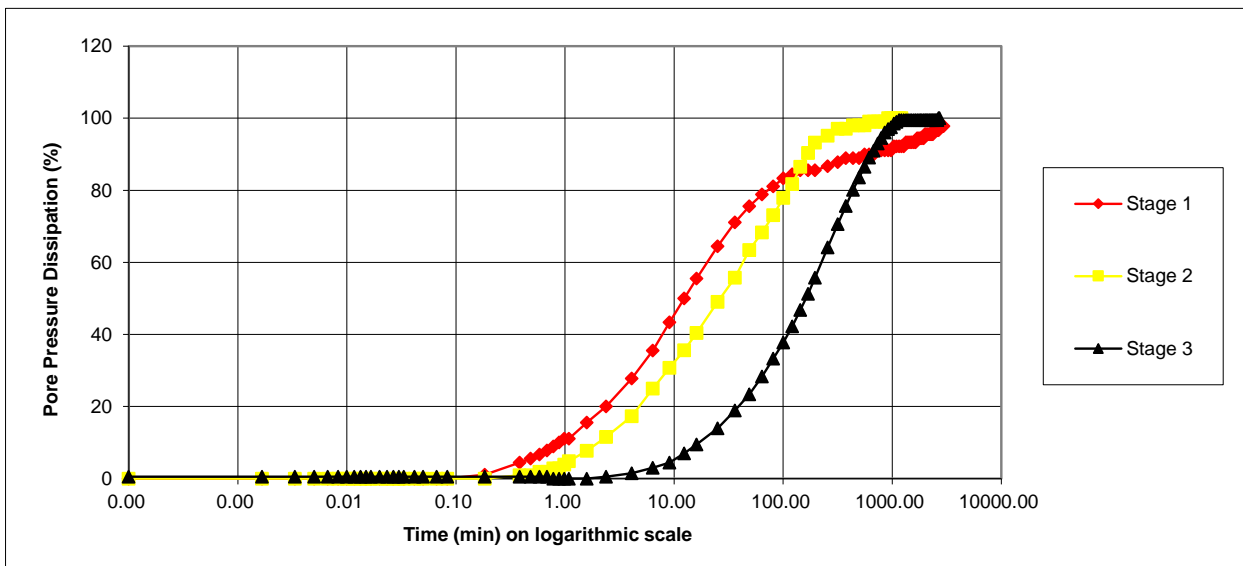
Borehole	BH02
Sample No.	
Depth	15.50-15.95
Date	29/05/2019

## Consolidation Stage

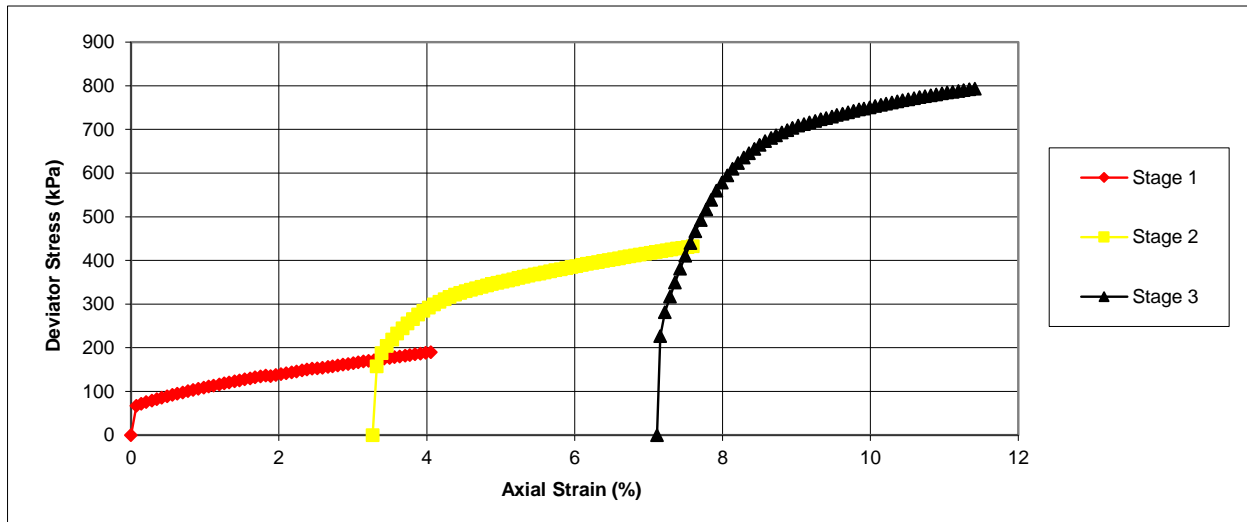
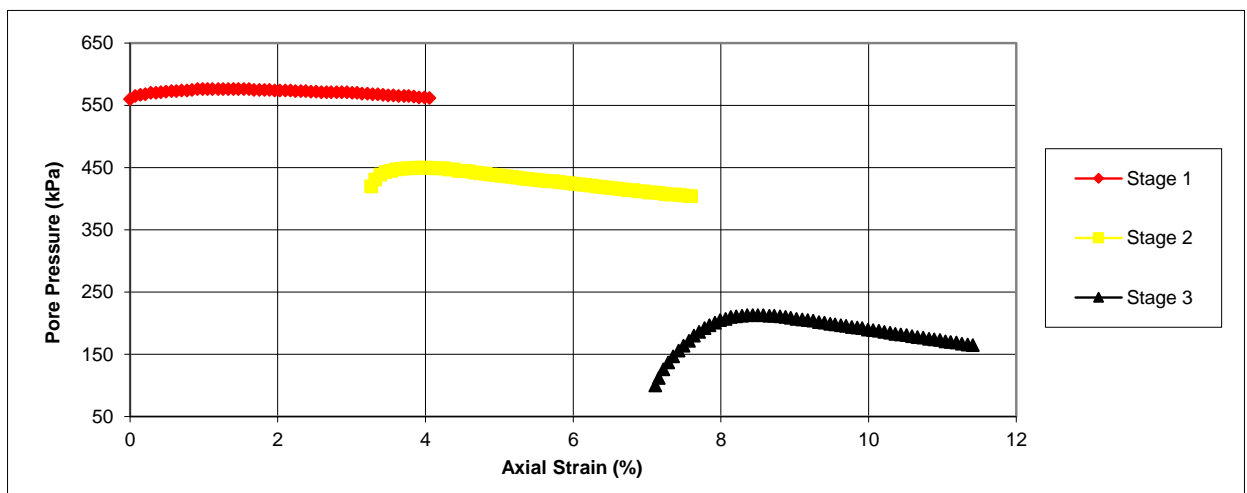
Borehole	BH02
Sample No.	
Depth	m 15.50-15.95
Date	29/05/2019

## Shearing Stage

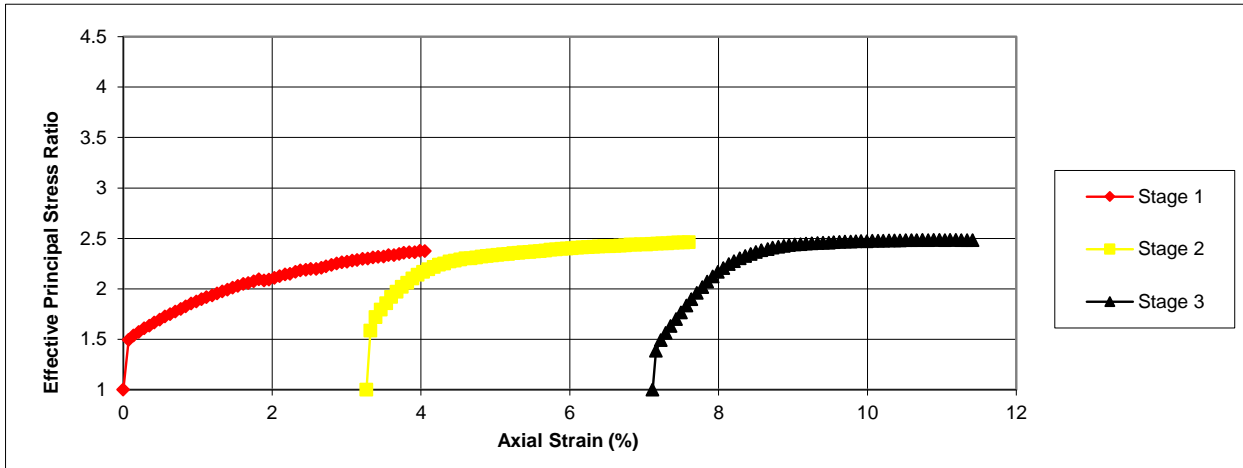
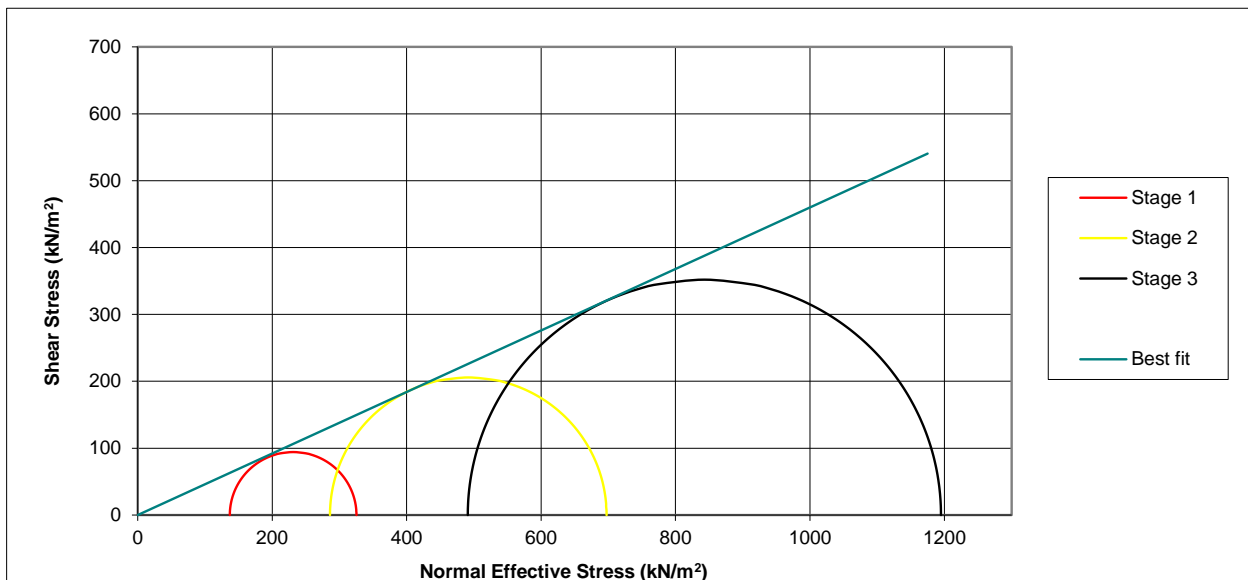
Borehole	BH02
Sample No.	
Depth	15.50-15.95
Date	29/05/2019

## Shearing Stage

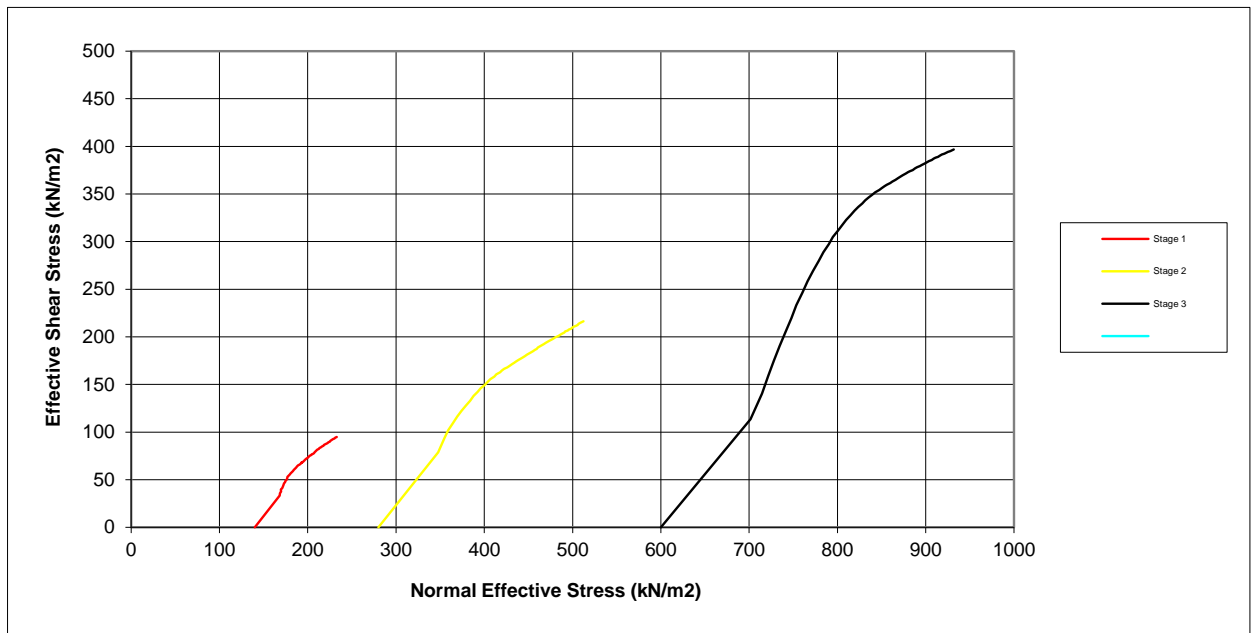
Borehole	BH02
Sample No.	
Depth	15.50-15.95
Date	29/05/2019

## Shearing Stage

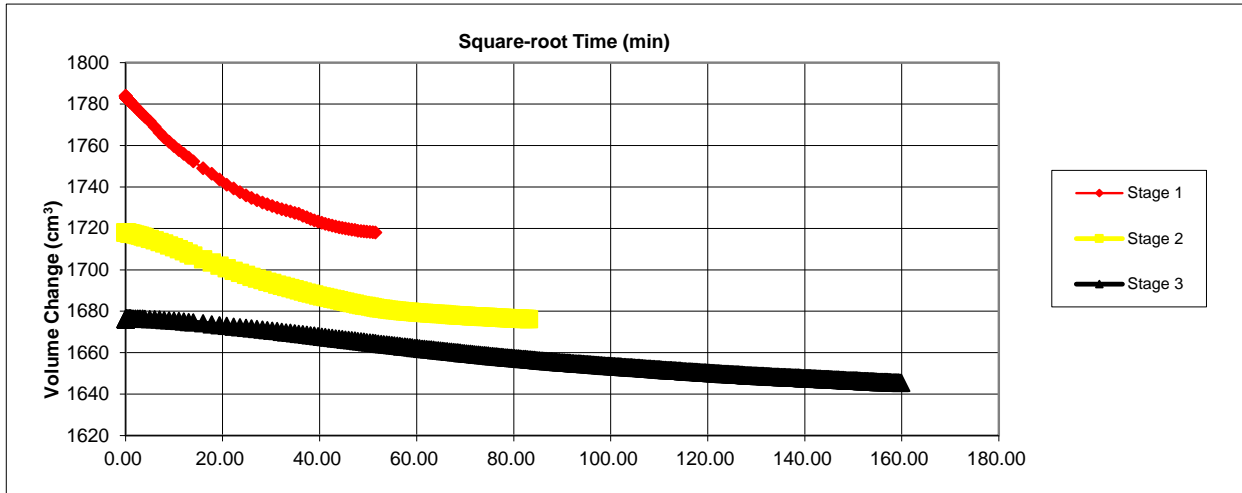
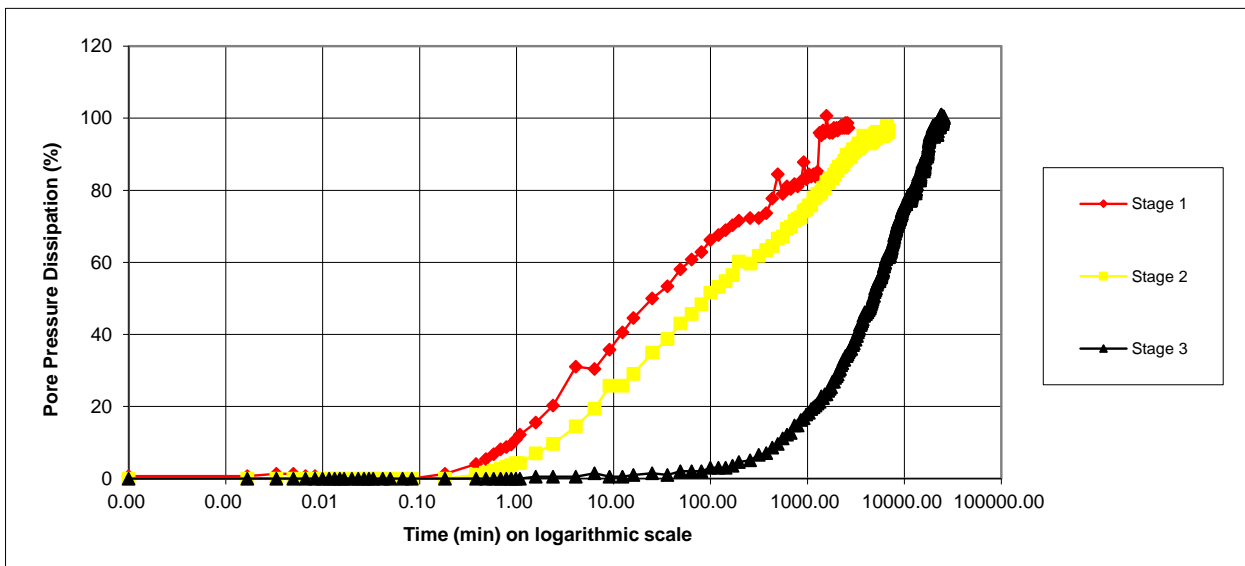
Borehole	BH02
Sample No.	
Depth	20.00-20.45
Date	29/05/2019

## Consolidation Stage

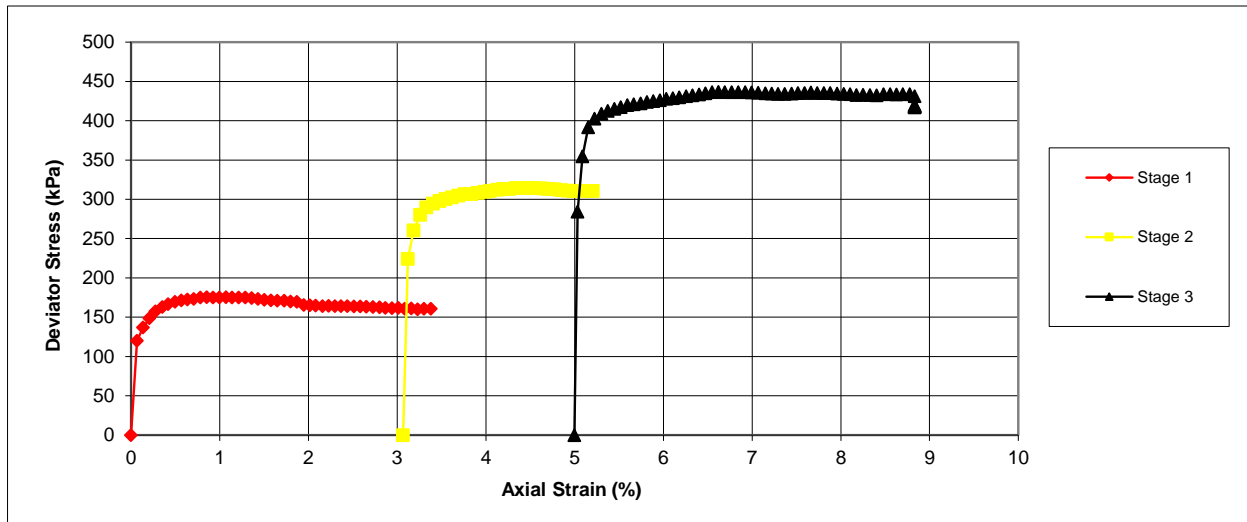
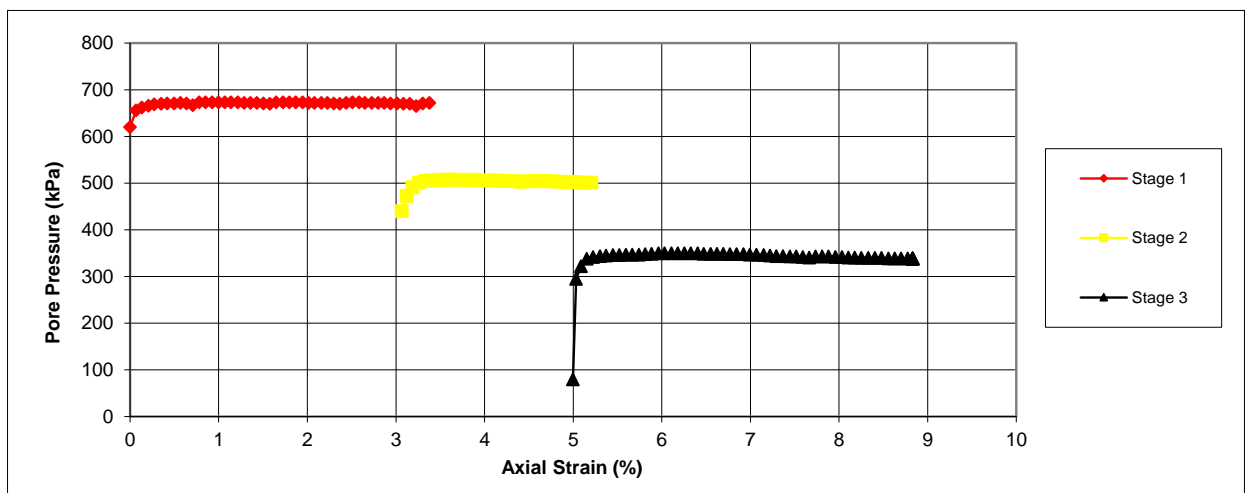
Borehole		BH02
Sample No.		
Depth	m	20.00-20.45
Date		29/05/2019

## Shearing Stage

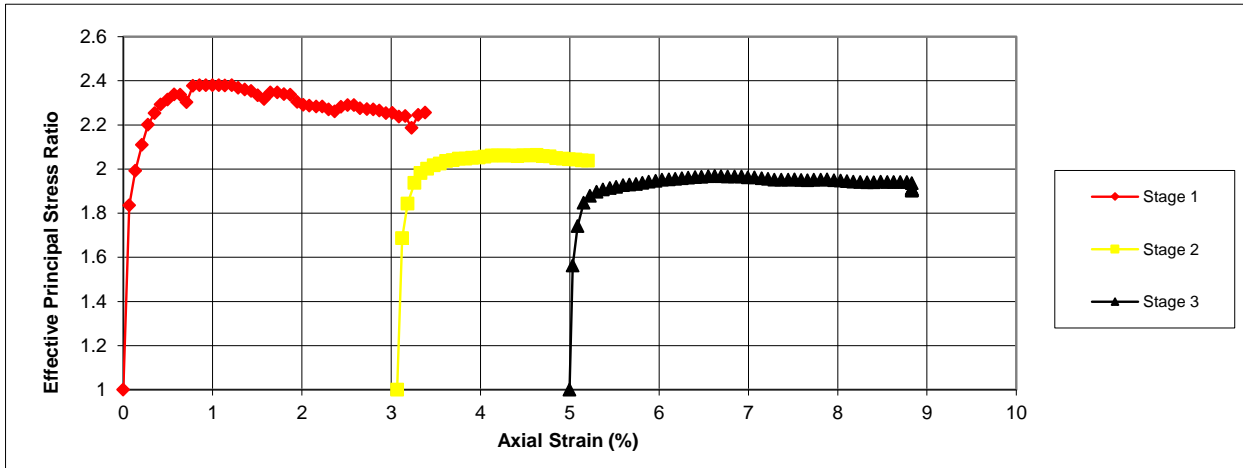
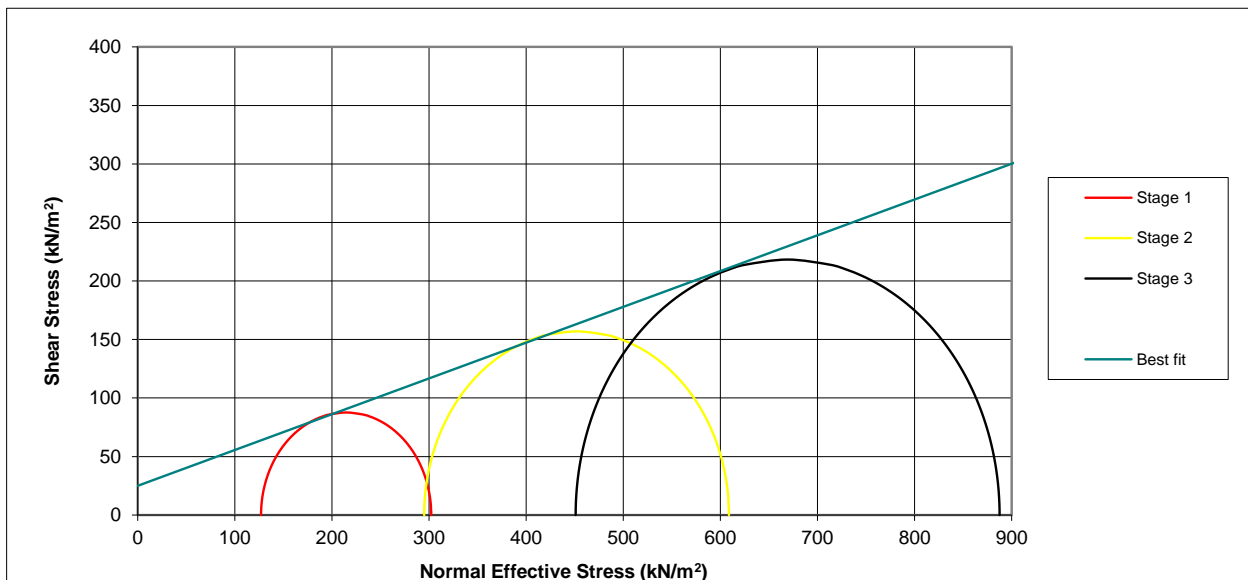
Borehole	BH02
Sample No.	
Depth	20.00-20.45
Date	29/05/2019

## Shearing Stage

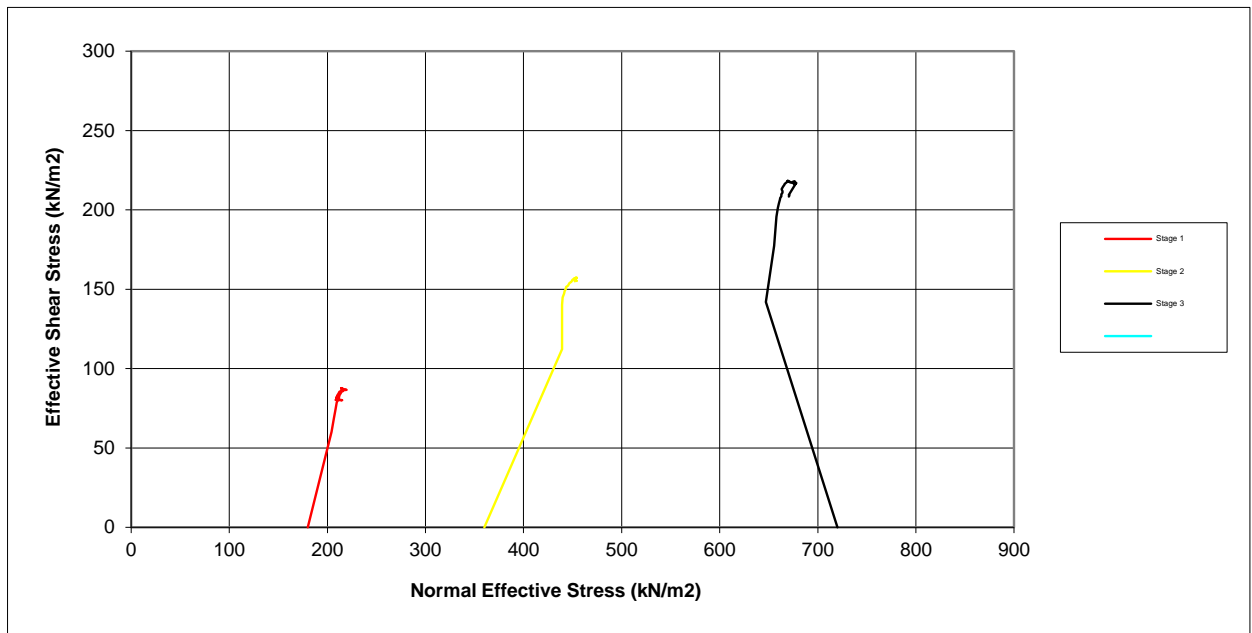
Borehole	BH02
Sample No.	
Depth	20.00-20.45
Date	29/05/2019

## Shearing Stage

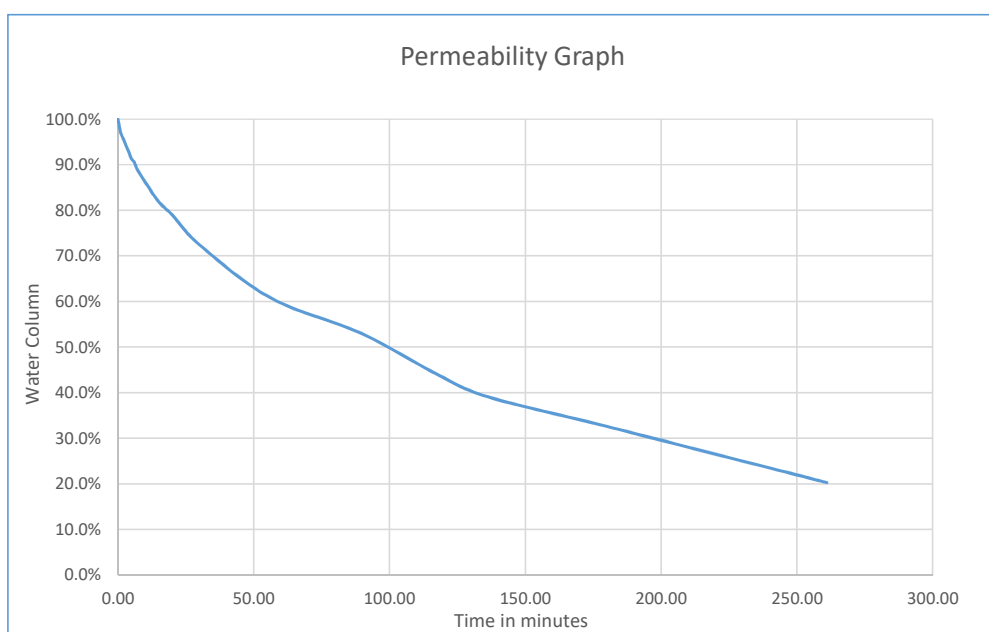
Infiltration Rate	from 75%-25%	9.68345E-06
-------------------	--------------	-------------

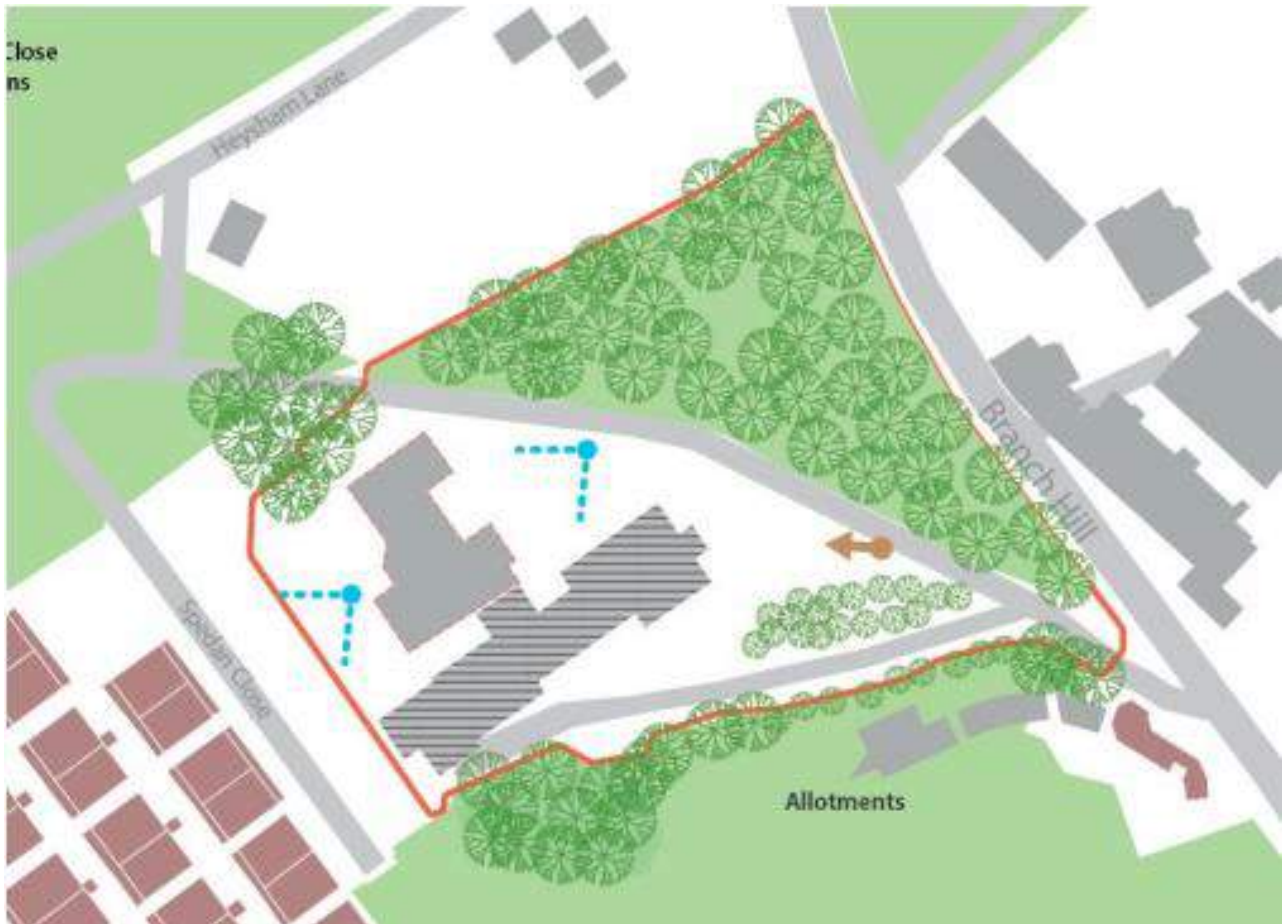
Figure 2 – Existing Site Plan

Neighbouring along the south-west of the property is the Branch Hill Estate (approx. 15m away), a multiplex of council-owned houses built upon a complex stepped-section of hill circa 1970s. The estate is likely founded

on strip foundations and is in reasonable condition. To the north of the property is West Heath Lodge (approx. 55m away), a 5-storey apartment block, constructed circa 1980s. The block is likely founded on piled foundations given its height, anticipated loadings and condition. At the entrance to the Spedan Close driveway is a small gate house (approx. 70m away). Directly south is a residential property (approx. 70m away)

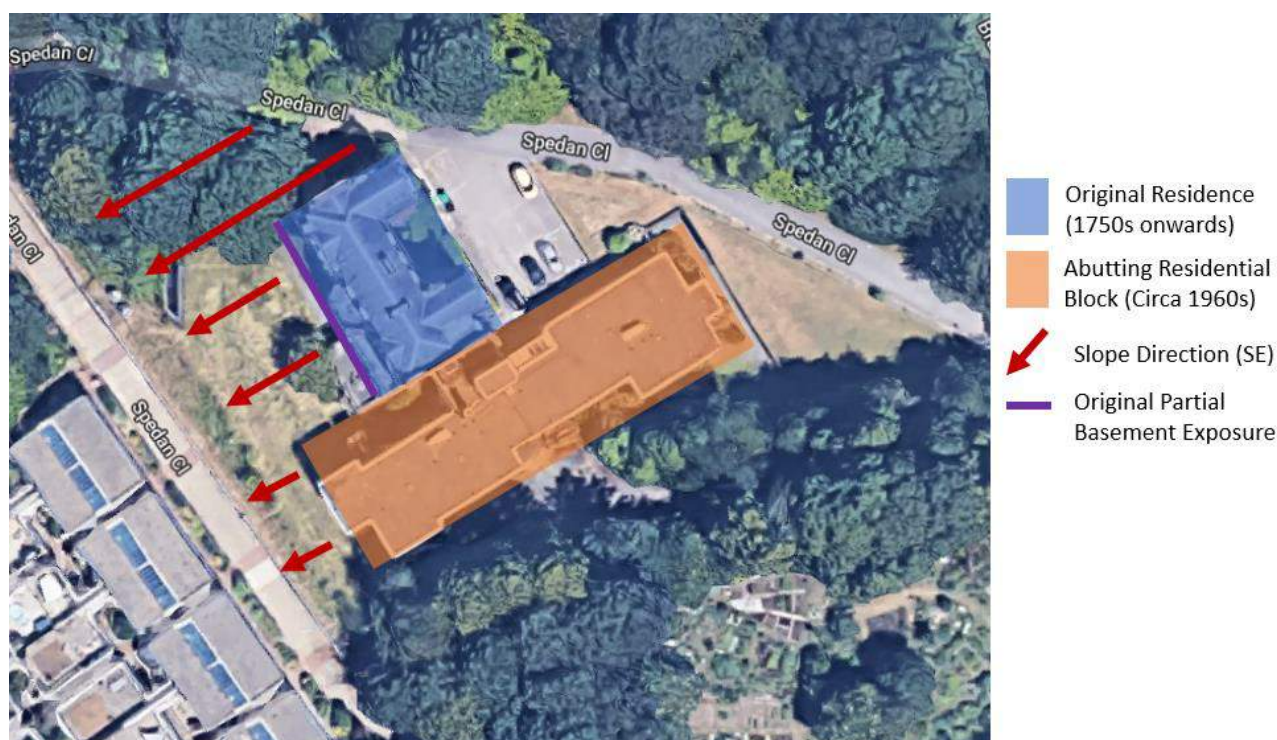
Figure 3 - Existing buildings showing site slopes and overland flow routes

The site slopes from east to west and north to south. A selection of approximate site levels is outlined below:

- NW corner: 115.3m AOD
- SW corner: 115.3m AOD
- NE corner: 124.5m AOD
- SE corner: 122.7m AOD
