HERITAGE STRUCTURAL ASSESSMENT
on
UCL INSTITUTE OF EDUCATION
PHASE 2

Train & Kemp (Consulting Engineers) LLP | 10 Kennington Park Place London SE11 4AS | Limited Liability Partnership No. OC305768

Job Title: UCL IoE		Job No. 14392
	Name	Signature
Author	Norman Train

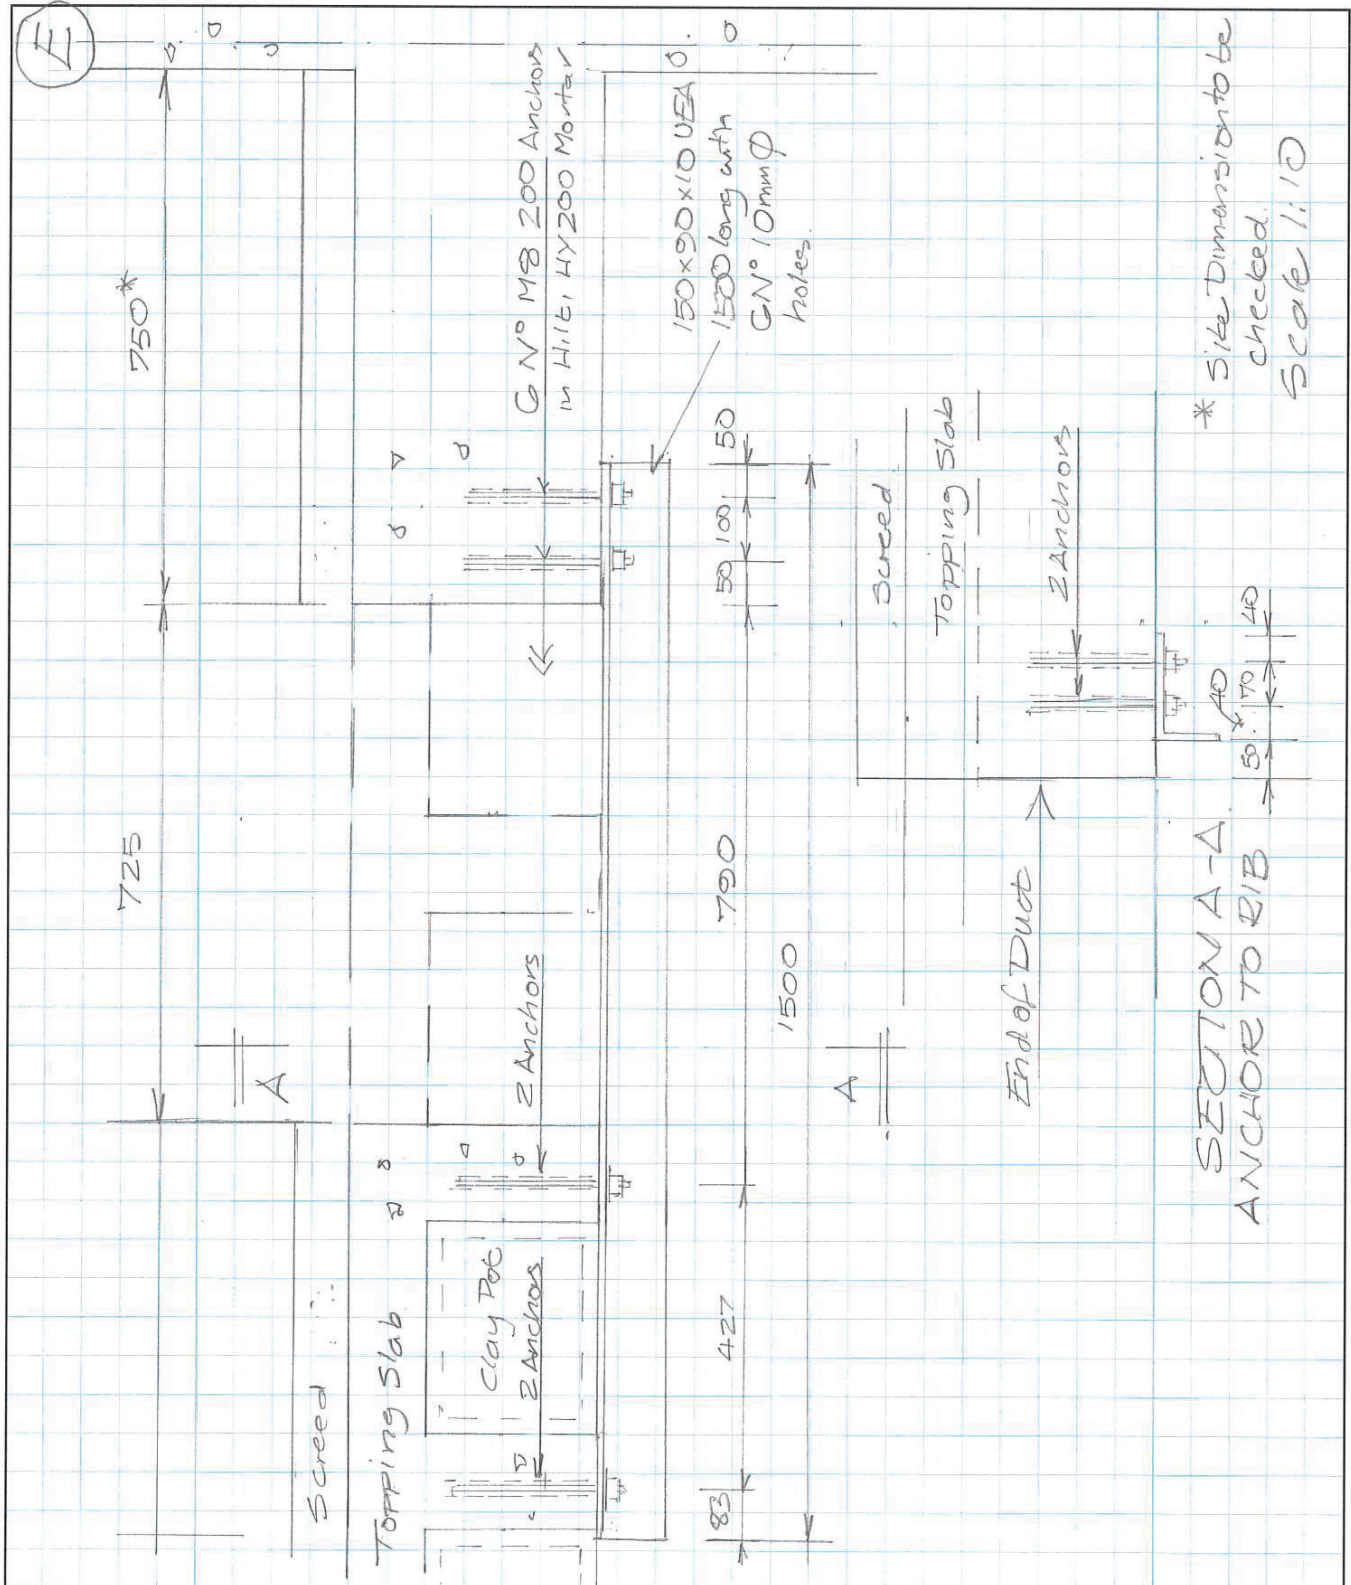
Designer NDT	Job Title INSTITUTE OF EDUCATION	Job No. 14140
Date Oct 18	Section TRIMMING TO SLOT 1.08	Pages No. SK 01

Rib trimming detail for Structural Alteration 02

Appendix 2: Floor rib trimming detail
