Flood Risk Assessment

Brad Briggs
108a Goldhurst Terrace
London
NW6 3HR

A new basement is proposed below an existing property at 108a Goldhurst Terrace. This report comprises a FRA (flood risk assessment) to support the planning application.

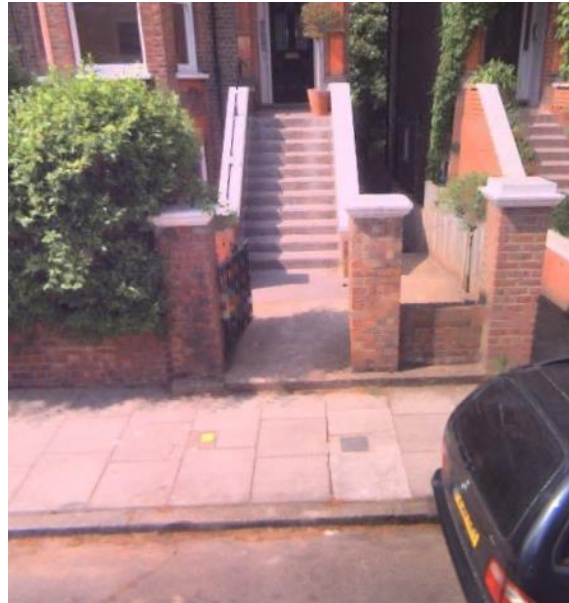
During times of high rainfall there will be an increased risk of surface water flooding from the impermeable surfaces of the street and pavement in front of the property. There are however a series of passive defences that help prevent rising surface water levels entering the boundary of 108a Goldhurst Terrace. The kerb line outside the property raises the pavement 65mm from the surface of the road. There is then another step up of 75mm from the pavement to the front garden on 108a Goldhurst terrace, as shown below.

Figure 2: Passive Defences at 108a Goldhurst Terrace

Further, there is a proposed 250mm masonry upstand around the front lightwell. This in total allows for 390mm of raised defence.

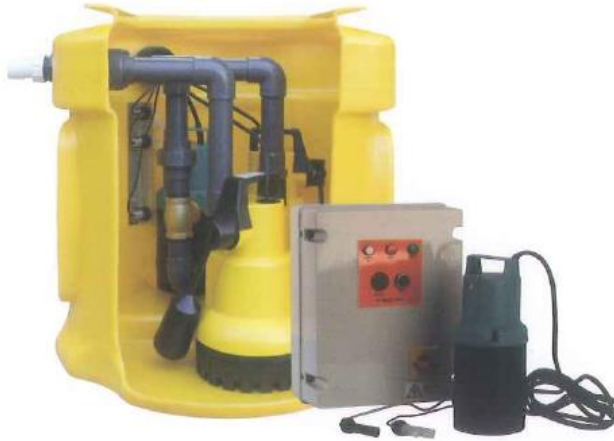
- A pumping system should be installed for the proposed basement. There is a likelihood that this may fail and allow excess water to accumulate. If this were to occur, the build-up of water would be gradual and noticeable before it becomes a significant life-threatening hazard.

- The pumping system should be a dual mechanism to maintain operation in the event of a failure. This should include a battery backup and a suitable alarm system for warning purposes.

Figure 5: Example of sump pump used commonly used for basement drainage

- Non-return valve to avoid the risk of backflow
- Install all electrical wiring at high level
