Hellical Mini Piles detail

Noemi Drew roject 109A Islip Street 134 roject No.

Tree protection plan 134-04-500 1:20, 1:100 @ A3

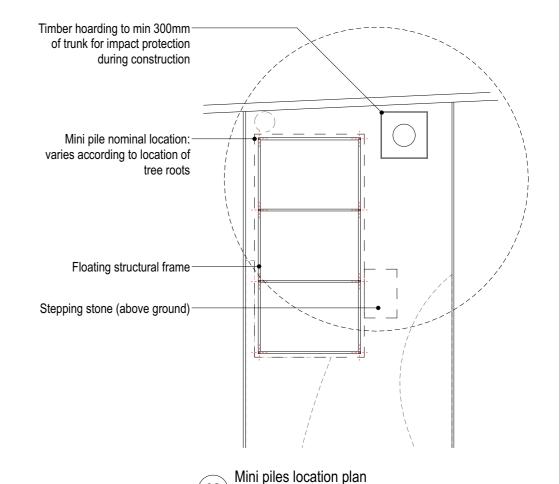
In order to offer maximum protection to the existing Lime tree, a construction strategy of 8 no. mini piles is proposed supporting a steel or timber frame (to structural engineers spec) which will float above the ground.

The piles are carefully drilled into position by hand. Their locations can vary in order to avoid tree roots (their exact location being unknown)

In order to further protect the garden and tree during construction, the new studio will be constructed as far as possible off site, with manual on site assembly to eradicate soil compaction or tree damage from heavy machinery.

The site is accessed only via the house interior. As such, no machinery will be on site during construction, further reducing risk to trunk damage.
