76 Lawn Road, London, NW3 2XB  
Heritage, Design and Access Statement

December 2019

Olympia  
Anesti

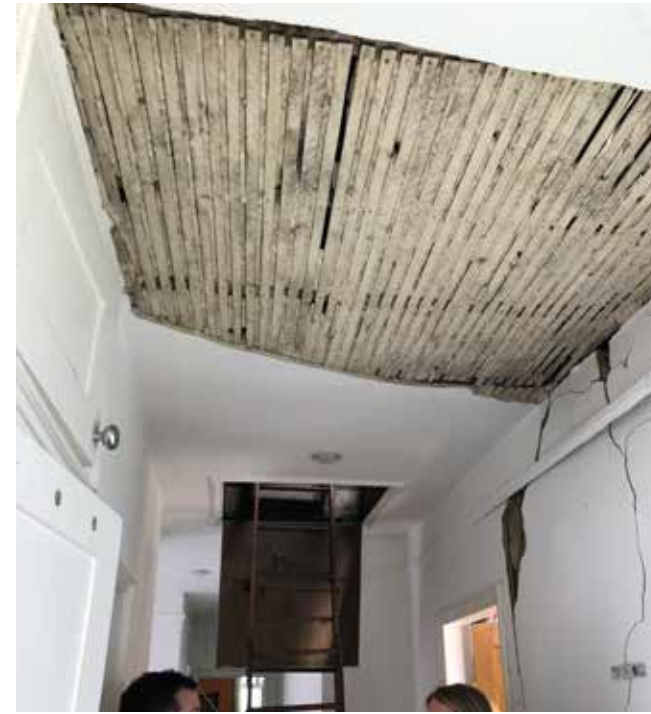
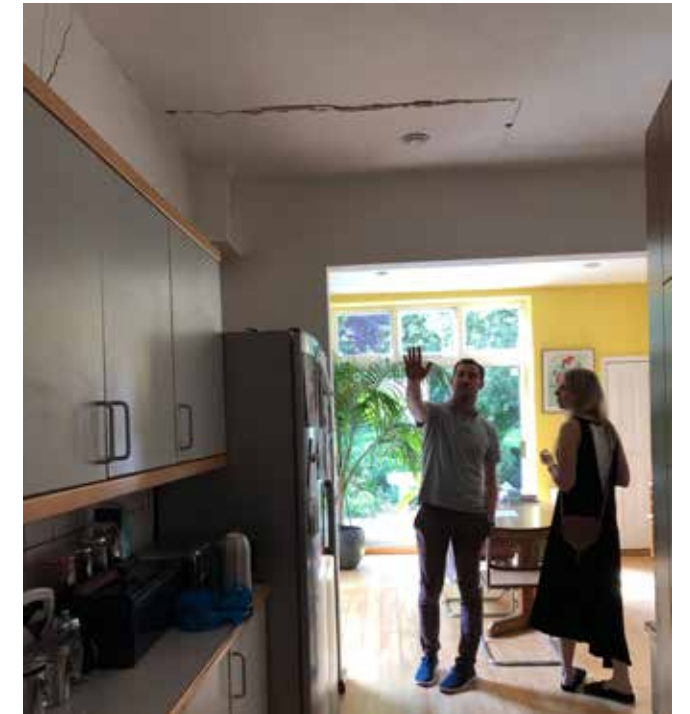
Internal photographs showing extend of cracking

76 Lawn Road has suffered severe subsidence in the past 4-5 years. It is evident in the photos below as well as the structural report commissioned by the previous owner. According to Alan Baxter structural engineer there are three main reasons that led to this unsafe condition.

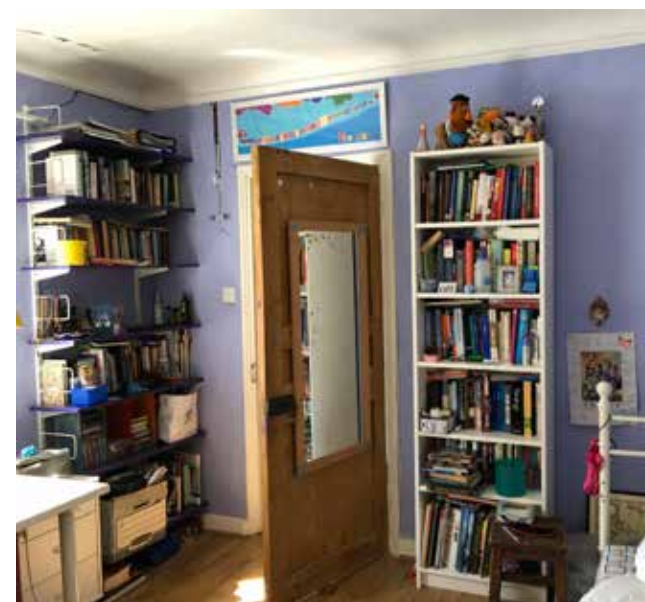
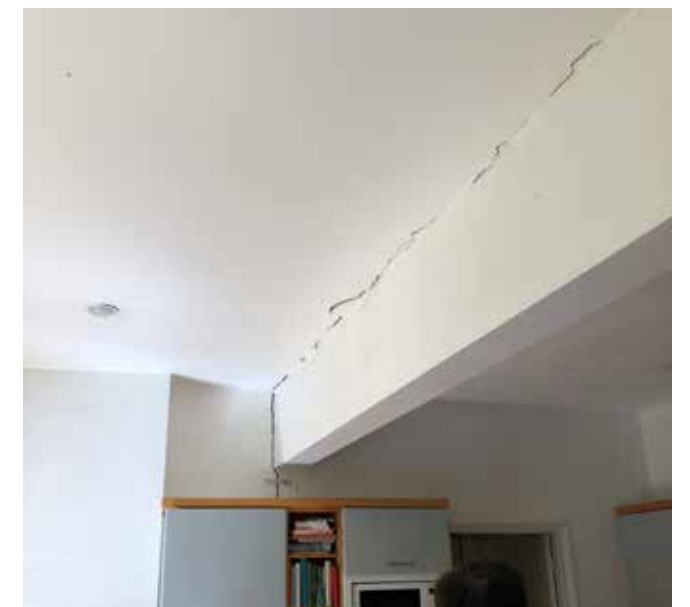
Internal photographs showing extend of cracking

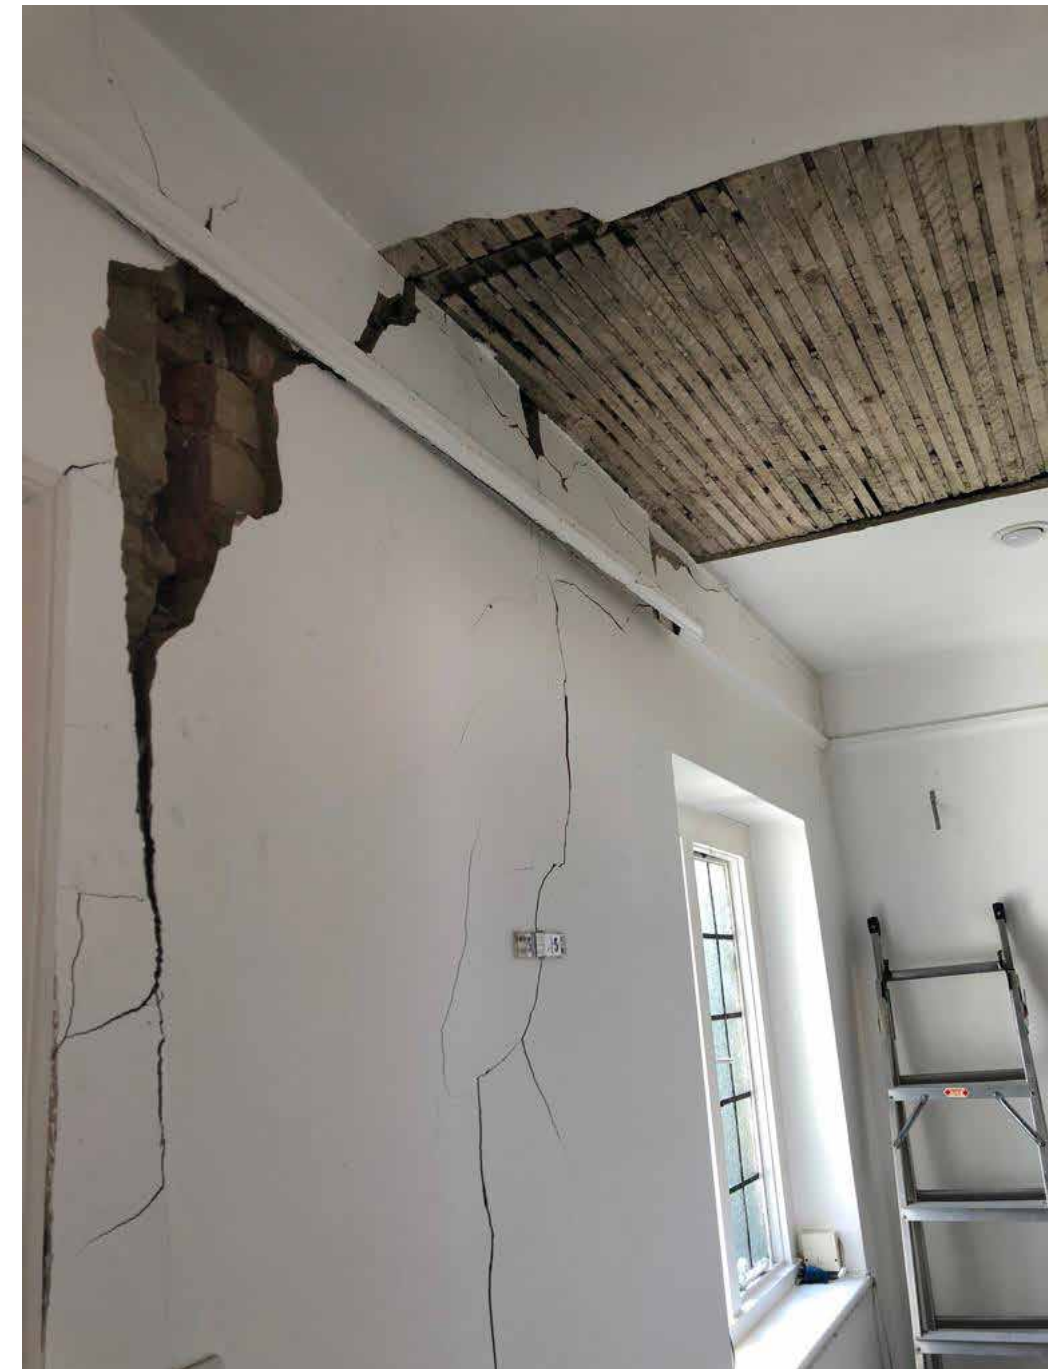
Internal photographs showing extend of cracking, subsidence and ceiling condition

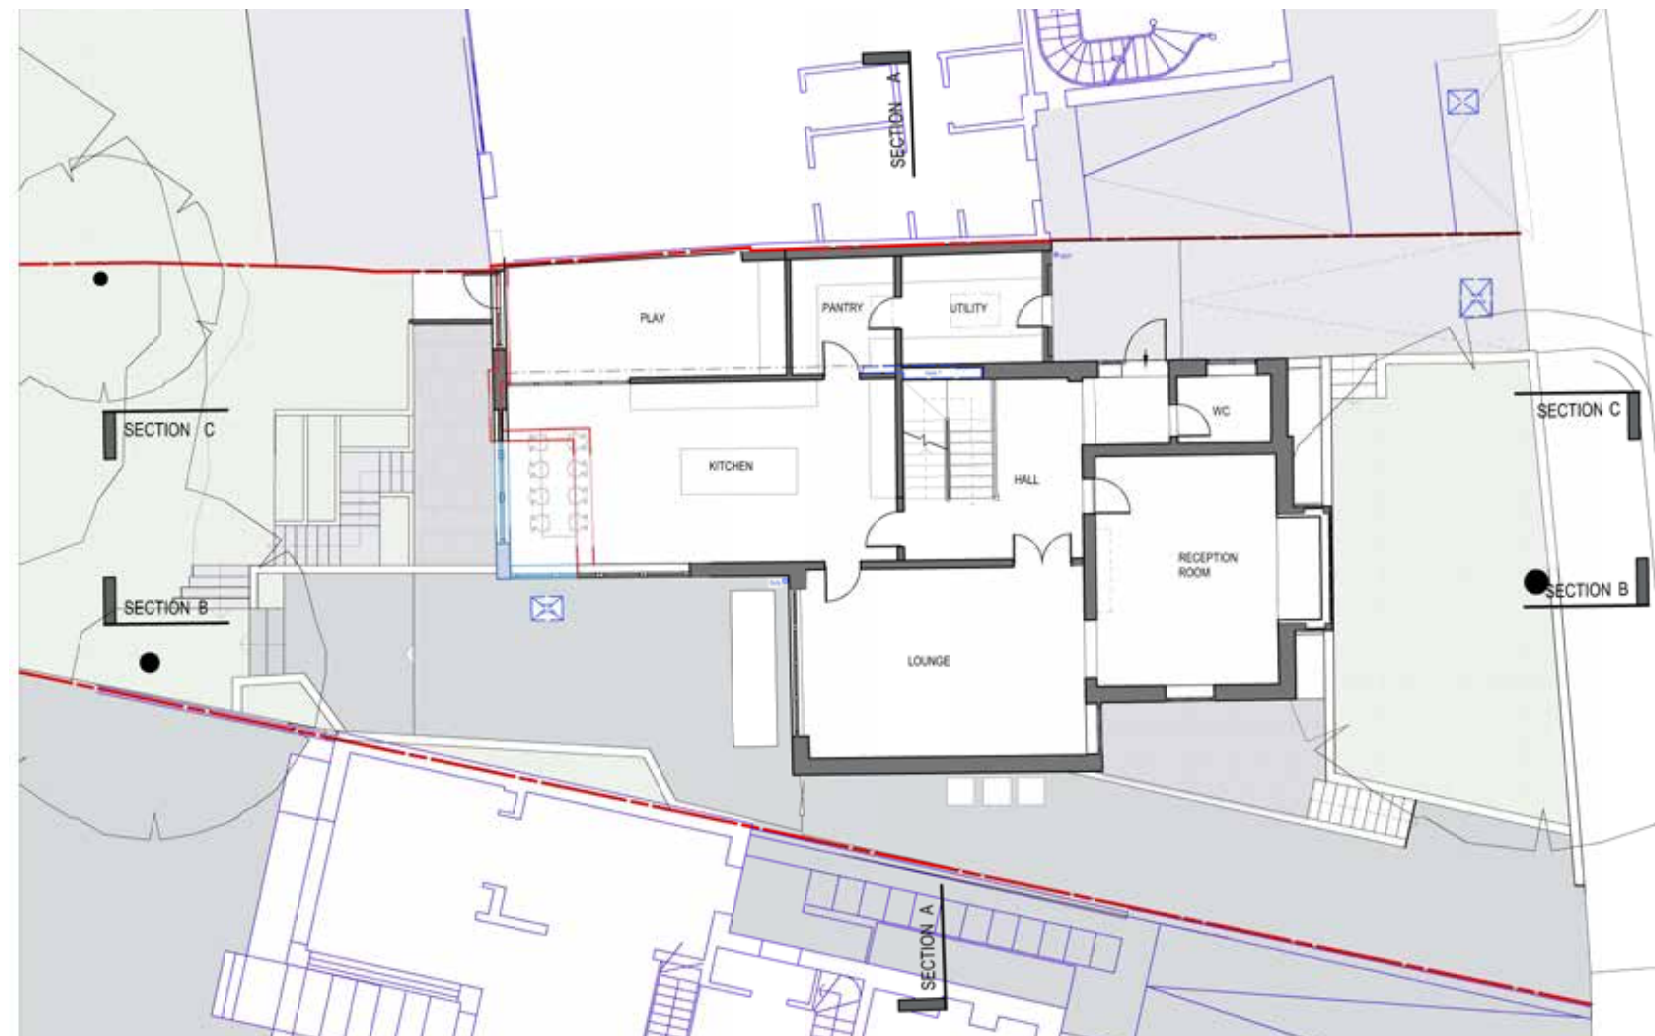
Proposed Ground Floor Plan

On the ground floor level, we will leave the plan largely intact and will only square off the rear part of the kitchen, so as to allow for better configuration internally and homogeneity to the external elevation. The extension in question is in the area of 5 square meters.

As you can see in the drawings here, as well as the three dimensional representation at the end, the proposed removal of the car port will have a significant beneficial effect on the appearance of the front of the property and the main entrance to the house.

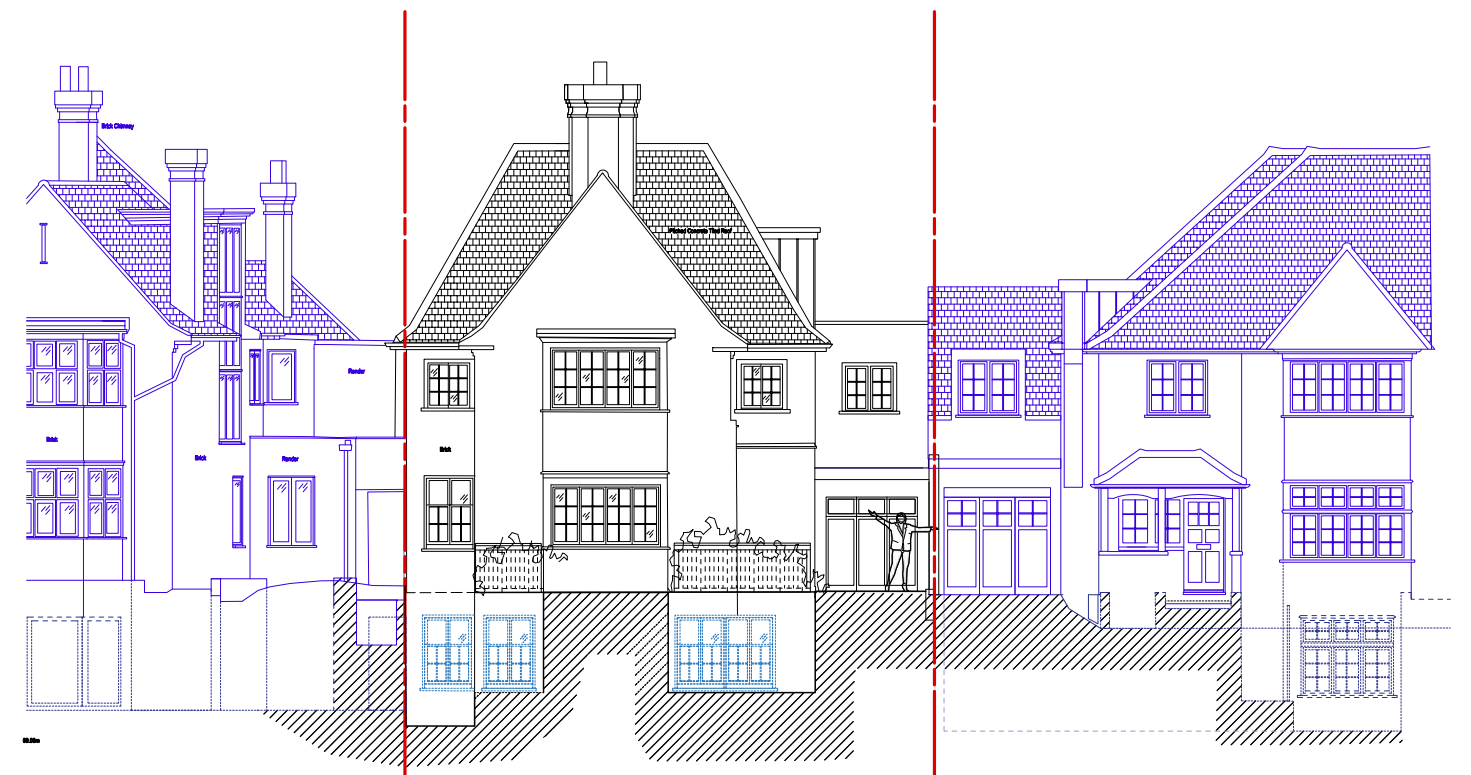
Proposed Front Elevation

The proposed drawings in the Design and Access statement show the neighbouring proposal of No75, currently being considered by Camden Council (ref 2018/2136/P). We feel that it is important to show our proposal in this possible future context, as well as the existing one.

We will be replacing all the windows with painted timber ones, restoring the masonry and repointing where needed, introducing wrought iron railings in the front and rear gardens and removing any out-of-character previous additions/ extensions.

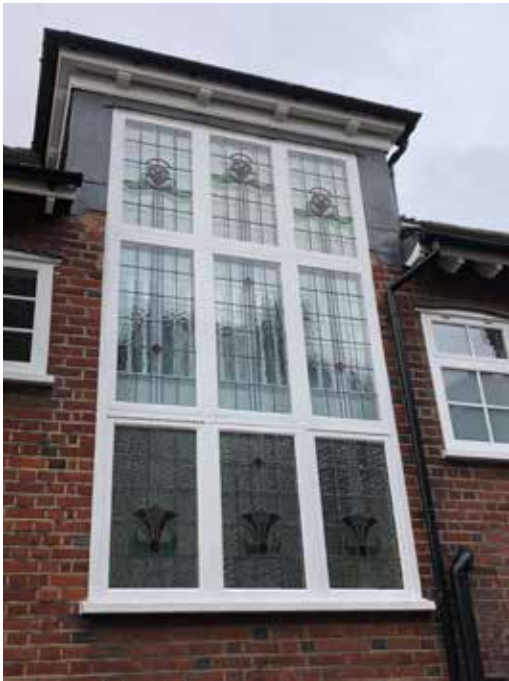
leaded light from No79

The side windows in the stairwell will follow the neighbouring examples of leaded lights.

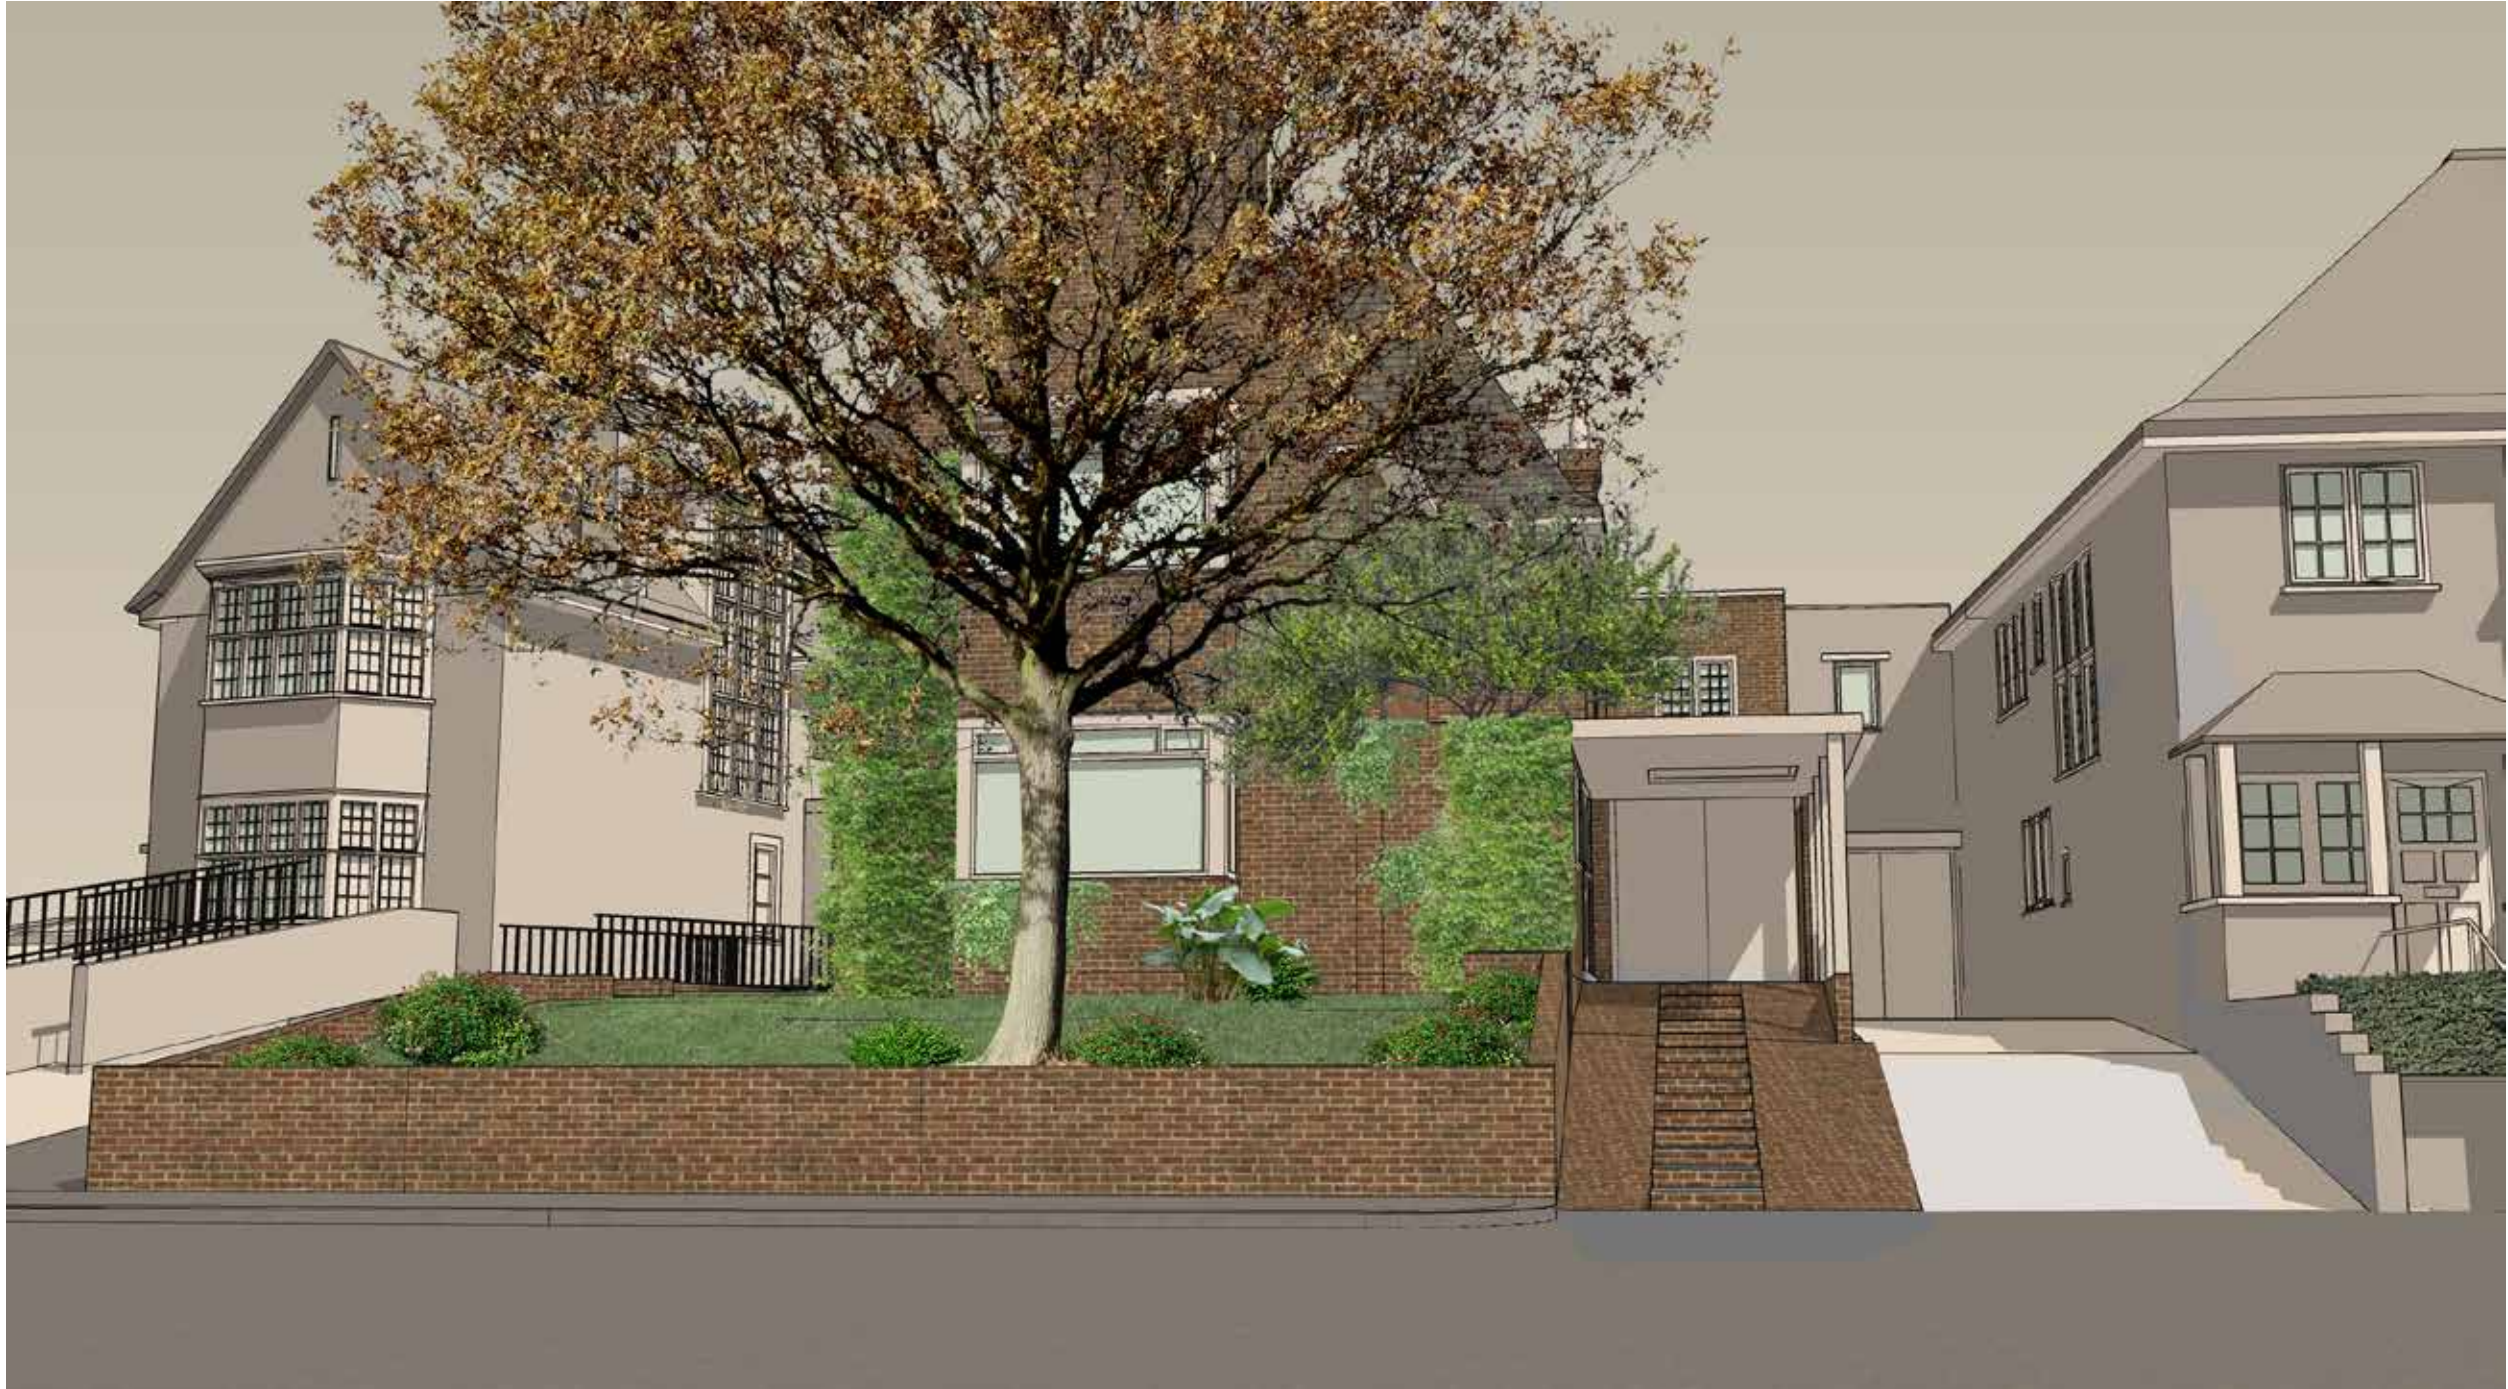
View from Lawn Road as existing

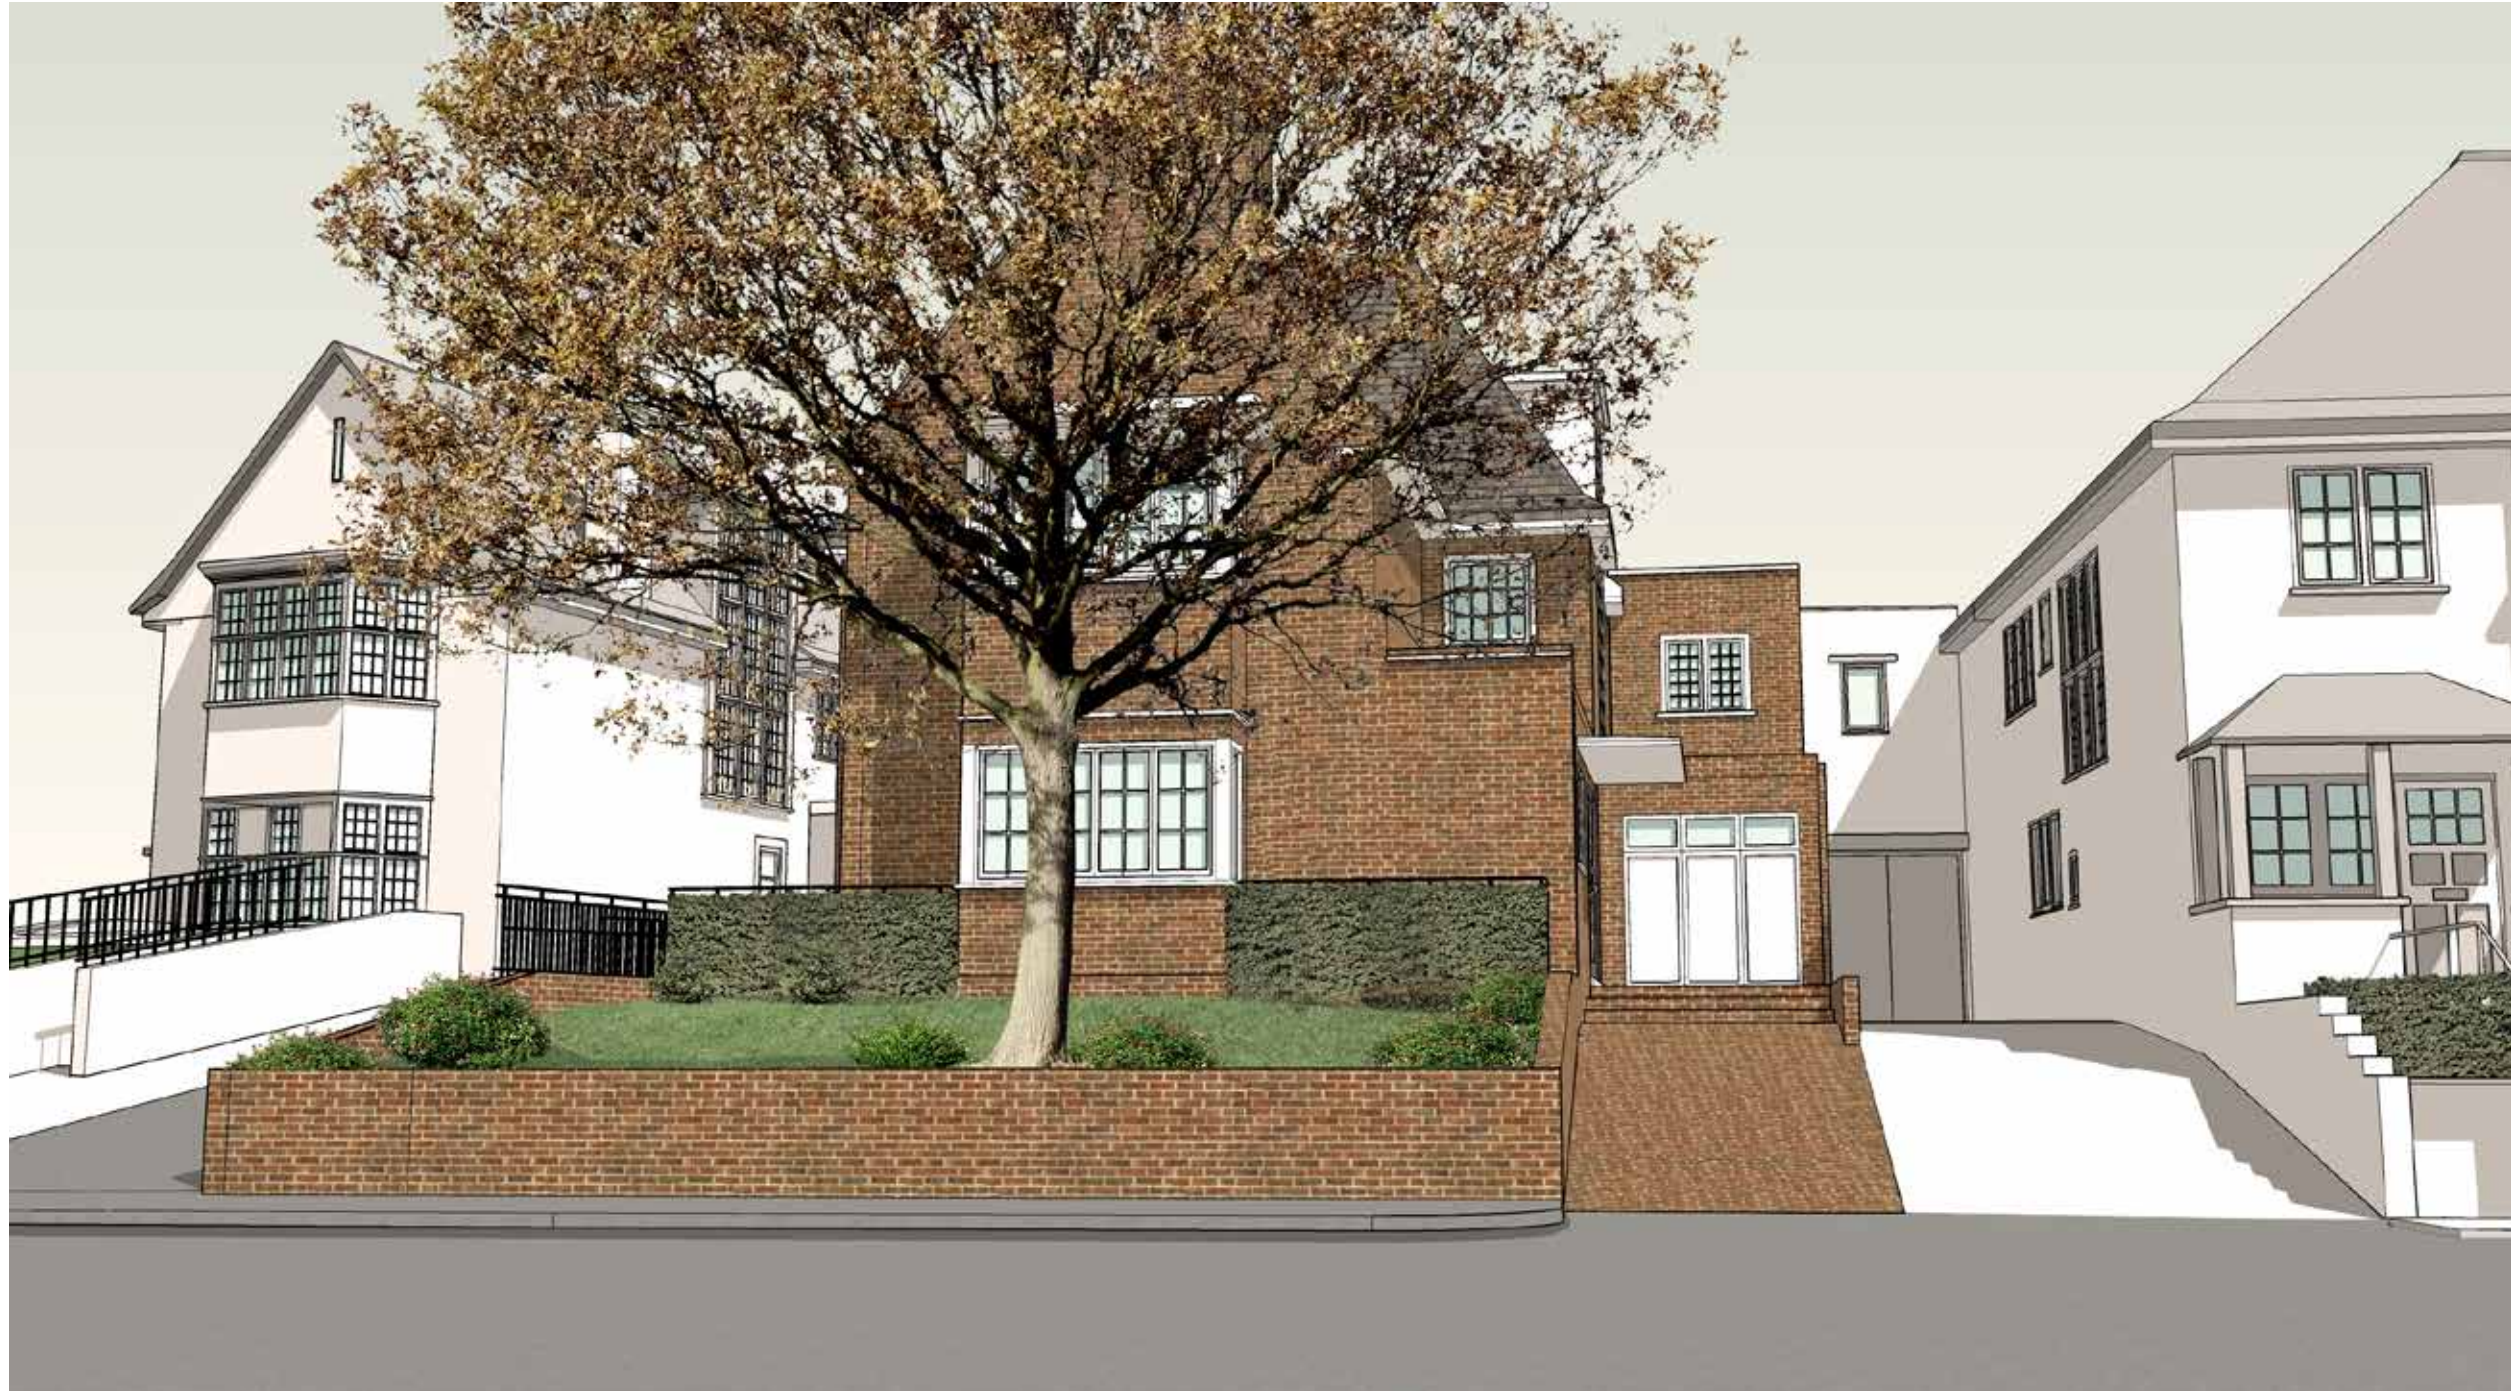
View from Lawn Road as proposed

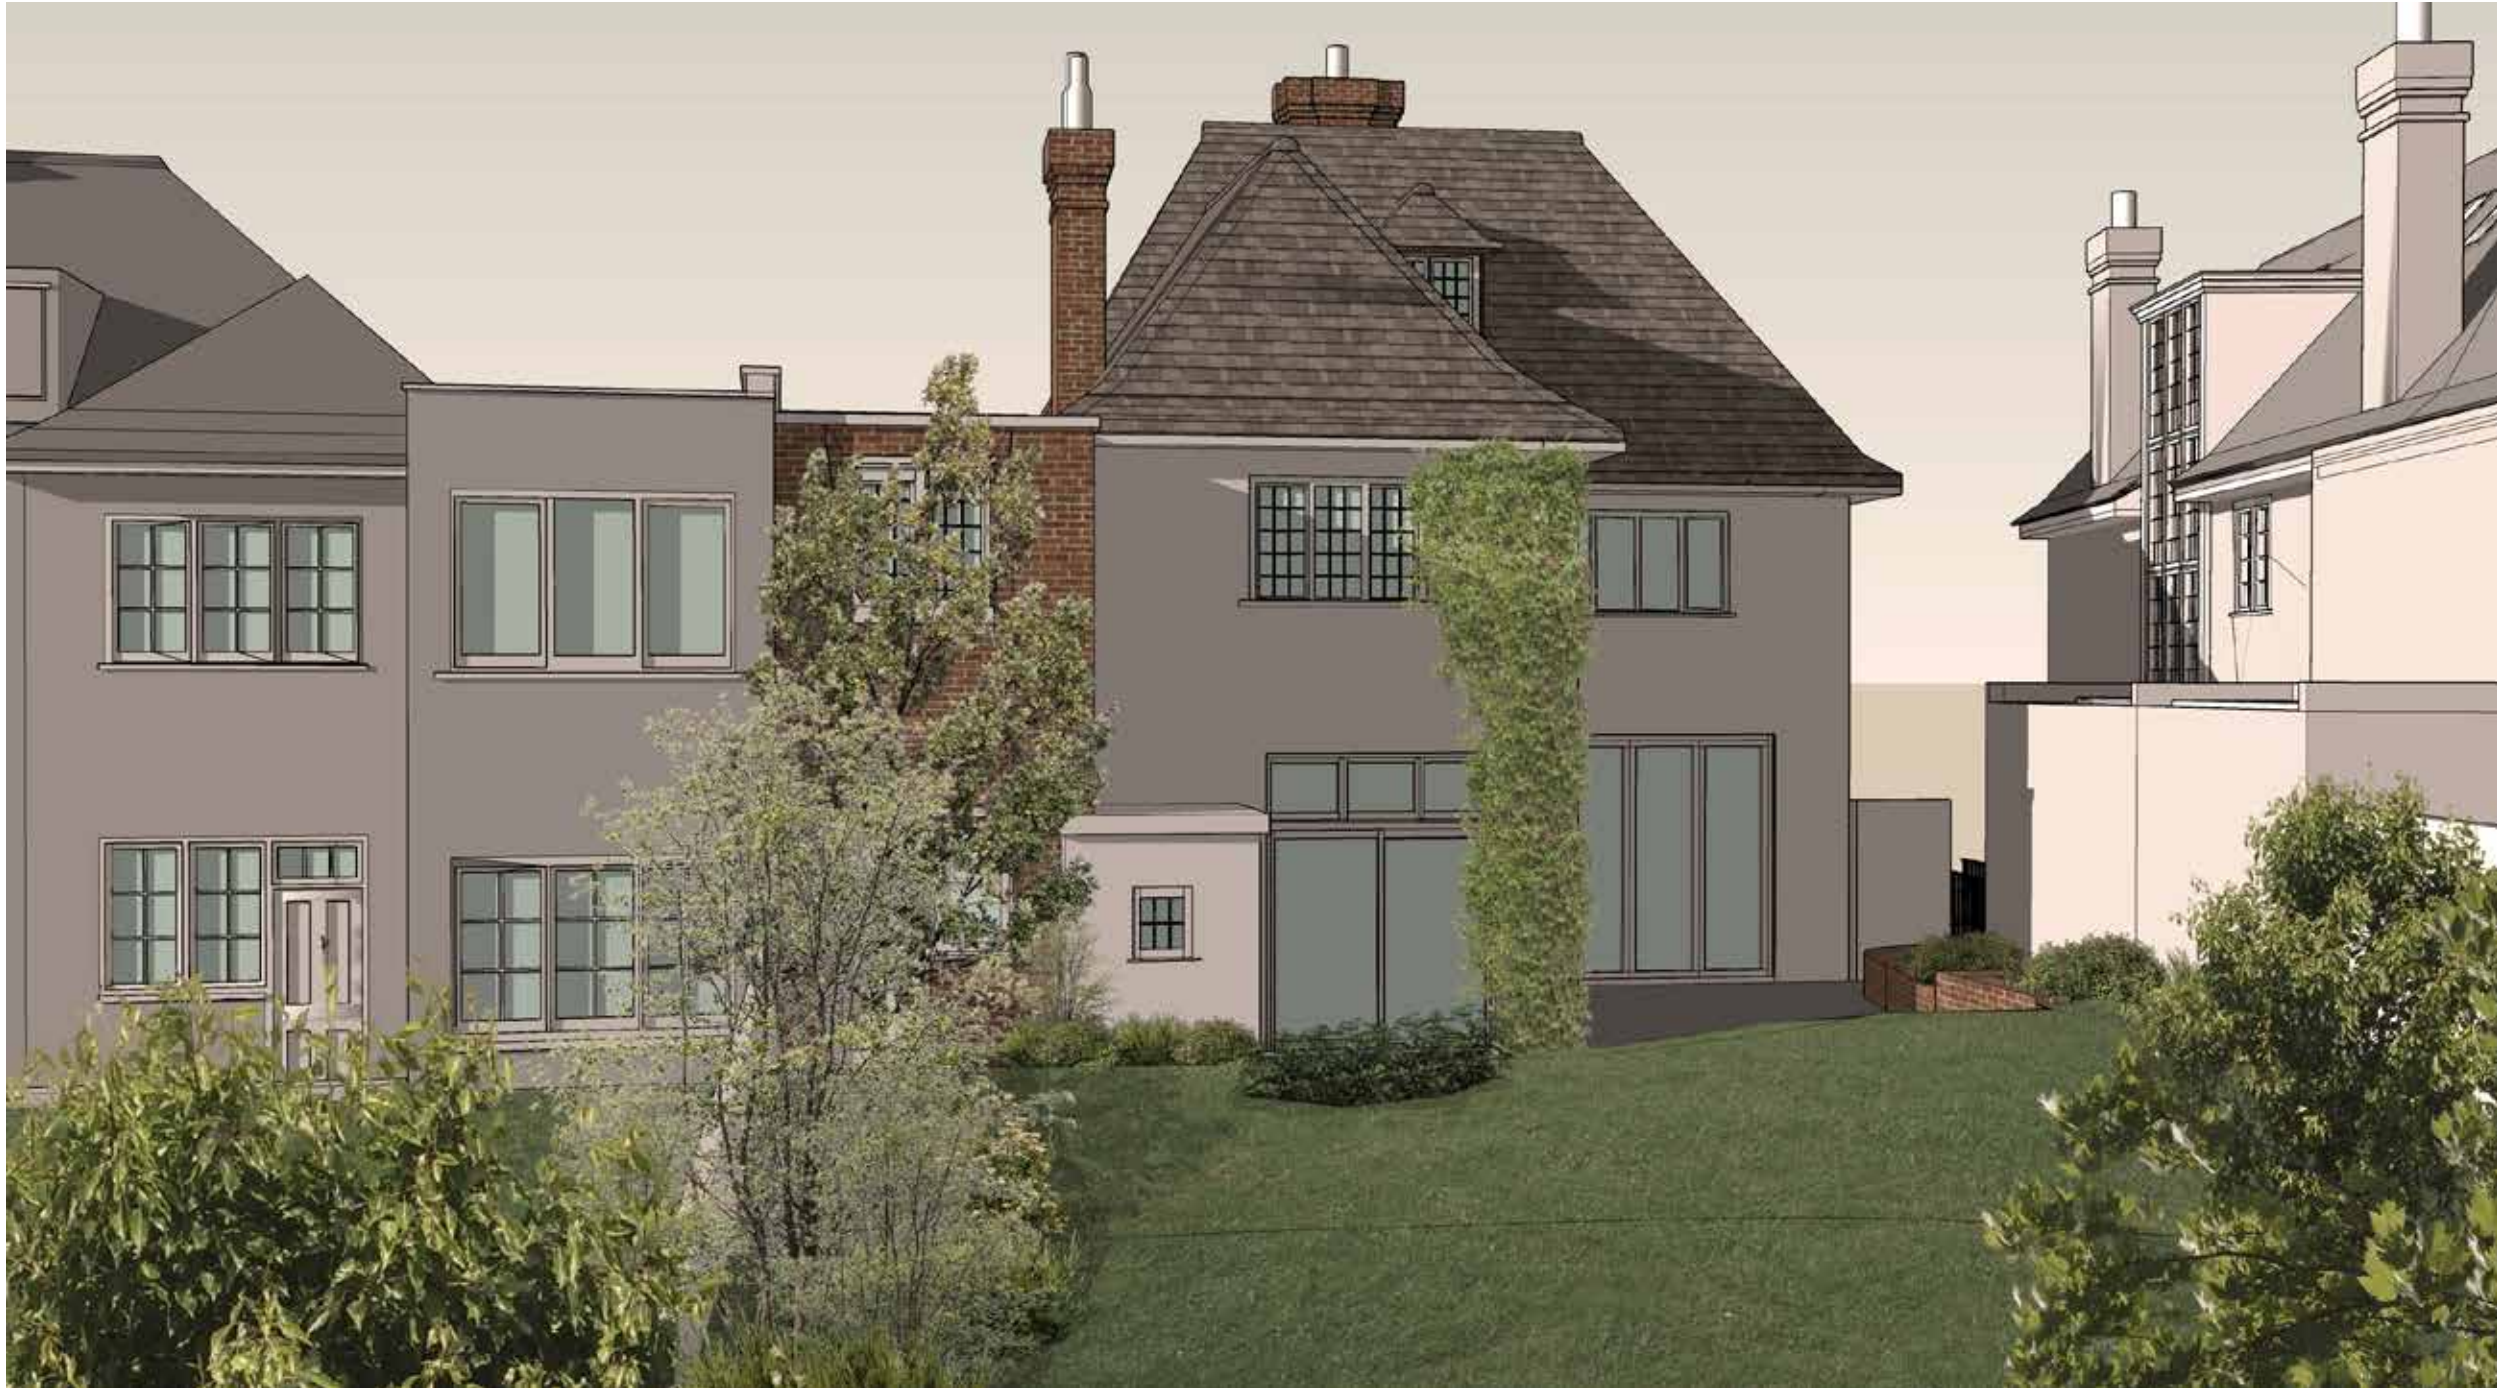
View from rear garden as existing

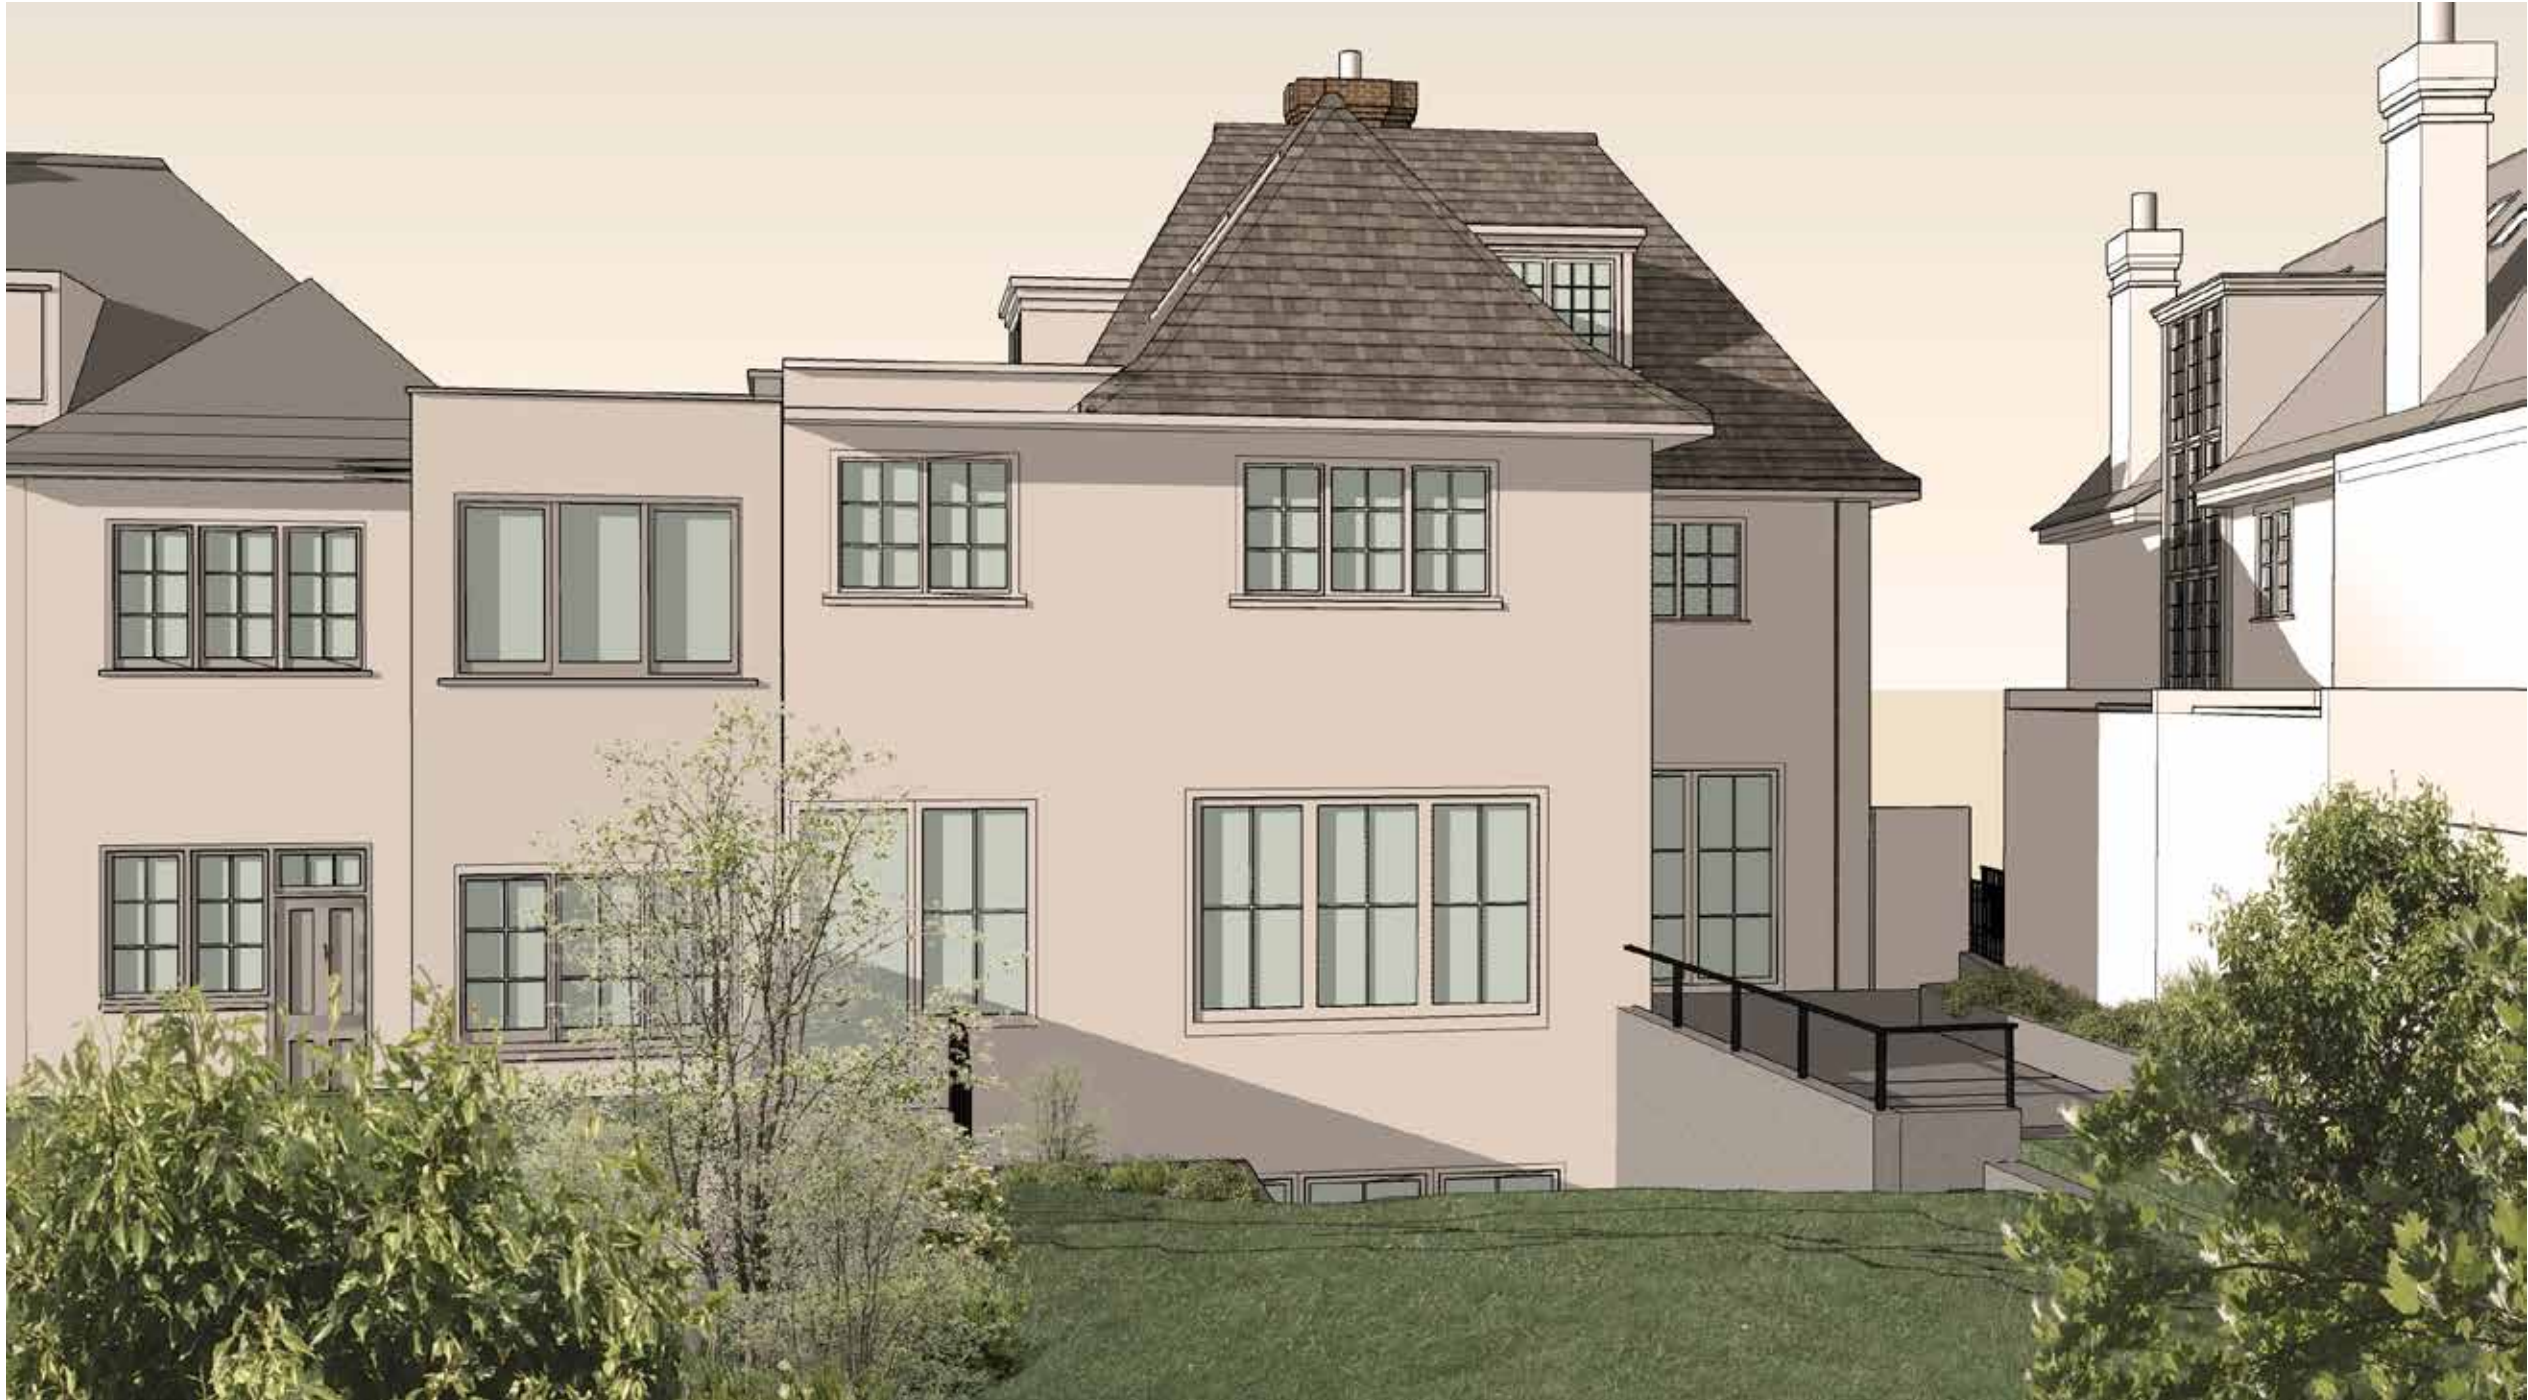
View from rear garden as proposed

Lastly, this proposal seeks to make the loft space habitable. By enlarging the rear dormer and introducing three pairs of conservation style rooflights, we will allow for better natural light and ventilation. The roof will remain as is, except for the stairwell part, where we will follow the example of the rest of the houses in Lawn Road and extend the staircase up with the help of a traditional lead cheeked side dormer and the replacement of the current pvc windows with more in-keeping leaded lights.
