**DESIGN AND ACCESS STATEMENT  
& HERITAGE STATEMENT**

**Renewal of Two Staircases  
and the  
Provision of Two Lead Overflow Pipes to the Front Parapet Gutters**

**48 & 49 Doughty Street, London WC1N 2LX**

Ref: PW/84.09  
Date: February 2020

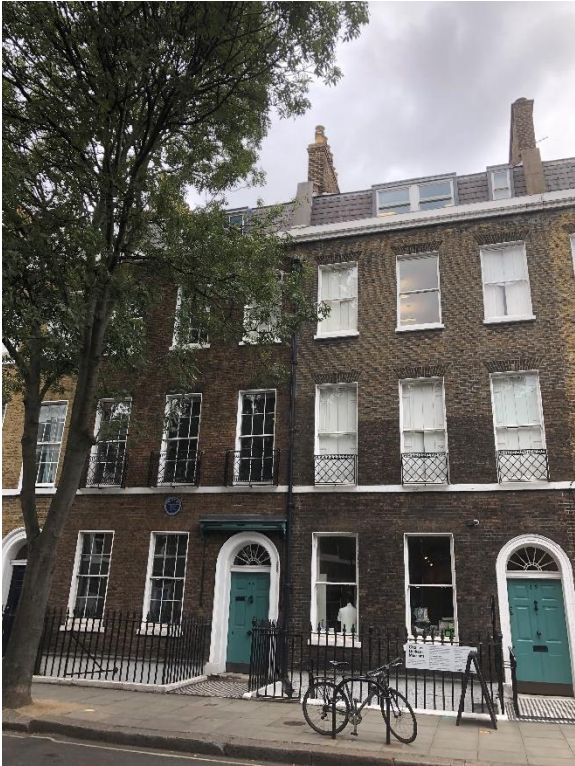
Photograph 1: Front elevation of 48 & 49 Doughty Street

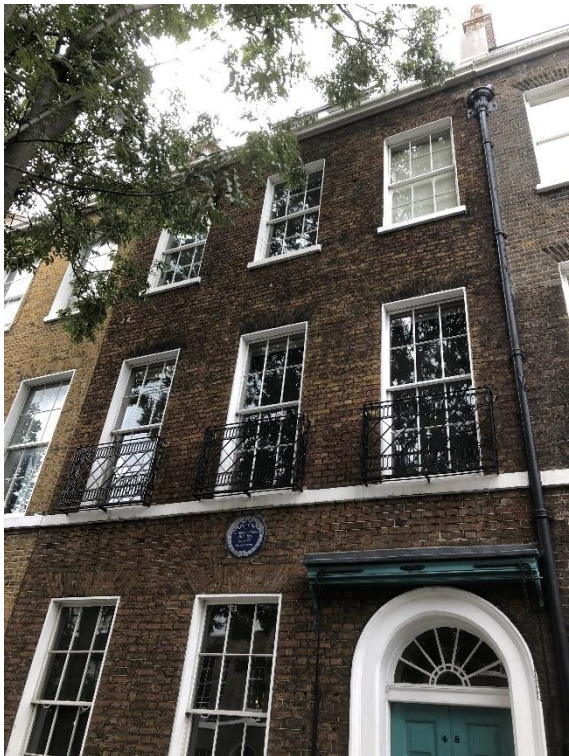
Photograph 2: Photograph showing the existing downpipe and hopper to the front elevations of 48 & 49 Doughty Street. The 2no. proposed overflow pipes will be installed above the cornice visible above the hopper.

In addition, following some blockages and damage to the fabric last year at 48 Doughty Street, Peter Wade FRICS has recommended that two new 50mm diameter lead overflow pipes are inserted in to the mansard lead parapet gutters to both properties. In the event of the downpipe serving both properties becoming blocked again, early warning would be provided by the overflows for the Maintenance Staff to take the required action. Again Murray Birrell have been informed by the London Borough of Camden that these two new overflow pipes will require the benefit of Listed Building Consent.

A blockage occurred to 48 Doughty Street last year caused by leaves and seeds from the nearby London Plane trees and although the parapet gutters are cleared regularly, a partial blockage was noted within the lead downpipe connecting the parapet gutter to the external hopper head. This blockage caused a build-up of rainwater in the parapet gutter to 48 Doughty Street and this then bypassed the lead upstands to the parapet gutter and entered the building.

Whilst the provision of the two new lead overflows may be visible from pavement level, we feel that these are an essential addition to the properties to avoid future damage occurring to the internal fabric and this is based on a previous incident last year. The presence of the London Plane trees creates significant numbers of leaves and also seeds and access to the parapet gutters is only possible via the use of a harness arrangement which is precarious. Therefore for the Maintenance Staff to have early warning of future blockages to these parapet gutters this will be a great advantage in organizing clearance works.

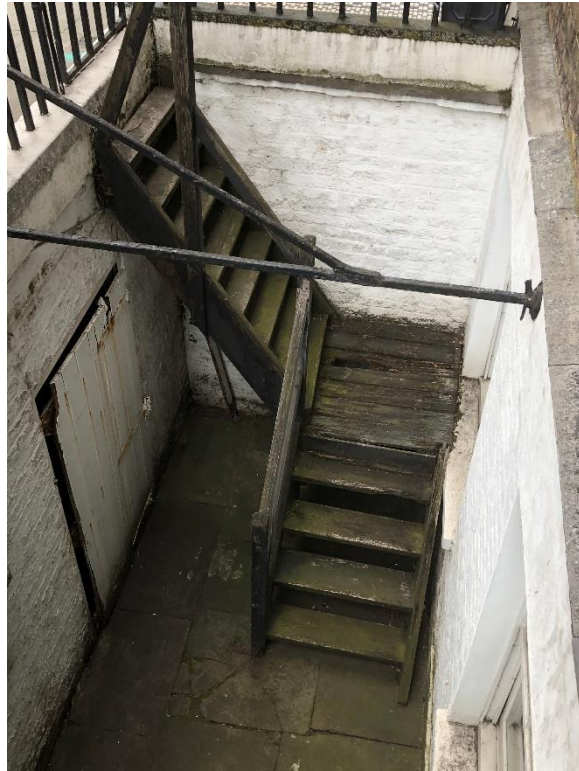
Photograph 3: Existing timber staircase to the front elevation lightwell of 48 Doughty Street. It is proposed to replace this with a new cast iron and mild steel staircase.

The first purpose of these proposals is to replace the inappropriate timber staircase to 48 Doughty Street and brick and concrete staircase to 49 Doughty Street with new cast iron and steel staircases providing safe access to the pavement vault areas and both of these staircases will be of a design to match the one at 47 Doughty Street which we believe may be an original staircase.

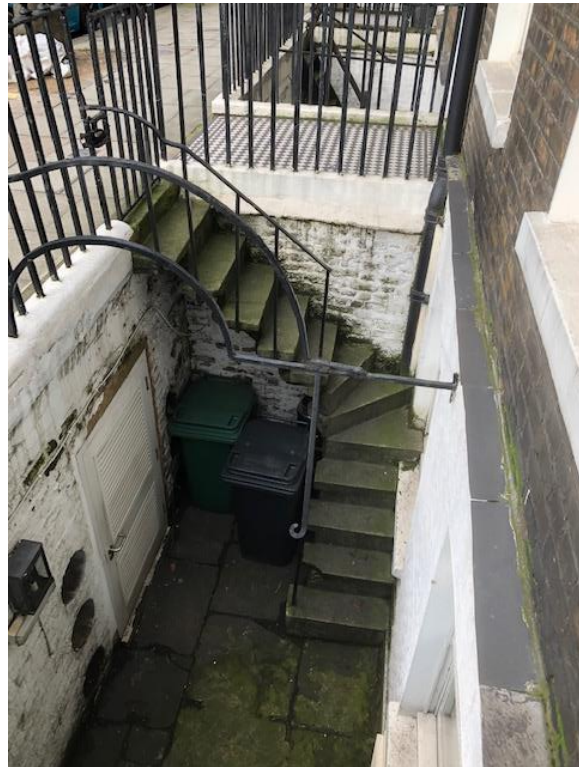
Photograph 4: Existing concrete staircase to the front elevation lightwell of 49 Doughty Street. It is proposed to replace this with a new cast iron and mild steel staircase.

The original staircase to 49 Doughty Street has long since been removed and replaced with a part brick and part concrete staircase. Brickwork has been used to form the strings and then in-situ concrete treads laid.

building and if any limited damaged is caused, for example, by the removal of one of the concrete treads which currently sits on a stone window cill, this will be carefully repaired using stone mortar and other similar conservation repairs if necessary.
