26 West Hill Park
London, N6 6ND

Basement Impact Assessment
Audit

For
London Borough of Camden

Project Number: 12985-55
Revision: F1

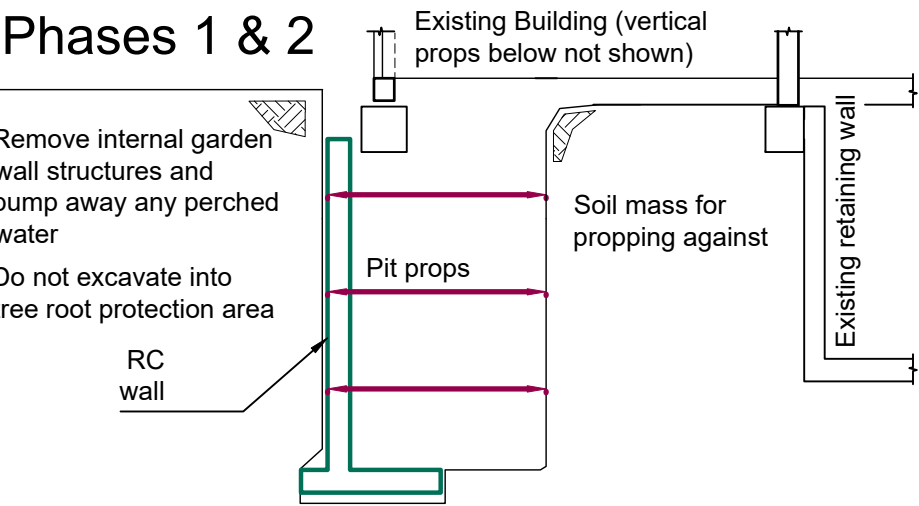
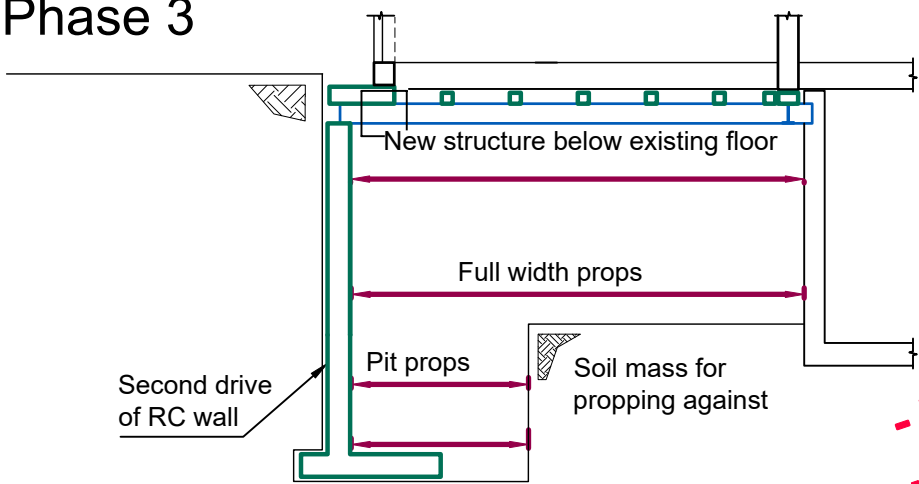
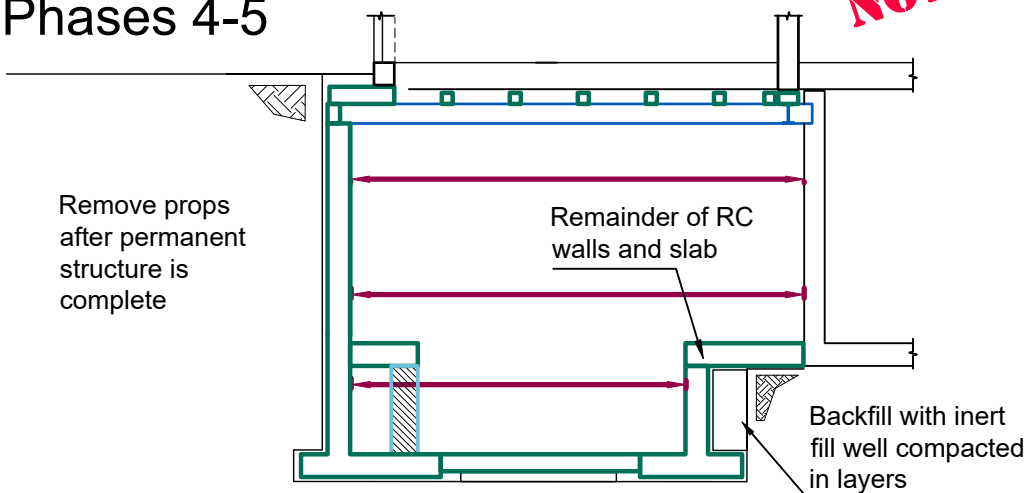
Typical section through rear basement showing construction sequence

Phases 1 & 2

Phase 3

Phases 4-5

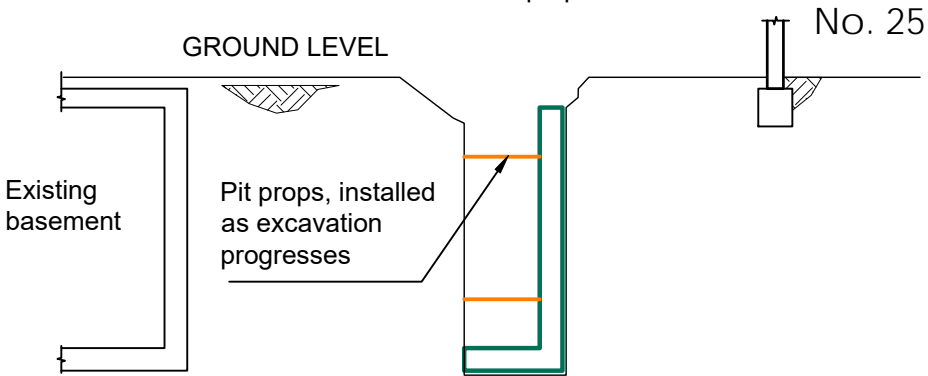
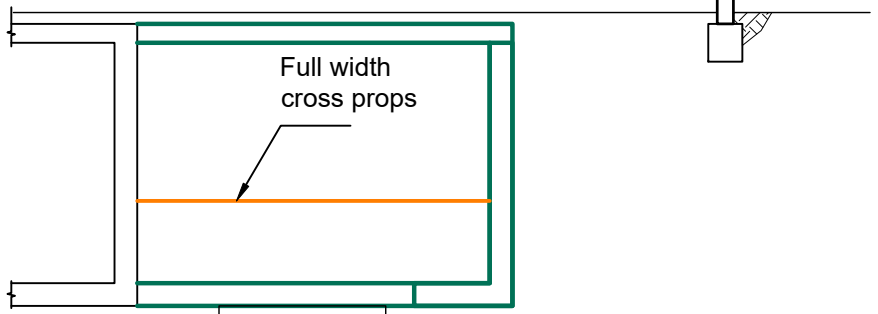
Typical section through front basement showing construction sequence

Phases 1 - 3

1. Remove existing paving slabs and pump away perched water, if present
2. Carefully excavate retaining walls in segments shown in plan
3. Install RC retaining wall and base. Excavate remaining soil in basement after retaining walls are cast. Install full width cross props.

Phase 4

4. Construct floor slab then ceiling slab then remove props
