BS5837 Arboricultural Impact Assessment

2 Lidlington Place, Rear of 75/76 Oakley Square, Mornington Crescent, NW1 2JU

Job Reference: 02992Rv2

January 2020

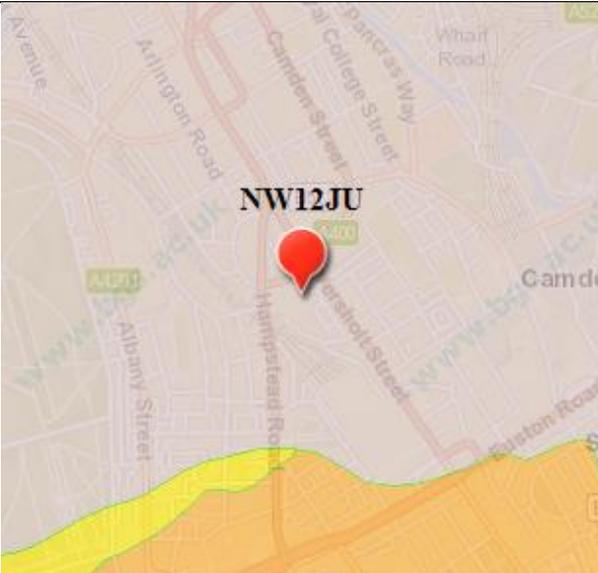
Soil Description

<p style="text-align: center;">London Clay Formation</p> <p>Clay, Silt And Sand. Sedimentary Bedrock formed approximately 48 to 56 million years ago in the Palaeogene Period. Local environment previously dominated by deep seas.</p>

Underlying Soil Material contains Clay	Yes
Soil Type increased rooting depth profile?	No
Increased risk of soil compaction due to soil type	Yes

- 5.1.1 Soil is an important factor in tree growth and the type of underlying soil can impact on successful integration of new developments.
- 5.1.2 A free draining sandy soil containing sand/gravel is likely to lead to water being accessible in the upper horizons during the growing season and available at greater depths and trees will generally be forced to explore a larger volume/ depth on such soils. The structure of such soil also makes compression more difficult (by heavy construction plant) and root penetration is easier for the trees. By comparison a clay soil is more easily compressed, particularly when wet and compression can have a greater impact on tree health.
- 5.1.3 As shown below the site is located within what is defined as clay.

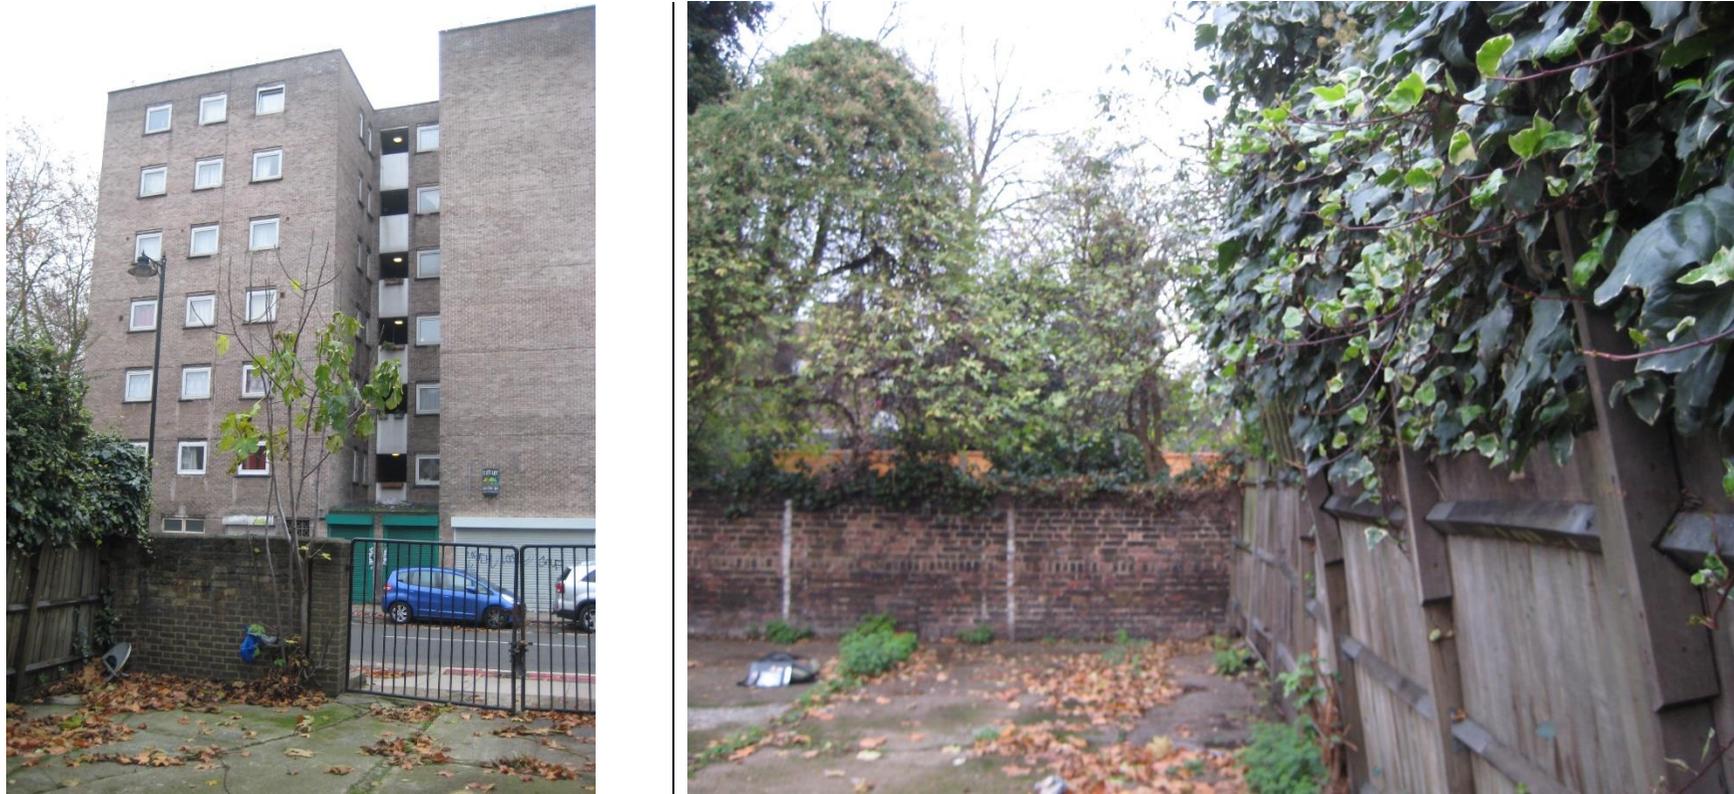
Fig 2 – T6 (Fig) above left will be removed and further overhanging branches (above right) cut back to the relevant boundaries for T2, T3, T4 & T5

5.3.1 T6 (Fig) will be removed, this is a small and insignificant tree. T2, T3, T4 & T5 will be pruned back to suitable side growth points to establish locations of repeat pruning whilst removing the current overhangs into the site.

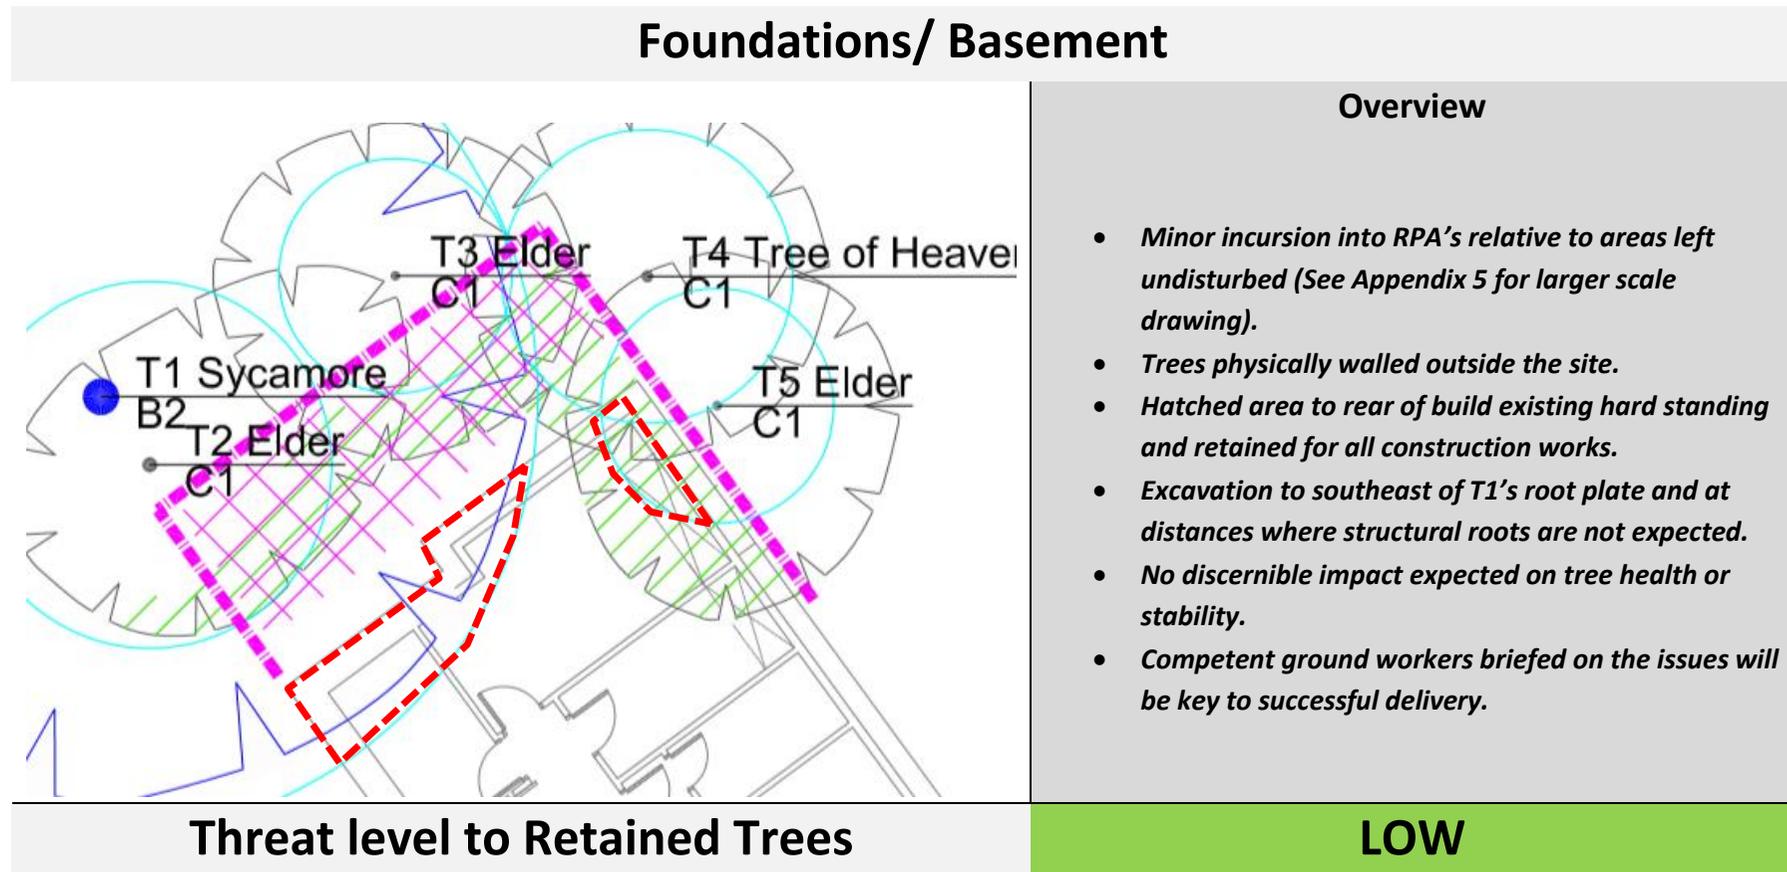
5.4.1 The minimal new incursions mean no special foundation measures are proposed:

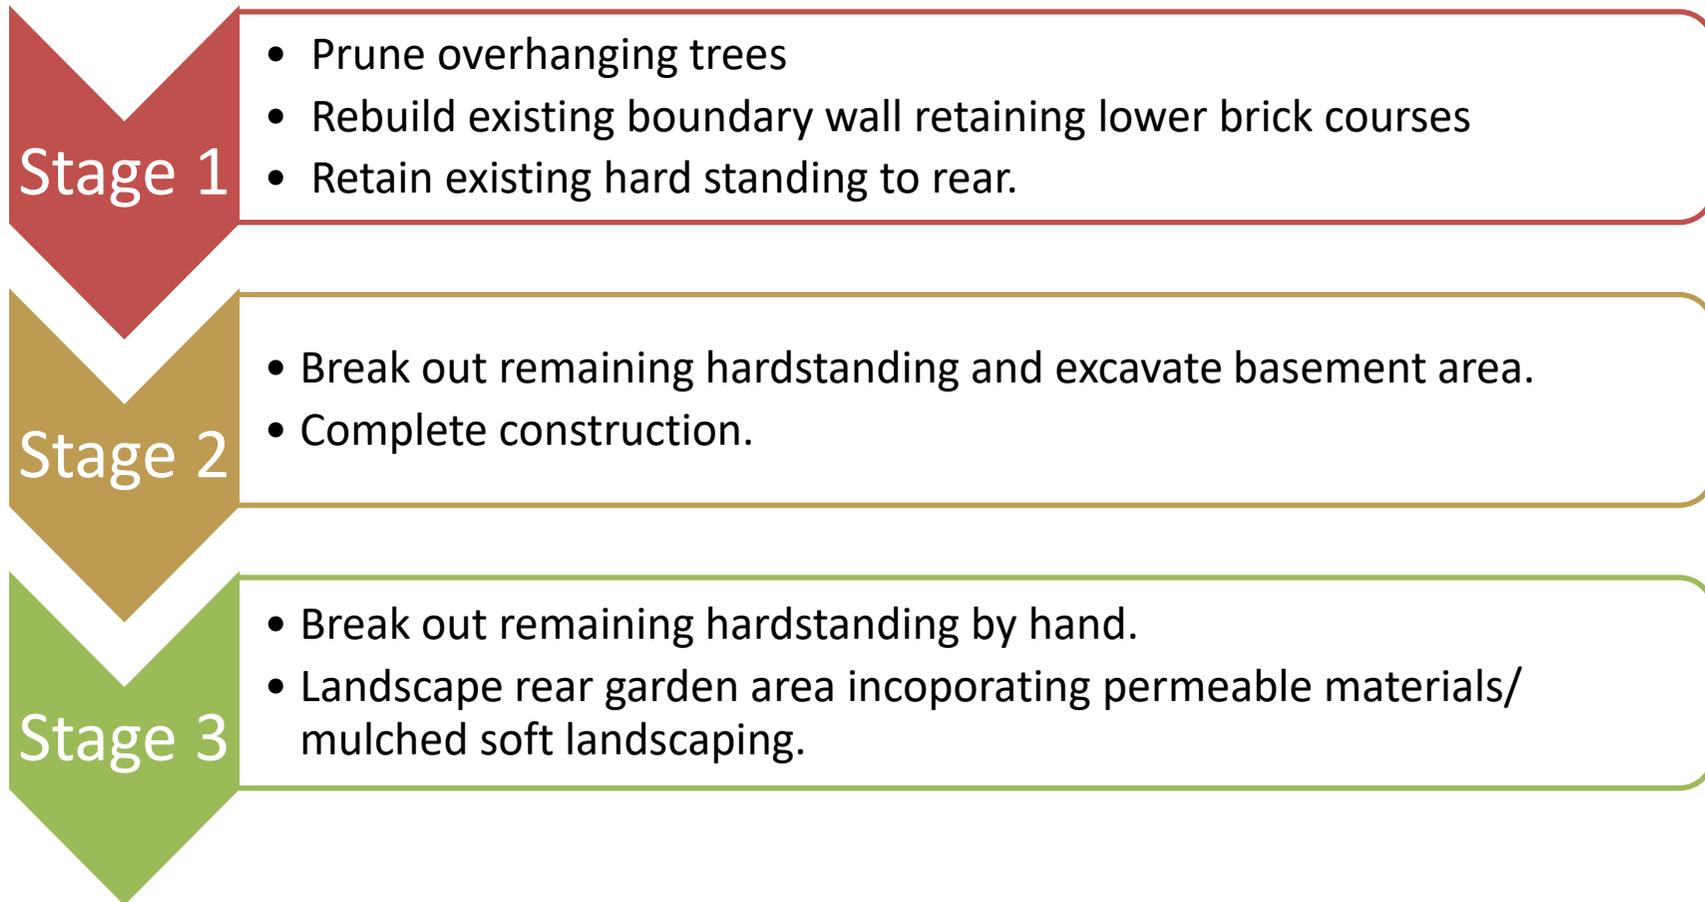
5.4.2 The proposed tree protection procedure can be summarised as follows:

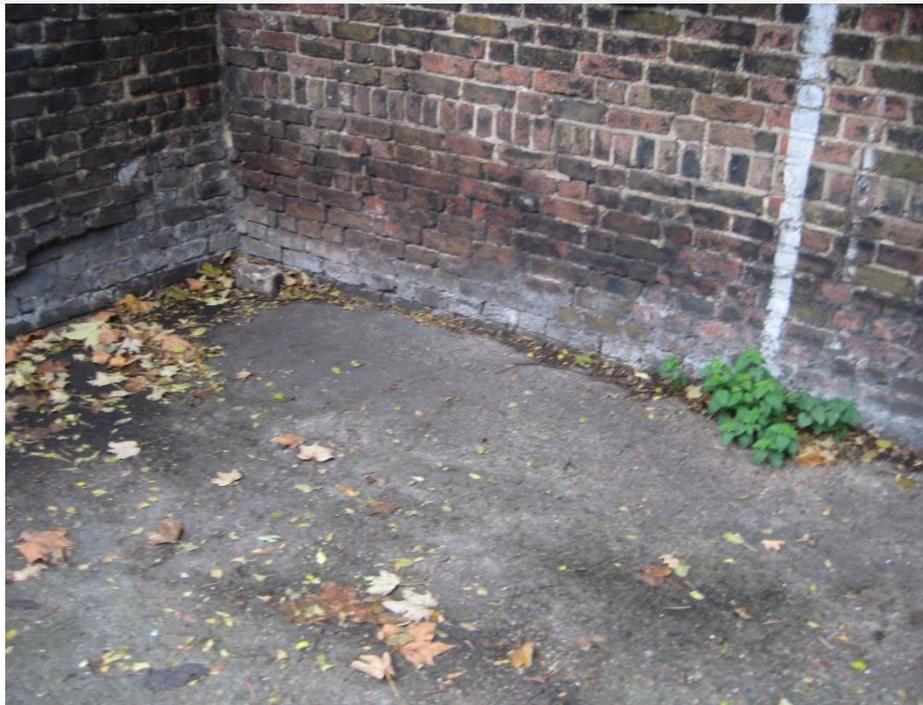
Tree Protection

5.4.3 The existing wall will be rebuilt and retained as a physical barrier to the retained trees. The hard surfacing in this area is also retained for the duration of site works.

- *Provided by wall (left)*
- *Hard surfacing in RPA's to rear of proposal retained.*
- *Removed by hand following construction.*
- *Removes need for temporary ground protection and allows for localised site storage.*

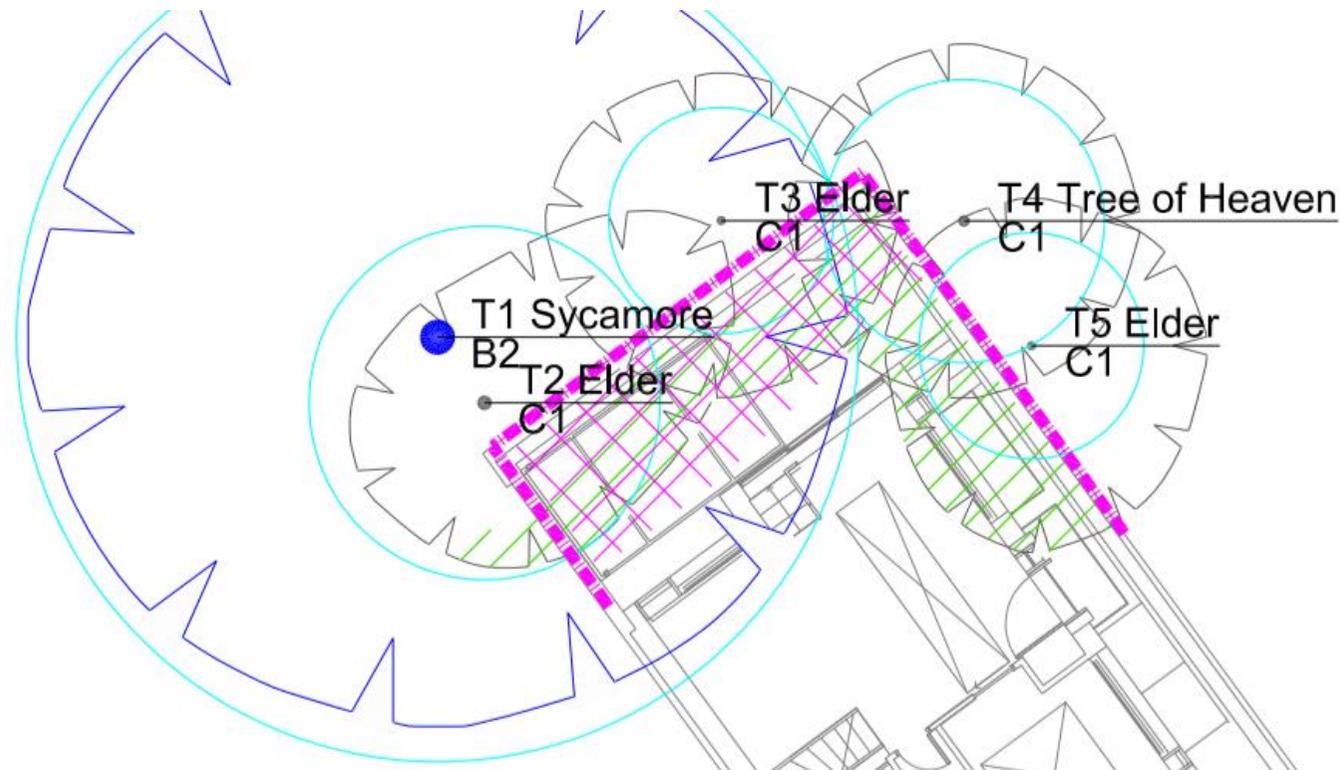
Fig 3 – Retaining this area of existing hard surfacing allows for site storage to the rear of the proposal during construction. It will then be removed by hand prior to localised landscaping.

5.5.1 No permanent new surfaces within the RPA of retained trees is proposed with the existing hard surface to the rear of the proposal retained during the main construction phase and removed towards the end of the project.

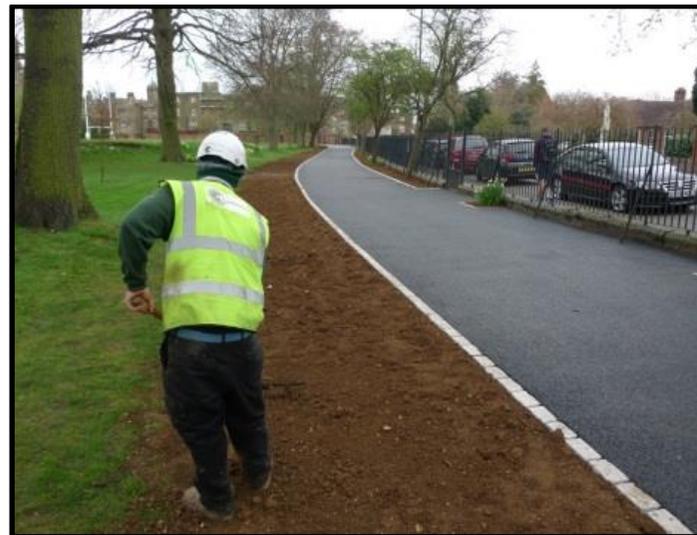
Fig 4 – In the event of 'making good' topsoil will be BS3882 compliant and raked out by hand to no greater depth than 100mm

5.7.1 Following completion of the project and removal of the existing hard standing any 'making good' will be with BS3882 compliant topsoil raked out by hand (to no more than 100mm depth within any tree RPA) and then seeded/ planted as appropriate. We encourage the use of composted bark mulch below tree canopies where possible to aid water retention and increase soil microbial activity. Any localized landscaping can then bridge over this with permeable materials (decking for example).

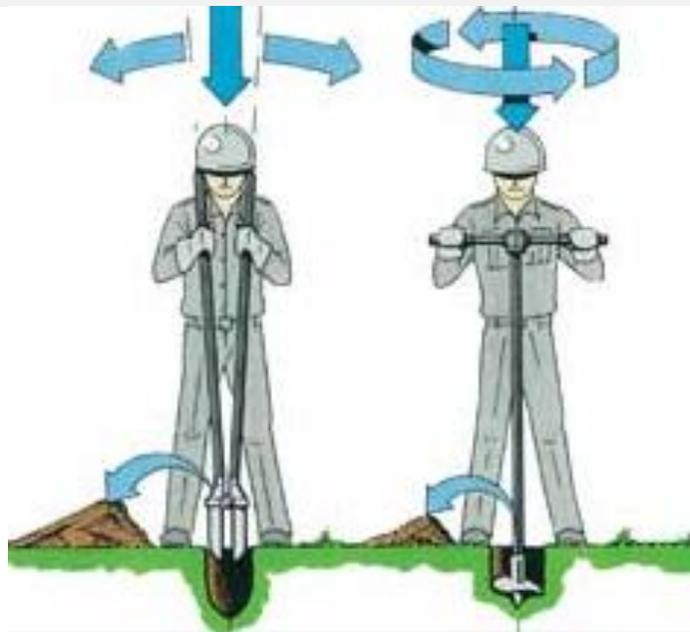
Pergola Post Supports

- *Hand dug/ augured (left)*
- *Localise repositioning if roots >25mm encountered.*
- *Lined with non-permeable membrane to prevent concrete to root contact.*

5.8.1 The proposal incorporates lightwell and roof windows and the potential impact of T1 (Sycamore) on the amenity space is appreciated by the client. It is proposed to incorporate a pergola to the rear. This provides a cover over any amenity area designing out issues with leaf litter and sticky deposits. The structure will be supported on hand dug post holes.

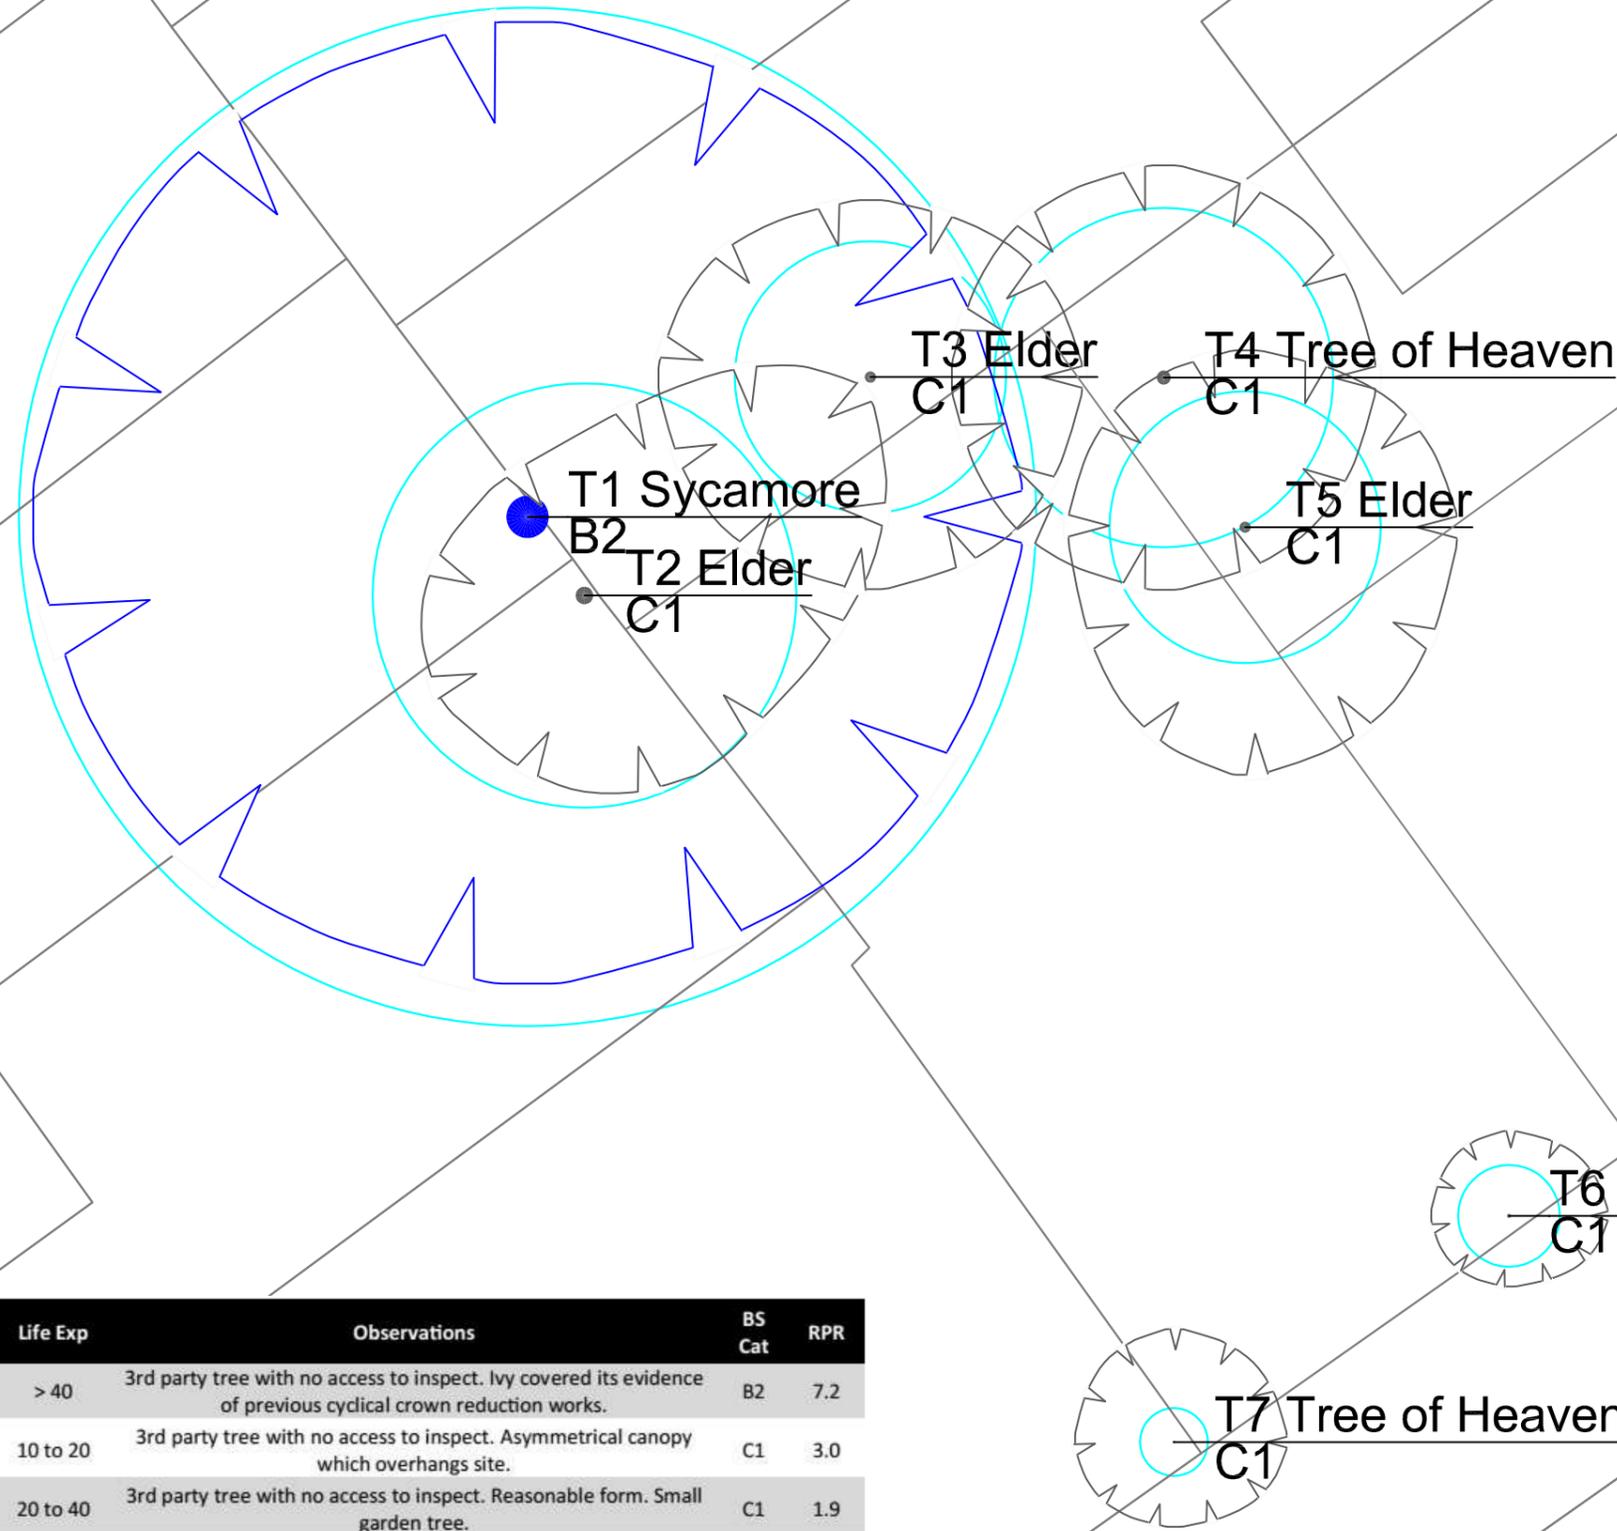
TITLE
Tree Constraint Plan (TCP)

Tree No	Species	DBH	Height	Age Class	Life Exp	Observations	BS Cat	RPR
T1	Sycamore	0.6	19	Mature	> 40	3rd party tree with no access to inspect. Ivy covered its evidence of previous cyclical crown reduction works.	B2	7.2
T2	Elder	0.25	4.3	Mature	10 to 20	3rd party tree with no access to inspect. Asymmetrical canopy which overhangs site.	C1	3.0
T3	Elder	0.16	4.2	Early-mature	20 to 40	3rd party tree with no access to inspect. Reasonable form. Small garden tree.	C1	1.9
T4	Tree of Heaven	0.2	8	Early-mature	> 40	3rd party tree with no access to inspect. Establishing fast growing ornamental with high growth potential.	C1	2.4
T5	Elder	0.16	4.2	Early-mature	20 to 40	3rd party tree with no access to inspect. Small garden tree.	C1	1.9
T6	Fig	0.06	4	Young	<10	Self-set tree growing through concrete. Below BS size threshold.	C1	0.7
T7	Tree of Heaven	0.04	4.5	Young	10 to 20	3rd party tree with no access to inspect. Below BS size threshold. Poor form.	C1	0.5

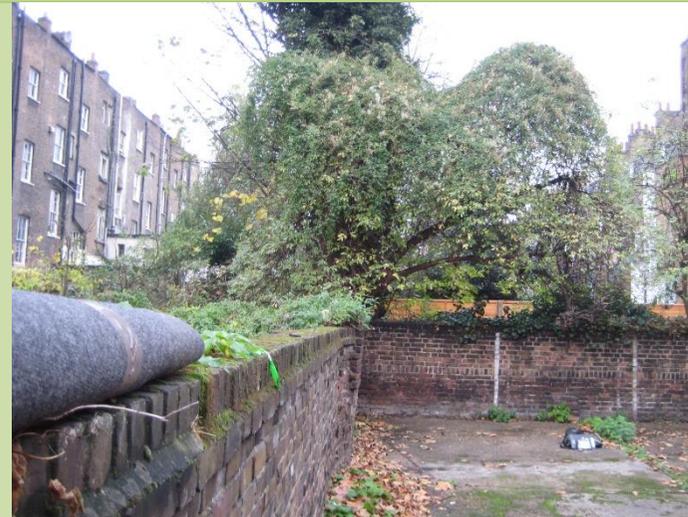
All our fencing specifications accord with advice and guidance within BS 5837. Modifications to fence types are possible but should be discussed prior to implementation. In all other instances the form detailed below should be shown. This offers the best protection to retained trees.

- All tree protection must be in place prior to any site activities. It is recommended that this fencing is installed prior to any site works (including demolition).
- To be effective Tree Protection must remain in place for the duration of the development and form part of the site induction process.
- In this instance protection provided by boundary brick wall.

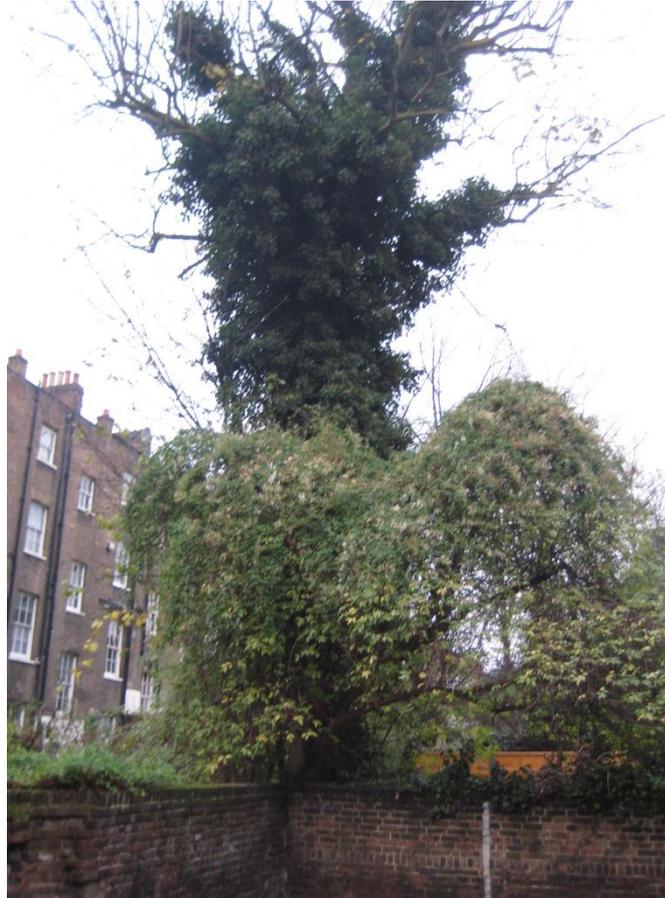
Image 1 – An existing wall prevents movement towards offsite trees (T1 and T2 shown above)

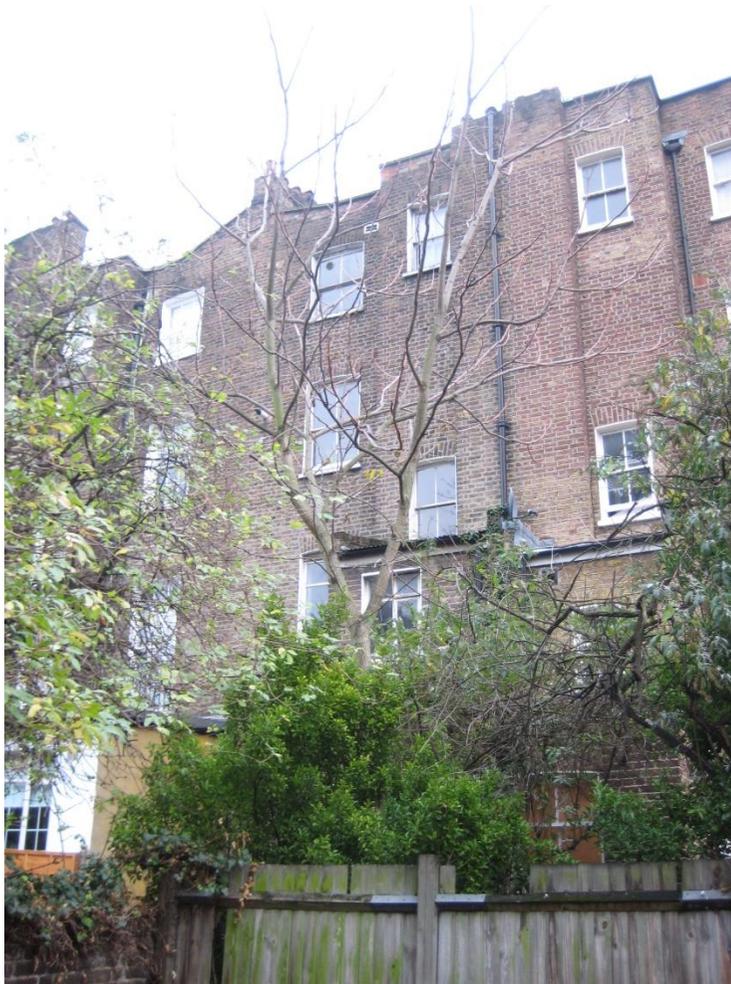
Image 2 – T4 Tree of Heaven

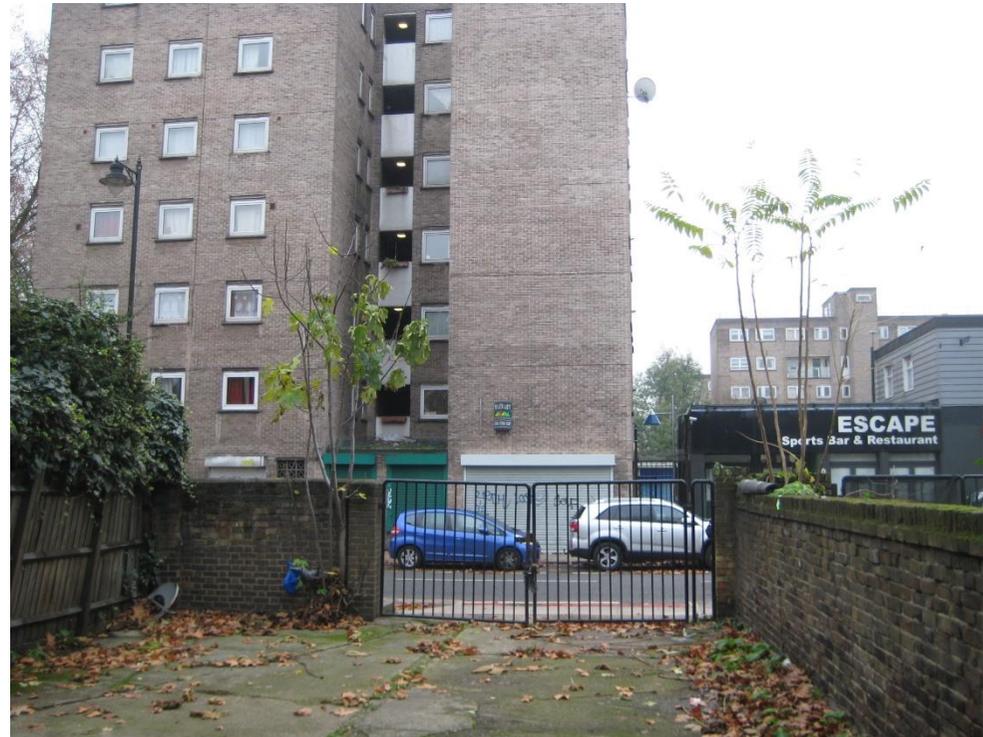
Image 3 – Site access is away from the retained trees
