**BASEMENT IMPACT ASSESSMENT**

17 PARK SQUARE EAST, LONDON

**17 PARK SQUARE EAST LTD**

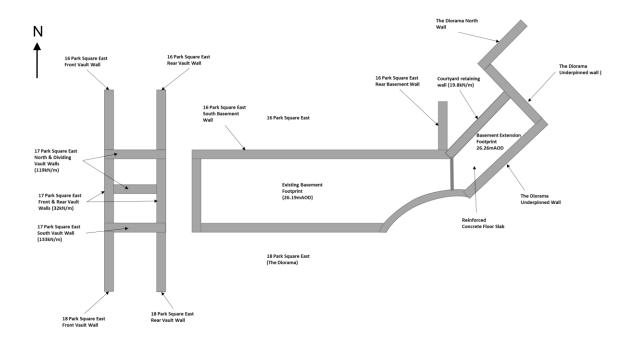
Figure 1: Loaded Zones Introduced to PDISP

Gross pressure changes across the development have been estimated based on information provided by the structural engineer. The load zones, positive and negative, used to model the proposed basement in PDISP are displayed in Figure 1. These include the excavation and loads on the retaining walls, excavation of central area from existing ground level and construction of the basement ground bearing floor slab.

The basement layout has been based on drawings provided by Form Structural Design (Figure 1). The layout of the extension is to be approximately 5m by 8m and to a level of circa 26mOAD. Line loadings on the underpinned walls have been advised as being between 276kN/m run and 19.8kN/m run.

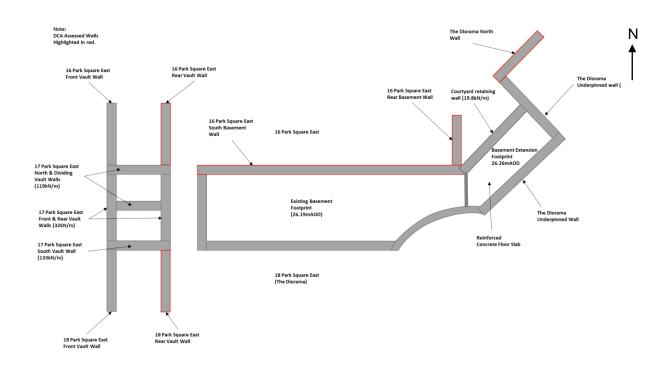
Figure 2- Figure 2: Critical Damage Category Assessment (DCA) Locations

As ground movements reduce with distance away from the proposed basement and the relative founding depths, the worst-case scenarios will be the rear and south walls of No. 16 Park Square East, the North Wall of No. 18 Park Square East and the rear vault walls of number 18 and 16 Park Square East. The locations of the assessed walls are displayed in Figure 2. There will be no lateral pressure release to the south west of the basement and therefore these walls are considered to undergo inconsequential movement and have therefore not been considered.

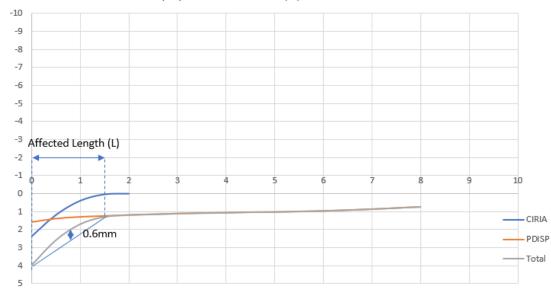
## 16 Park Square East Rear Basement Wall Distance from proposed basement wall (m)

Settlement/Heave (mm)

The settlement profile produced by PDISP along the assessed wall locations must be added to the settlement profile presented in Figure 6.16 of CIRIA Report C760, which is appropriate for the proposed construction method. The combined maximum settlements, at the closest point of the assessed walls are displayed in Table 8-2. The CIRIA settlement profiles from the basement wall to the maximum distance of affected ground are predicted to be the same for both walls and this is displayed in Figure 3.

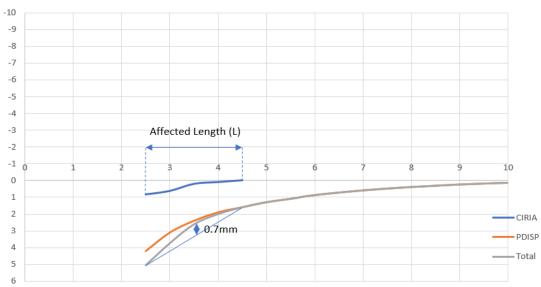
The Diorama North Wall
Distance from proposed basement wall (m)

Settlement/Heave (mm)

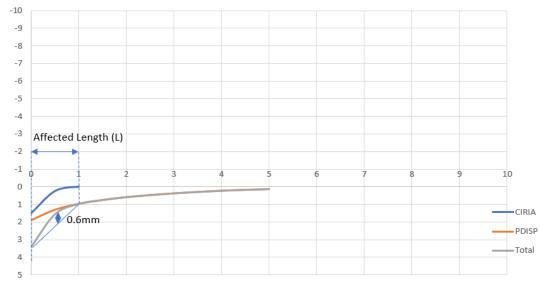
Figure 3: Predicted Displacements for Assessed Walls

Settlement/Heave (mm)

The maximum vertical deflections, from the convex settlement curves for the coarse-grained soils support case and the relevant deflection ratios are displayed in Table 8-4.2.

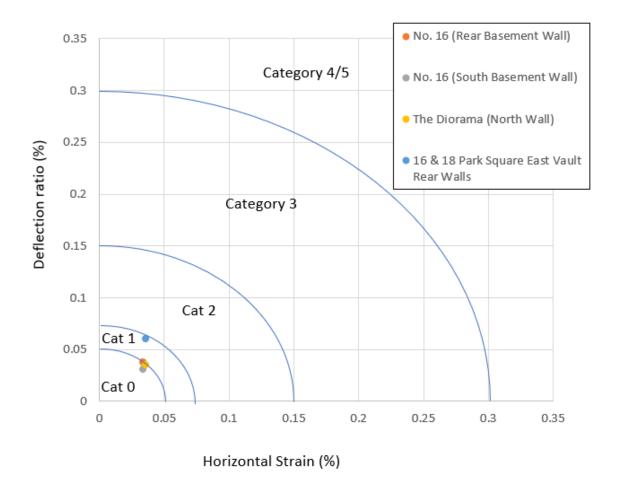
Figure 4: Damage Category Ratings

The damage category for both assessed walls are identical and are illustrated in Figure 4, using the damage category ratings and graphs given in CIRIA SP200. Figure 5 explains the damage categories.

The results show the affected walls are:

Any walls outside of the ones considered above are further away from proposed excavations and as such will have damage categories lower than those presented in figure 4. As such these would be expected to have damage categories of below 2 which is allowable under Camden guidance.

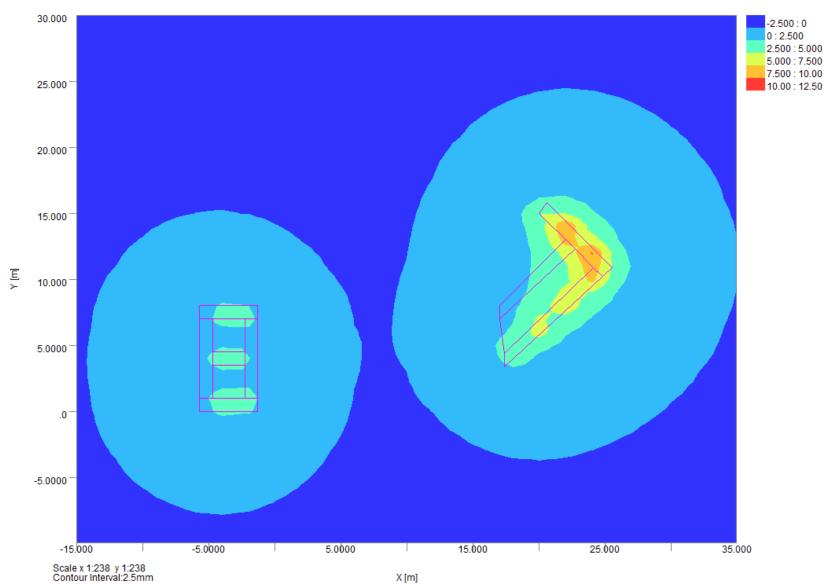
17 Park Square Underpinning

Settlement Contours: Grid 1 at -4.6000m

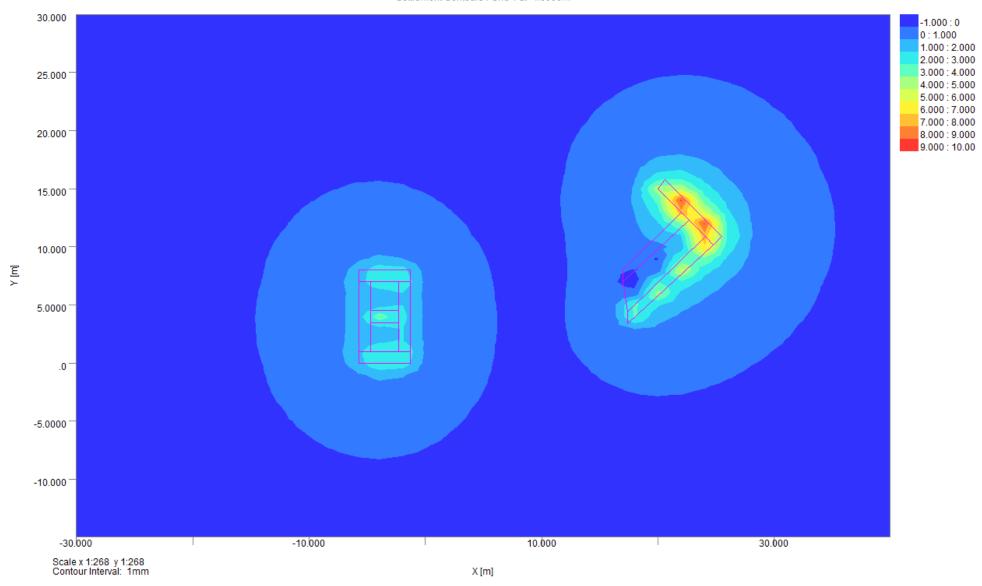
17 Park Square Basement Slab

Settlement Contours : Grid 1 at -4.6000m

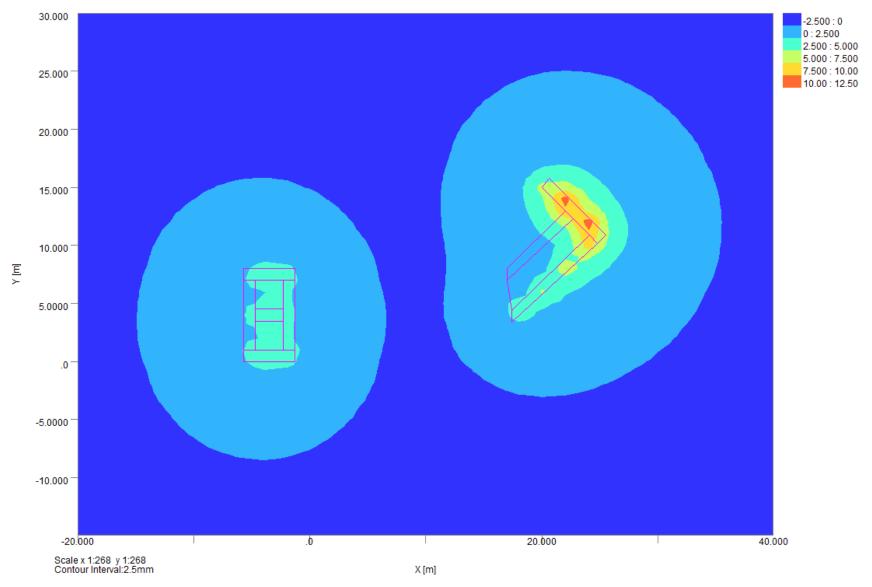
17 Park Square Total Settlement (inc. Long Term)

Settlement Contours : Grid 1 at -4.6000m
