4 John Street, London
for

Proposed Elevations

Drg. No: Jcsm.15 - 200b

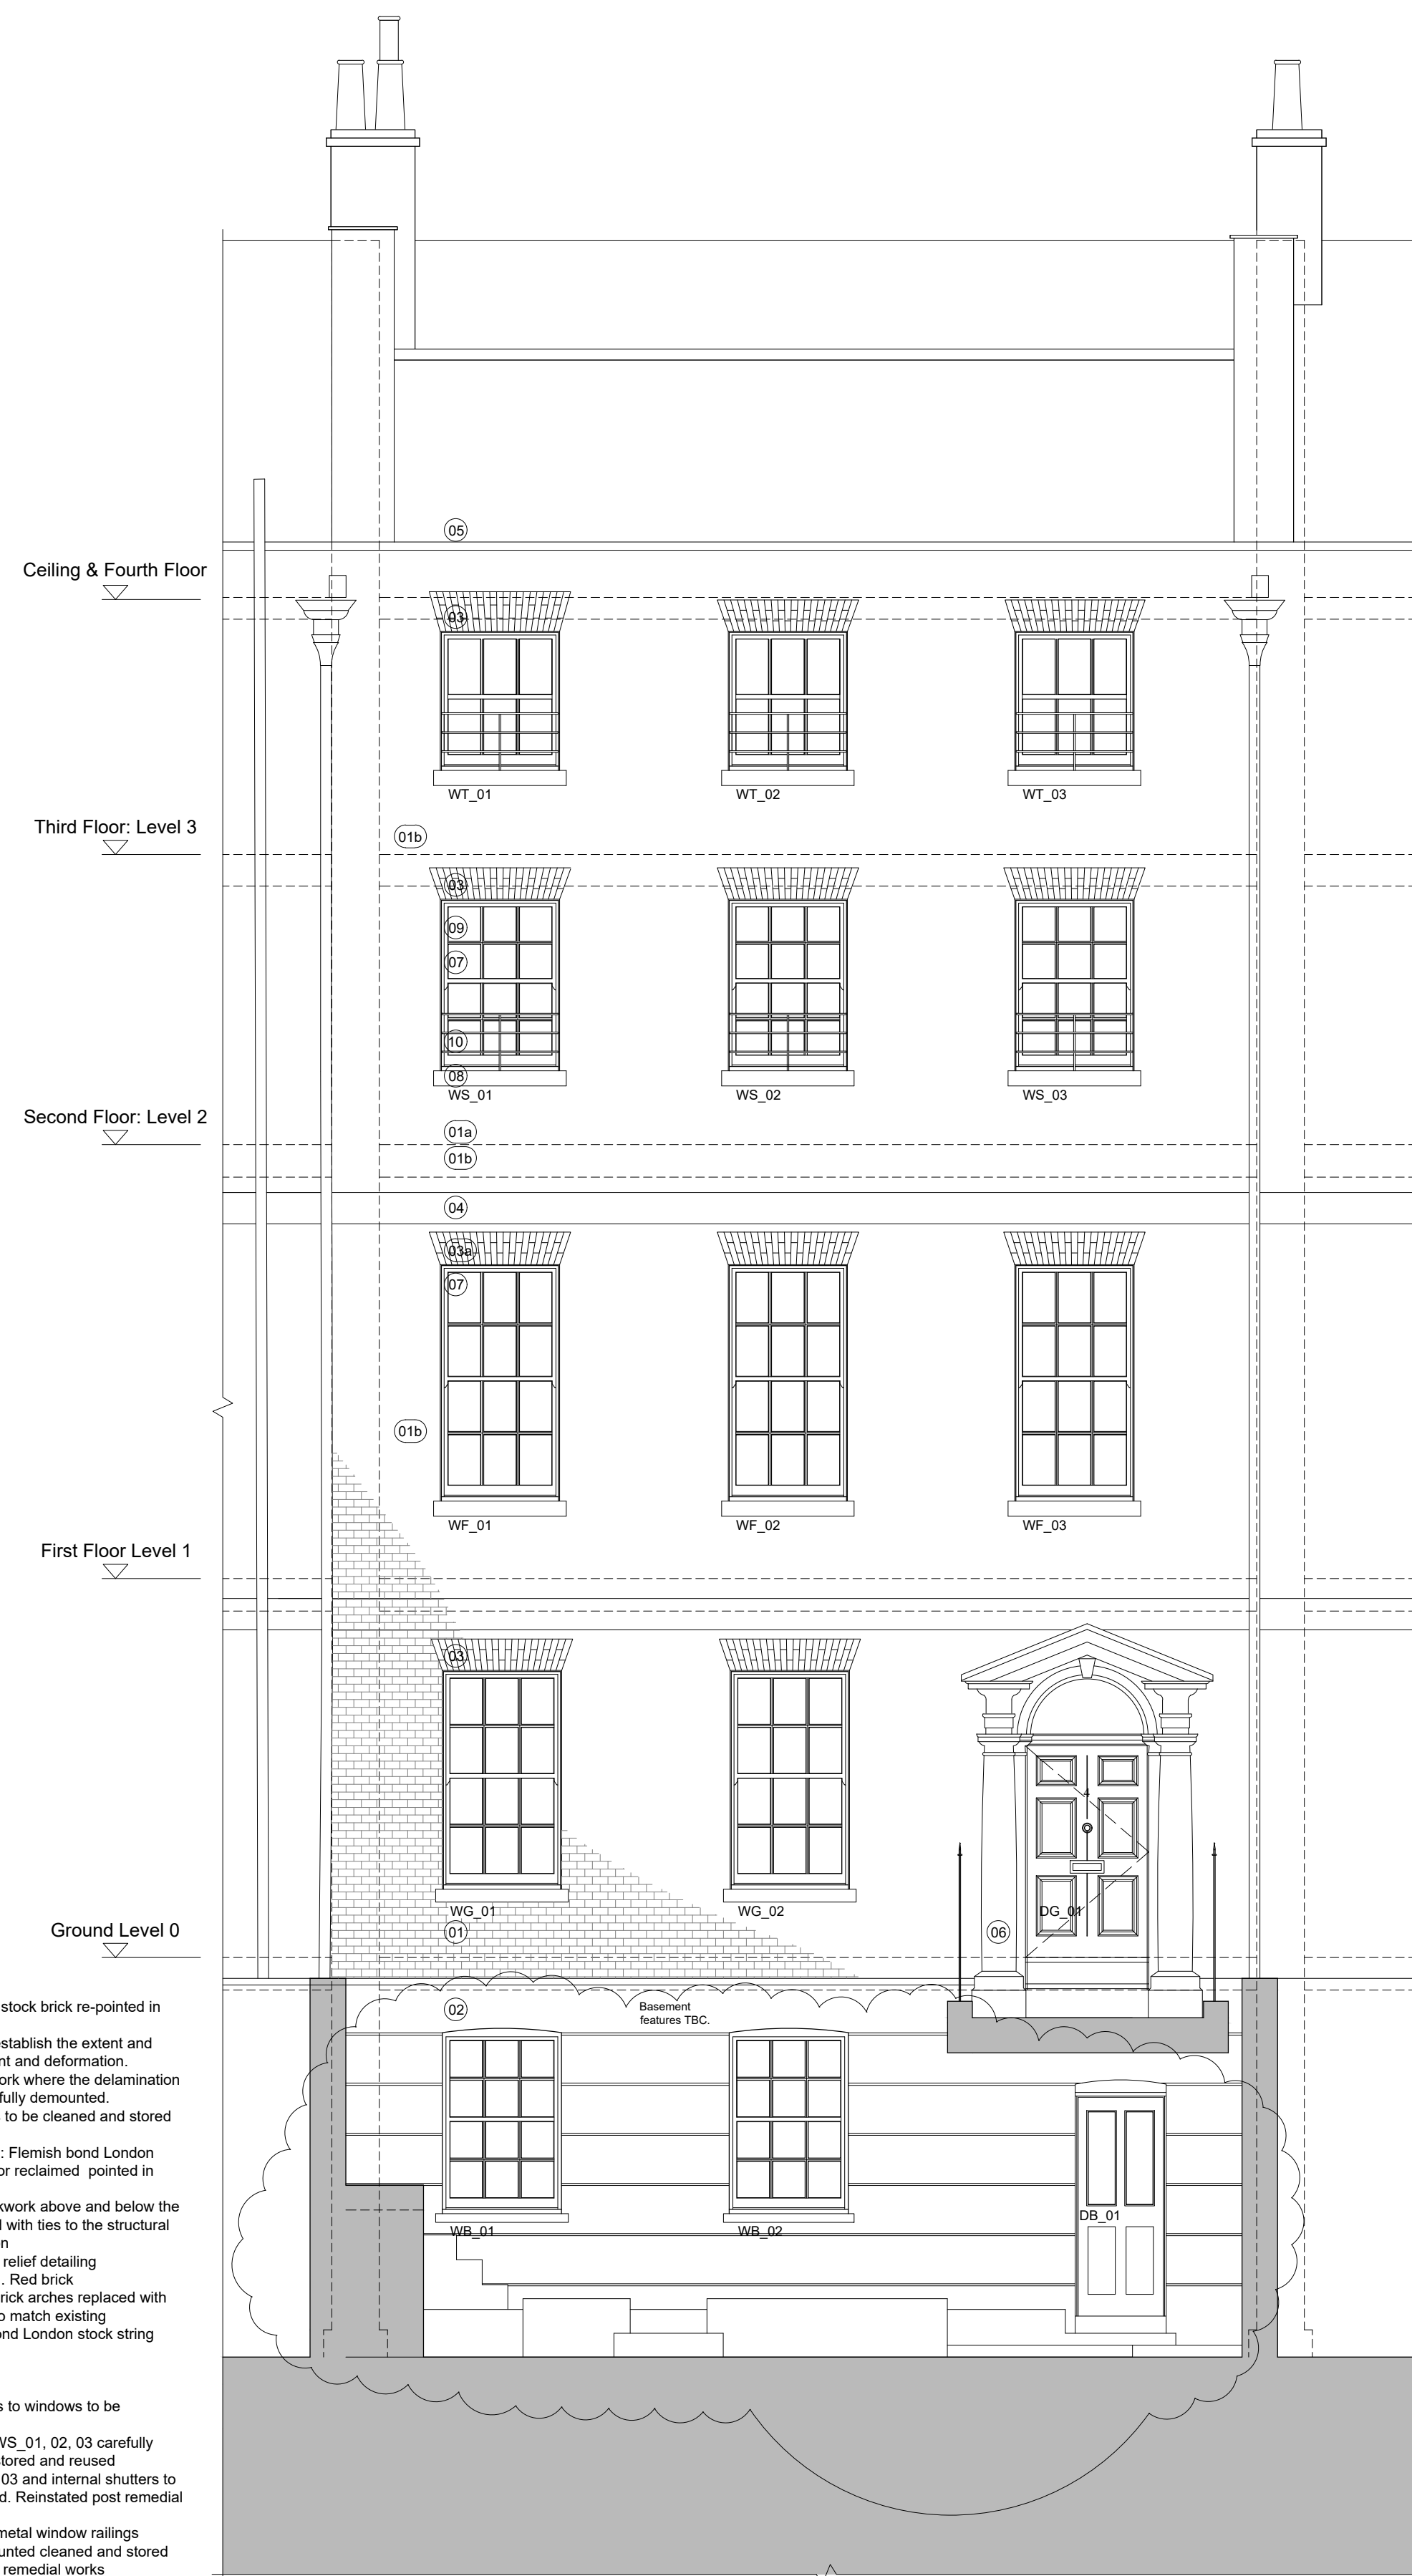
Proposed Elevation

- LEGEND:
- 01 Flemish bond London stock brick re-pointed in hydraulic lime mortar
 - 01a Exploratory works to establish the extent and properties of movement and deformation. External facing brickwork where the delamination is identified to be carefully demounted. Salvageable materials to be cleaned and stored for re-use.

- 01b Location of debonding; Flemish bond London stock brick, salvaged or reclaimed, pointed in hydraulic lime mortar
 - 01c Areas of retained brickwork above and below the rebuilt area to be fitted with ties to the structural engineer's specification

- 02 Stucco with rusticated relief detailing
 - 03 Flat gauged brick arch. Red brick
 - 03a Damaged flat gauge brick arches replaced with new using lime putty to match existing

- 04 Reinstated Flemish bond London stock string course
 - 05 Coping
 - 06 Painted door case
 - 07 Painted render reveals to windows to be reinstated
 - 08 Existing window cills WS_01, 02, 03 carefully demounted, cleaned stored and reused

- 09 Windows WS_01, 02, 03 and internal shutters to be removed and stored. Reinstated post remedial works
 - 10 Existing second floor metal window railings WS_01, 02, 03 demounted cleaned and stored for reinstatement post remedial works
