drawing title : Roof Plan
Proposed Roof Repairs

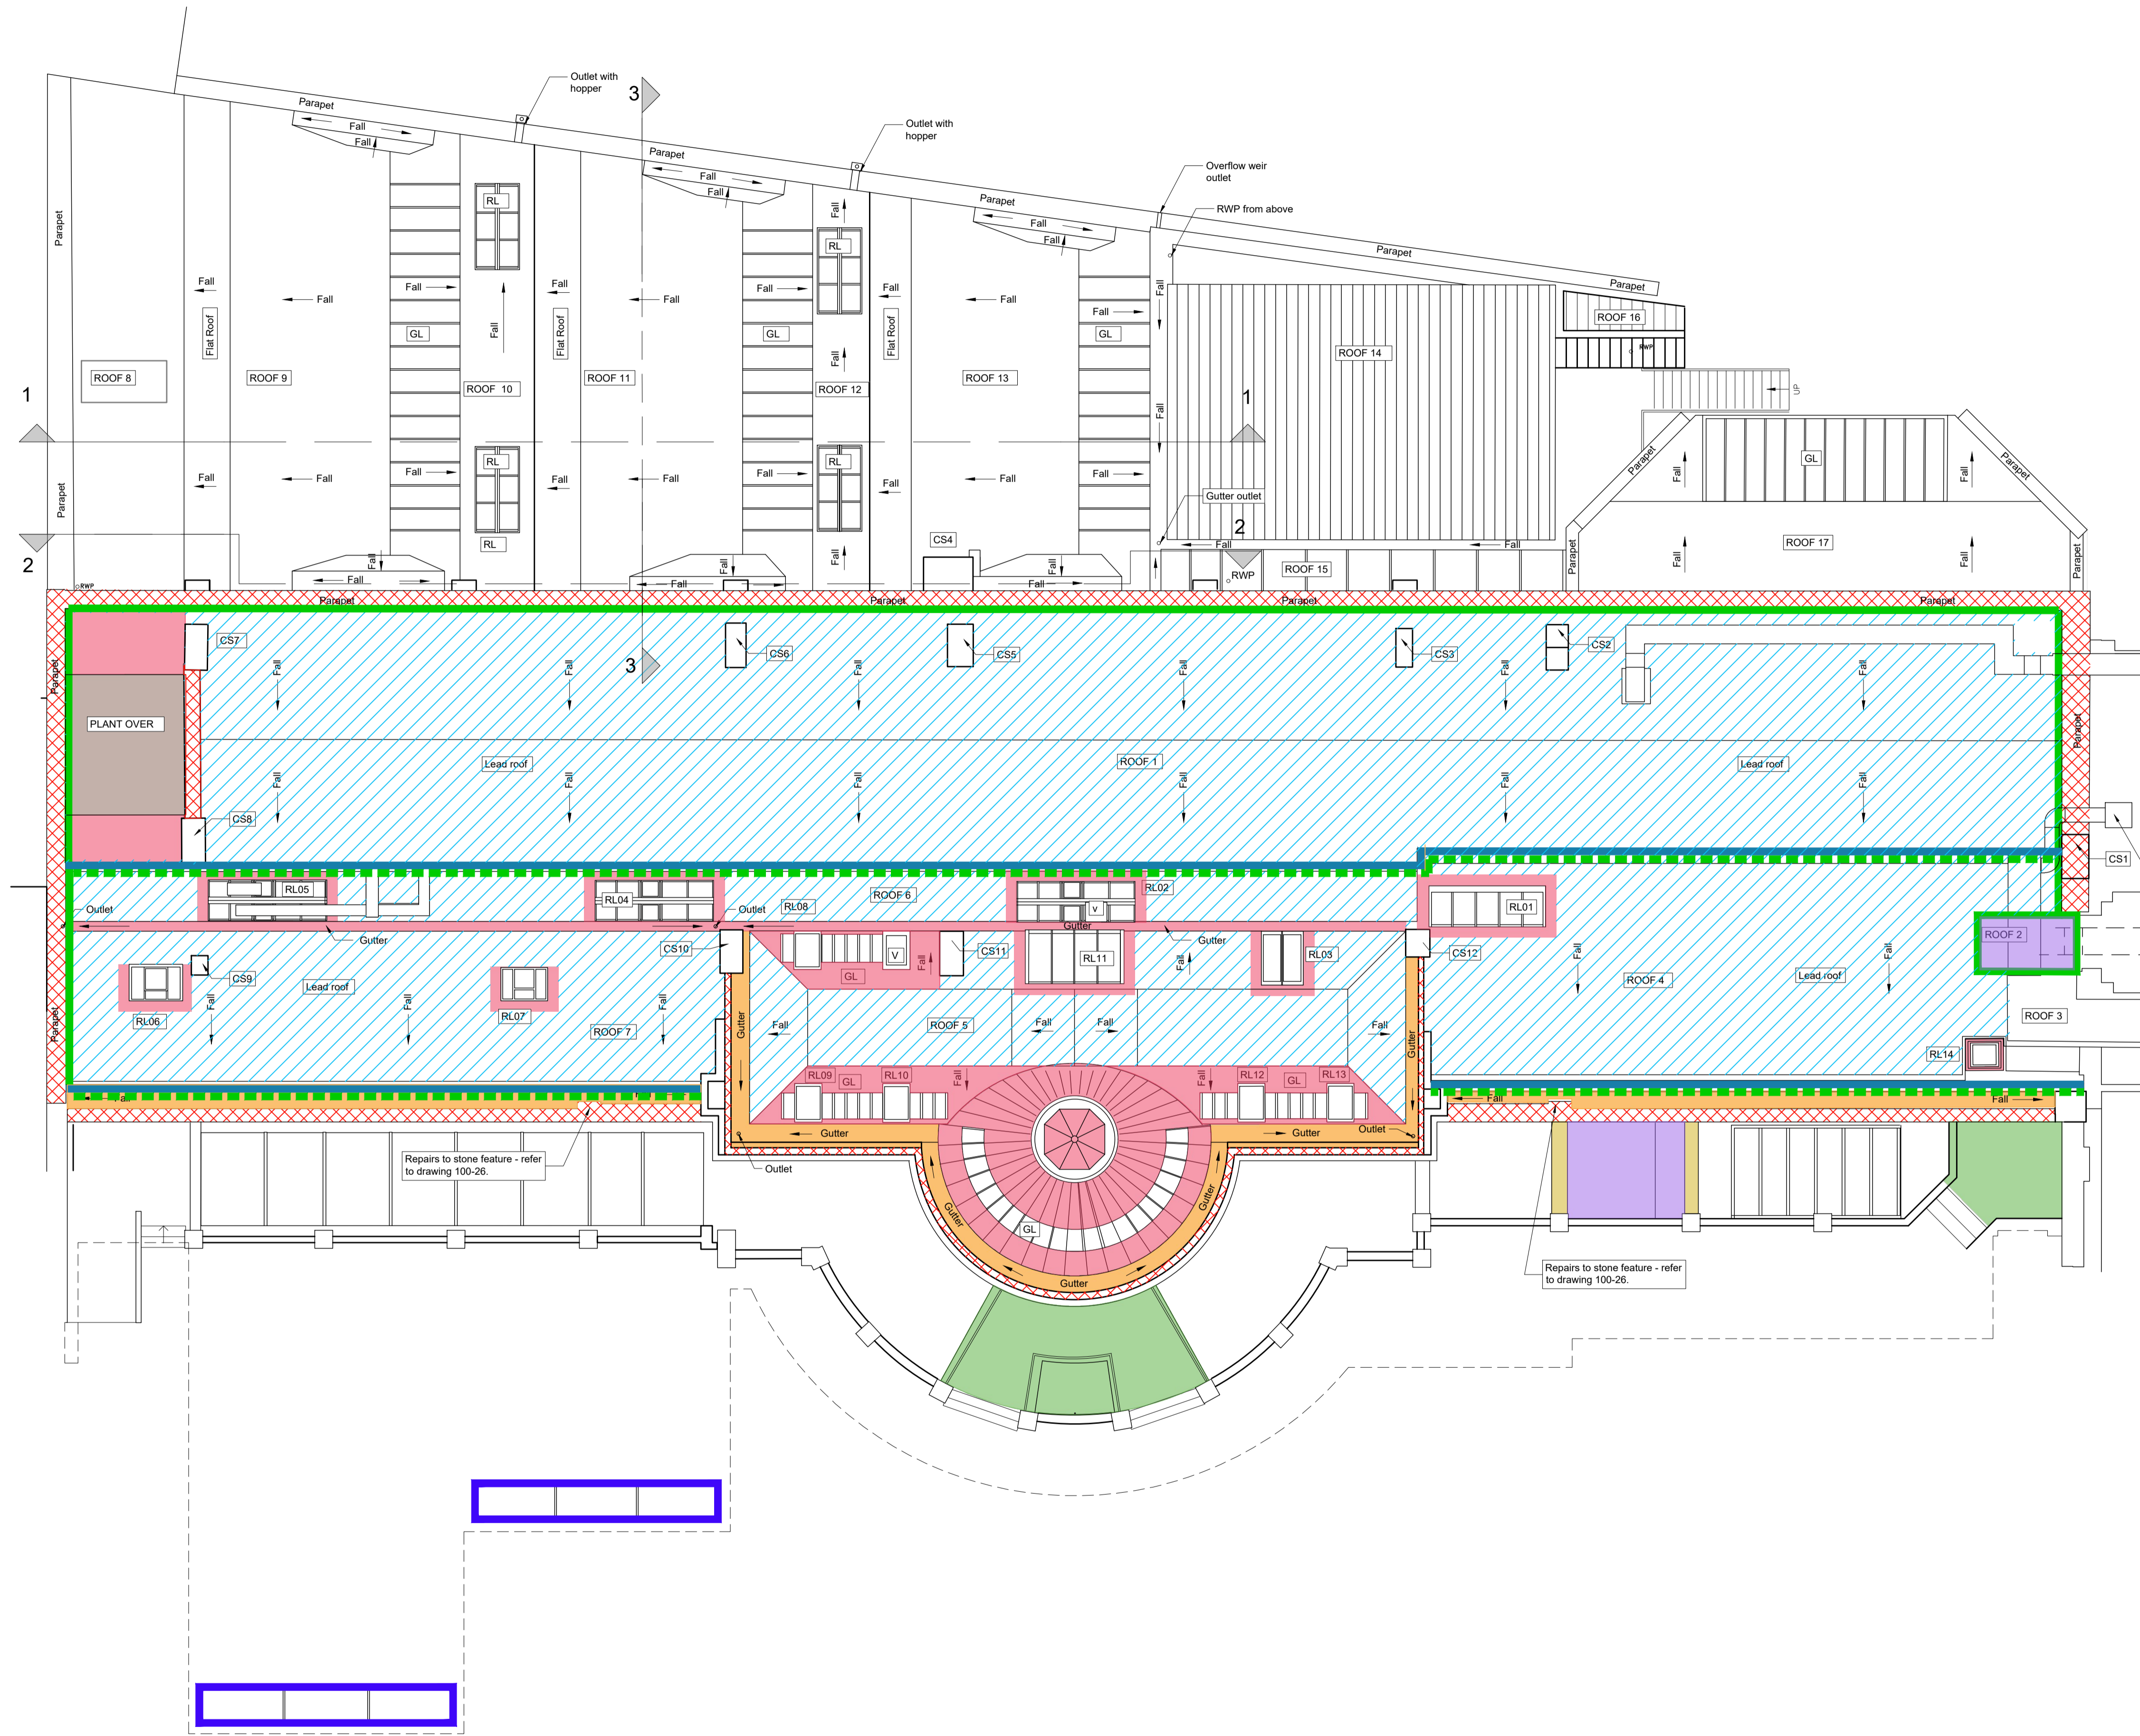
Removal and reinstatement of fall arrest system subject to specialist input / design.

Repairs to stone feature - refer to drawing 100-26.
