BRITISH MUSEUM PERIMETER PROPERTIES

**38 RUSSELL SQUARE**

DESIGN AND ACCESS STATEMENT AND ARCHITECTURAL PROPOSALS  
Addendum February 2020

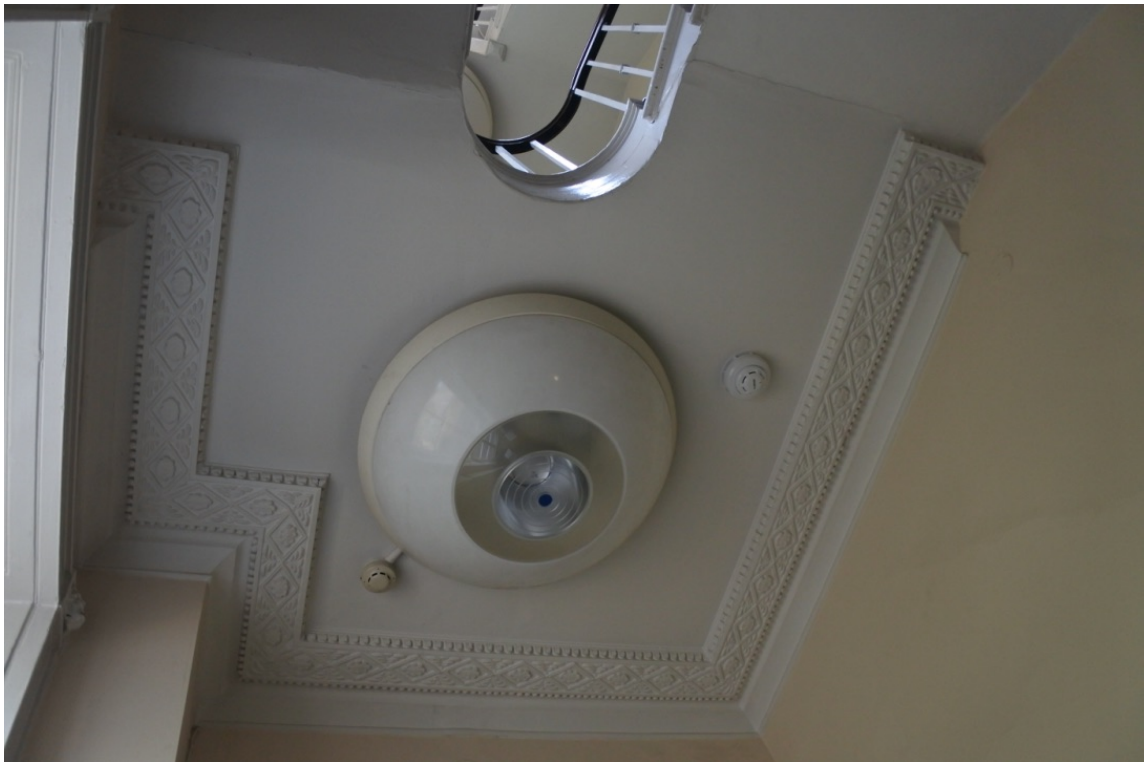
The riser in stair 1 stairwell has interrupted the existing cornices on ground and first floor. The decorative plasterwork has been reinstated around the risers to match existing. See photograph 1.

**Top:** Photograph 1. Ceiling view of Stair 1 landing on first floor.  
**Right:** Photograph 2. Riser in the corner of the landing of secondary stair 2.

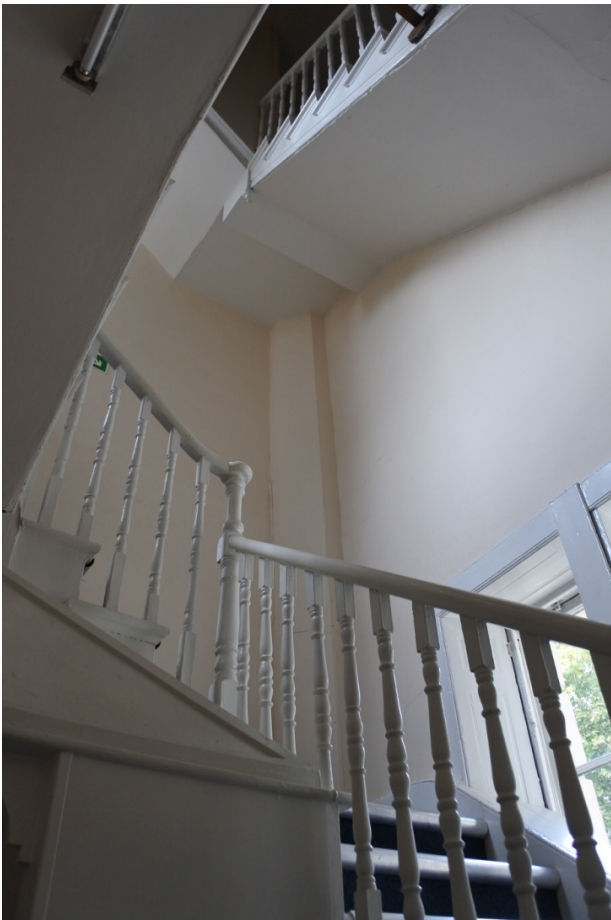
The vertical riser in the corner of secondary stair 2 also runs from basement to third floor and part of the services are diverted horizontally on second floor mezzanine. This riser is smaller in size and does not have any decorative features. See photograph 2.

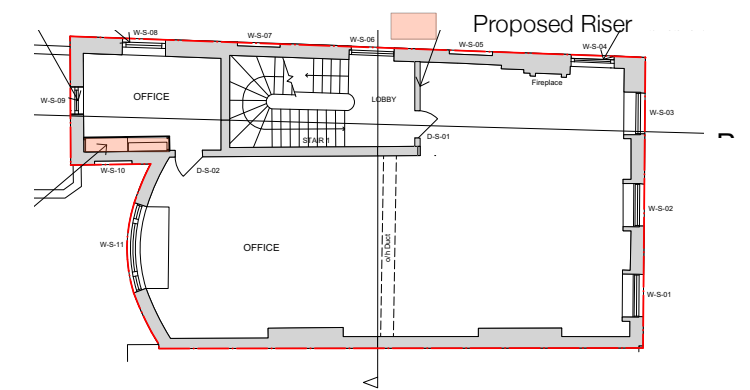
**Top:** Image 1. Riser reflecting the chimney breast opposite.  
**Below:** Image 2. Riser located in the former stair 2 stairwell.

Another option was considered where the secondary stair 2 was removed and the floors on all levels reinstated. This provided opportunity for locating the vertical risers in the stairwell. Please see image 2.

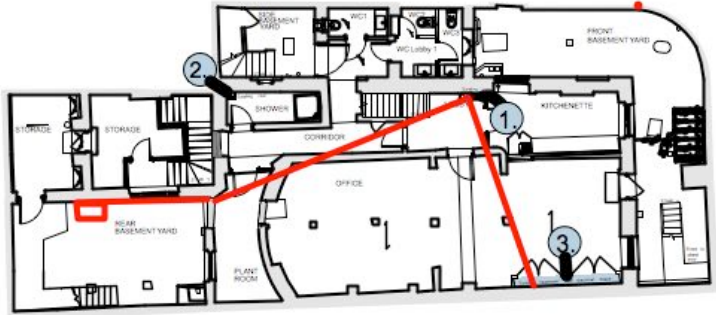
Basement Level

Proposed service routes running externally and in basement suspended ceiling void

Existing service risers: Blue  
New service cupboard: Red

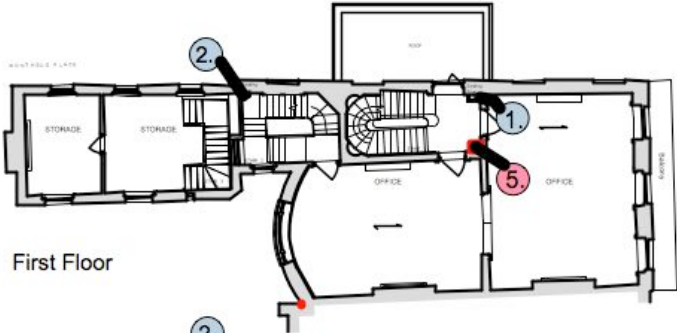
First Floor

Existing service risers: Blue  
New service riser: Red

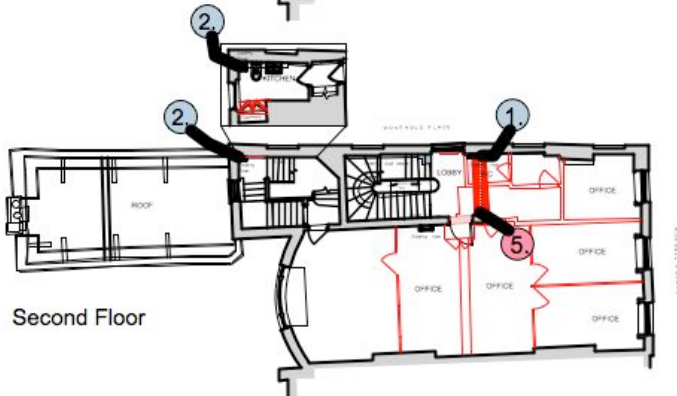
Second Floor

Existing service risers: Blue  
New service riser & Cupboard: Red

The second and third floor risers are contained within the new walls separating the front office from the stairwell and also contain the mechanical pipework. Access doors are provided fro the distribution boards. The second floor riser will also contain the distribution boards fro the first floor allowing the primary levels to have a minimum riser space.

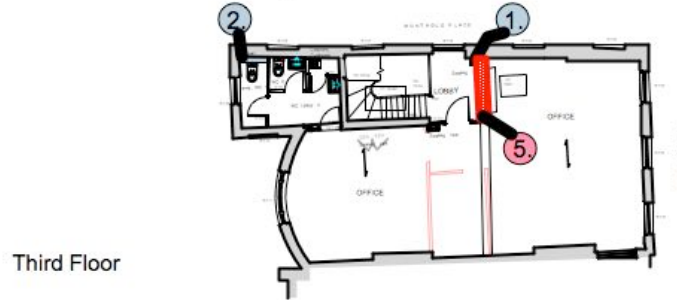
Third Floor

Existing service risers: Blue  
New service riser & Cupboard: Red

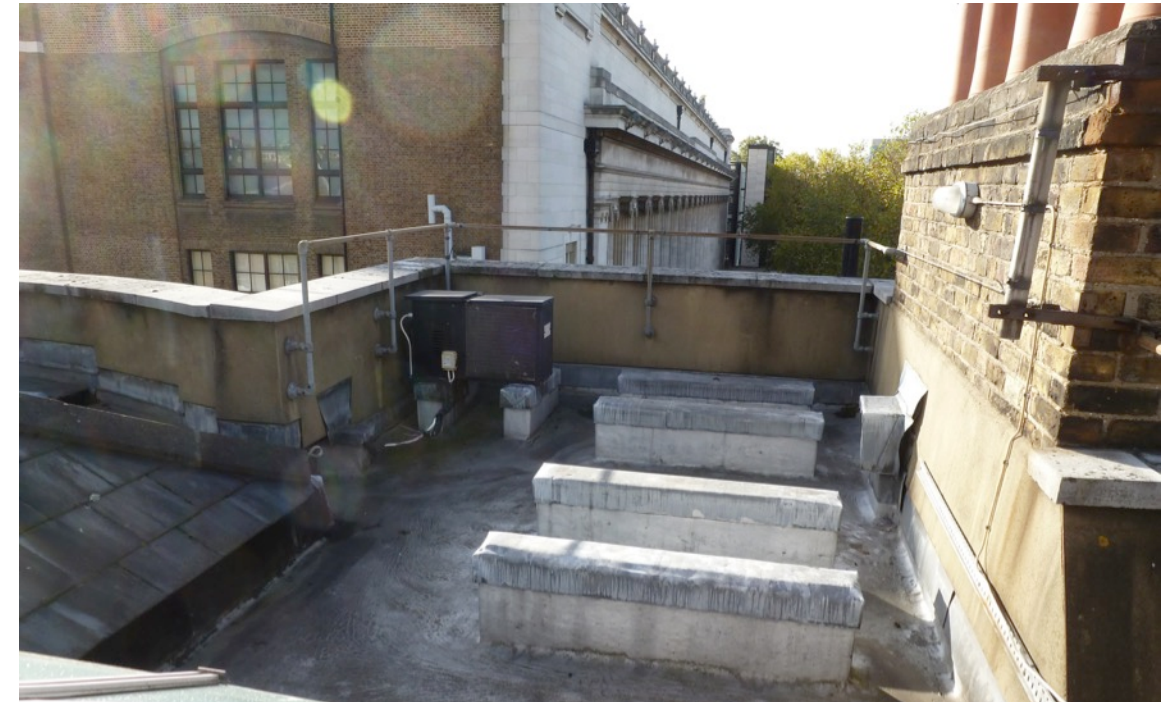
**Above:** Existing concrete plinths on flat roof area to be removed.

- Remaining plant footings to be removed. Flat roof surface to be repaired or overlaid with new membrane applied over asphalt flat roofing surface.
- Perimeter metal balustrade to be replaced with new.

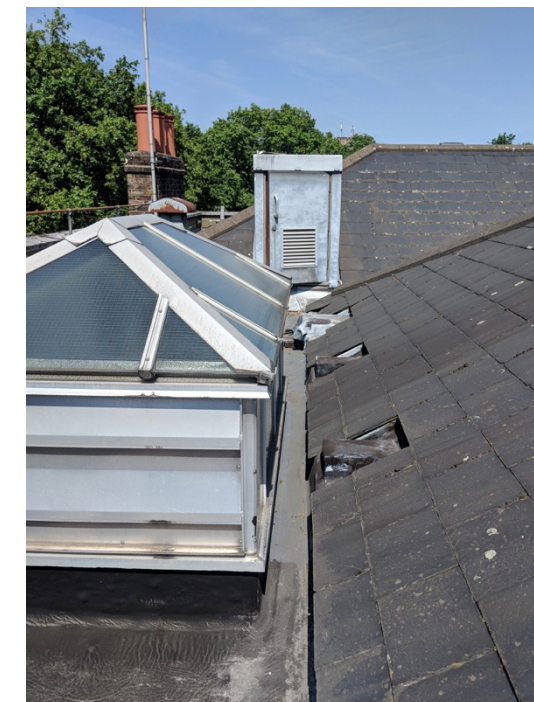
**Below Left:** Repair works to skylight and roof are essential to achieve waterproofing.

- Lightning protection may be required. To be advised.
- Existing skylight to be refurbished, repaired, and redecorated. Cracked glass to be replaced. Weather seals and ventilation filters to be replaced with new.

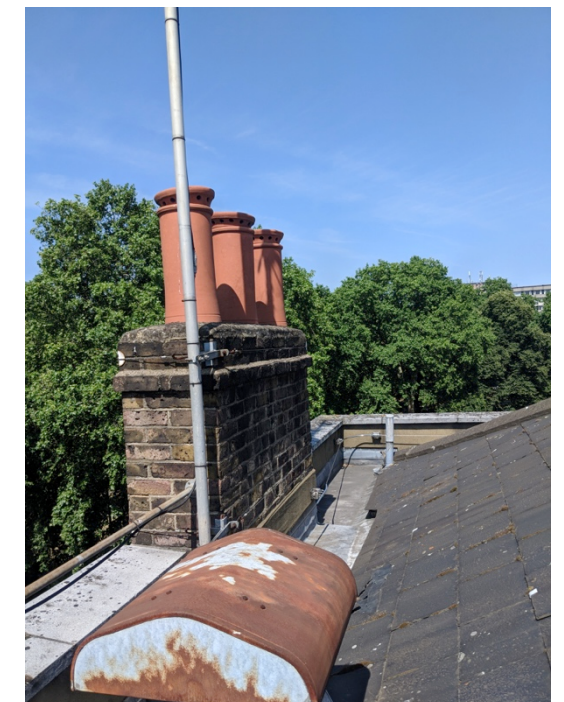
**Below Right:** Existing man safe system to be tested. If upgrading is required, new system to be provided as a like-for-like replacement.

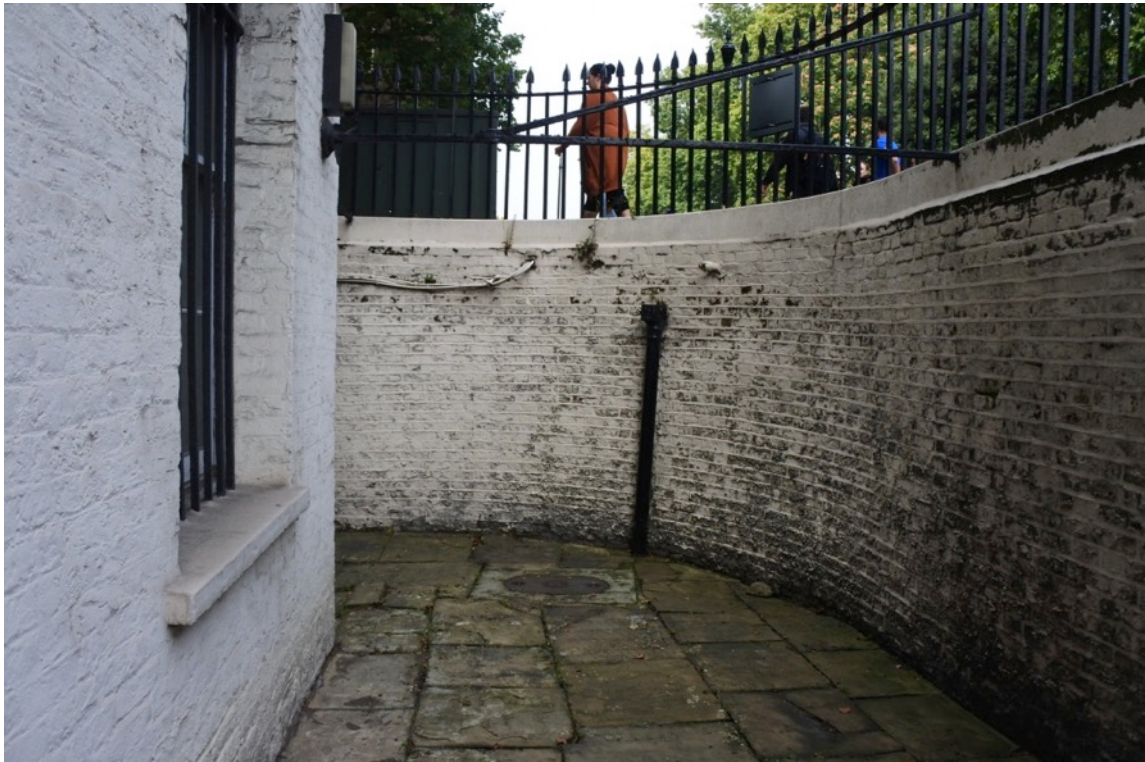
**Top:** Front Basement yard. Brickwork walls to be cleaned, repaired and repainted.  
**Left:** Side Basement yard. Existing stone staircase and York stone paving to be cleaned and repaired. Essential maintenance works to be carried out to unblock drainage gullies.  
**Right:** Entrance portico to be cleared of organic growth, repaired and redecorated. Brickwork to main elevations to be toned down to match existing patina..

- Basement yard stone floor and brickwork walls to be cleared of organic growth and debris.
- Painted brickwork walls to be repaired, cleaned and repainted. Silicate based paint in cream colour to match existing.
