# The Heath & Hampstead Society

## To London Borough of Camden, Development Control Team

**Planning Ref:** 2019/5141/P

**Address:** 33 Willow Cottages NW3 1TN

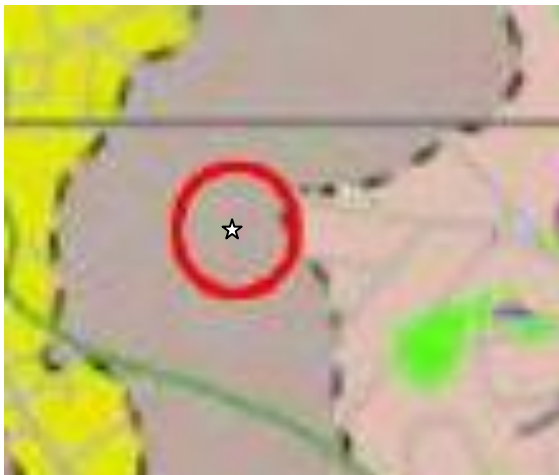
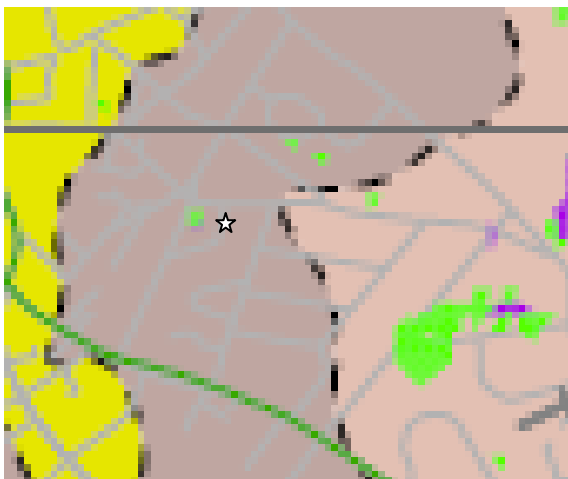
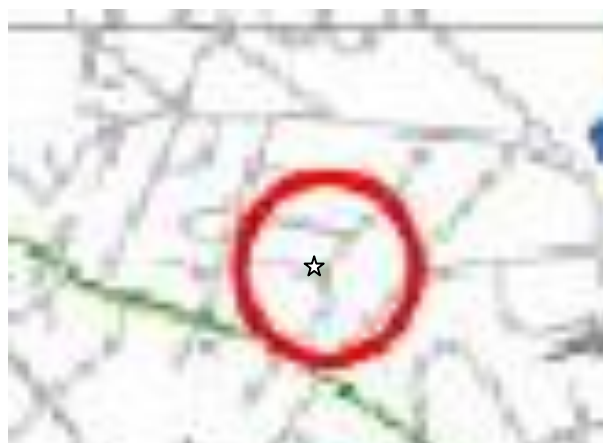
Figure 16 actually centred over 13 Gayton Cresc

Figure 12 actually centred over 12 Pilgrims Lane

It is clear that parts of the BIA are actually inaccurate. The red circle defining the position of 33 Willow Cottages on Arup's 'Camden Geological, Hydrogeological and Hydrological Study: Slope Angle Map' Figure 16 for example is actually centred over 13 Gayton Crescent, and on Arup's Figure 12 over 12 Pilgrims Lane! It doesn't help that poorly reproduced maps are given.

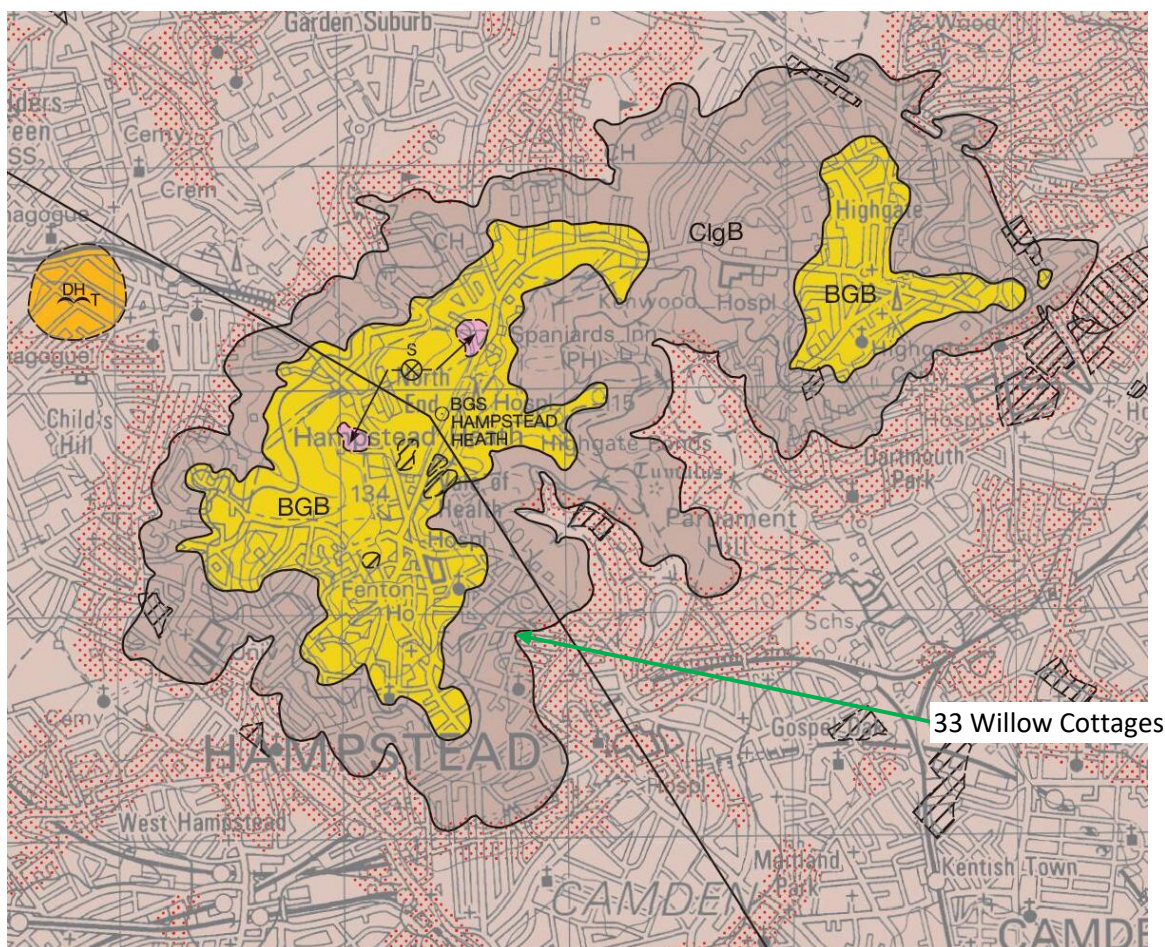
British Geological Survey 1 : 50 000 series North London Sheet 256 Bedrock and Superficial Deposits

It is interesting that despite reference to it, Arup's Figure 17 is not shown at all, with or without an inaccurate red circle. In fact this shows that 33 Willow Cottages are right bang on this area:

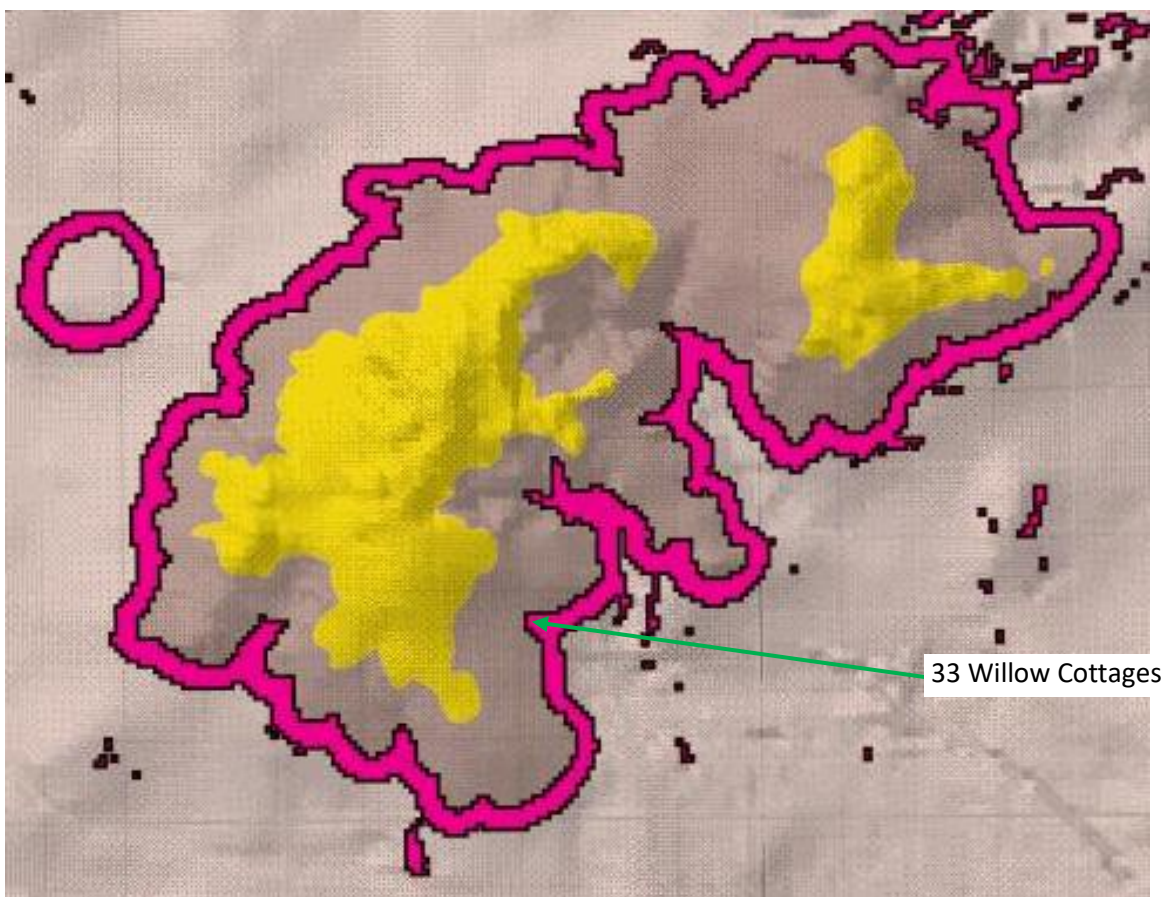
British Geological Survey Areas for Greatest Potential for Slope Instability

**This is NOT TRUE.** It is right over an area of High/Very High risk for slope instability - see British Geological Survey Areas for Greatest Potential for Slope Instability <http://www.largeimages.bgs.ac.uk/iip/mapsportal.html?id=1001750> (and see over) based on Forster A, Wildman G & Poulton C. (2003) Landslide potential modelling of North London. British Geological Survey Internal Report, IR/03/122R.
