42 BEDFORD SQUARE

PROJECT NUMBER
P2005698

FIRST FLOOR
REFLECTED CEILING PLAN
AS PROPOSED

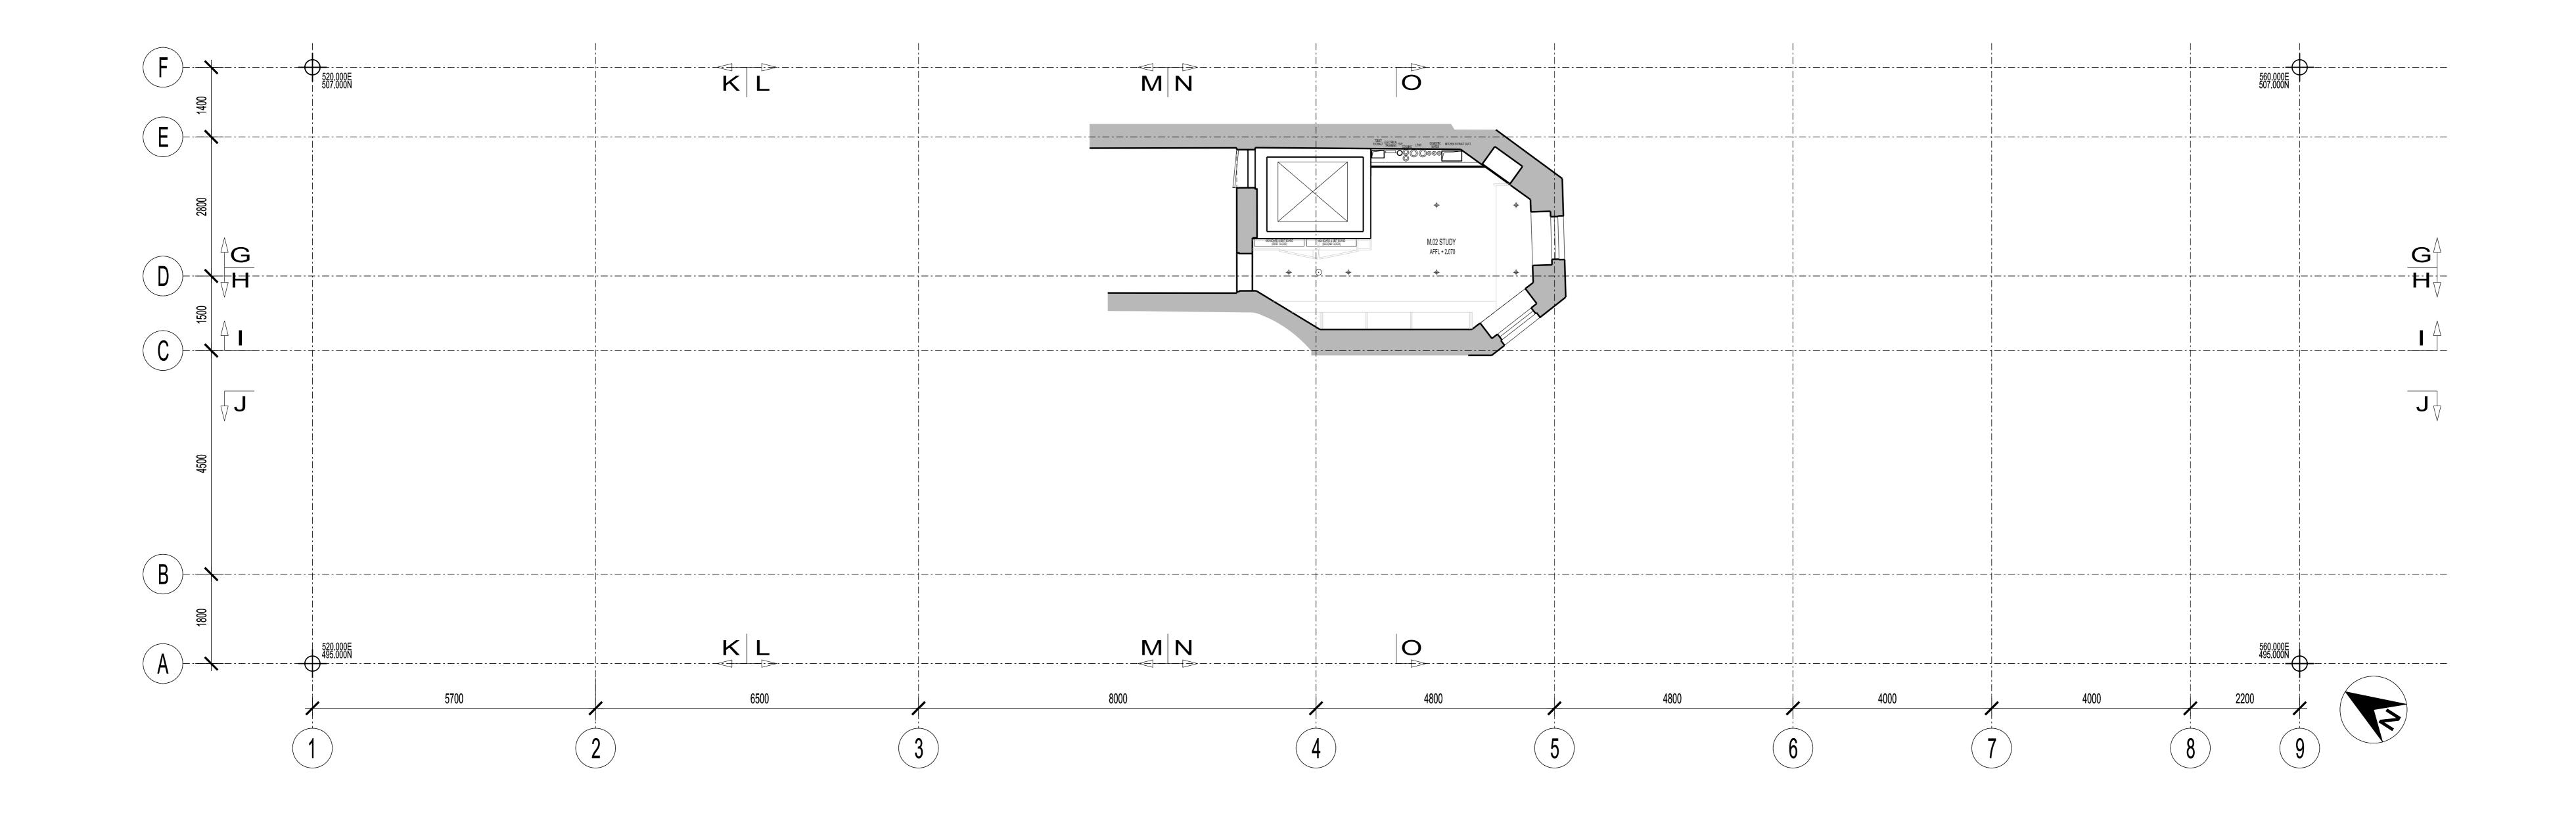
(15)AP124

→ Ceiling Spotlight ○ Unknown Electrical Fe ⊕ Smoke Detector

ℍ Heat Detector DRAWN CHECKED DA

P	42 BEDFORD SQUARE
•	PROJECT NUMBER P2005698
	FIRST MEZZANINE REFLECTED CEILING PLAN AS PROPOSED

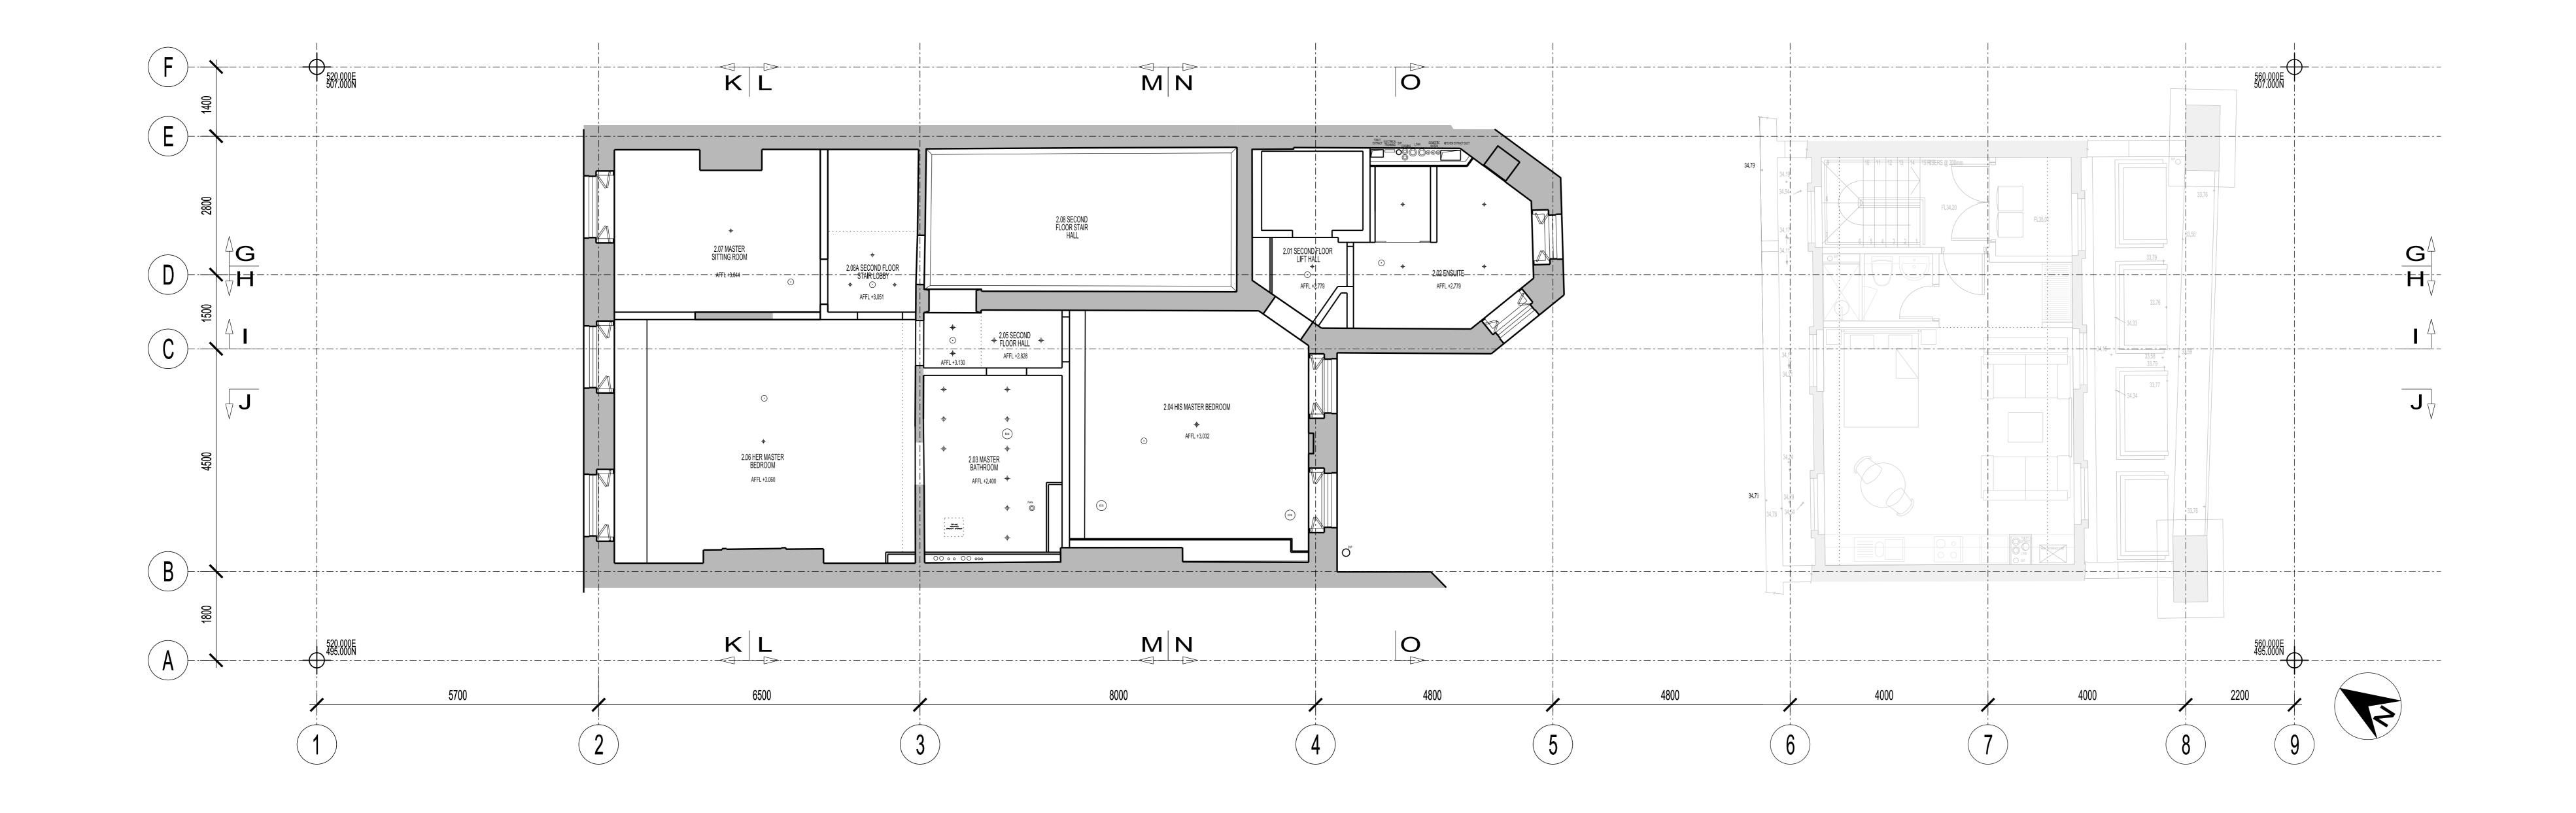
42 BEDFORD SQUARE	
P2005698	
SECOND FLOOR	1:50
REFLECTED CEILING PLAN AS PROPOSED	12.2017
(15)AC125	A

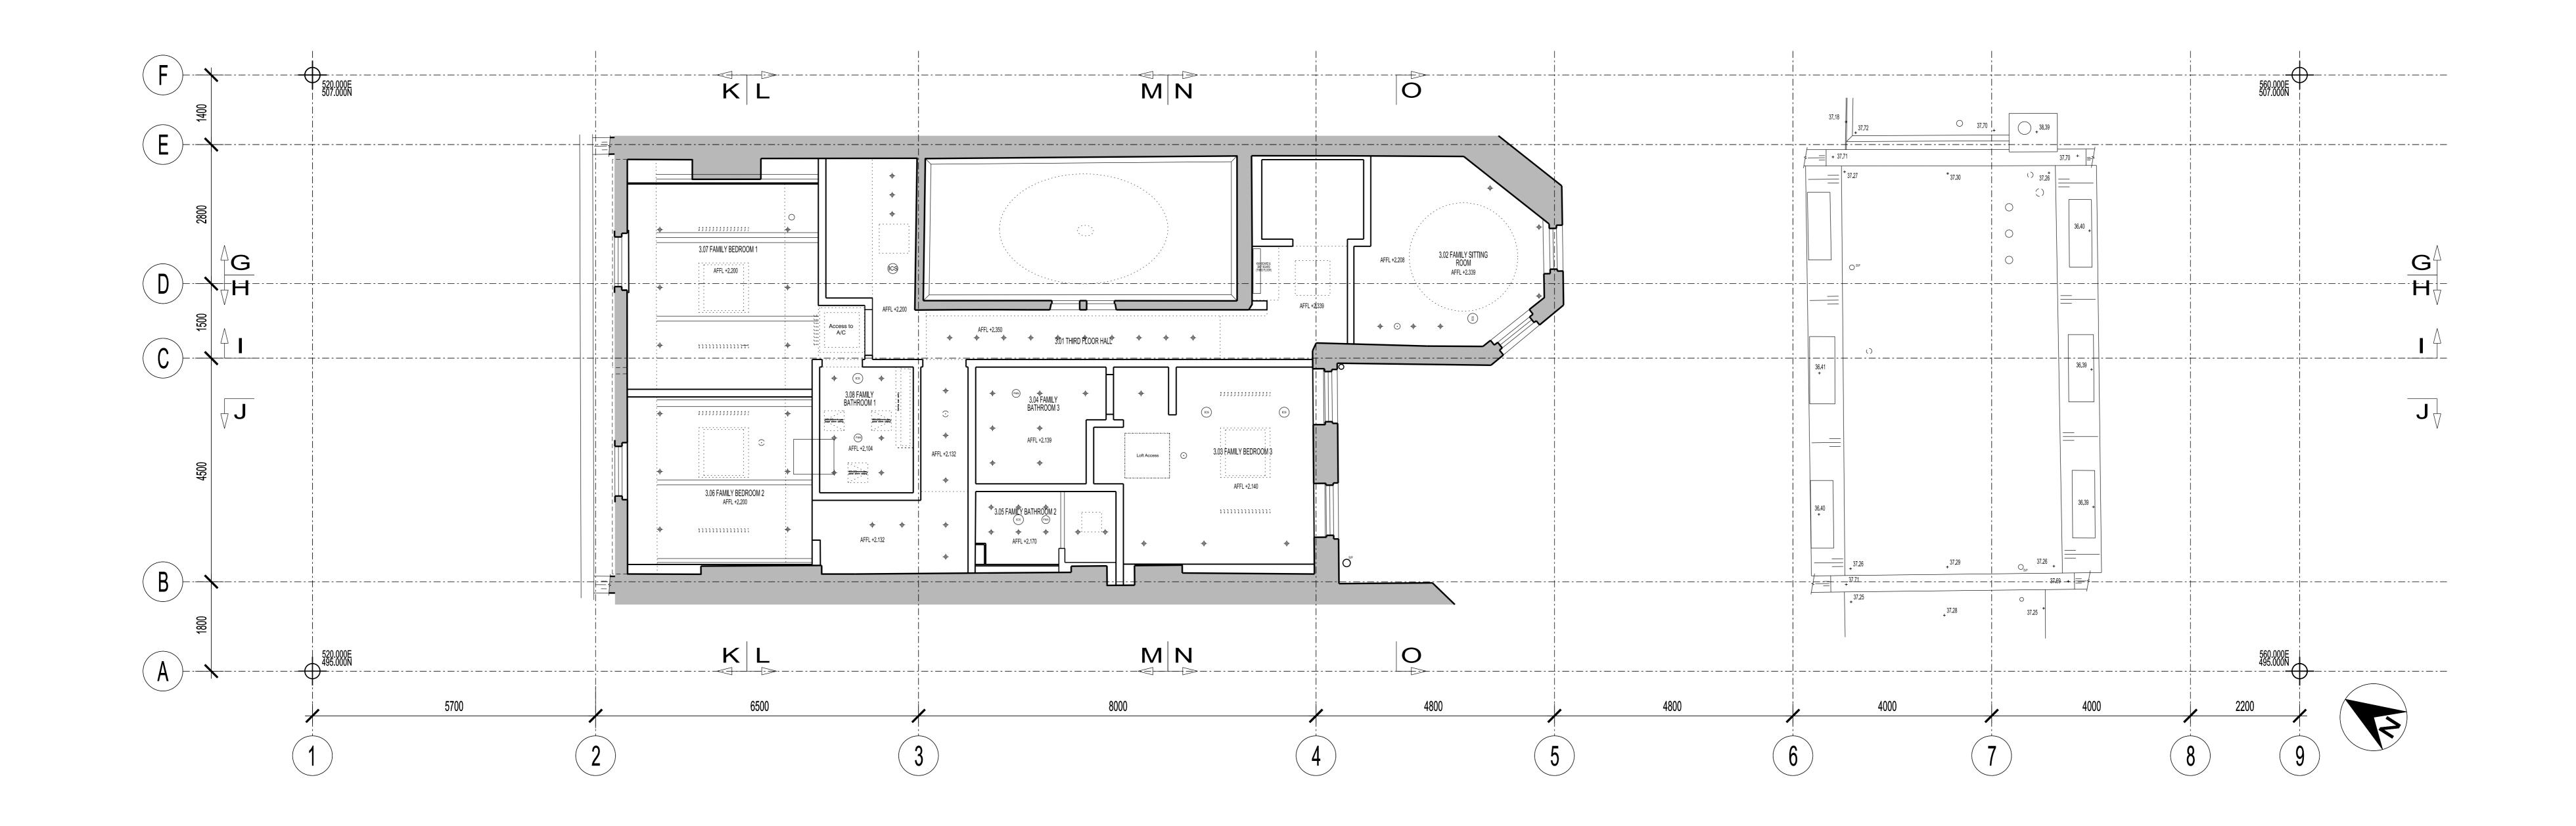
42 BEDFORD SQUARE THIRD FLOOR REFLECTED CEILING PLAN 12.2017 AS PROPOSED (15)AC126

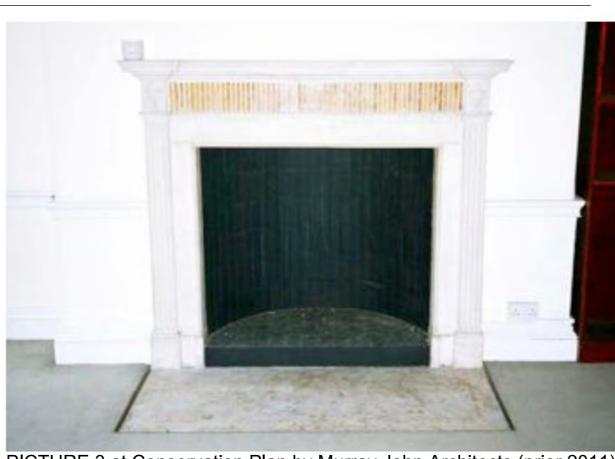
PICTURE 3 at Conservation Plan by Murray John Architects (prior 2011) Reproduction to be specified by specialist.

EXISTING CHIMNEYPIECE IN SAFE STORAGE TO BE CAREFULLY REINSTATED STONE HEARTH TO BE REINTEGRATED REPRODUCTION OF ORIGINAL CHIMNEYPIECE TO BE REINSTATED AS RECORDED PICTURE 7 FIRST FLOOR 1.04 Reception Room fireplace to be reinstated, as recorded in this picture: 1.03 Library fireplace missing prior 2011, to be reproduce, as recorded at Conservation Plan (prior to 2011):

Reproduction of original chimneypiece to be reinstated as recorded PICTURE 3, specified

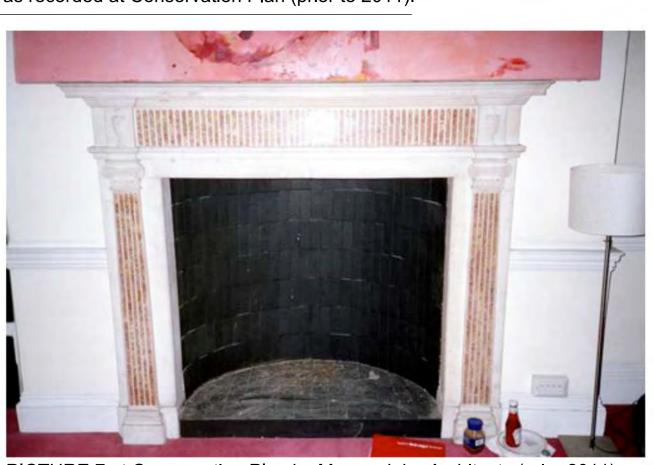
PICTURE 7 at Conservation Plan by Murray John Architects (prior 2011) Reproduction to be specified by specialist.

(A) Existing fireplace in safe storage to be reinstated

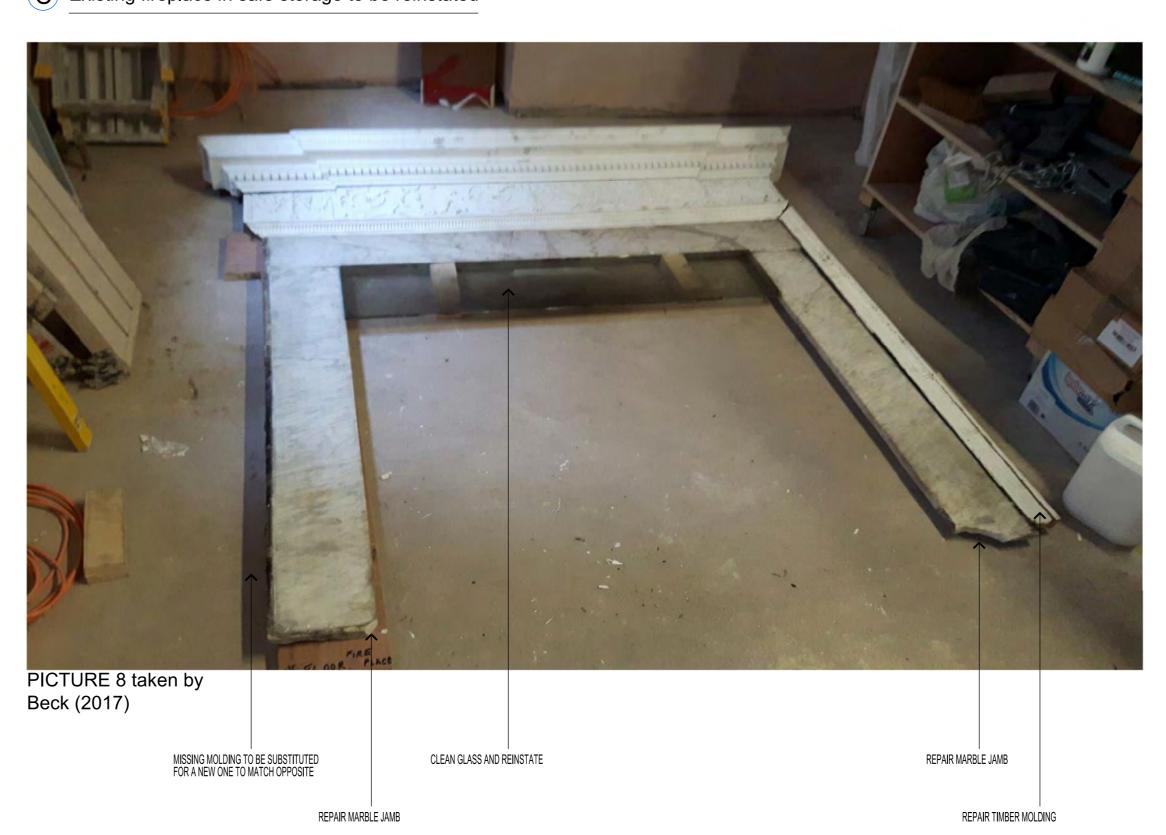
PROPOSED REINSTATEMENT OF ORIGINAL FIREPLACES

A complete damage assessment and work proposal to reinstate the stored parts of the fireplaces will be made by the Constructor and approved by the

Clean and repair existing firebox and reintegrate original hearth.

Clean, repair and carefully reinstate original pieces to their original location. And add new pieces, in a like for like basis, when missing or not able to be repaired.

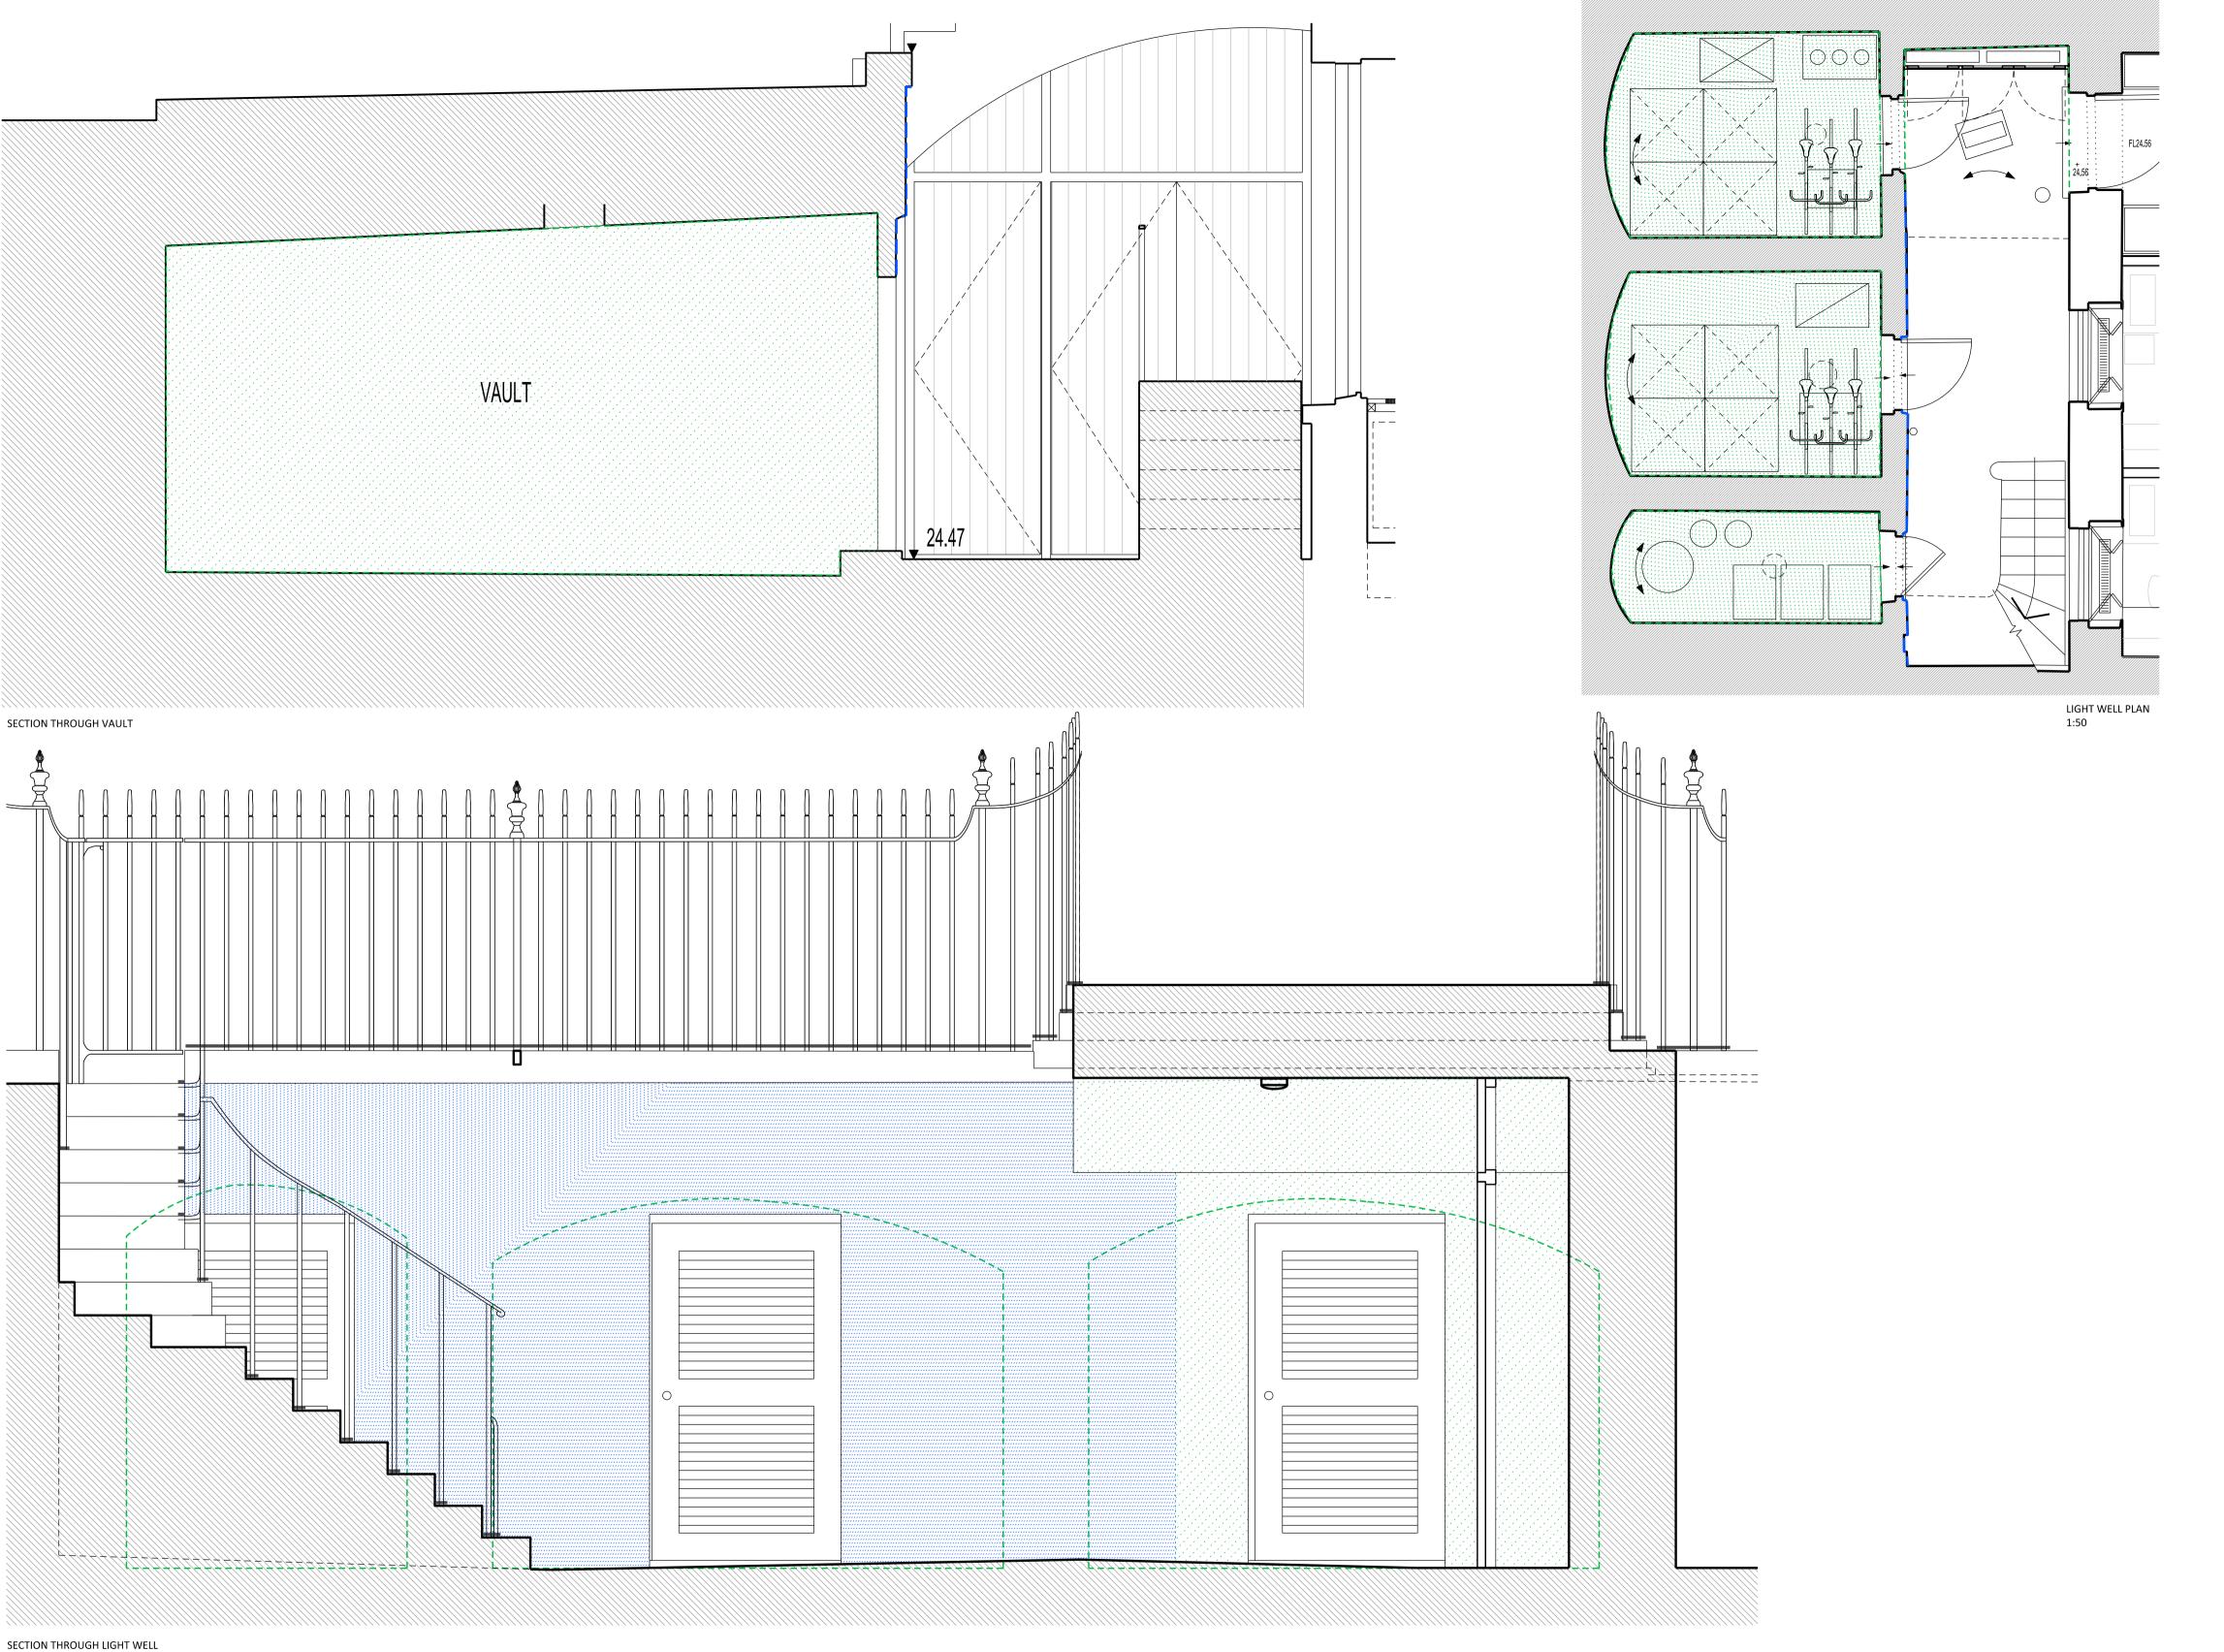
IMAGE 1

NEW LIME RENDER

A. Cleaning and strip out render in bad condition or cementitious render.

Floating coat: 1 Mature lime putty, 2.5 well-granded sand, 3kg/m3 hair, PFA TRASS 10%
Finishing coat: 1 Mature lime putty, 2.5 well-granded sand, PFA TRASS 10%

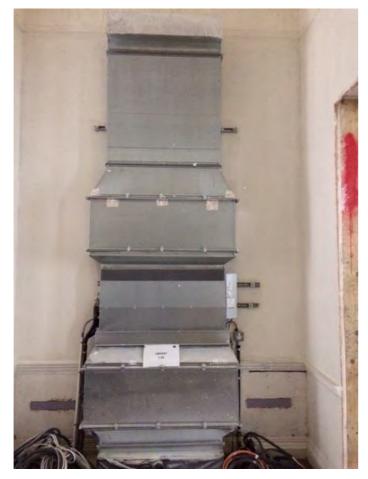
Image 2.0.1: Exsiting FCU located in Library

This project memorandum considers the options available for re-modelling the existing joinery around a Bedford Square fan coil units. The current joinery is being reviewed as part of addressing comments made by the planners/listed building consent officer.

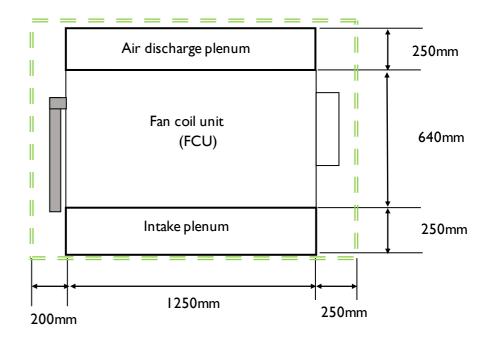
The minimum manufactures clearances/access requirements are indicated on the plan view below:

The current proposal is to box these type of units into the rear of full height joinery. As a less intrusive arrangement we have been asked to consider omitting the attenuators and reducing the unit's height to sit within a lower item of joinery. The sketch below indicates how this arrangement could work in elevation for a typical fan coil unit (FCU):

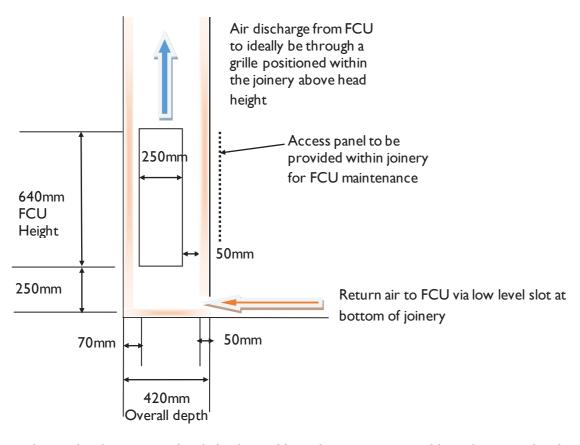
In section the dimensions are as below:-

- In order to develop a more detailed solution Hoare Lea acoustics would need to consider the impact on the room NR levels given the omission of the silencers. For example to design NR level for the Library space was NR25 and this will increase if the attenuators currently specified are removed.

- It would be suggested that the plenum boxes are acoustically lined to help reduced the noise levels from the FCU's or the plenum boxes could be removed and acoustic lining provided to the joinery to assist in noise reduction form the unit.

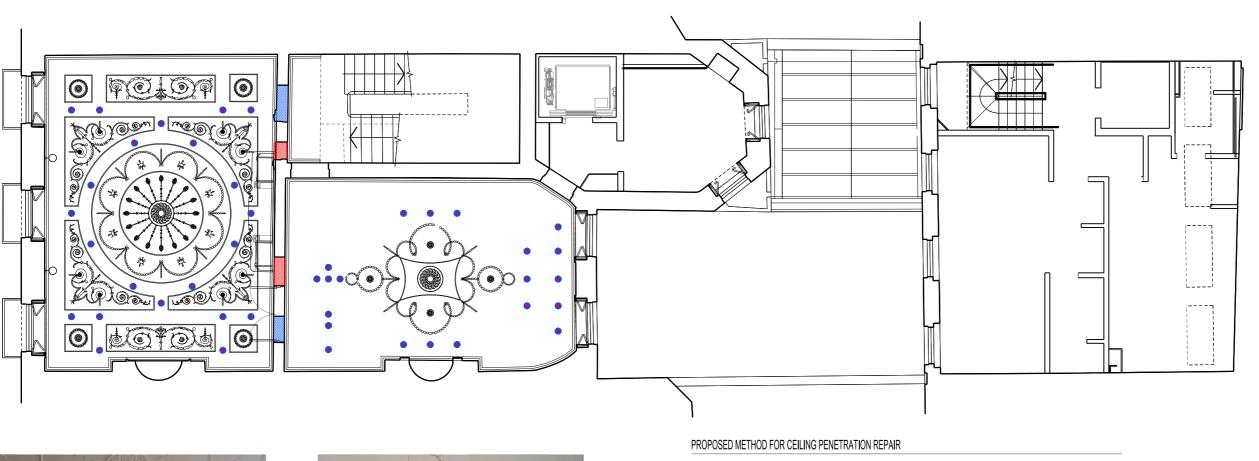
Decorative plaster ceiling to Front Reception Room to be reinstated

Lighting holes to be repaired as

Proposed repair works:

A complete damage assessment and work proposal will be made by a Specialist and approved by the Architect.

Repair damaged laths with new pieces to match exisiting. Screw new pieces using brass or stainless steel screws and washers
