**Project:** 4 John Street, London  
**Applicant:** James Moores

## 1.0 Introduction

- 1.1 This Supplementary Heritage Impact Statement is to be read in conjunction with the Heritage Statement dated 03.03.2020 submitted with the application for listed building consent for façade repairs at 4 John Street.

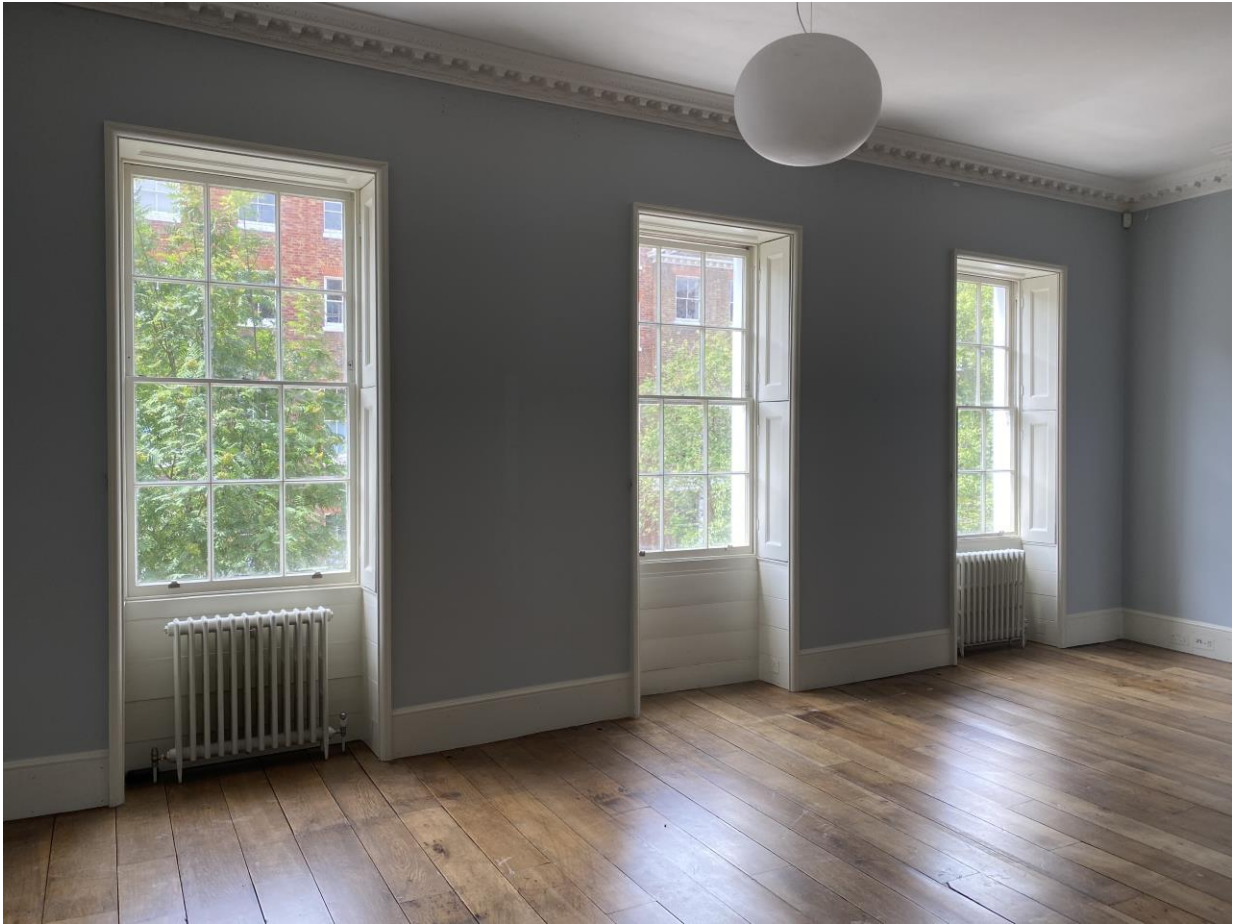
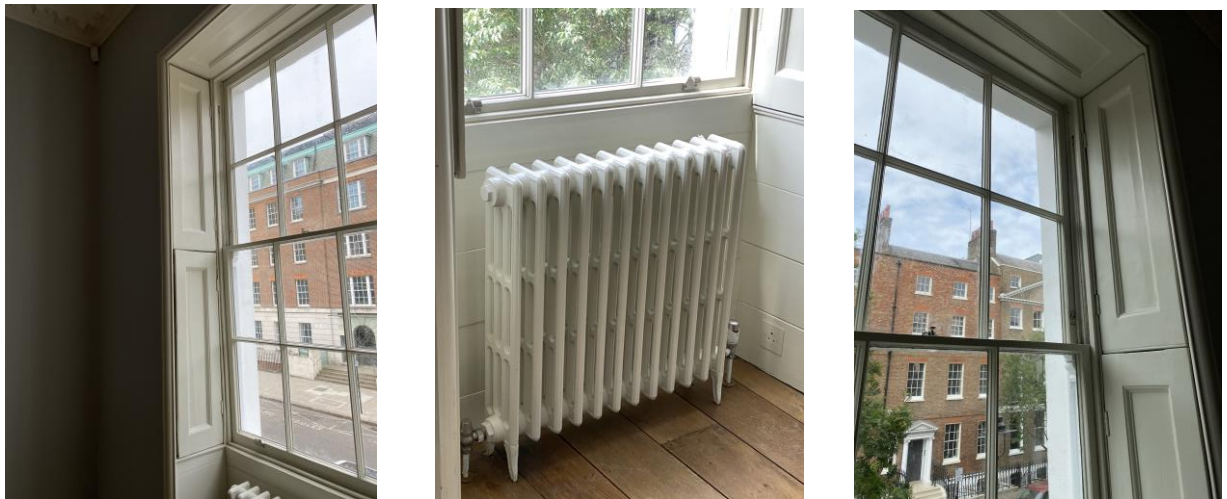
4.3 **First floor drawing room.** Lath and plaster ceiling; painted plaster walls; modillion cornice; three 6/6 double hung sliding sash windows; ovolo moulded panelled shutters and soffits; boarded recess down to floor; ovolo moulded architraves; bead moulded skirting boards; butt-jointed oak floorboards; cast iron column radiators in two window recesses.

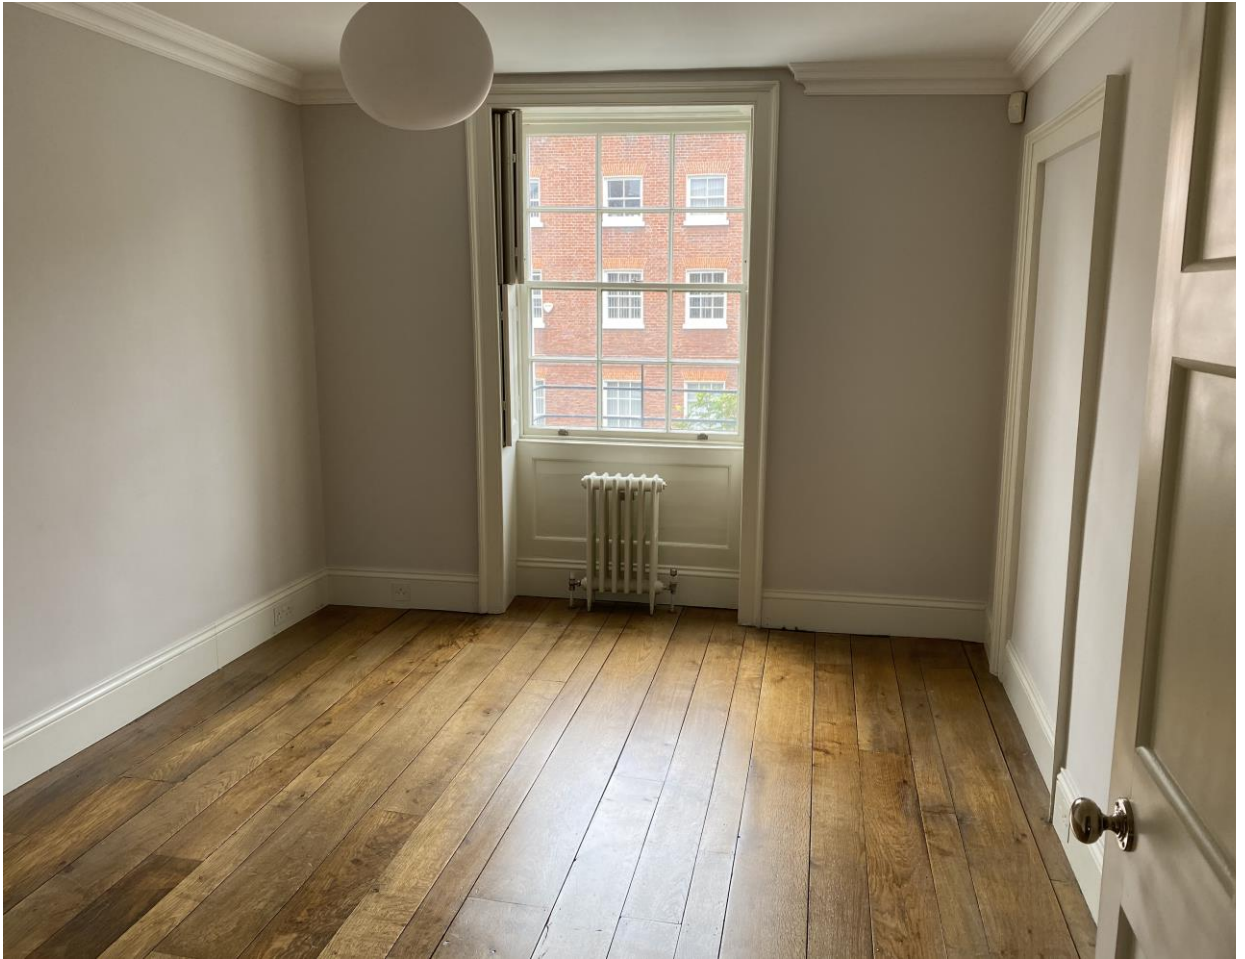
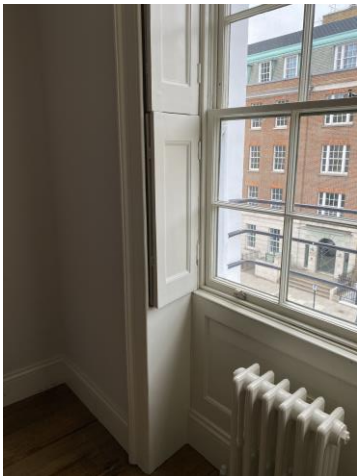
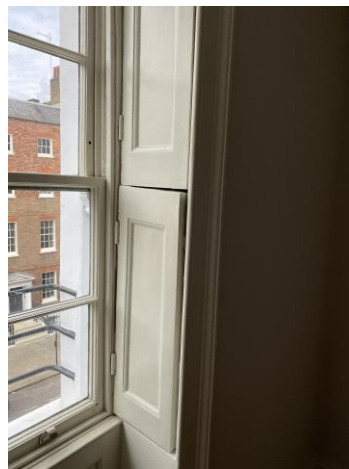
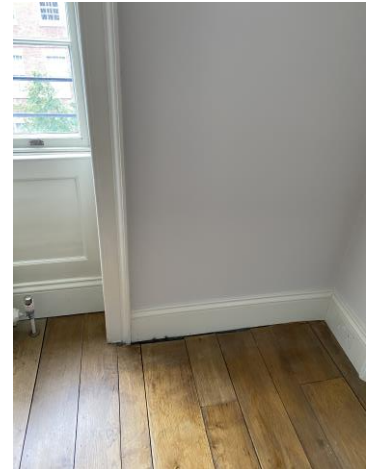
- 4.4 **Second floor bedroom.** Lath and plaster ceiling; painted plaster walls; moulded plaster cornice; 6/6 double hung sliding sash window; ovolo moulded panelled shutters, soffit and recess down to floor; ogee moulded architraves; ogee moulded skirting boards; oak floorboards; cast iron column radiator in window recess.

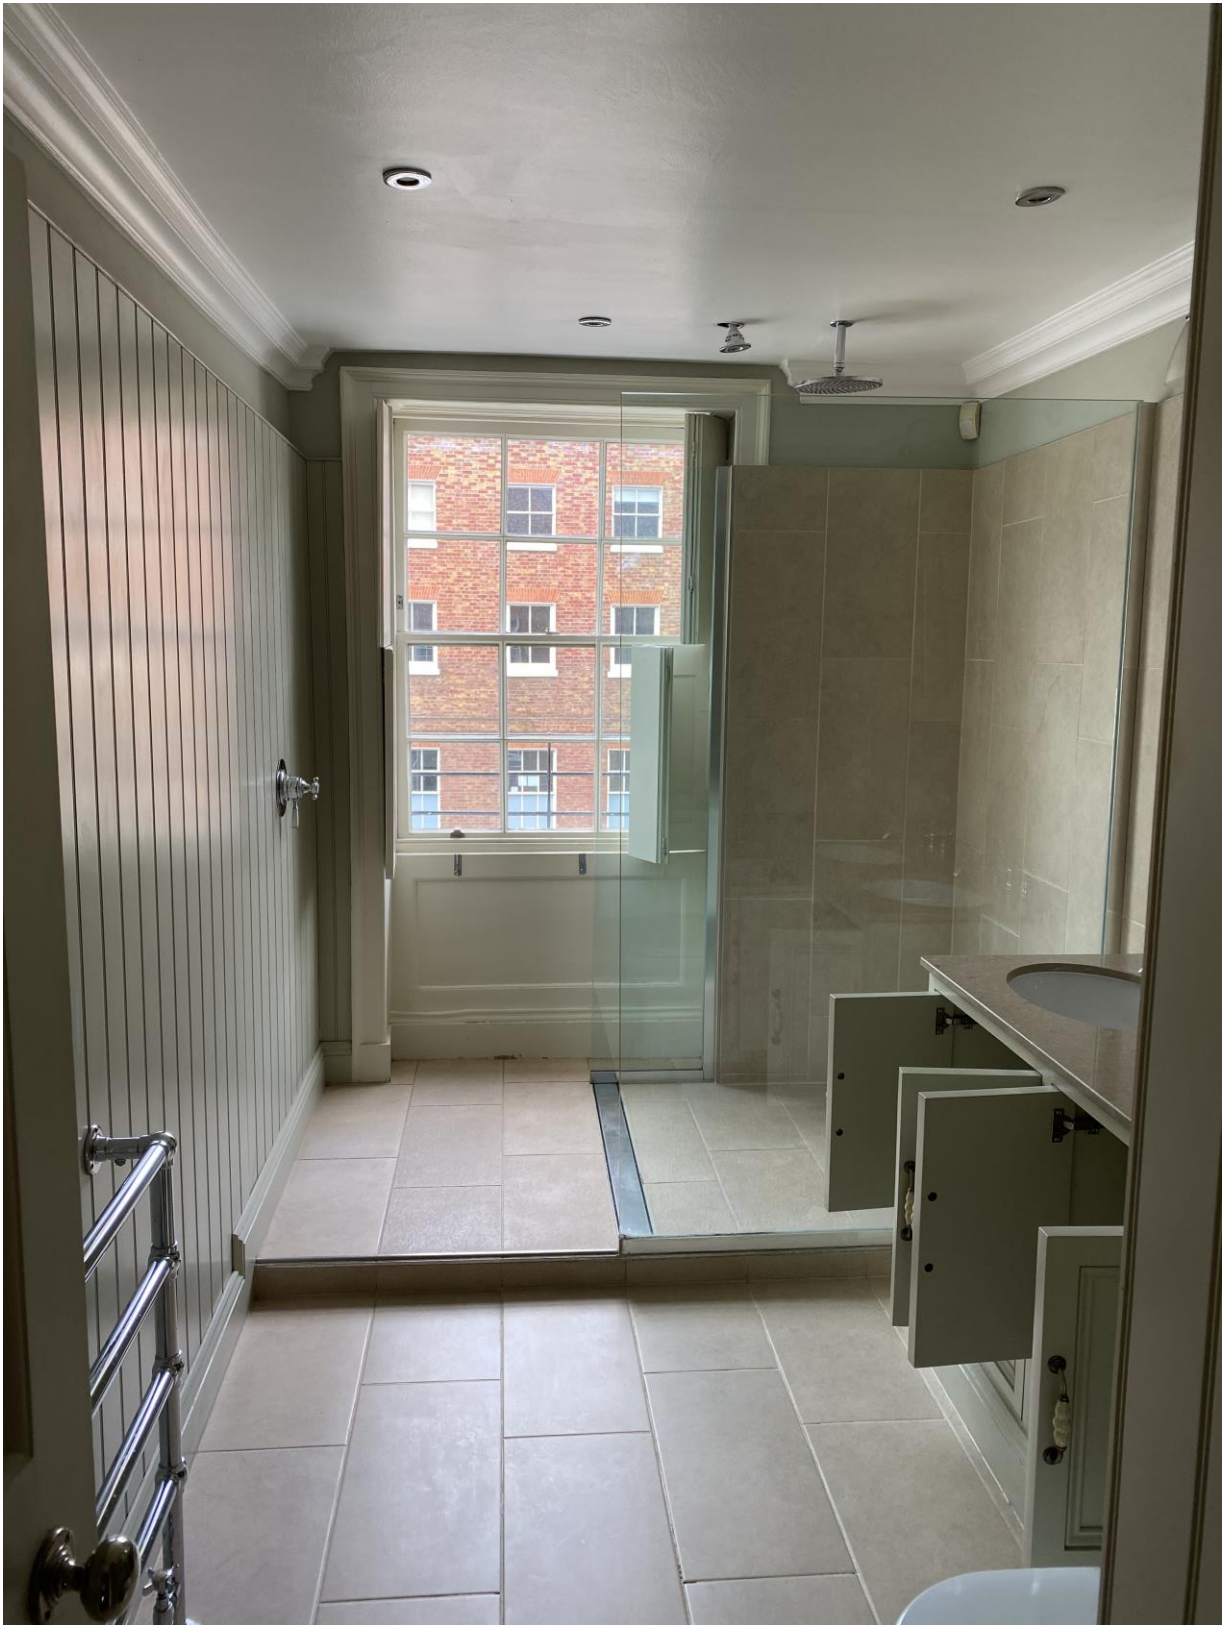
4.5 **Second floor bathroom.** Lath and plaster ceiling; painted plaster walls; moulded plaster cornice; 6/6 double hung sliding sash window; ovolo moulded panelled shutters, soffit and recess down to floor; ogee moulded architraves; ogee moulded skirting boards; ceramic tile floor.

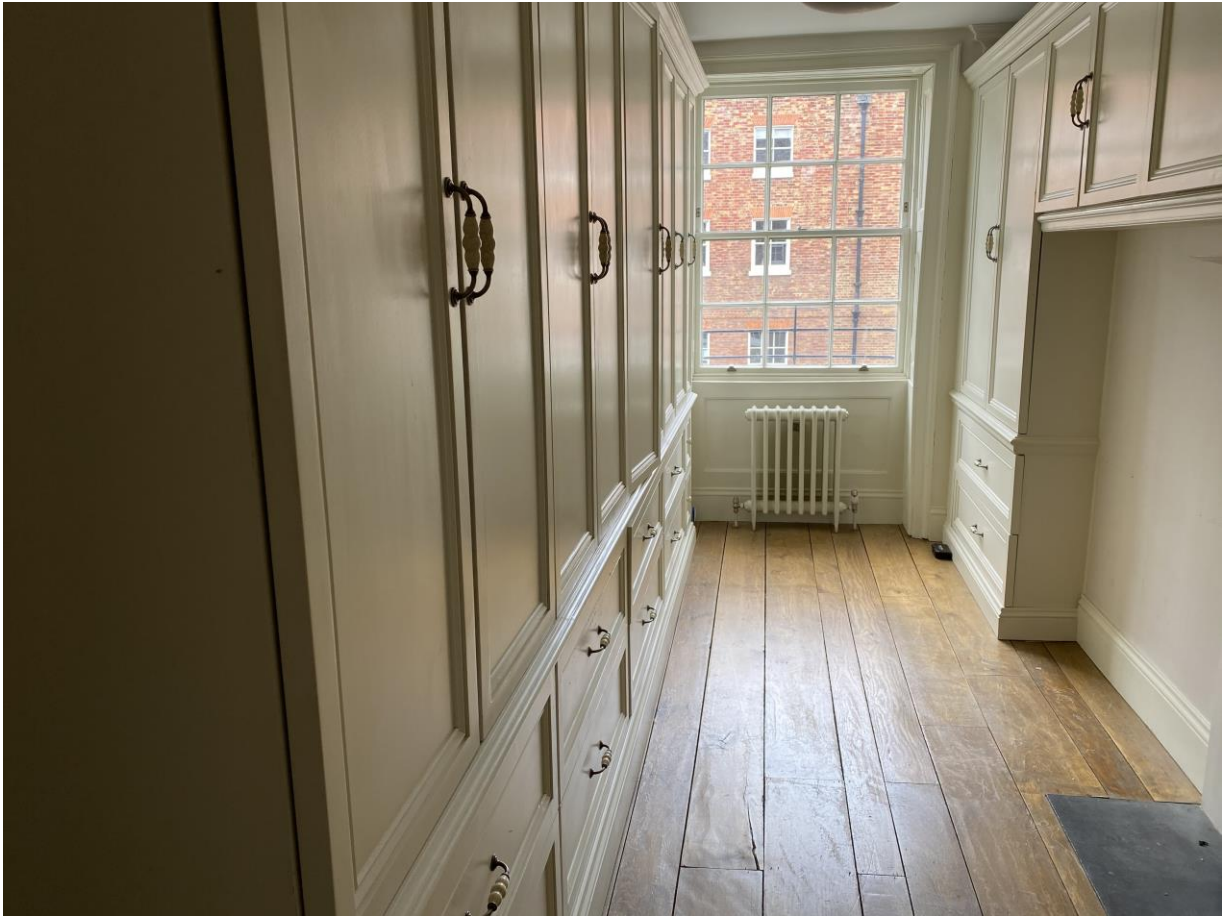
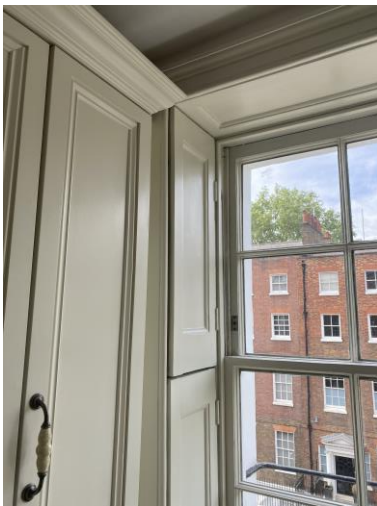
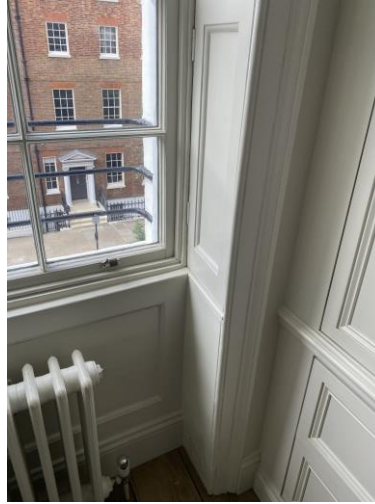
4.6 **Second floor walk-in wardrobe.**

Lath and plaster ceiling; painted plaster walls; moulded plaster cornice; 6/6 double hung sliding sash window; ovolo moulded panelled shutters, soffit and recess down

to floor; ogee moulded architraves; ogee moulded skirting boards; oak boarded floor; cast iron column

radiator in window recess; fitted wardrobes.

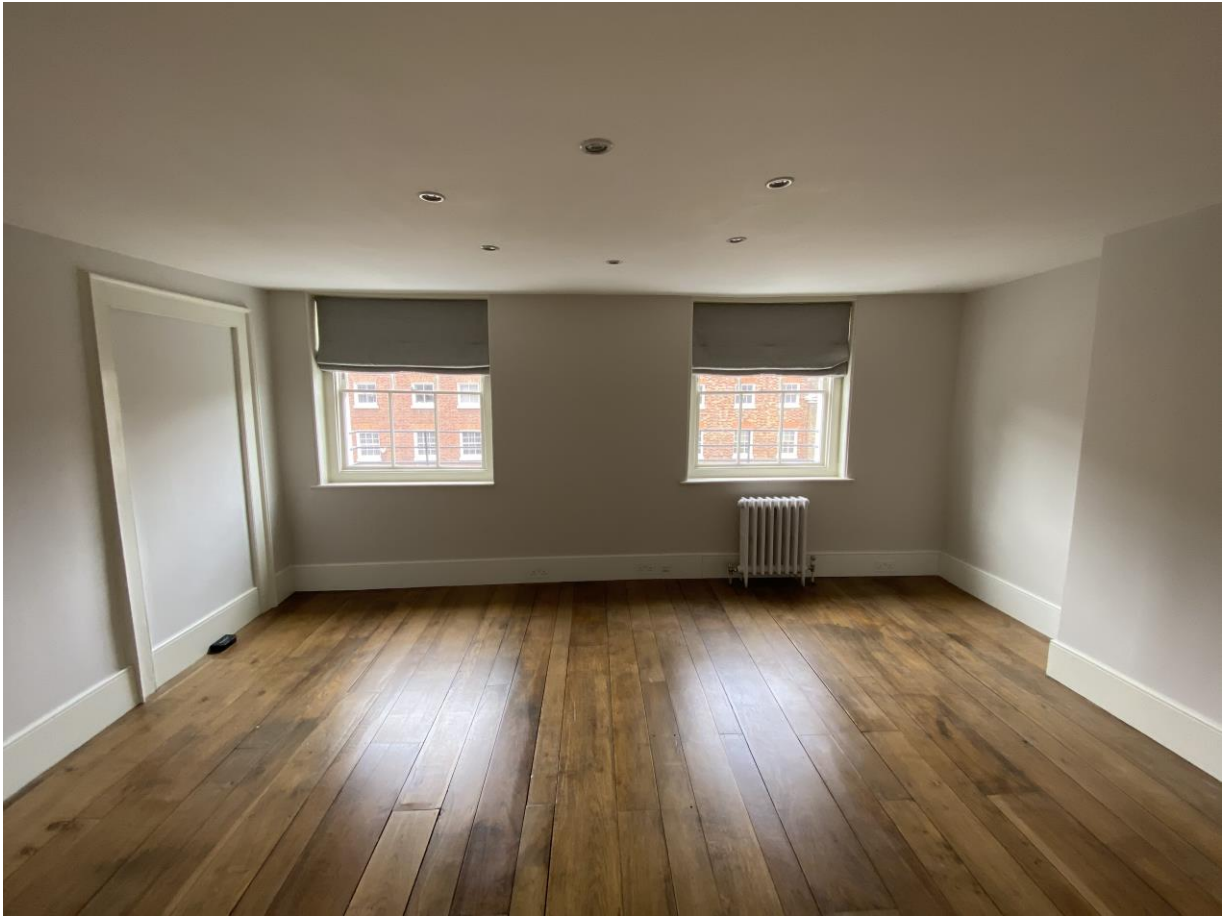
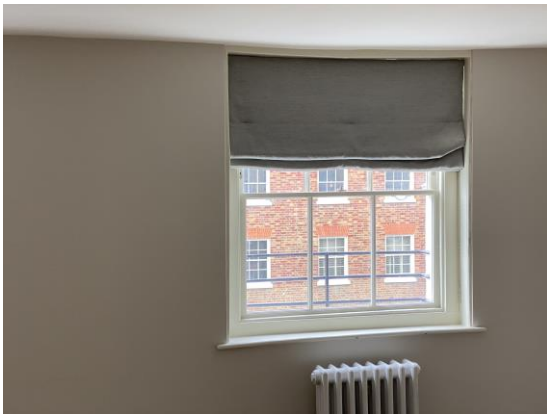
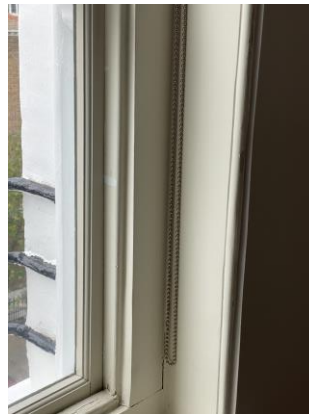
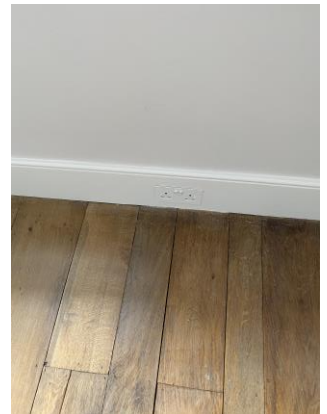
- 4.7 **Third floor large bedroom** Lath and plaster ceiling; painted plaster walls; 3/3 double hung sliding sash window; roll bead moulded lining and soffit; bullnosed window board; bead moulded skirting boards; oak boarded floor; cast iron column radiator below window.

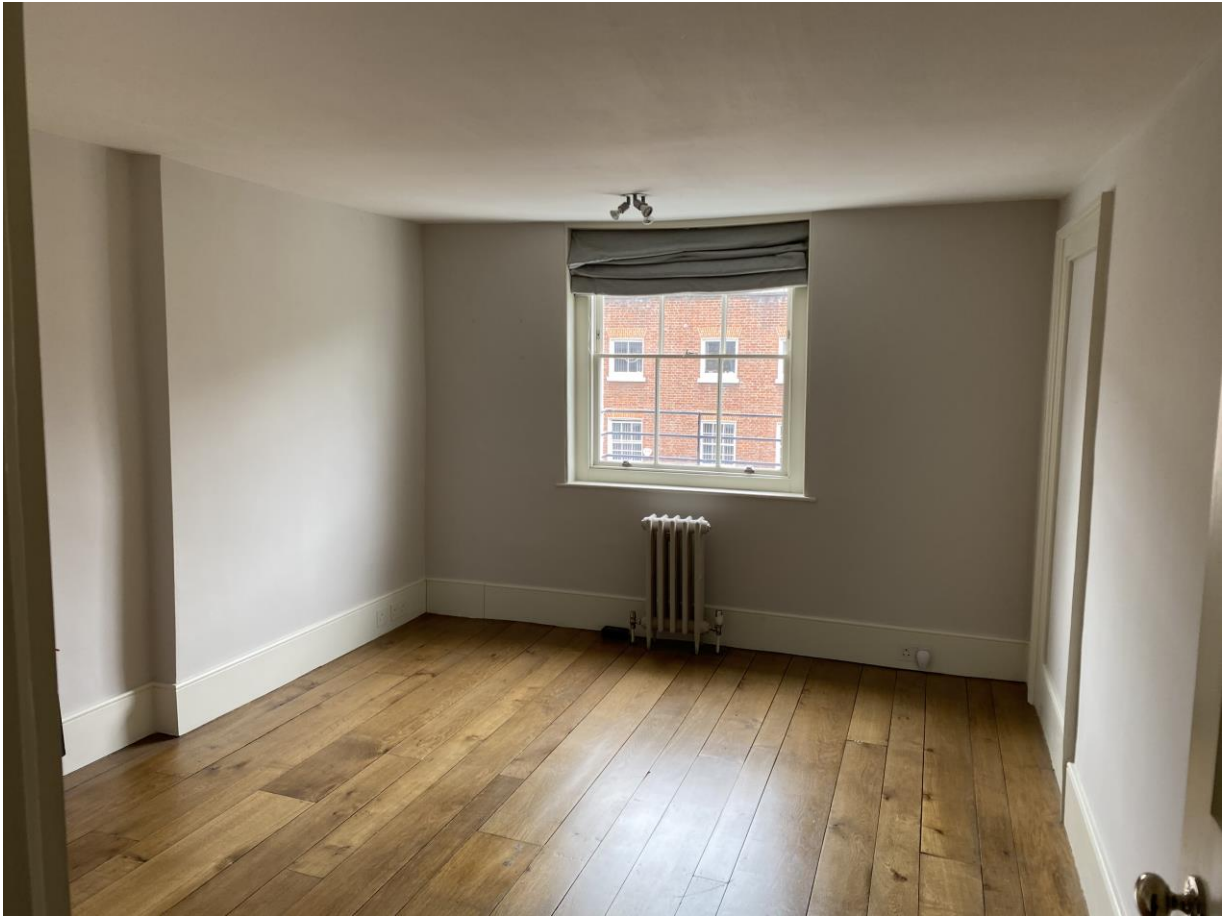
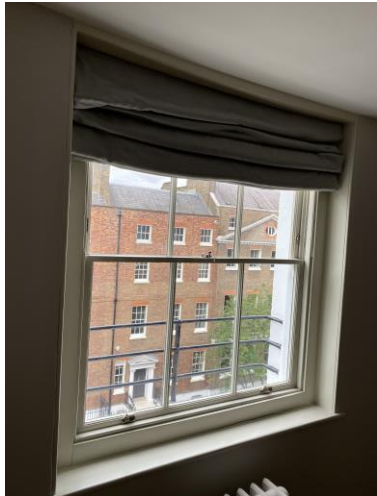
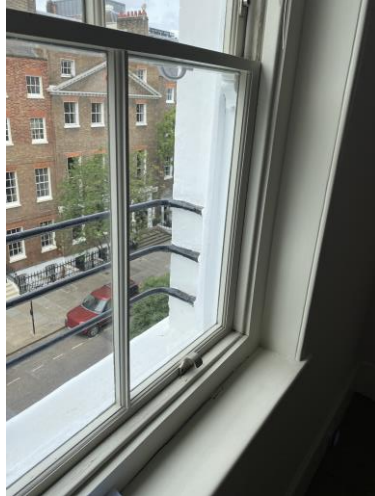
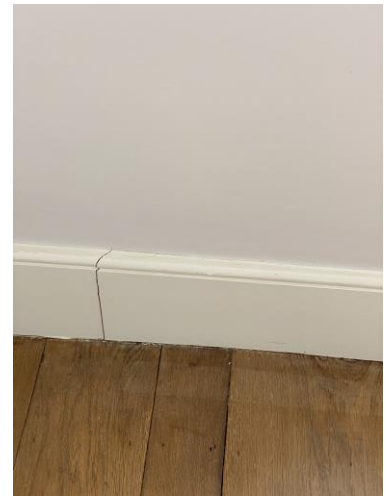
- 4.8 **Third floor large bedroom** Lath and plaster ceiling; painted plaster walls; 3/3 double hung sliding sash window; roll bead moulded lining and soffit; bullnosed window board; bead moulded skirting boards; oak boarded floor; cast iron column radiator below window.
