Lighting Strategy Victoria House Heritage Areas

Issue Status: Heritage Planning Permission

Project Number: 0987
Date: 21/08/20
Client: LABS

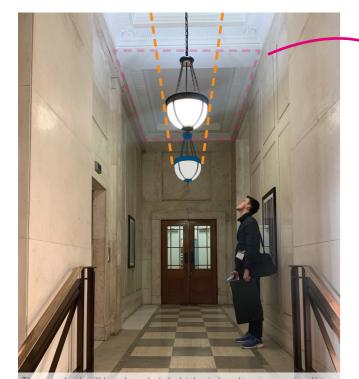
The pendant will be placed at its historic location improving the visual aesthetic of the corridor and creating a symmetry on both side of the circulation space. The Heritage luminaire will also help to improve the overall lighting level by providing soft ambient light to the corridor.

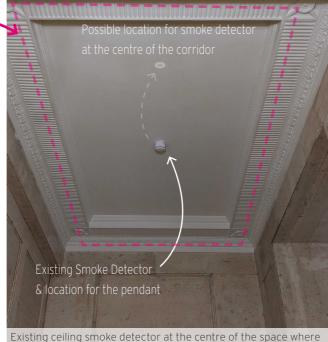
power could be taken to supply the heritage luminaire.

Additional work to the ceiling must be done in order to anchor the pendant at the middle of the soffit and at the same time to re-locate the smoke detector to centre of the hallway for safety

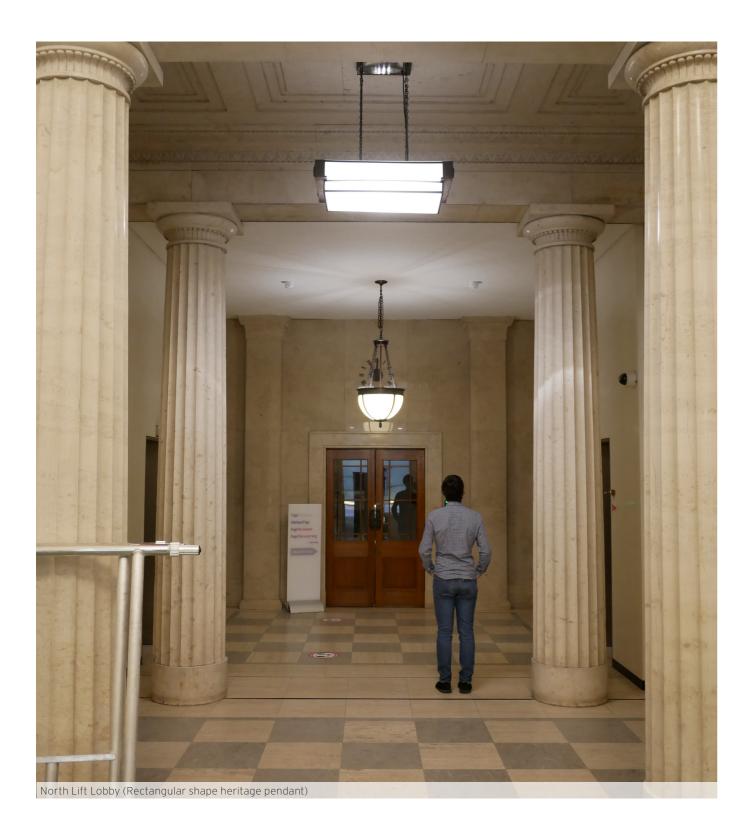
To be restored to its historic nature

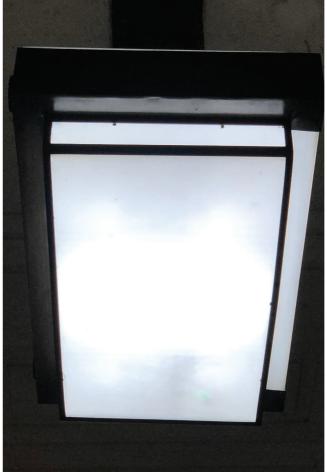
Rectangular Pendants North and South Ground Floor lift lobby

The existing heritage luminaires were initially refurbished were possible utilising modern LED light source in 2017. The new lighting scheme aim to improve/refurbish the historic luminaires in a general and minimal way focusing in the internal LED to provide a much better light quality to the space.

The front cast face of the metal frame has been cut away and a diffuser inserted, the removal of this section is crude and it has undermined the structural integrity of the fitting which accounts for the frame work appearing to be bent. This has been fitted with poor quality frosted acrylic. It is noted there are no safety cables fitted.

- A new cast section should be made to replace the section removed to restore the luminaire to its historic nature.
- The interior fixtures should be replaced with new 2700K LED striplights.
- The diffusers should be removed and fitted with a quality opal acrylic.
