6.0 IMPACT ASSESSMENT AND PROPOSAL JUSTIFICATION

- 8.1 The proposed works aim to improve the internal and external conditions of 14 Endsleigh Street, while preserving the historic character of the site. As such, the majority of the design proposals comprise internal works to update the current use of the building for contemporary private residential use.

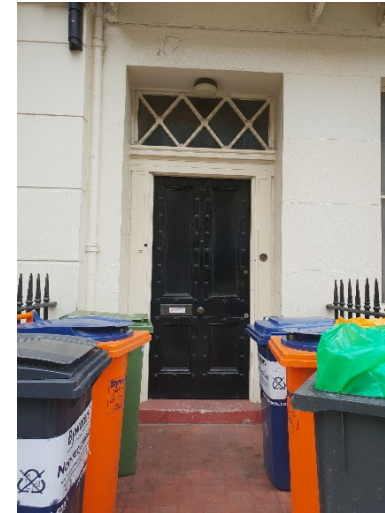
Existing red quarry tiled paving leading to main entrance
basement entrance

- The raised paved area connecting the pavement to the ground floor entrance will be re-tiled (replacing the modern red quarry tiles with something more sympathetic in appearance), and ramped gently from the landing area adjacent to the new platform lift, to ensure a level access threshold at the front door.

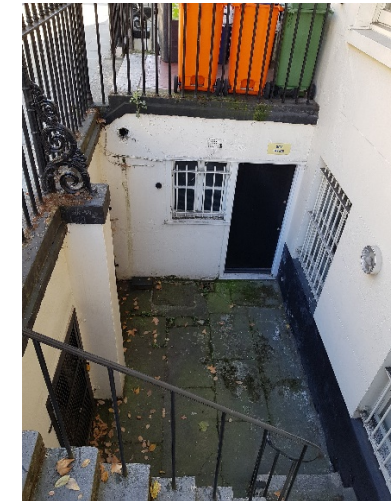
Existing modern door and sidelight to
basement entrance

- The entrance door and sidelight from the basement courtyard into the property will be replaced with a wider door. The existing door is not original, probably dating from the late 20th century.

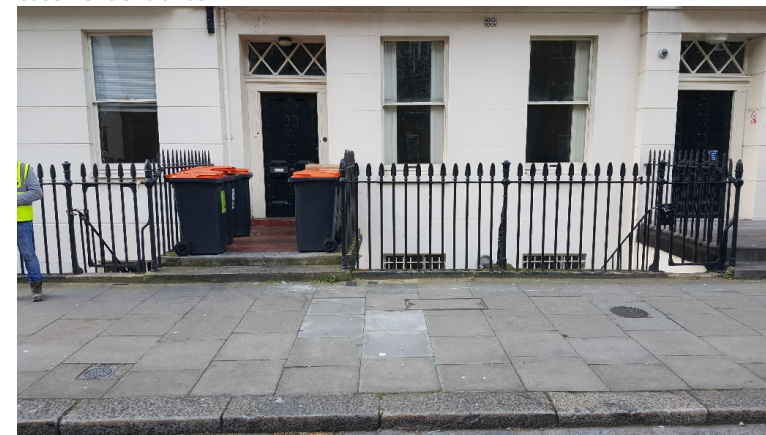
Existing iron railings and differing levels to be altered to provide wheelchair access

- The railings around the basement courtyard to the street elevation will be altered. Two sections of the iron railings will be carefully cut out and converted to gates, allowing access to the platform.

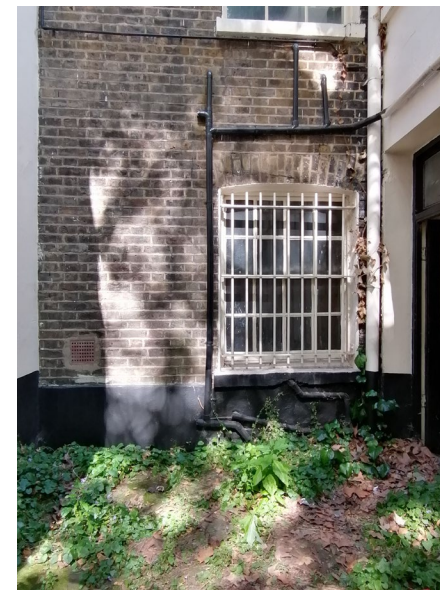
Photograph of existing modern air brick in rear elevation and drawing showing how the new extract fan will be disguised and use the existing opening

- Provision of two new wheelchair accessible toilets, one in the basement and one in the ground floor of the two storey closet wing to the rear.
- Installation of an extract fan (with attenuators to reduce the noise) to a Servery adjacent to the Business Meeting Room in the basement. The Servery will be used to 'finish' food that is mainly prepared off-site in one the University's main catering facilities in surrounding area. The extract fan will be located on the ground in the rear garden and disguised by a new timber planter and external storage facility for use by the occupants. The duct connected from the Servery to the external fan has been sized to use an existing opening in the historic external brick wall that currently houses a modern air brick approximately 250mm x 250mm. This intervention will be reversible without any damage to historic fabric, at which time a more sympathetic infill could be made.

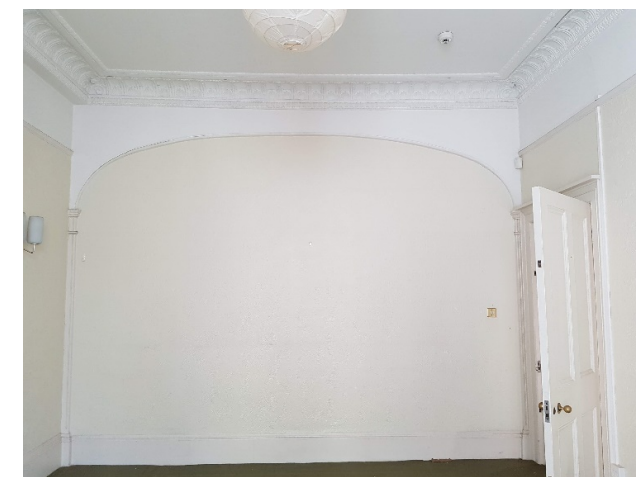
Photograph of the infilled arched opening in the wall dividing the two reception rooms on the First Floor

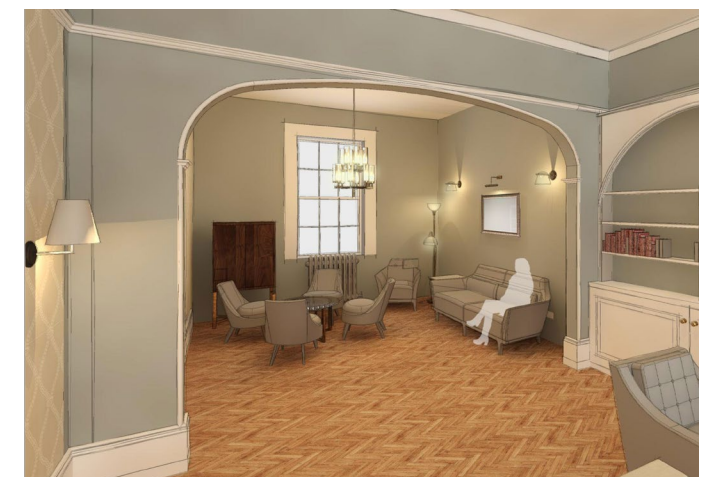
Visualisation of the proposed opening between the two reception rooms on the Ground floor using a flat arch to reflect the existing form in the photograph above

6.3.2 The only proposed intervention at ground floor level that removes historic fabric, is to enlarge the opening, which is currently a servery hatch to form a large arched opening connecting the two spaces. The servery hatch is clearly a modern addition, which dates the use of the rear room as a kitchen to the 20th century. This is not in keeping with the use or character of the rooms either side. Whilst it involves some loss of fabric, the change will enhance the reading of the two spaces, as entering the rear room is currently via the rear section of the hall, which can only be accessed through a very narrow gap between the bullnosed bottom step of the stairs and internal wall.

The new opening will permit the rooms to function together, but as two distinct spaces with differing characters, in what could be seen as a contemporary interpretation of the rooms' original function – a restoration of use. The lost fabric is of low material significance, its value being in its room bounding capacity, which the proposed alteration can also offer. The arched form of the proposed opening is inspired by a similar arched opening on the first floor which previously joined the two main rooms on that floor but has subsequently been in-filled (see photo overleaf). The downstand and nibs formed either side of the arched opening will allow the original plan form to be clearly read.

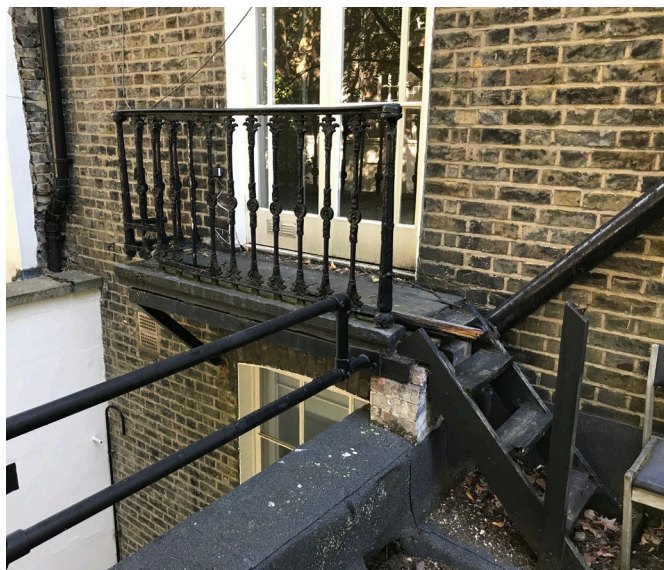
Photograph of current Juliette balcony WITH modern timber alterations and metal balustrade to parapet

6.4.3 At the back of the rear room French Windows currently lead out to a Juliette balcony and beyond that, via a rather poor and awkward modern timber addition, to the roof of the two storey closet wing, which has clearly been used as an outdoor roof terrace. An earlier proposal sought to rebuild the balcony and steps to provide safer access from the door out onto the terrace, which itself would have been improved with new surfacing and screening. Pre-application discussions with the Conservation and Planning Officers established that this current use of the roof as a terrace does not have permission and the proposal to continue the use, albeit with improved and safer access, would be resisted. This proposal has therefore been omitted from the current application but a simple reconstruction of the Juliette balcony is proposed because it is currently structurally unsound and unsafe. The proposal is to reuse the existing York Stone Slab forming the floor of the balcony but replace, on a like for like basis, the existing retrofitted steel gallows bracket and frame that supports the stone slab. The iron railings will also be replaced (they are

severely corroded and sections are missing) with new steel railings of matching profile that conform to current structural and height restrictions. This will enable the balcony to be used as originally intended. The only alternative would be to retain the existing ugly and unsafe construction in its current state and make the doors impossible to open. The terrace currently features a parapet upstand and extremely simple, utilitarian railing. Given the intricacies of the stair balustrades and railings to the first floor front balcony, this represents a poor later addition, which will be removed if consent is granted to rebuild the balcony as submitted. The roof of the closet wing (currently covered with modern roofing felt) will be resurfaced to ensure it continues to be waterproof for the next 20 years or more. A clip-on 'mansafe' harness system will be included as part of the re-roofing works to enable safe access for future maintenance. This will have minimal visual impact and will be lower than the parapet.

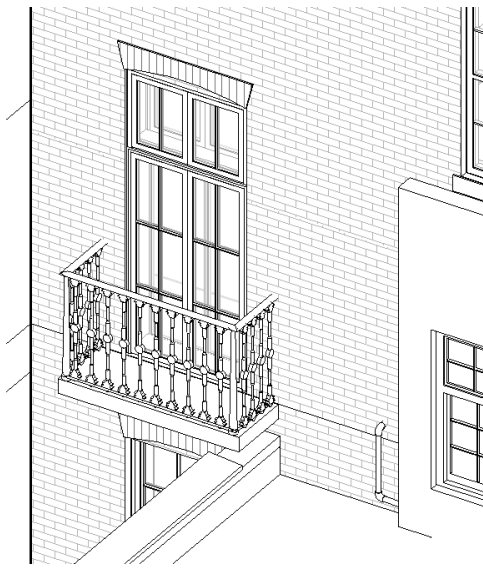
Sketch drawing of proposed replacement balcony

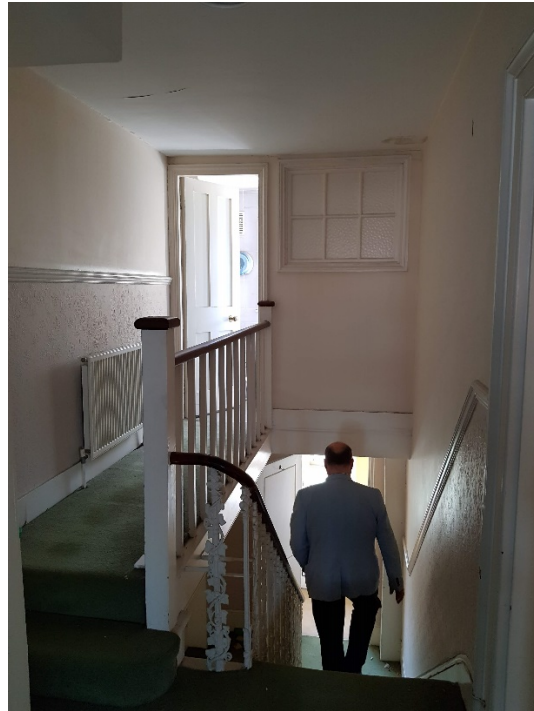
The third floor return landing

- 6.6.6 It is proposed to replace the balustrade to the return landing using matching spindles at compliant spacing and re-using the existing handrail, but at a compliant height.

- 6.6.6 The balustrade to the return landing, and the final flight of stairs up to the fourth floor, are of low significance compared with the main stairwell. Apart from removal of the unsightly services boxing, no changes are proposed.

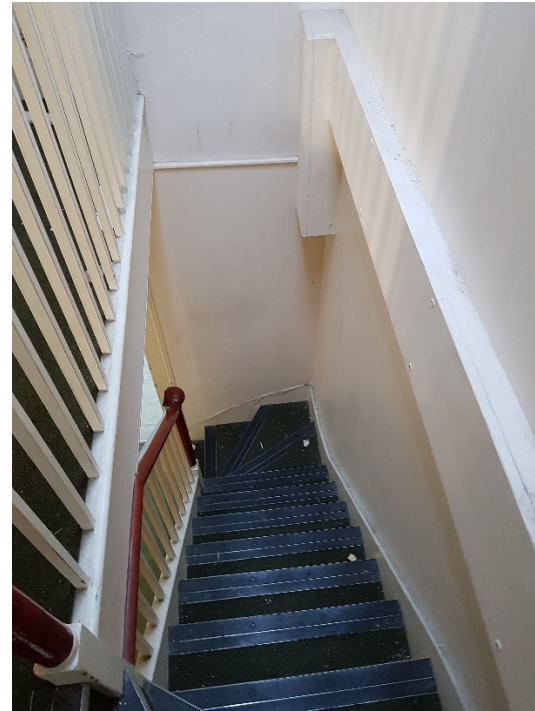
The final flight of stairs leading to the fourth floor, viewed from the top

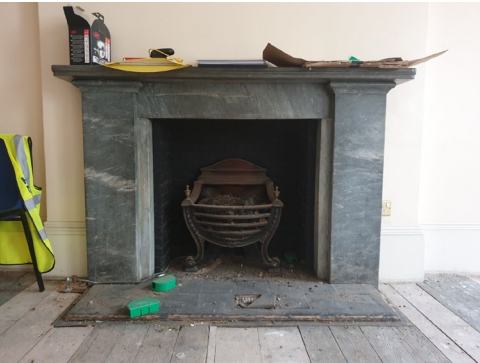
Grey marble surround on ground floor

The existing fireplaces are generally in good condition and will be preserved as historic features of the building. The surrounds become less elaborate and use simpler materials as one rise up the floors, with marble on the ground, first and second floors and timber on the third floor.

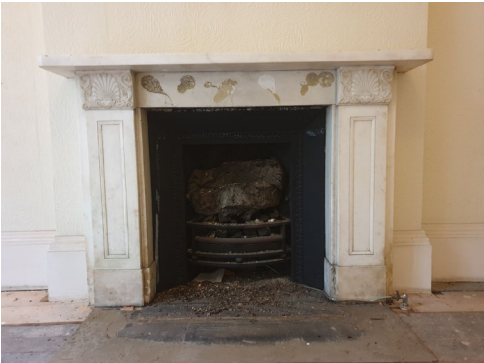
Carved white limestone surround on first floor

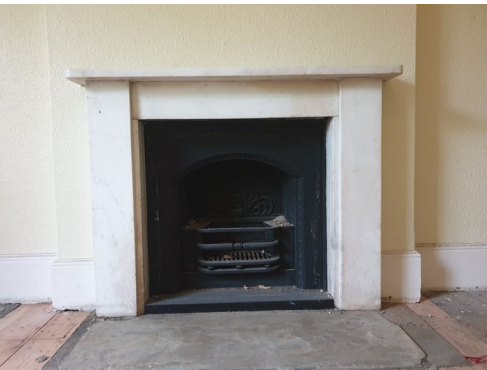
Plain white marble surround on second floor

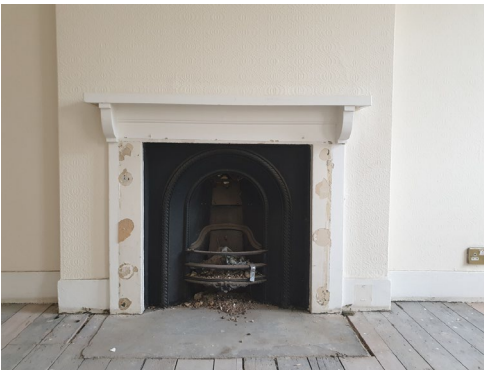
Plain painted timber on third floor with overboarding removed

The fireplaces on the third floor were boarded over but removal of this was possible with only superficial damage to the decoration, which will be made good. The basement and fourth floors do not have surviving surrounds and the fireplaces themselves have either been bricked up or masked by a new wall lining. The fireplace to the second room on the ground floor (last used as a kitchen) has also been covered up as part of the kitchen installation. When this area is uncovered a survey of what is revealed will inform the next step, but currently it is assumed that nothing remains and a new fireplace is not created.

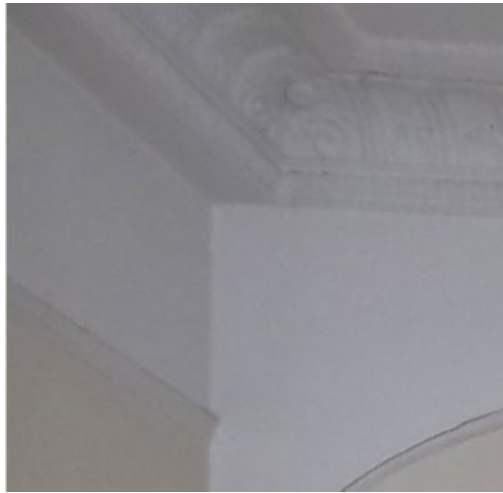
Photo of existing projected cornice detail

the historic fabric will result. Vertical risers for small pipework and cables on the first floor (in the proposed kitchen) are located to take advantage of the existing projecting cornice detail that typically would have accommodated shallow cupboards at the side of the fireplaces – see photograph and detail below.

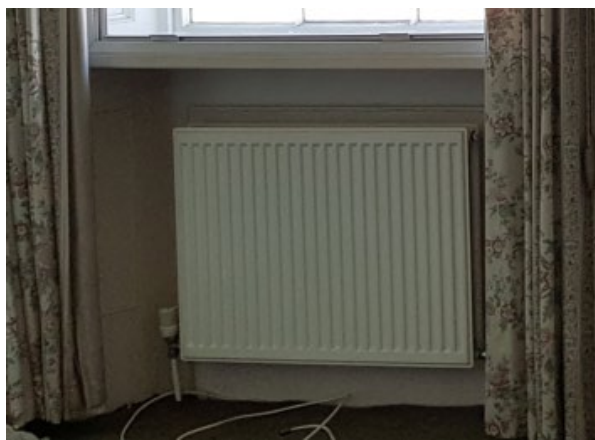
Existing radiators

The existing radiators are modern but still dated and in poor condition. The proposed replacement 'column' radiators will be more aesthetically in keeping with the age of the property.

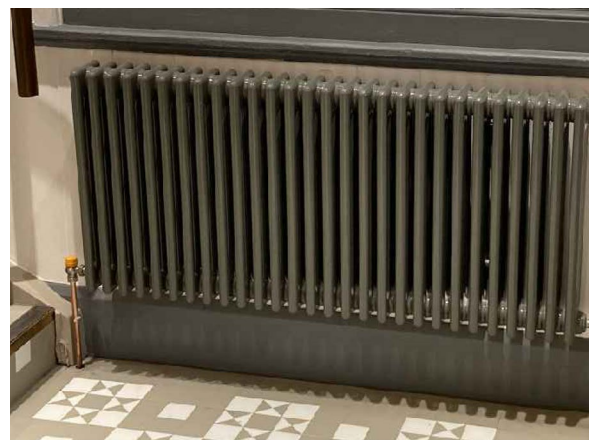
Proposed radiators

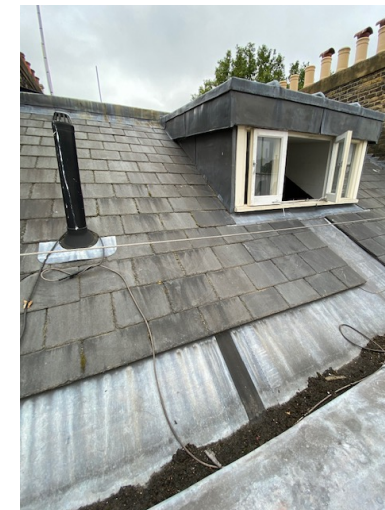
Photograph of the front section of slate roof, including the lead cladding to the dormer, the lead parapet gutter and the lead dressing over the top of parapet wall

Pre-application consent for the erection of scaffolding has enabled detail inspection of the existing roof and it was found to be in reasonable condition despite some slipped, cracked and friable slates. The proposal, therefore, is to largely retain the slate covering in place and carry out isolated replacement of damaged slates and to renew the flat section of the mansard roof by installing a new GRP covering on

The lead lined parapet gutters and abutment flashings are generally in good condition, despite evidence of several poorly executed emergency repairs on the rear elevation, where the parapet gutter has clearly failed in the past. The existing gutters and flashing will be retained unaltered but a lead dressing detail will be installed over the top of the rear parapet wall, matching the existing detail to the front elevation.

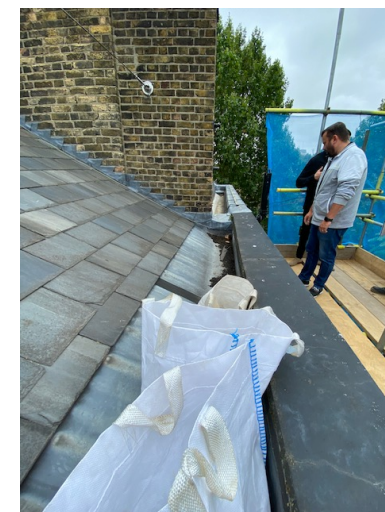
Photograph of the rear section of slate roof, including the lead parapet gutter. The top of parapet wall does not have a lead dressing unlike the adjacent property beyond and the front parapet wall
