ROSS & PARTNERS
Consulting Civil & Structural Engineers

Method Statement for the Creation of a Waterproof Basement Floor

14 Endsleigh Street

London WC1

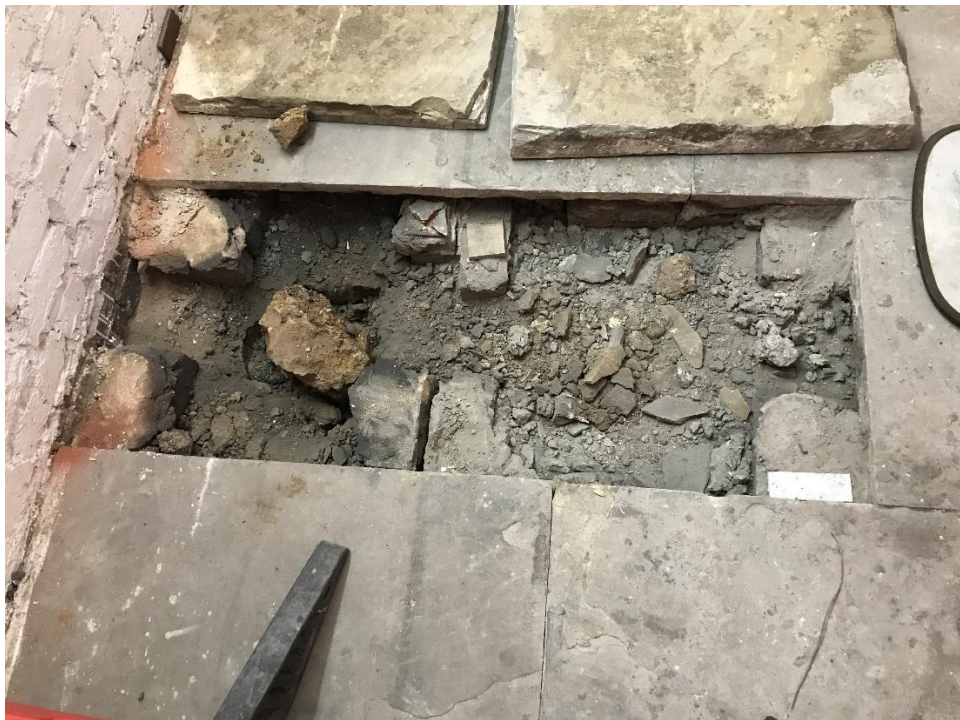
Close up Detail of the floor Construction

The existing basement floor is formed of York stone flags laid on a course of bricks leaving a cavity below. The walls and floor are damp, the underfloor cavity prone to rats. In order to provide an healthy environment and provide a floor construction in accordance with Part C of the Building Regulations, it is proposed the existing flagstones will be carefully lifted, temporarily stored on site and reinstated on completion of the new basement floor construction.

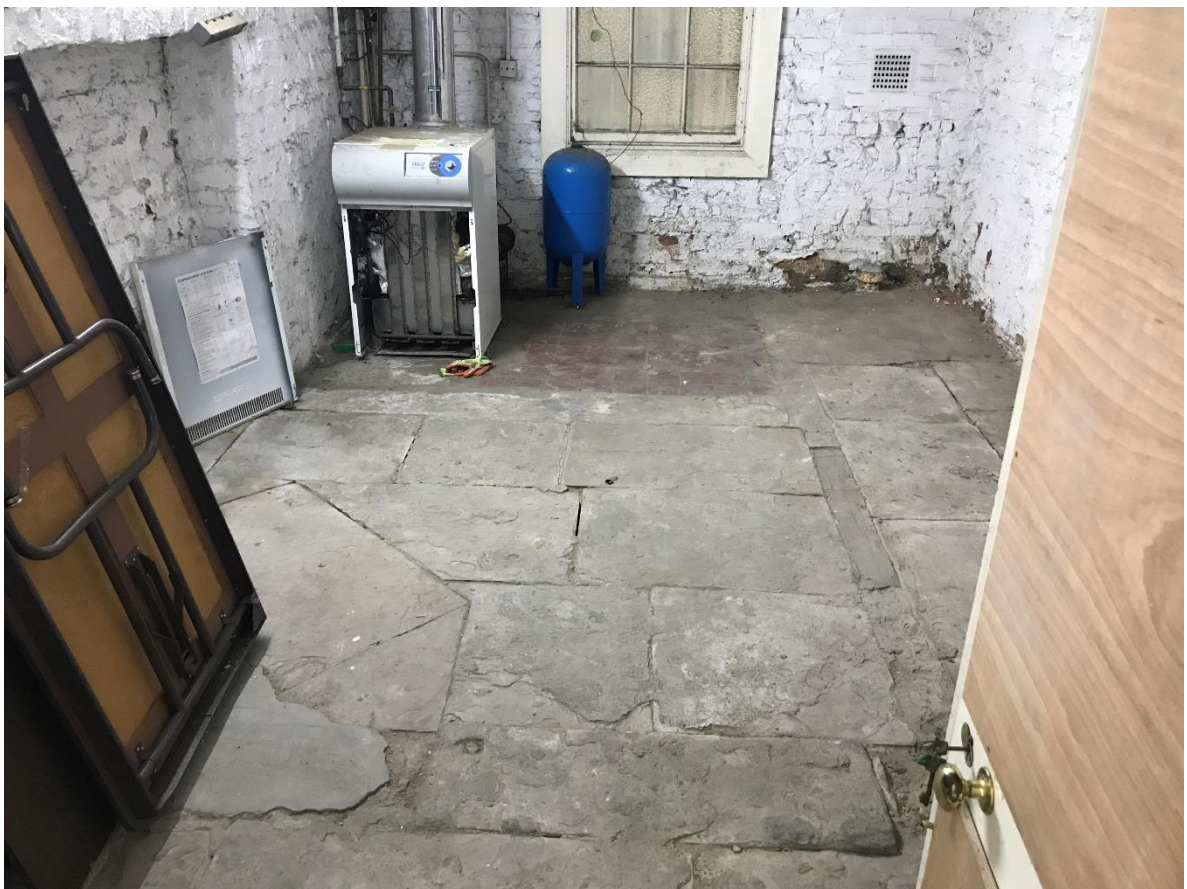
On a room by room basis, each stone is to be given a unique reference number that will define its existing position. The reference number will be marked upon the stone with chalk and upon a reference drawing. The room will be photographed. Each stone is to be visually surveyed to record existing condition and damage.

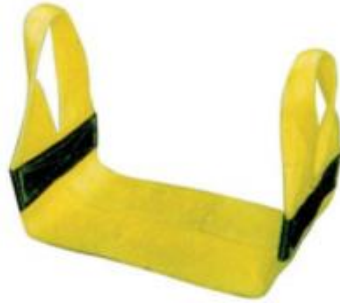
The existing stone will be carefully lifted by hand. This will require the attendance of two operatives and a supervisor. The voids beneath the stones enable the operatives to slide two nylon lifting slings beneath each stone and manually lift out of position. This activity has already been successfully achieved on site. The stones nearest the garden shall be lifted first working gradually towards the front of the building.

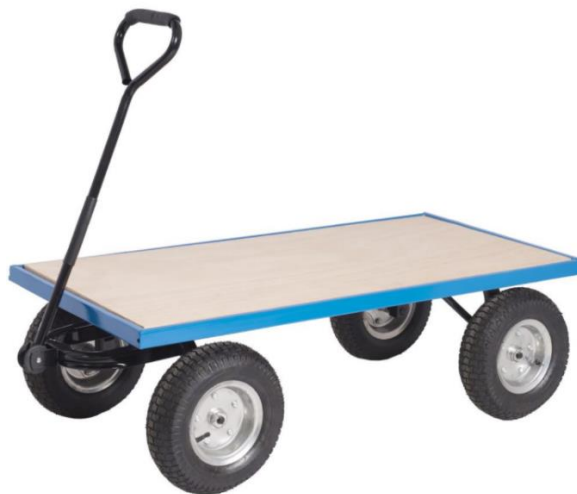
The stone will then be laid on a four pneumatic wheeled flatbed trolley and moved into the garden area for temporary storage.
