# Koko Refresh and Renew, 1a Camden High street, London nwi 7je

Planning Application  
September 2020

DESIGN & ACCESS STATEMENT

Job No: KKC Fire Reinstatement and refresh and Renew works  
Job: Koko + Hope & Anchor, 1 Bayham St and 65 Bayham Place  
Date : September 2020  
Revision: A

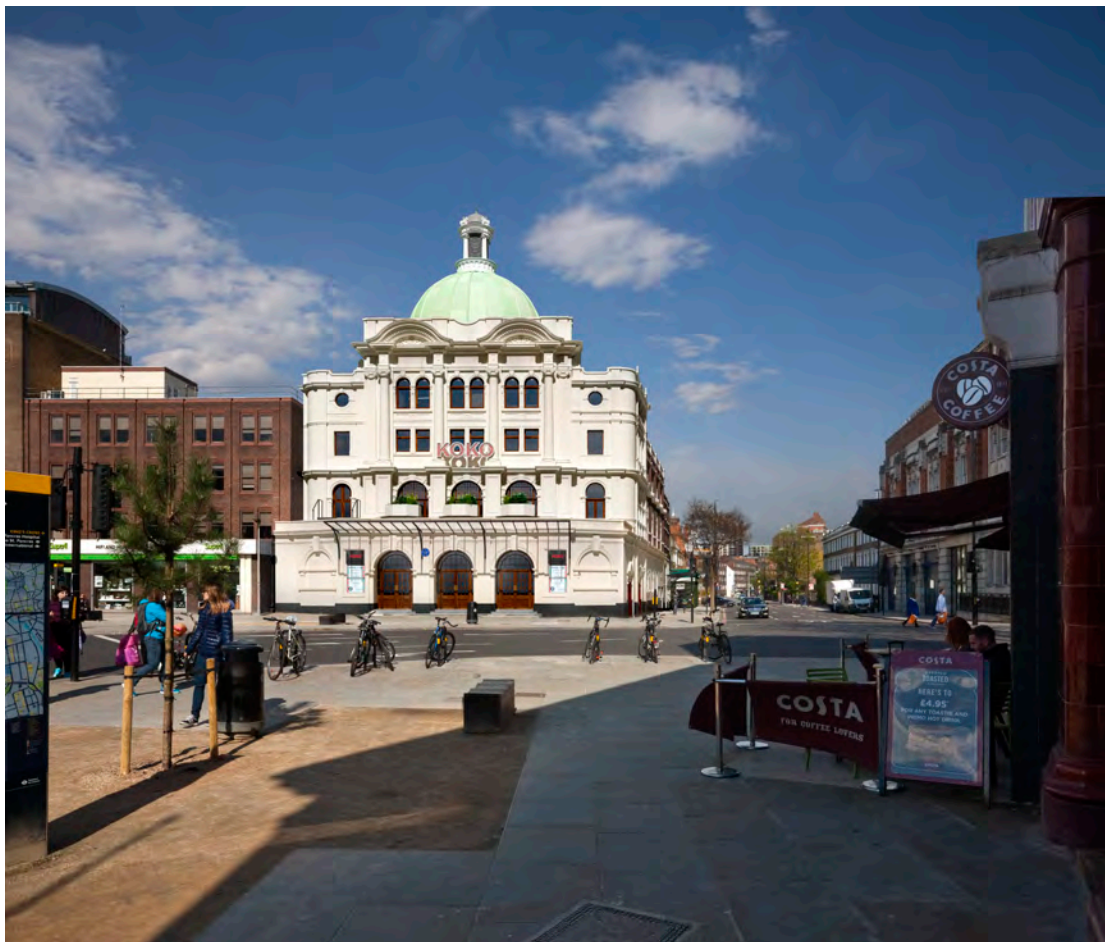
Image 1: Indicative Proposed View 1 from Camden High Street

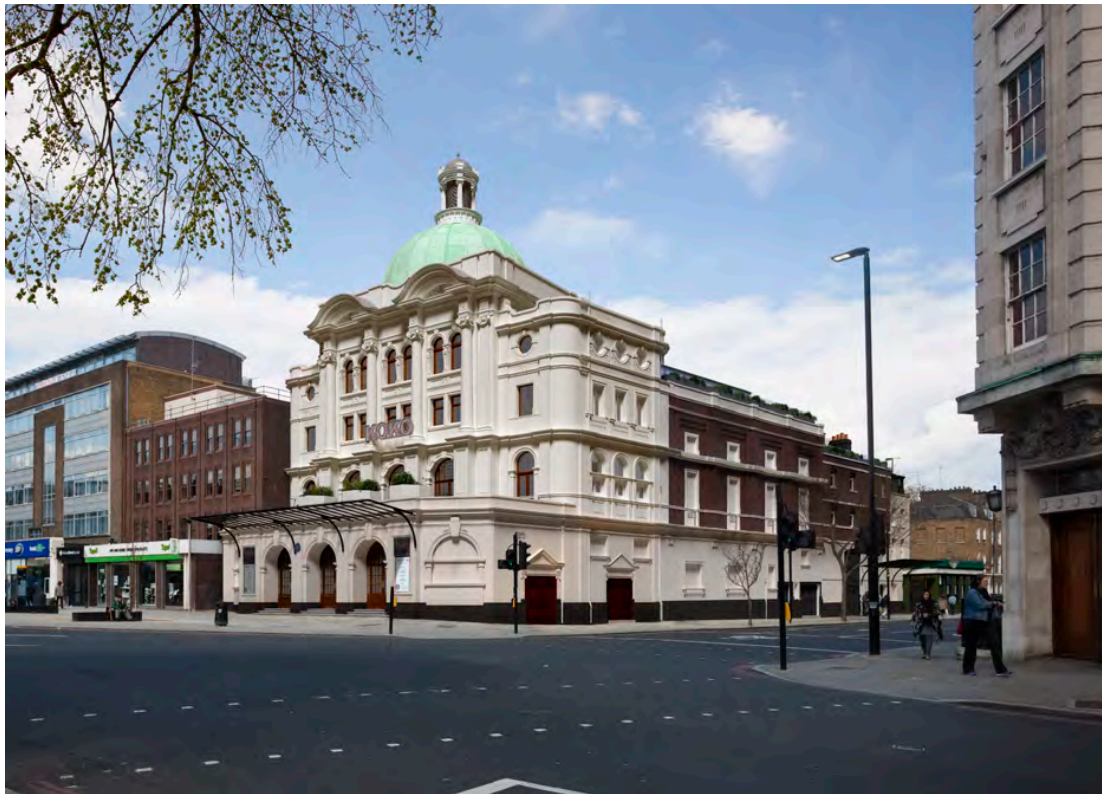
Image 2: Indicative Proposed View 2 from Camden High Street looking down Crowndale Road

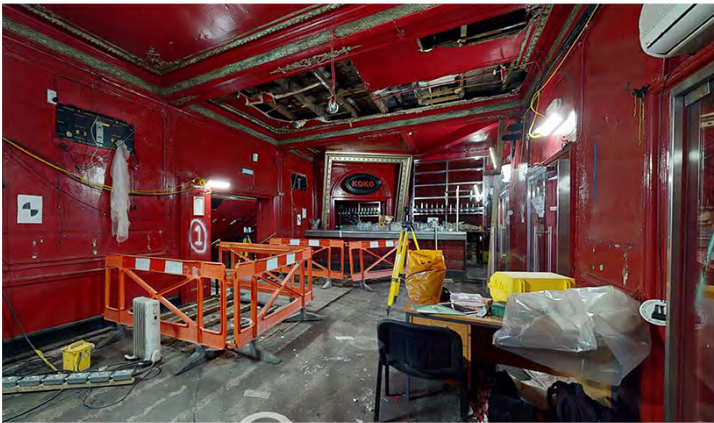
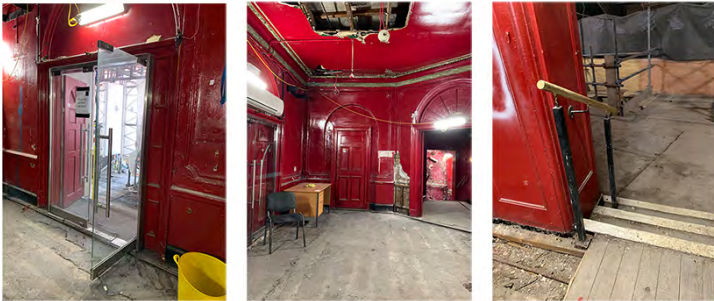
EXISTING PHOTOS  
ROOM RM 1 14

Image 09: EXISTING site photos of room 1-14

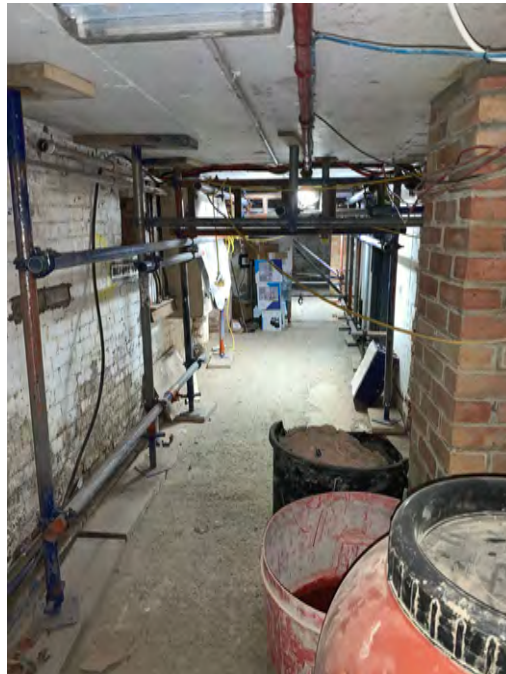
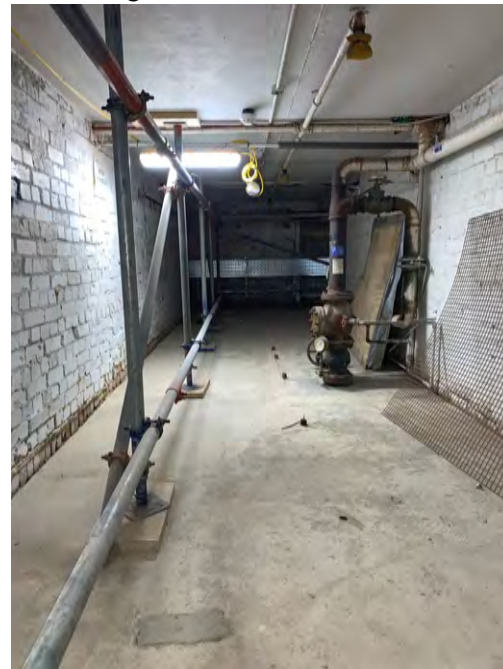
Image 12: Existing Sub-Basement

13: Existing Sub-Basement

- The lower basement is located underneath the stage. The lower basement is a low ceiling storage area and a space for services M&E (refer to images below). These spaces will contain beer barrels storage that will be chilled and dispensed from this location to basement and first floor bars and M&E services.
- The python beer pipes will travel from lower basement up into the floor void of the basement level using existing opening. These Pipes will then travel within a wall adjacent to the bar at ground. These pipes will enter a service room and travel to first floor and arrive at the back to back bar in the balcony area. These pipes will then travel within the void under the tiered ceiling, within existing openings and ceiling void to end up at the terrace bar.

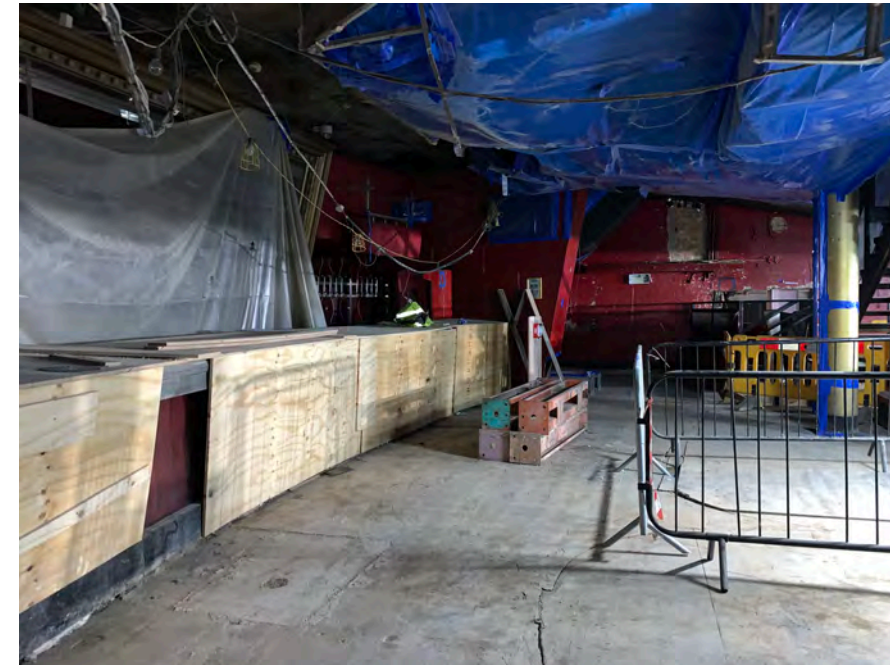
Image 14: Existing Basement photo of back bar area

- All floors, ceiling and walls that have been removed will be reinstated. The ornamental figures on columns will be protected to be repainted and restored in area of extensive damage. The back bar will be reinstated with a newly designed bar. A space adjacent to the bar area will be blocked off and allocated for washing facilities.
- A new Pizza area will be allocated adjacent to the main bar.
- Toilets will be updated and renovated.
- A large supporting kitchen will be allocated in RM B20 adjacent to the main staircase.
- In the main space in front of the stage, there will be an enclosed area allocated for sound and lighting control.

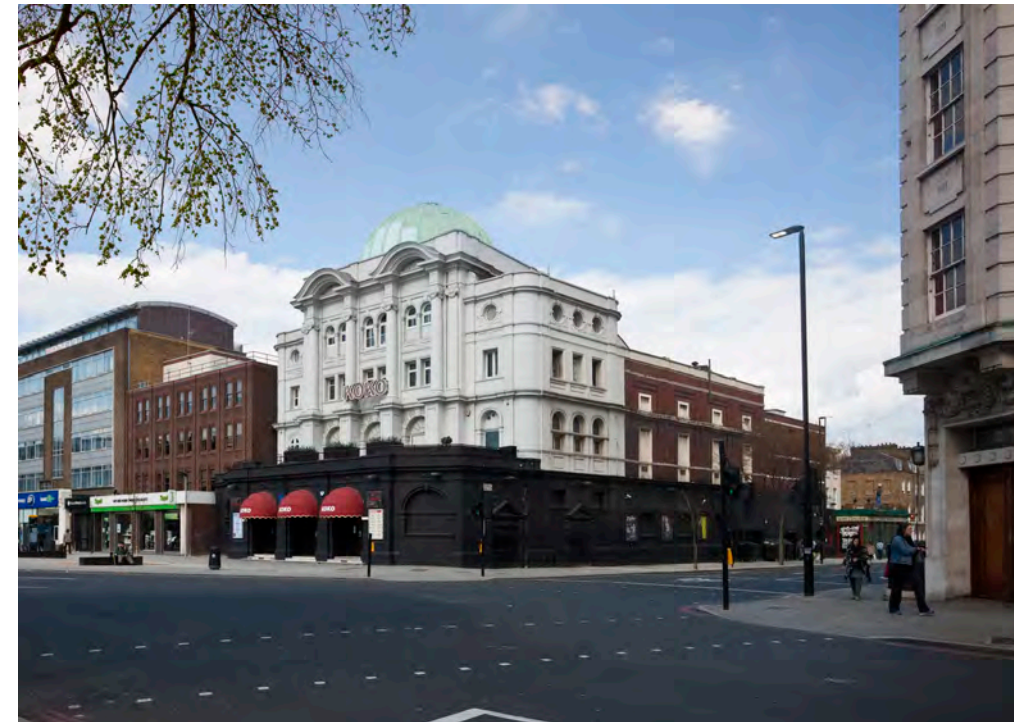
Image 18: Existing view corner of Camden High street & Crowndale Road

- The white and black paint on the Camden High Street and Crowndale Road will be removed, so that the façade can breath and dry out. The paint removal is par of the Dome application but relevant to this application as information for reinstatement. The building will then be painted of white making good a black plinth along the lower portion of the façade, please refer to the images 18 which show the existing black plinth and the proposed reinstated off white base and building in image 19.

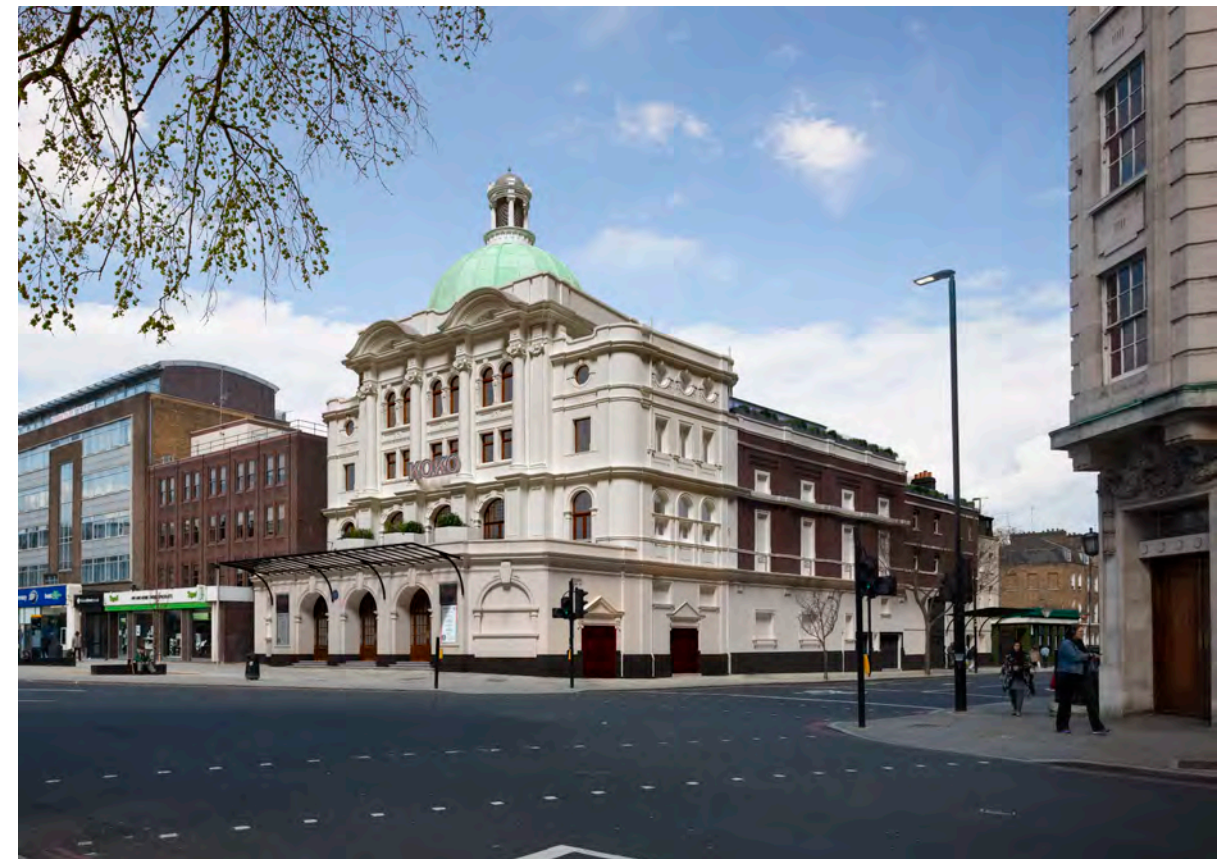
Image 19: Indicative Proposed view corner of Camden High street & Crowndale Road

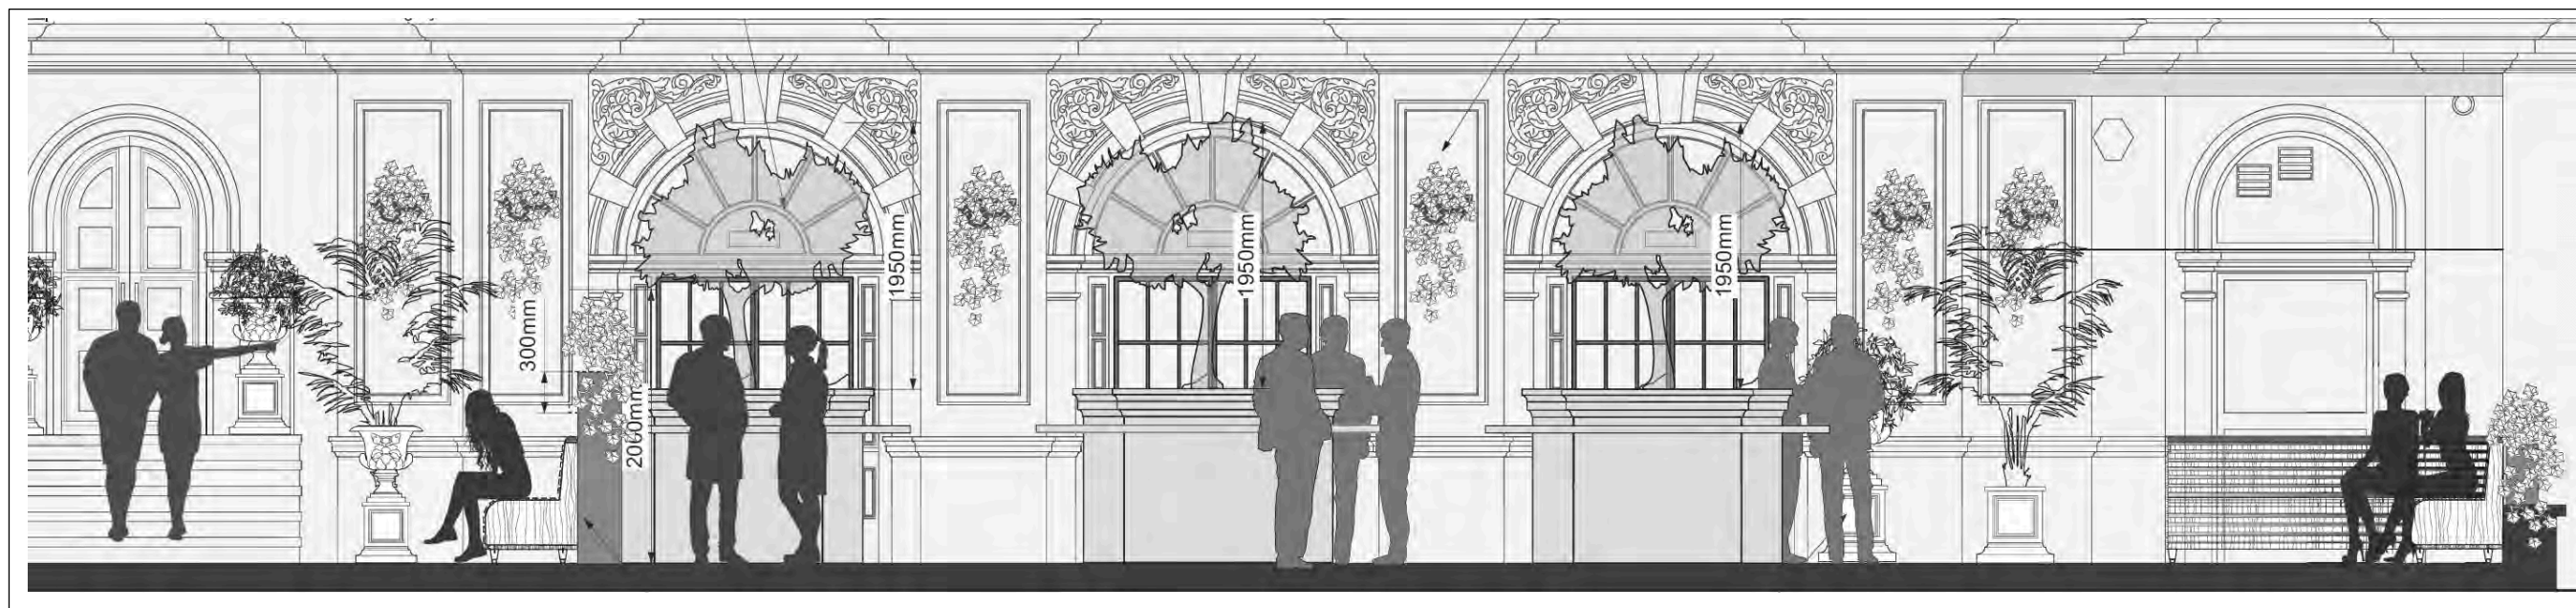
Image 20: Terrace outdoor space Redhouse

- The bar in Room 1-14 will be reinstated and upgraded with new materials and equipment.
- Room 1-14 leads out into the terrace outdoor space. The outdoor terrace proposal will have new floors installed, false trees and timber fixed seating.
