KOKO, Camden High Street

## HERITAGE STATEMENT: Baseline, Significance and Impact Assessment

Prepared for:  
KOKO, Camden

September 2020

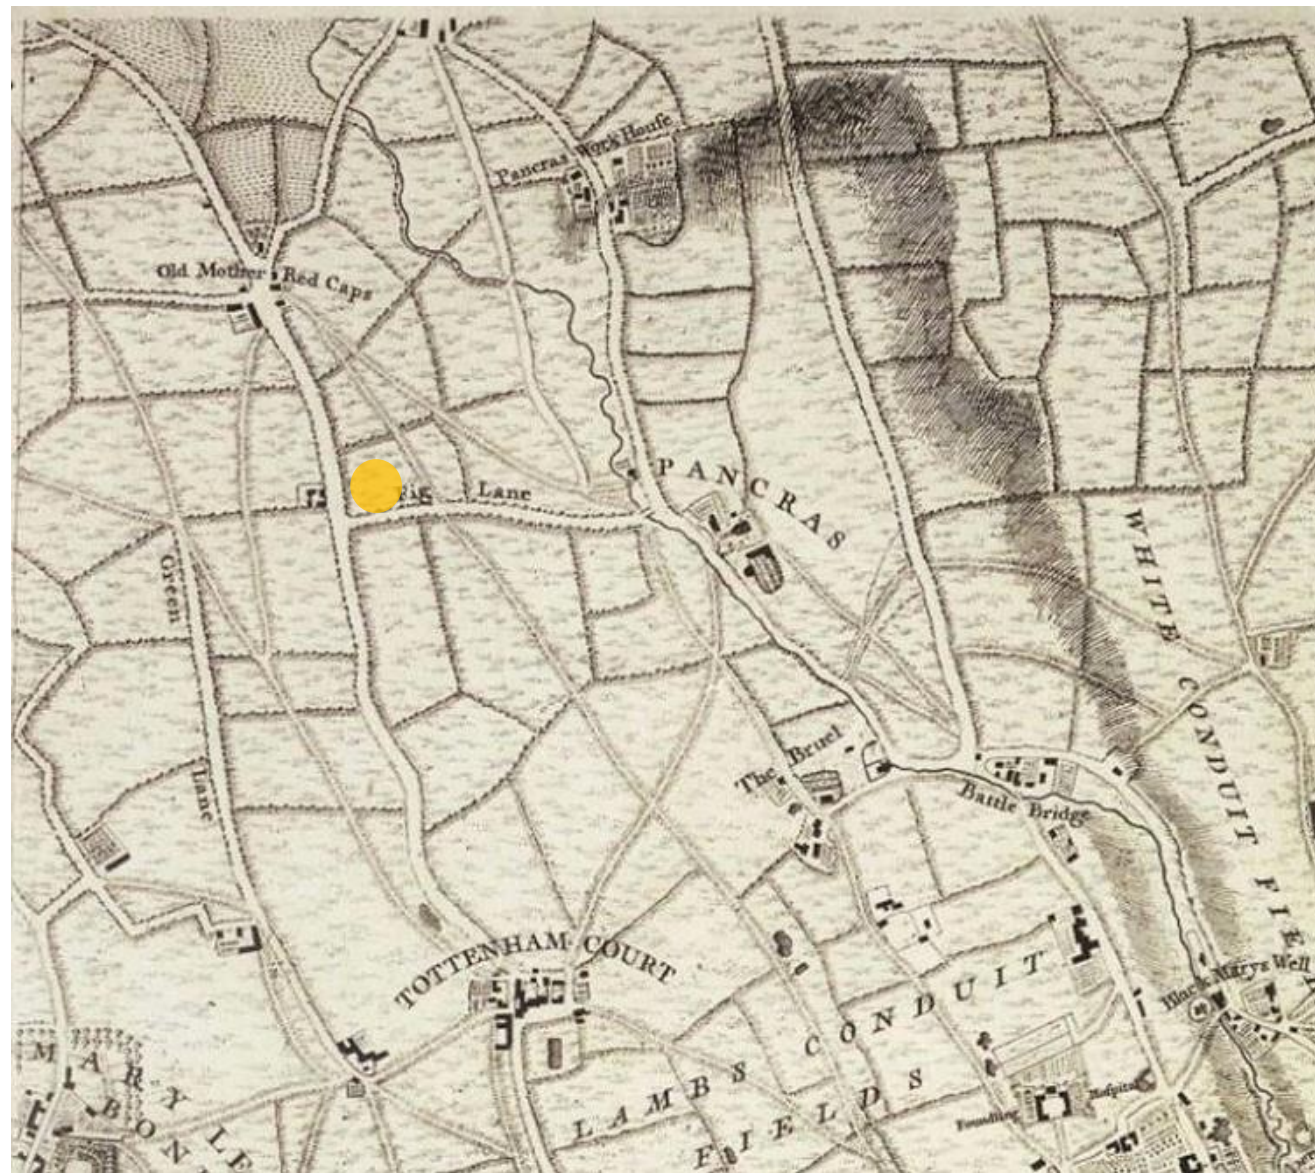
## 1745 Rocque Map

**Figure 8:** 1745 - Rocque Map of London. Site of KOKO location indicated red. Camden town is not yet developed at this time. Only The Old Mother Red Cap and a coaching inn at the Mornington Crescent Underground Station corner are built at this time.

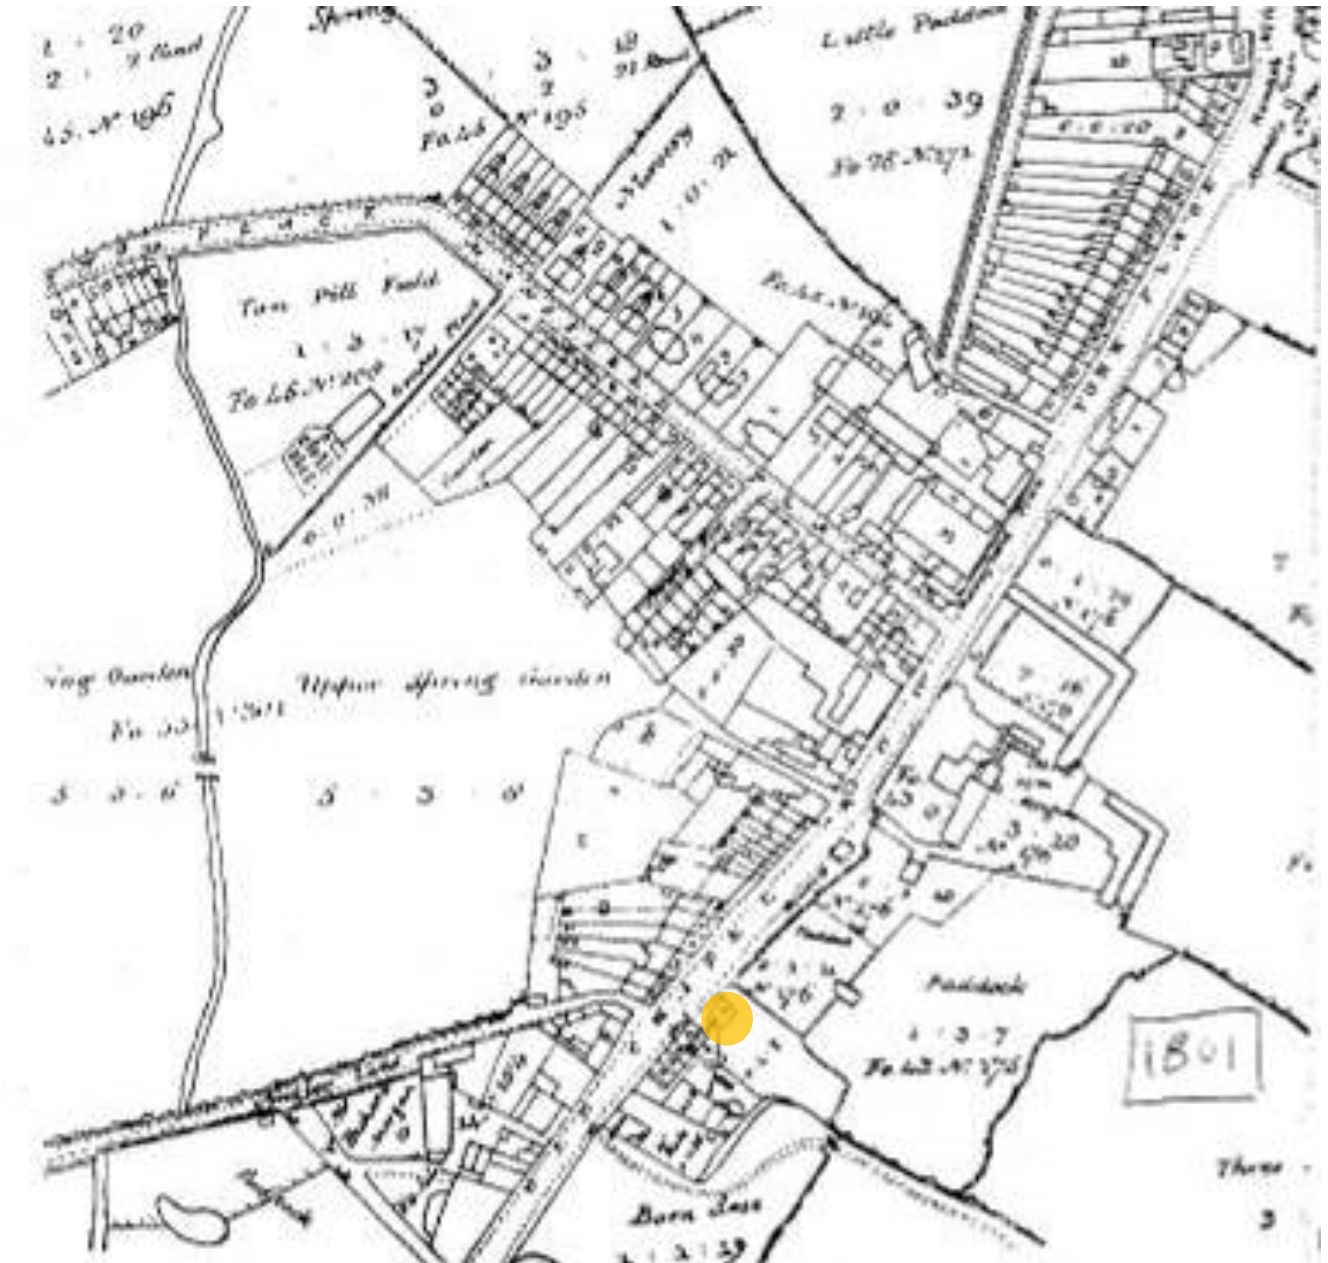
## 1801 Thompson Parish Map

**Figure 9:** 1801 – Thompson Parish Map. Terraces built on narrow plots have been built along the high street between the Britannia Junction and Mornington Crescent (not yet built at this time). Some of these buildings on the high street still exist and have been converted into shops.

During Camden Town’s early development towards to end of the 18<sup>th</sup> century, the land owners Charles Pratt, the Earl of Camden, and Charles Fitzroy, Baron Southampton sold many of their leases for the development of residential buildings, mostly terraced houses on narrow plots. This development can be seen in Thompson’s Parish map, 1801/1804 and some of the buildings still survive today as shops.

Camden started out as a wayside hamlet, and developed gradually off the main road (now Camden High Street). As seen in Thompson’s parish map (**Error! Reference source not found.**), by the 1800s, the high street between the two underground stations (which had not yet been built); and Gloucester Place (now Crowndale Road) had terraces with narrow plots, though the surrounding land still consisted of open fields.

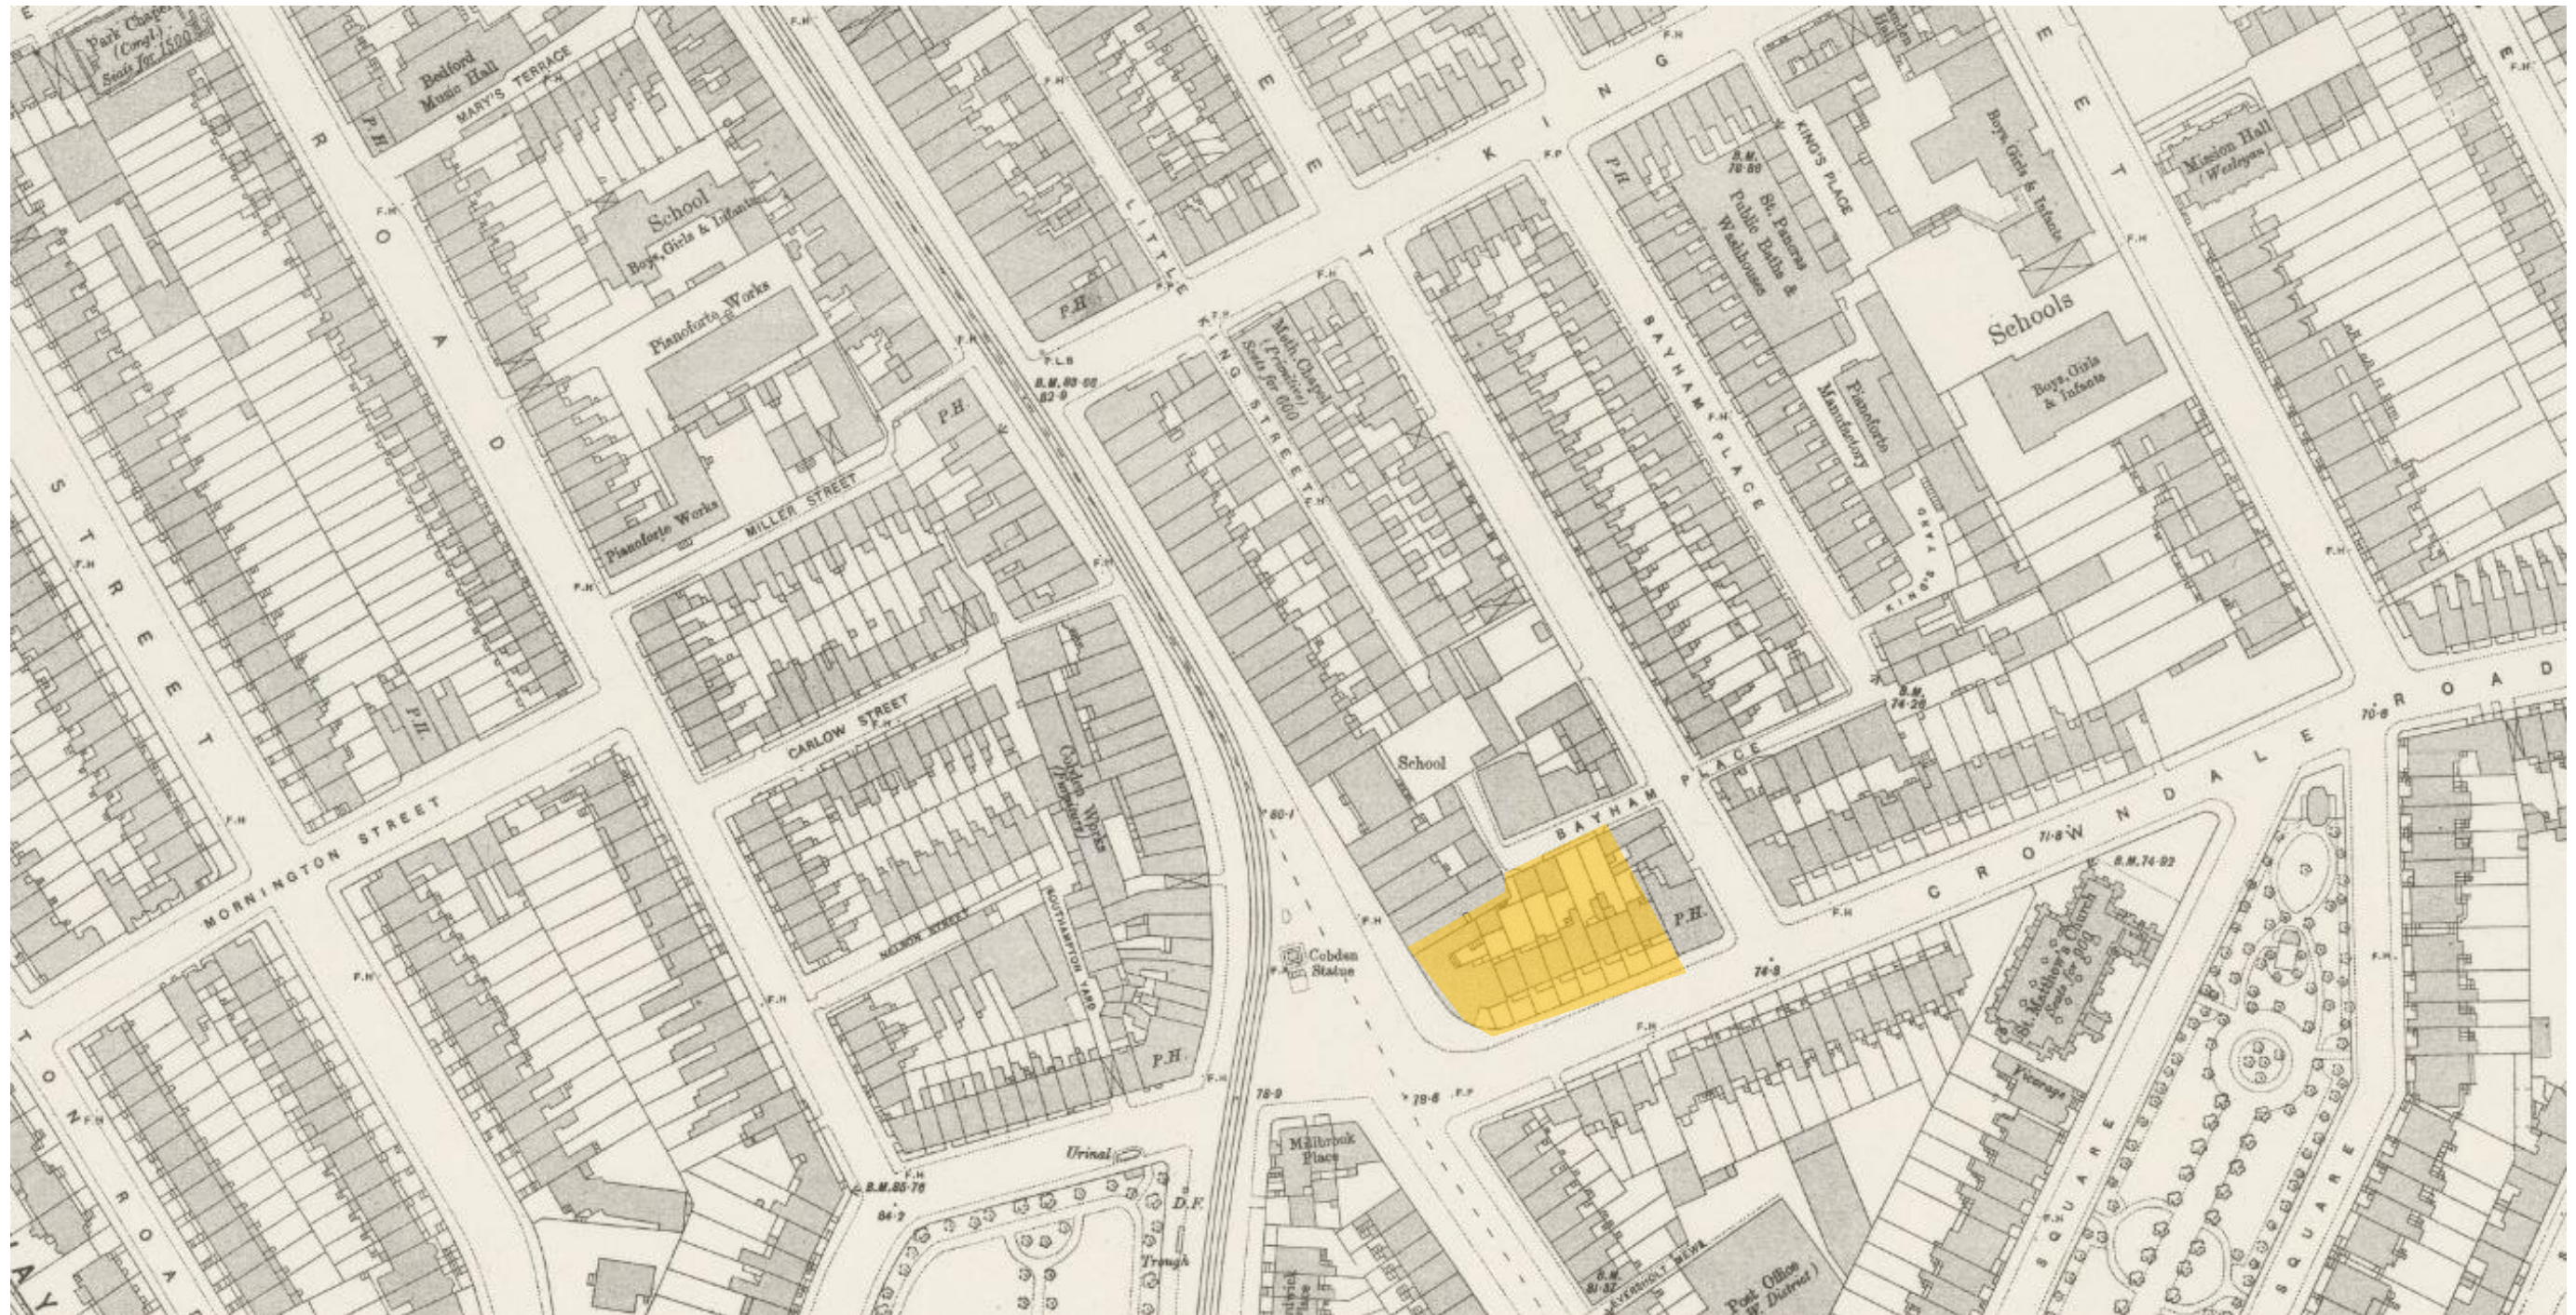
## 1894 OS Map

**Figure 11:** The outlines on The Hope & Anchor, Bayham Place are clear. Not much development occurred between 1875 and 1894. KOKO's site and the corner of Crowndale Road and Eversholt Street are still occupied by residential buildings. By this time the Bayham Street and Bayham Place buildings have the same footprint to what is seen today. The rear of Bayham Place is still not infilled (what would later be the addition of the theatre).

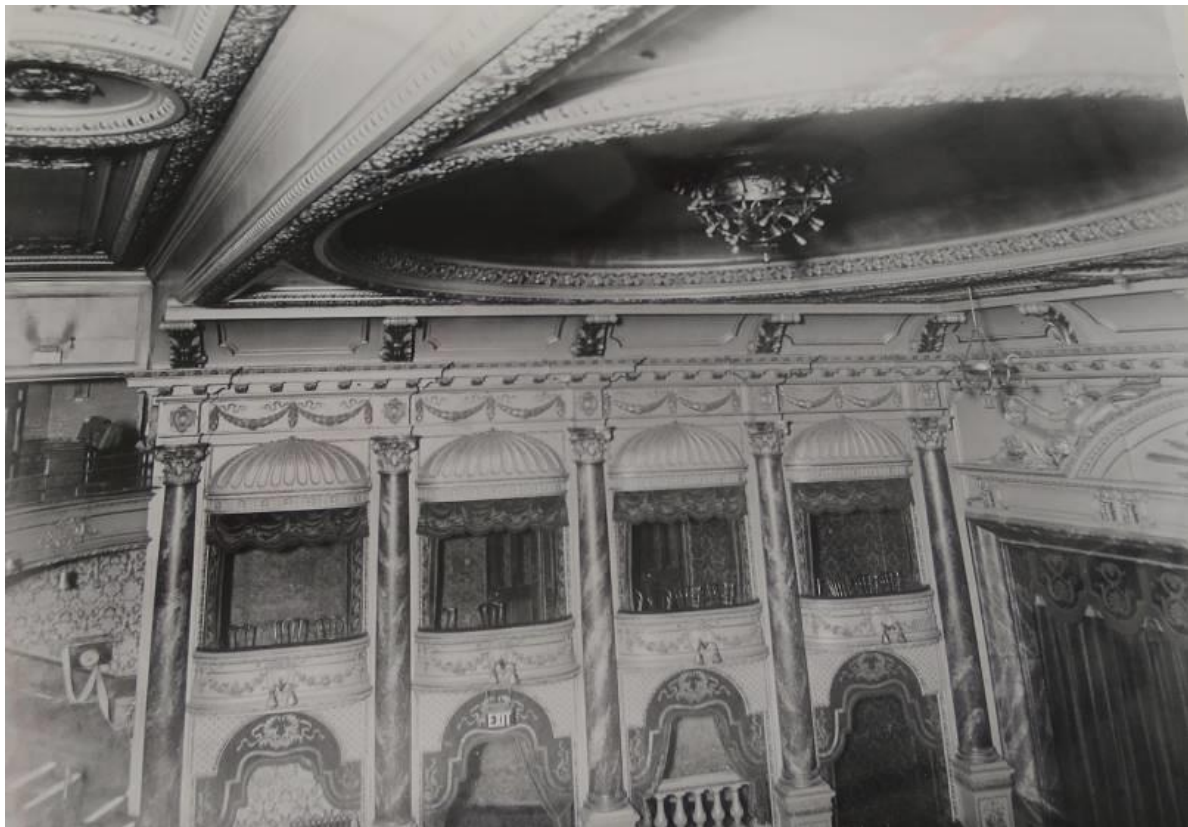
Figure 15: Camden Palace Theatre Auditorium – 1928 (London Metropolitan Archives)

The theatre’s interior was fitted and decorated with lavish cream and gold baroque/rococo style ornament by Waring & Gillow. There are three levels: stalls and two circles originally seating up to 2,434 people. This was divided up two cantilevered tiers; the dress circle and balcony on the first tier and the amphitheatre and gallery on the second. The entrance lobby was decorated with marble fittings and decorative plasterwork in the Louis XV style; similar décor can be seen in the house and saloon.

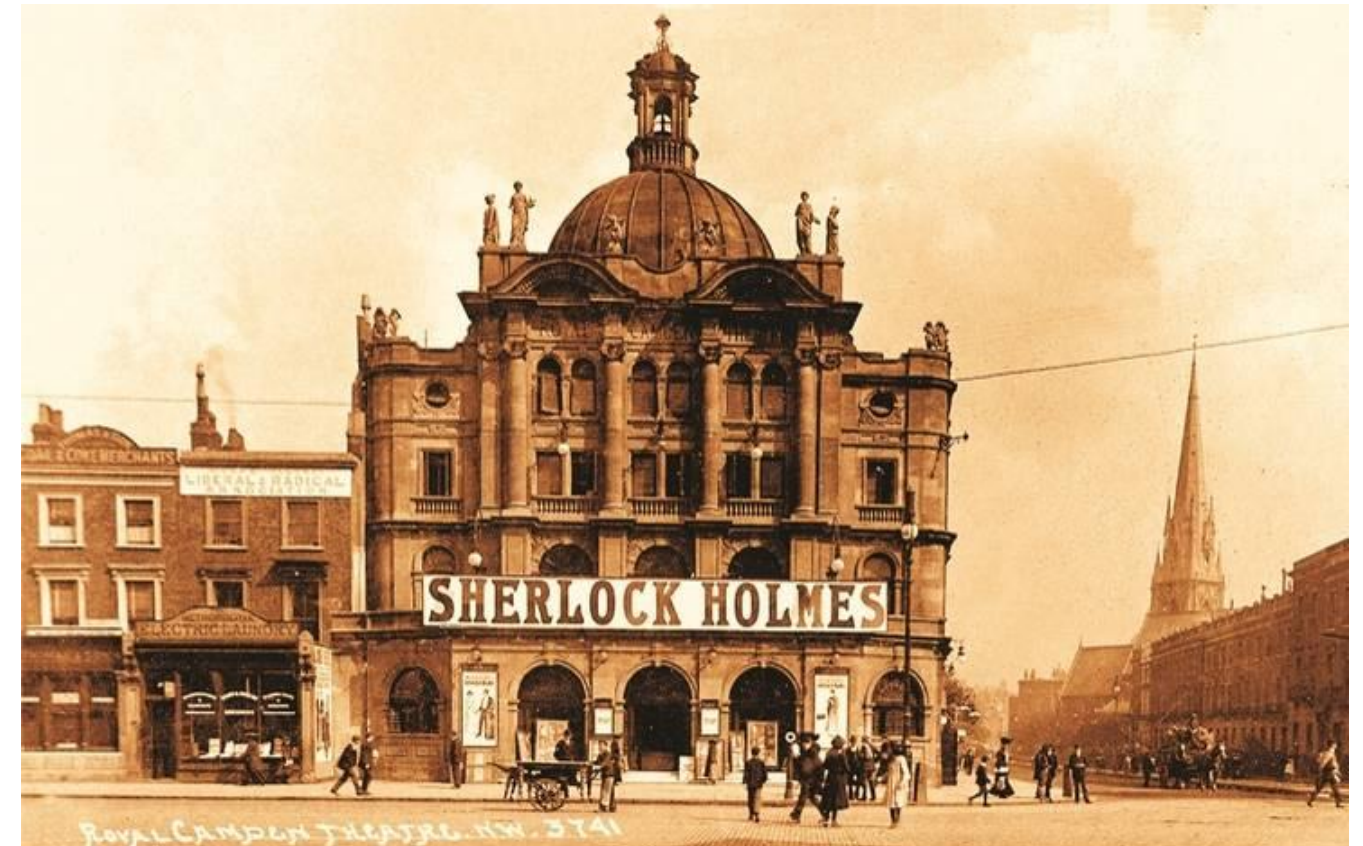
Figure 17: In this early photograph, the cupola and sculptures can be seen clearly. Unfortunately, none of them survive and the letters 'Royal Camden Theatre' are no longer visible/have been rendered over.

The exterior was designed in a baroque pastiche style; its façade the centerpiece for the junction at Mornington Crescent. The theatre has a stucco front and was topped with sculpted statues above the parapet (these no longer exist). The roof comprises a copper dome supported by a timber structure reaching approximately 33 meters above street level. Originally the dome had a decorative cupola; this was however removed later, possibly due to bomb damage. Facing Crowndale Road, the materials of the theatre change to red brick with white rendered, possibly cement dressings.
