## ARBORICULTURAL ASSESSMENT REPORT

<b>For:</b>	<b>Client:</b>	Sedgwick International UK
	<b>Insurer:</b>	
<b>Site:</b>	<b>Policyholder:</b>	108 Greencroft Gardens Ltd
	<b>Risk Address:</b>	Flat 1 & 2 108 Greencroft Gardens, London, NW6 3PH
<b>Refs:</b>	<b>PRI Ref:</b>	
	<b>Client Ref:</b>	
	<b>Insurer Ref:</b>	Client Account

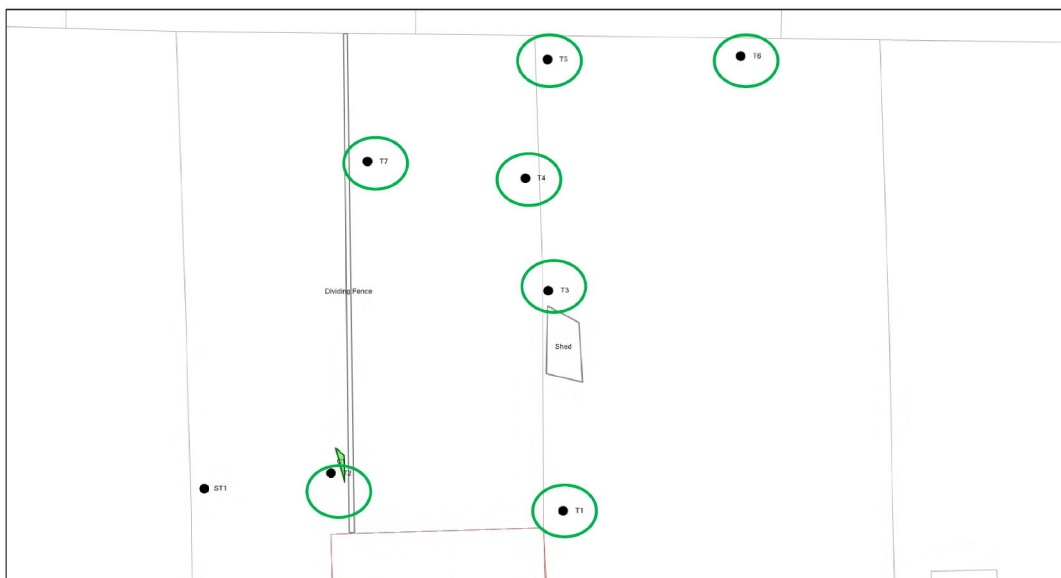
## 7.0 APPENDIX 2: SITE PLAN

Location:	flat 1 & 2 108 Greencroft Gardens, London, NW6 3PH
Job Ref:	135710
Survey Date:	19/09/2019 - NTS
By Property Risk Inspection - Insurance Services	
Crown copyright 2016. License number 100043594
