33A ARLINGTON ROAD LONDON NW1 7ES T: (020) 7383 4778 architect@artslettres.com PROJECT 23 Gloucester Crescent

SUBJECT North Elevation planning issue

NUMBER GC 308 **REVISION A**

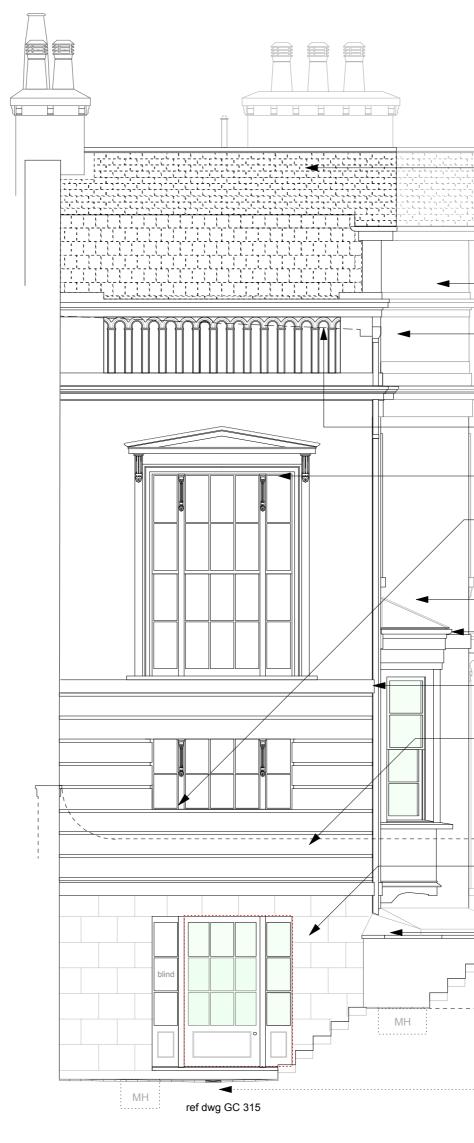
replacement valley gutter - code 5 lead as per LSA details draining to existing outlet, which is replaced with a cast iron hopper matching the hopper on the South elevation and iron downpipe painted in oil-based version of the wall colour (off white)

remove all plant growth, ensure invasive roots fully removed/neutralized, Roman cement repair to cracked or blown render

strip and repair minor damage to blind windows

provision of Roman cement cill aligned with reinstated rustication taken from original corner

re-new lead covering to bay roof - standing seam ridges, renew failed flashings removing portland cement repairing in Roman cement

install land drain to foundation level

Cement render covering the flashing to be removed a 35mm upstand to the wall abutment used for the wood roll detail, a cover flashing bossed to cloak the meeting point of the two ridge rolls where they meet at the wall. Head fixings must be sealed prior to the cover flashing. Roman cement used to repair render to the cover flashing (lead wedges @450mm ctrs) no render used over flashing (note failure of render and damp ingress in existing detail).
