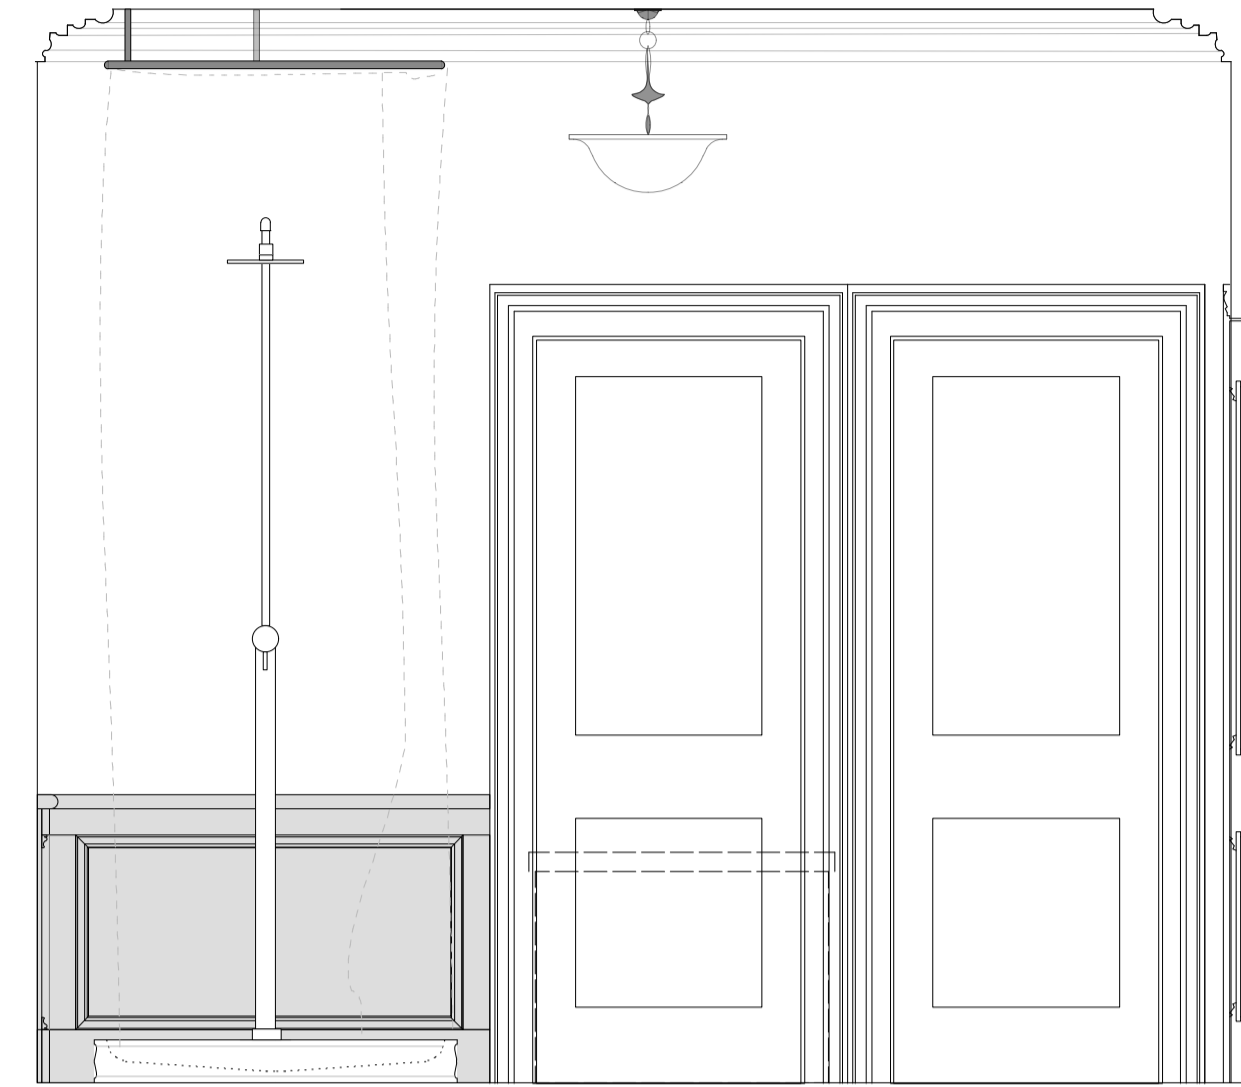
section AA

retained cupboard doors redecorated

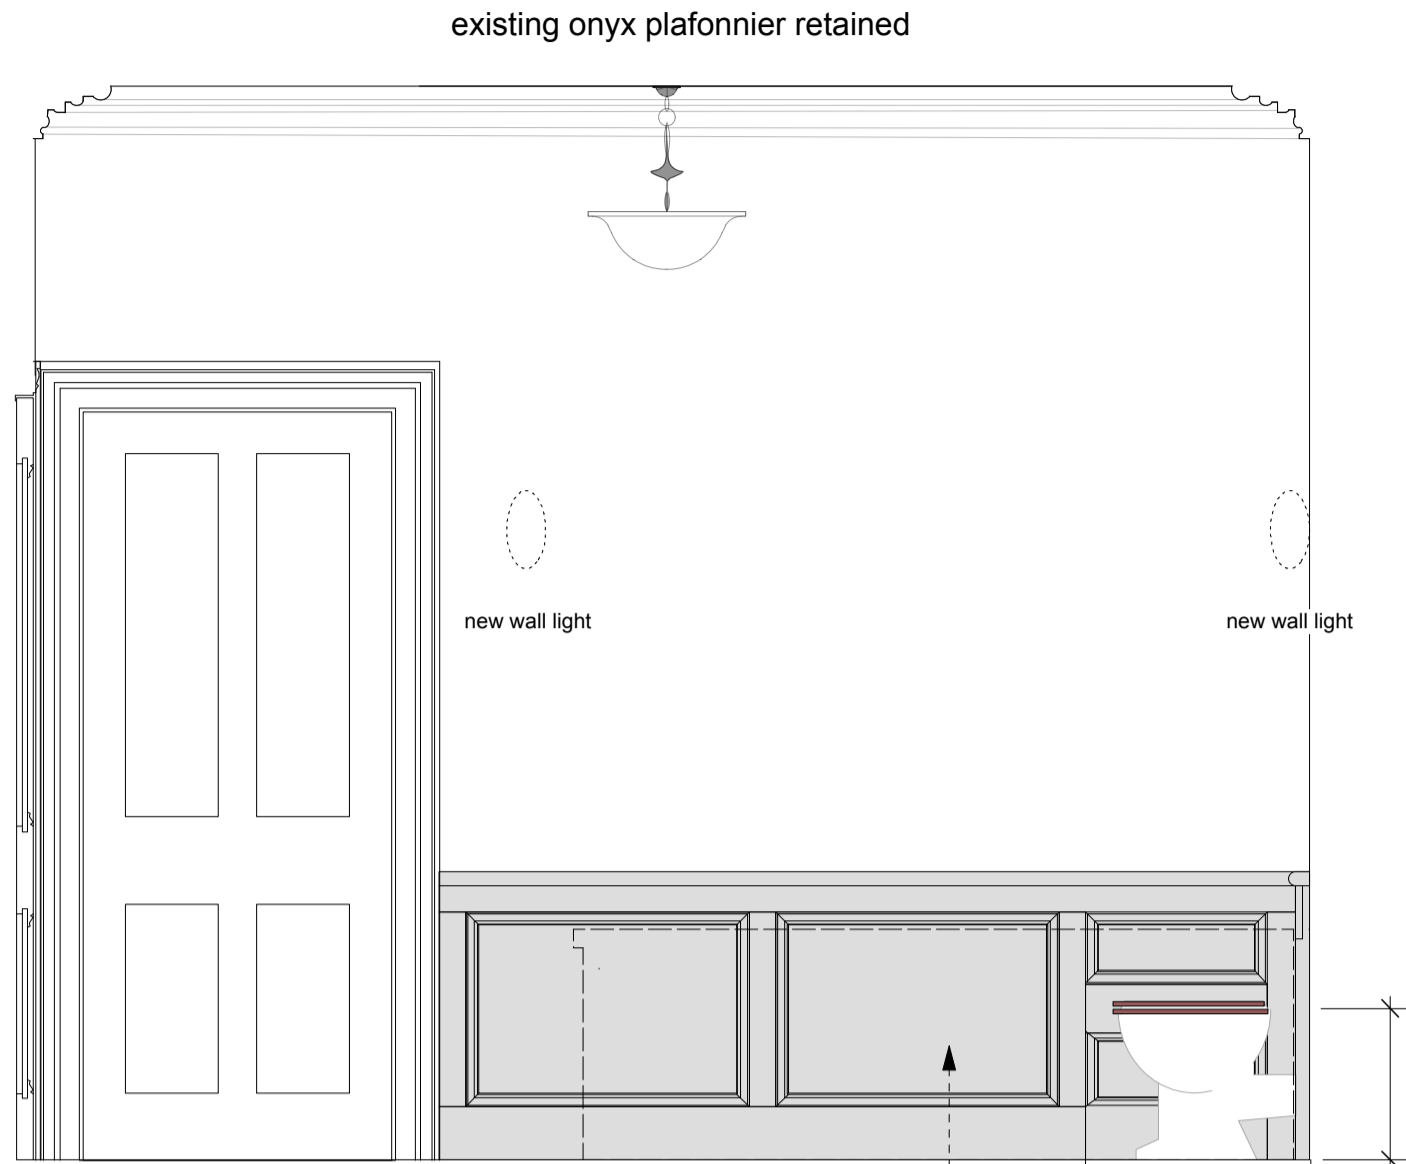
elevation A

retained door redecorated

existing onyx plafonnier retained

new wall light

additional paneling to match panel above

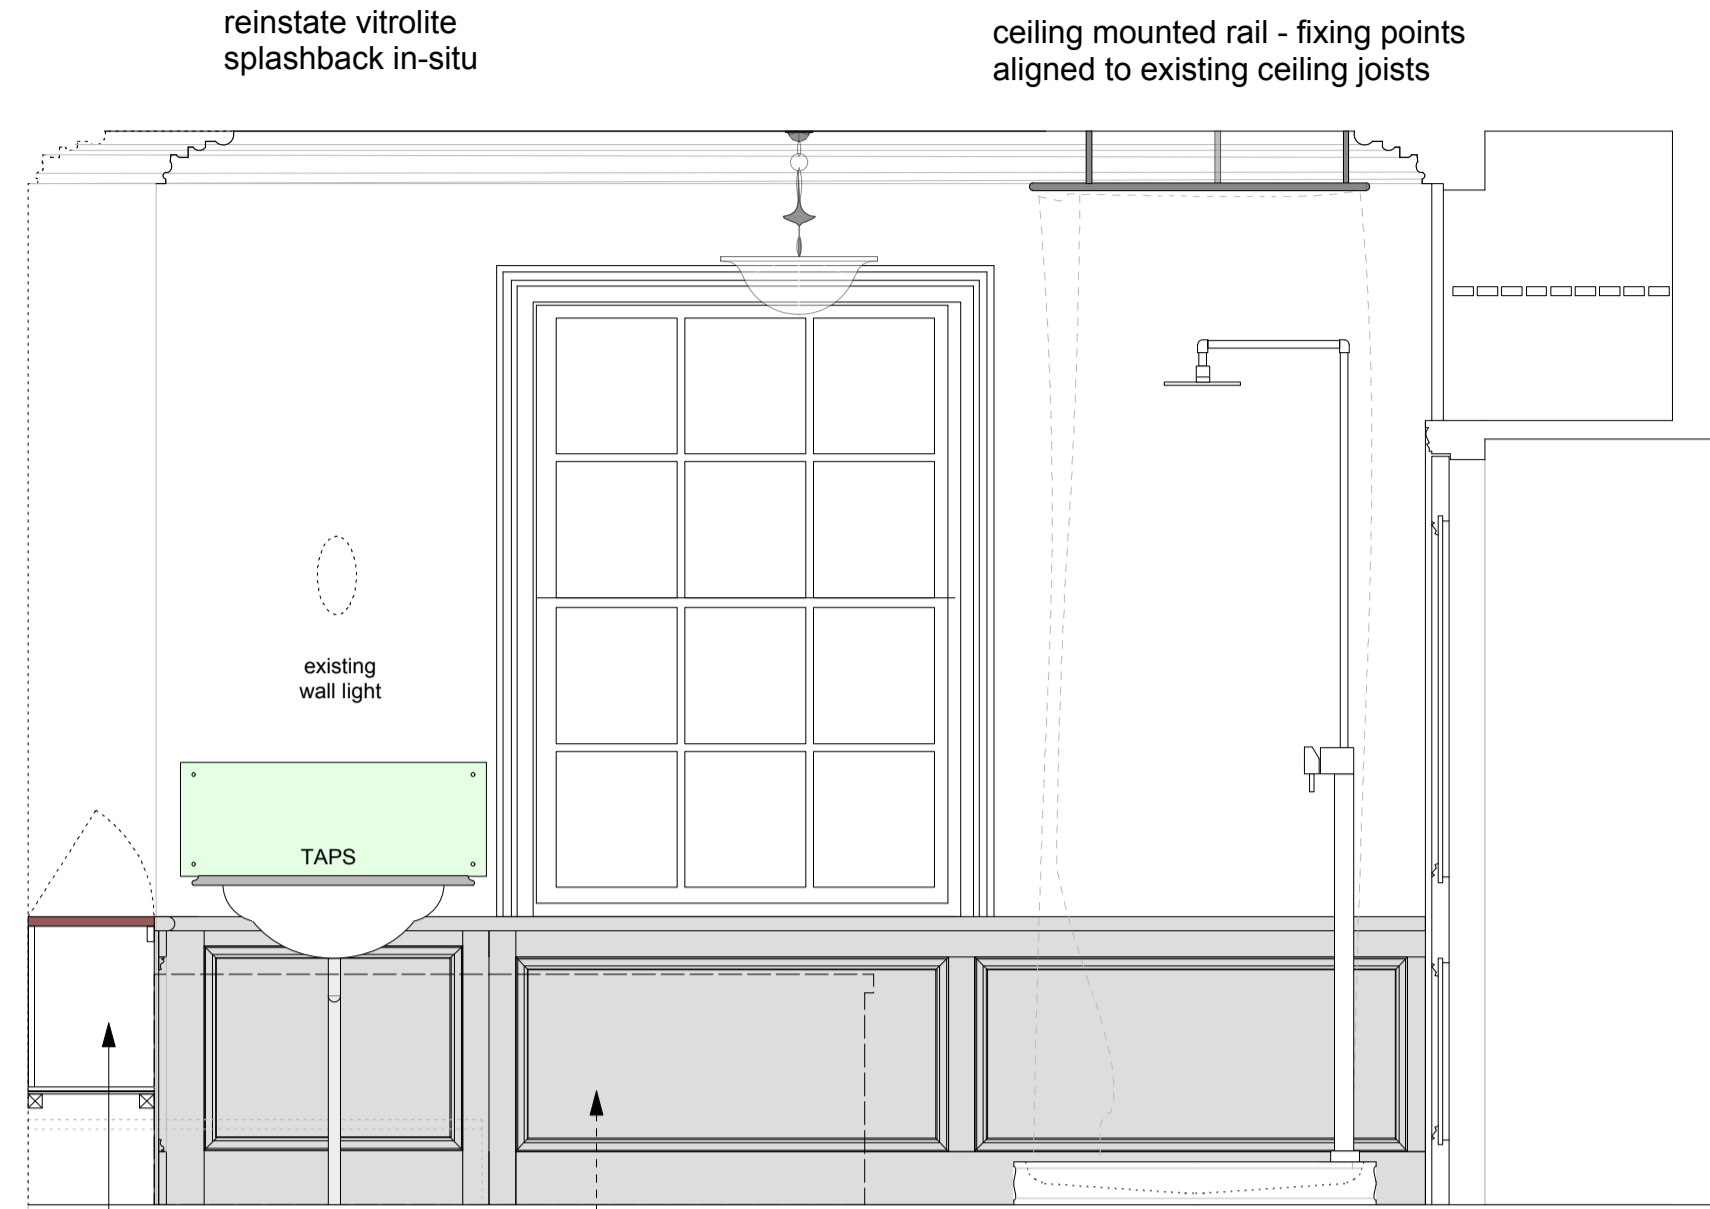
elevation B

reinstated vitrolite splashback in-situ

ceiling mounted rail - fixing points aligned to existing ceiling joists

existing wall light

hinged mahogany shelf for access to storage within dado paneling

relocate existing vanity unit panel to continue existing dado

marble floor standing shower tray and a tray-mounted floor-fed shower unit

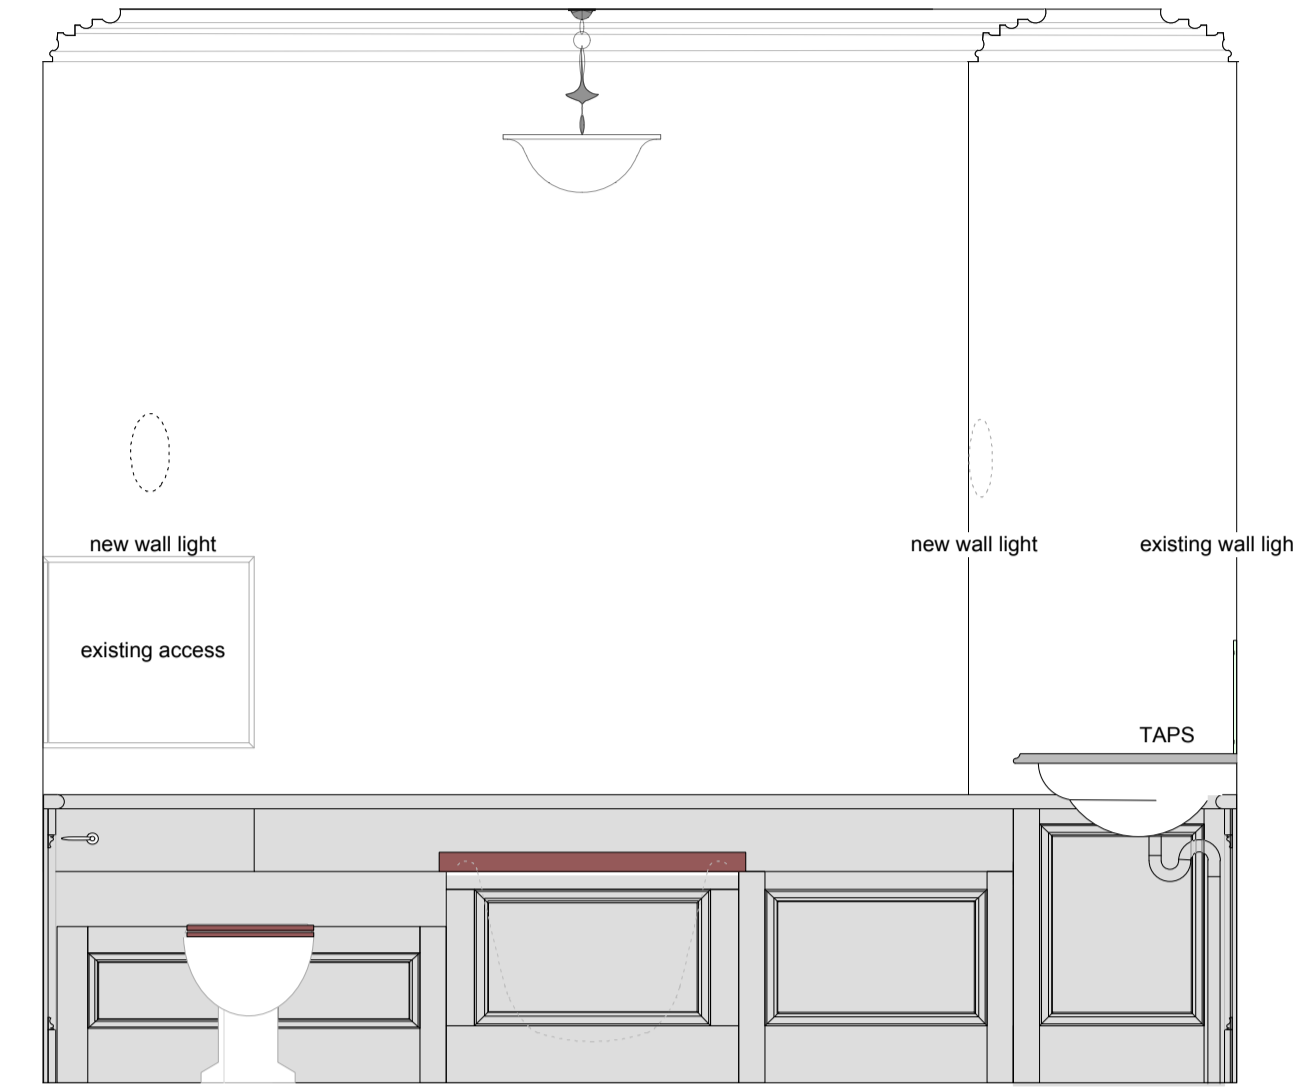
elevation C

additional panel to match adjacent

new wall light

existing access

existing wall light

relocate existing WC facing panel to continue dado

re-make existing bath end panel re-using mouldings replace MDF with ply to match side paneling

relocate existing vanity unit door panel to continue existing dado

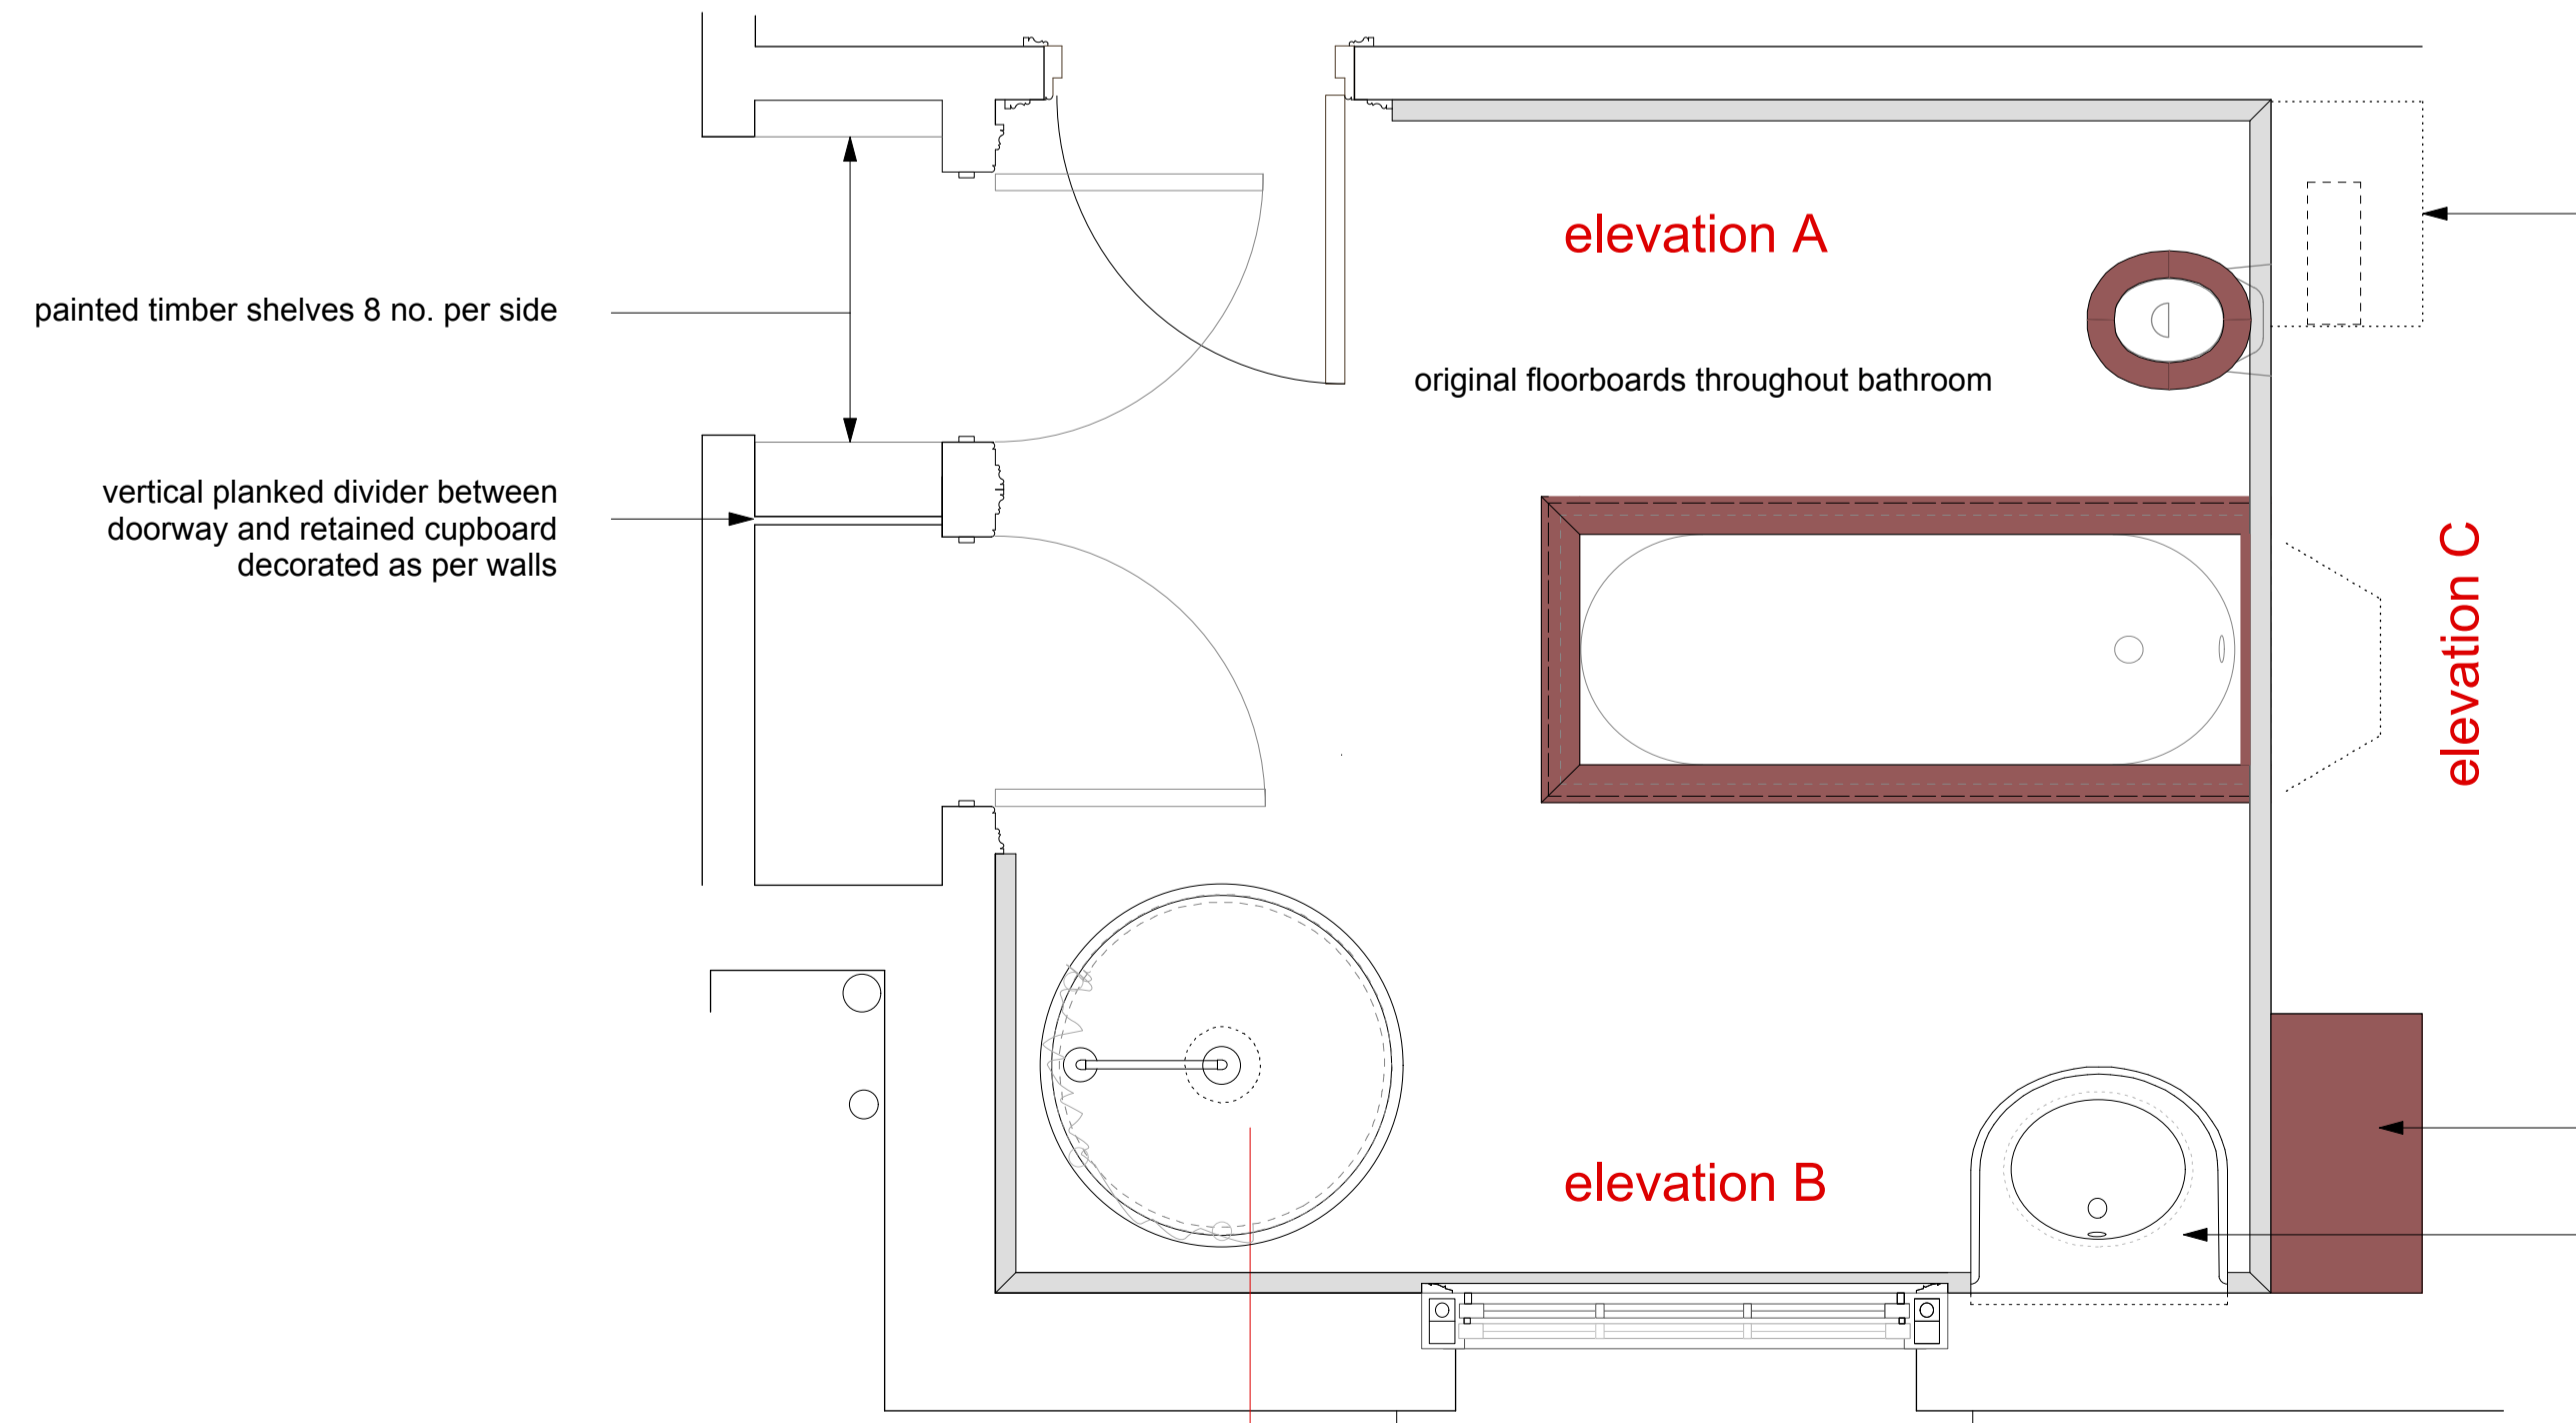
painted timber shelves 8 no. per side

vertical planked divider between doorway and retained cupboard decorated as per walls

original floorboards throughout bathroom

Rockwool firestopping between every floor within riser

hinged mahogany shelf with storage below in original mahogany shelf location

reclaimed Shanks undermount basin re-made marble vanity top in original location, traditional chrome pipes and fittings

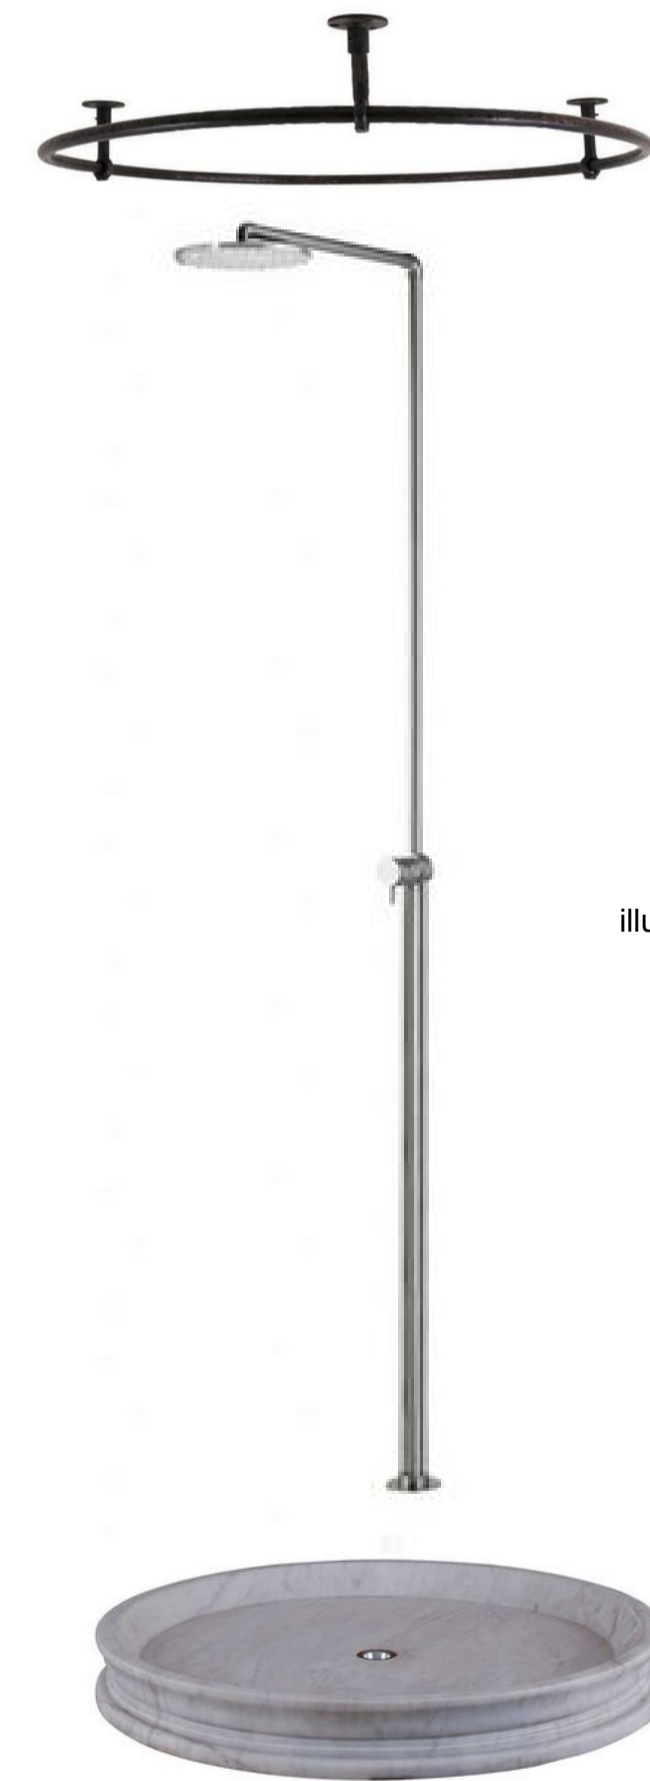
illustration of shower components
