hazard: outline method statement

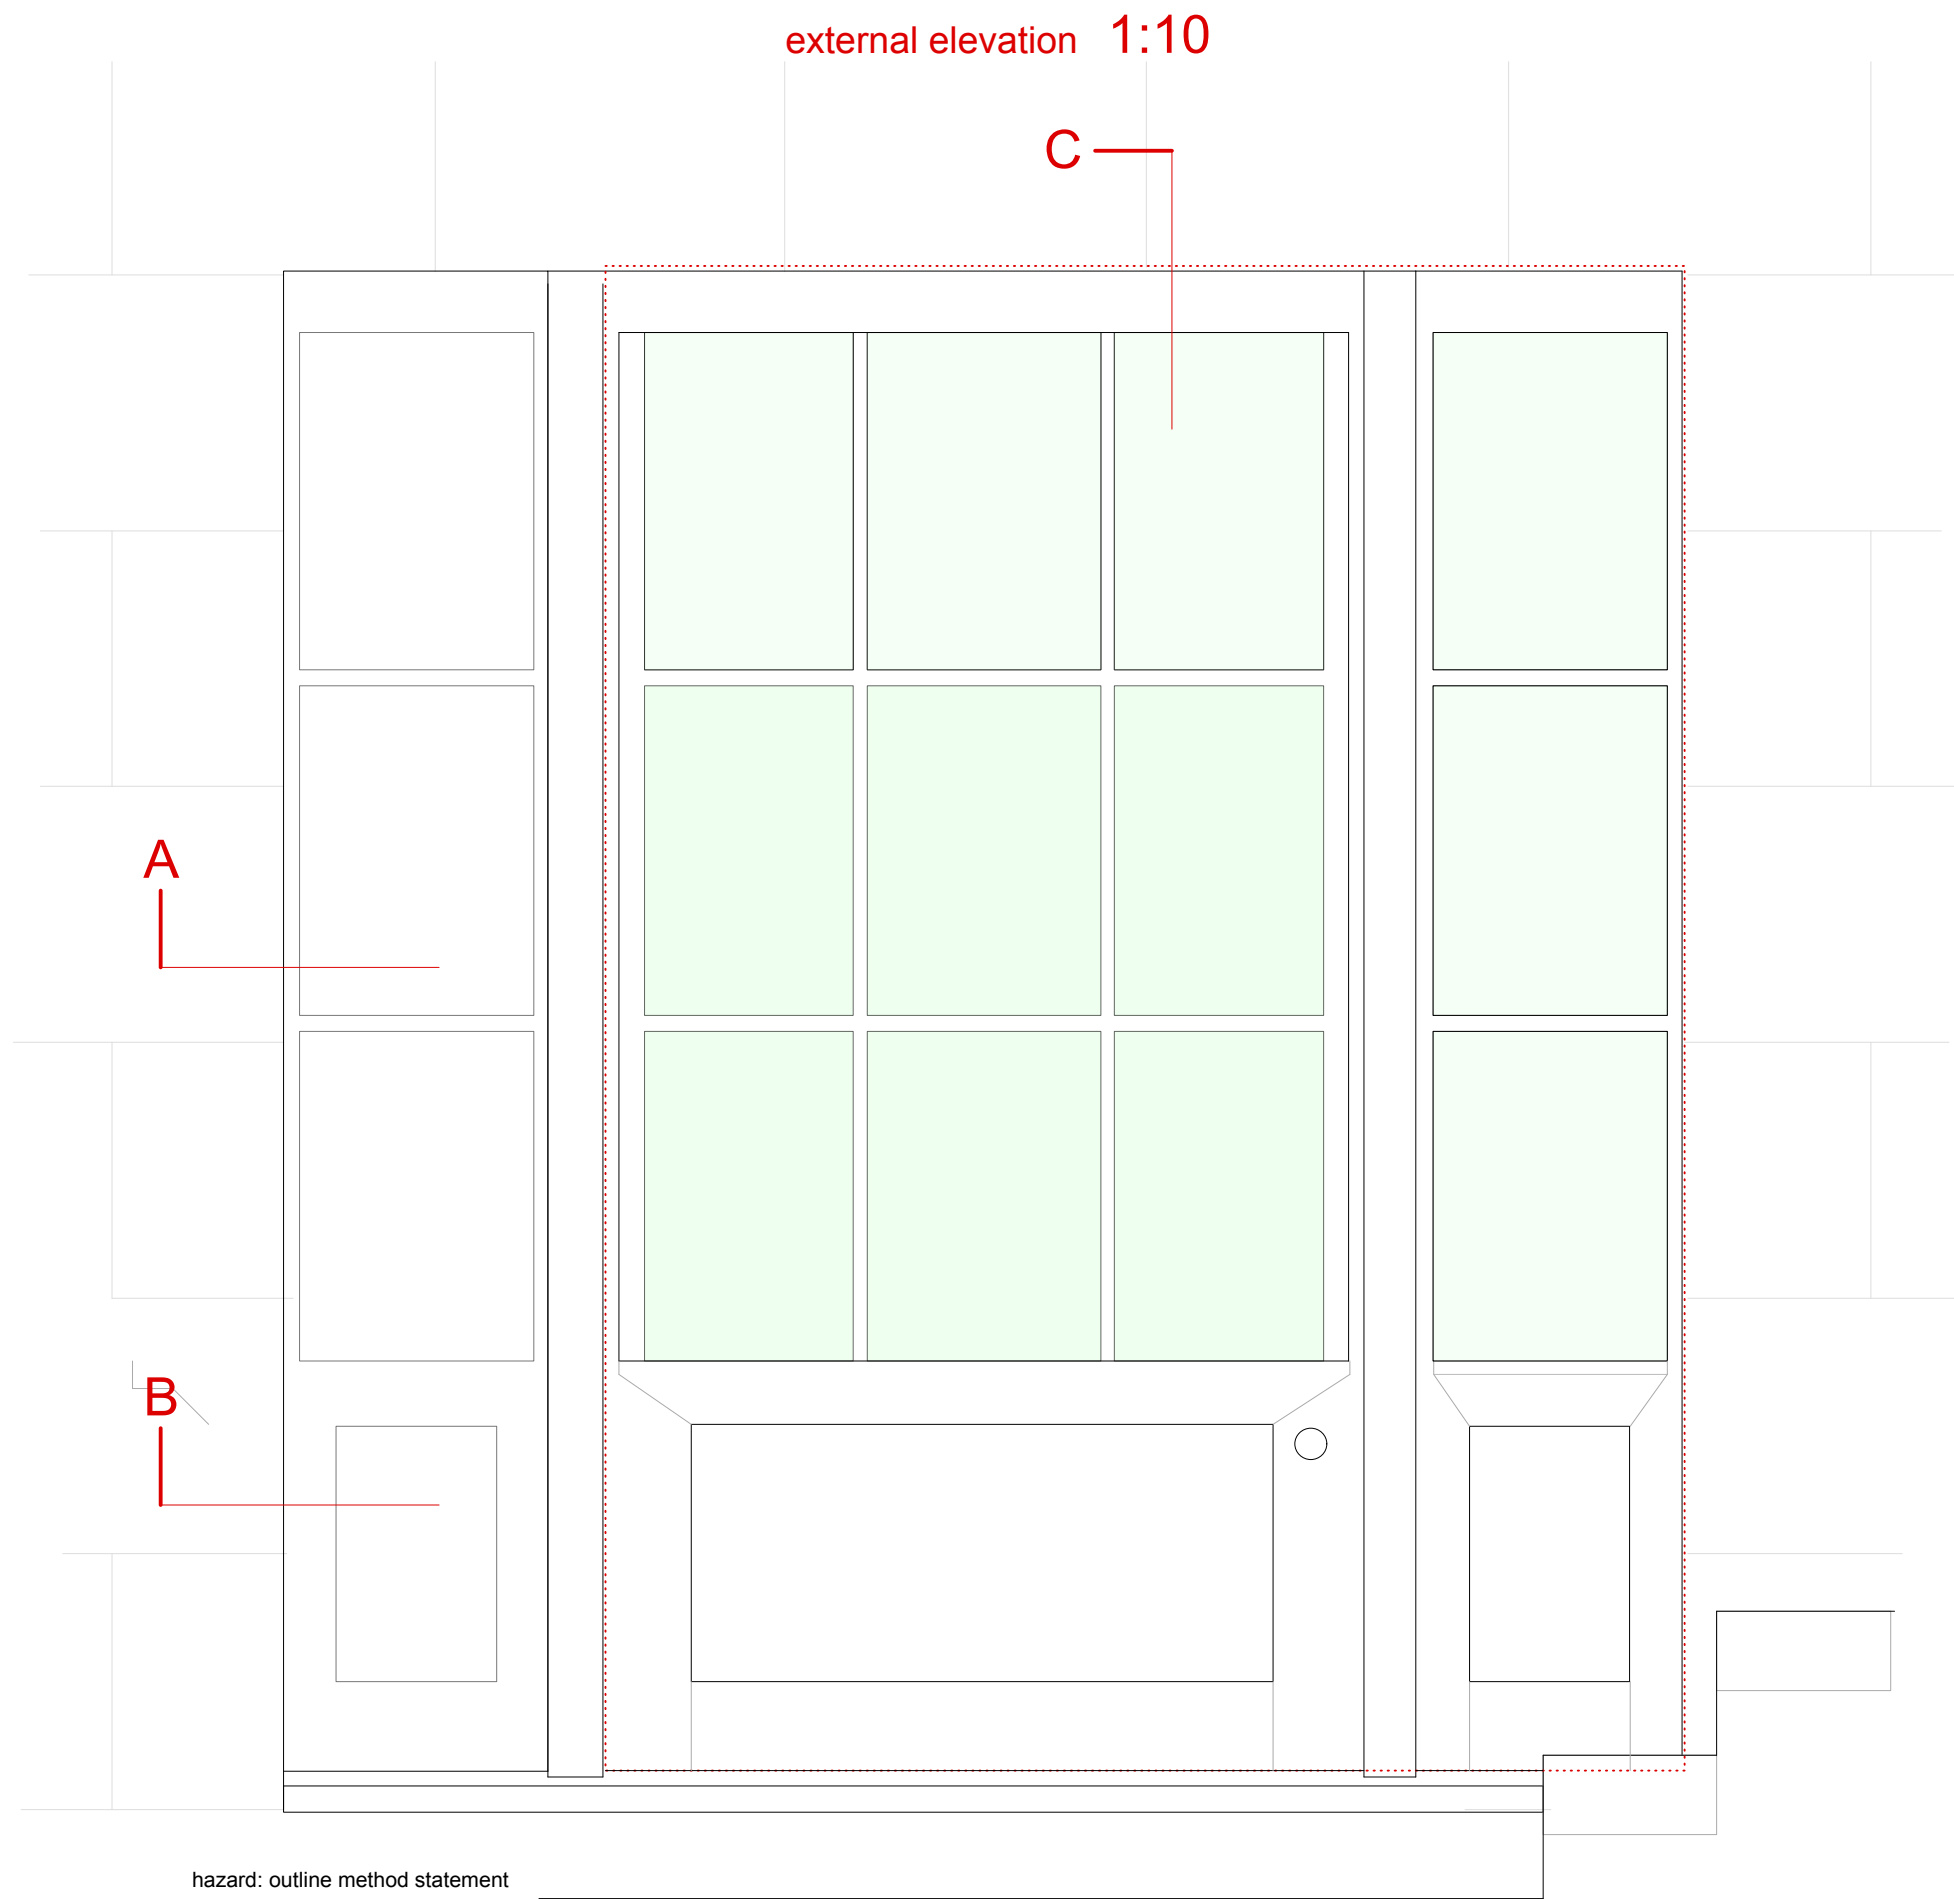
Opening
Removal of brick infill to use small power tools -
no breakers to be used to avoid vibration damage
Concrete beam retained in situ - structural
assessment by qualified site engineer of beam to
confirm integrity prior to opening up, propping should
not be required.

Door
Fabricated offsite using FSC accredited European
hardwood fitted by experienced joiners, relevant
Risk Assessment to cover operation noting weight
of door. Roman cement render to external facade
by experienced heritage plasterer - all detail
dimensions as per blind window above.
