### **Technical note TN03**

This Technical Note is written to demonstrate progress on structural issues related to change of use of R05 Retail Unit previously fitted out and occupied by Vapiano. R05 on first floor and part of ground floor is proposed to be converted into an office.

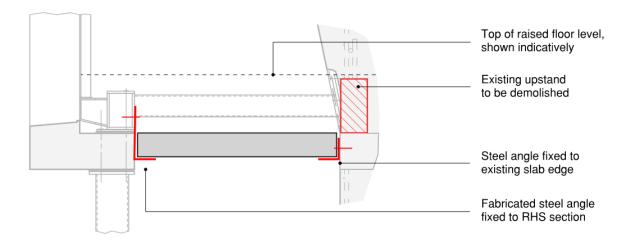
The remaining reinforced concrete element on the perimeter of the building along the Western edge of existing void has very limited remaining capacity and drilling into it should be avoided as it would likely damage closely spaced existing reinforcement. A feasible option is fixing steel angles into existing perimeter box girder to provide a line of support for precast slab panels. On the other side the precast panels would be supported by post-fixing steel angles to existing upstand. At this point, for the purpose of initial structural checks, 175 mm thick solid precast slab has been assumed, based on typical recommended span/depth ratios for simply supported one-way slabs.

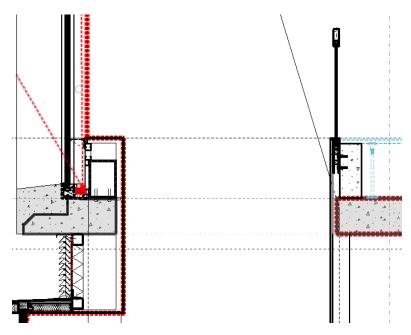
Concrete upstand on the opposite side of the slab void was cast as part of Centre Point redevelopment works and was designed to support the balustrade, transferring all the loads to the original first floor slab structure.

To allow access for raised floor services within new infilled floor, it was proposed to remove the upstand. Since the upstand is not utilised for supporting floor loads, it is considered to be redundant once the balustrade is removed, therefore there are no implications on the building structure.

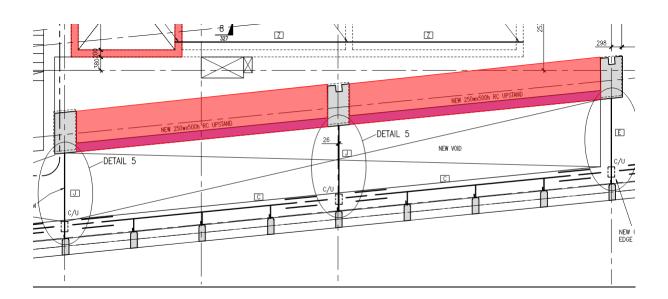
To assess the capacity of slab edge, historical building drawings were used to determine existing reinforcement within a slab strip between RC columns. It was justified that the slab has sufficient capacity for vertical load from a new precast infill.

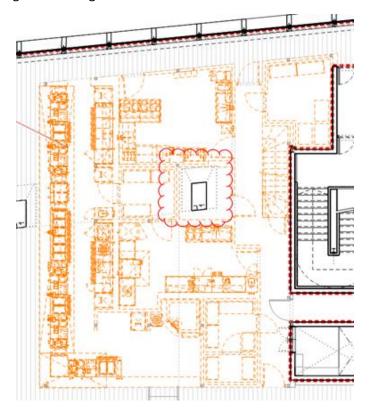
The current Vapiano mezzanine structural frame was designed as 'independent' frame to avoid drilling into existing RC columns, therefore bracing was added for stability, which may now affect the flexibility for the new space below mezzanine floor

There is an opportunity for reducing the required bracing if the mezzanine steel frame can be tied into the existing column positioned roughly in the middle of mezzanine floor. This would involve a detail requiring drilling into existing concrete columns.

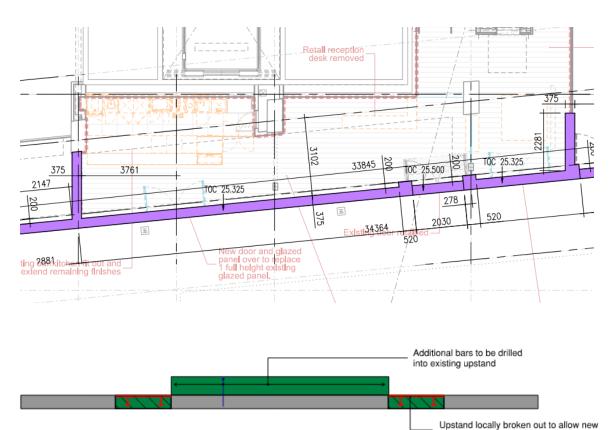
Pell Frischmann drawing A12504/VAA/345 shows a new RC upstand along ground floor edge for façade support. Note that although there is a continuous upstand along the façade, the upstands at current door positions are 175 mm higher, which is what Seele may require if the same door threshold details are kept. Also there appear to be little upstand nibs framing existing door openings.

It is proposed that the upstands are extended by casting additional 175 mm of concrete within new door opening width. To accommodate new cast-in baseplates for the door frames, some of the concrete will have to be locally broken out before casting the RC base back with Seele's details cast-in.

door frame baseplates to be cast-in
