**18A FROGNAL GARDENS  
LONDON NW3 6XA**

## **BASEMENT IMPACT ASSESSMENT**

**PROPOSED DEVELOPMENT AT  
18 A FROGNAL GARDENS, LONDON NW3 6XA**

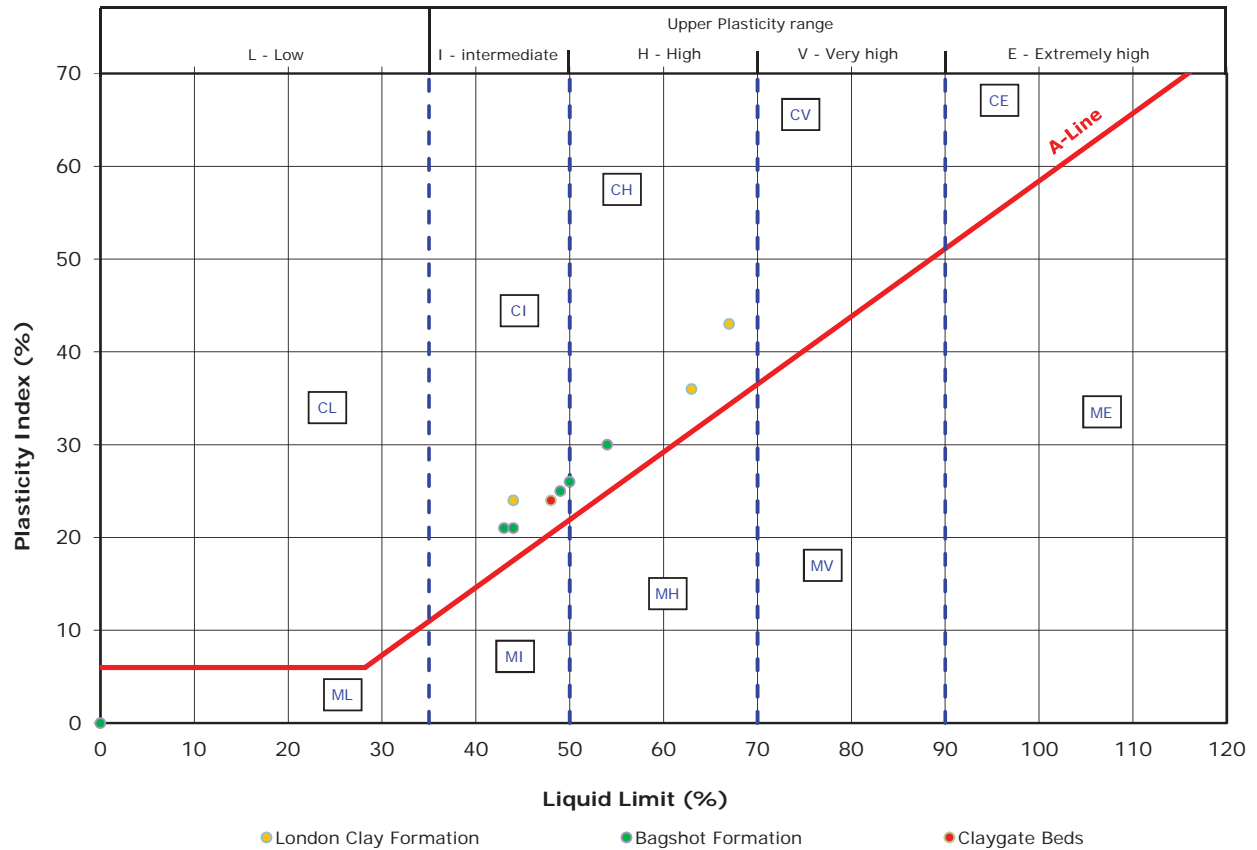
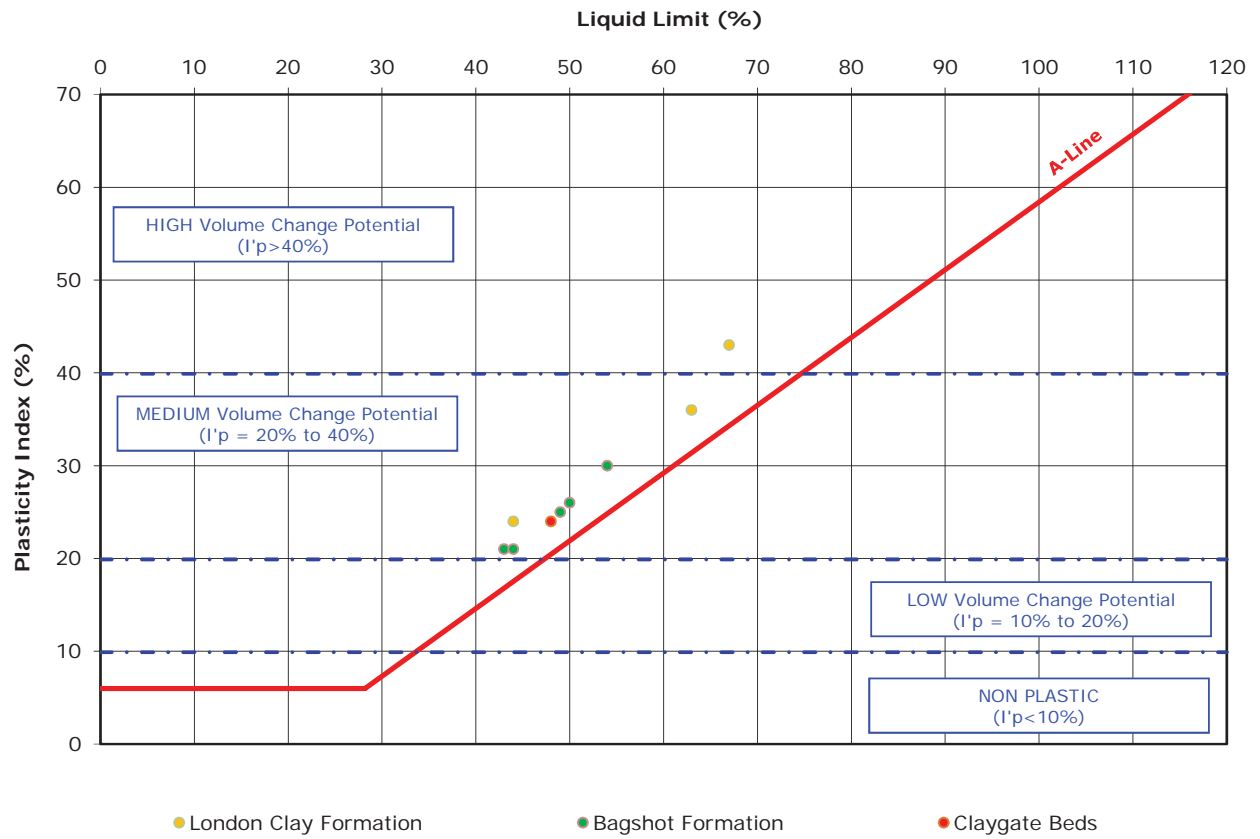
### Plasticity Chart

M - SILT [plots below the A-Line]  
C - CLAY [plots above the A-Line]

Classification in accordance with BS5930:2015 "Code of practice for site investigations"

Modified Plasticity Index, I'p:

$$I'p = \frac{I_p \times (\% \text{ passing } 425\text{mm})}{100\%} \quad (\text{where } I_p = \text{Plasticity Index})$$

BH ID	Depth (m)	Type	w (%)	w <sub>L</sub> (%)	w <sub>p</sub> (%)	Pass 425 (μm) (%)	I <sub>p</sub> (%)	Mod I <sub>p</sub> (%)	I <sub>L</sub> (%)	LOI (%)	Description
BH1	1.20	D	26	54	24	>95	30		0.05		Grey brown sandy very silty CLAY
BH1	3.00	D	20	44	23	>95	21		-0.13		Grey brown sandy very silty CLAY
BH1	7.50	D	32	48	24	>95	24		0.33		Grey mottled brown sandy silty CLAY
BH1	9.50	D	26	67	24	>95	43		0.04		Grey slightly sandy silty CLAY
BH1	12.00	D	28	63	27	>95	36		0.04		Grey slightly sandy silty CLAY
BH1	13.75	D	27	44	20	>95	24		0.29		Grey sandy silty CLAY
WS1	3.00	D	30	44	23	>95	21		0.33		Orange brown mottled grey very sandy silty CLAY
WS2	2.40	D	25	43	22	>95	21		0.13		Orange brown mottled grey very sandy silty CLAY
WS2	2.90	D	29	49	24	>95	25		0.22		Orange brown mottled grey very sandy silty CLAY
WS2	4.20	D	30	50	24	>95	26		0.23		Light brown/orange brown slightly sandy silty CLAY

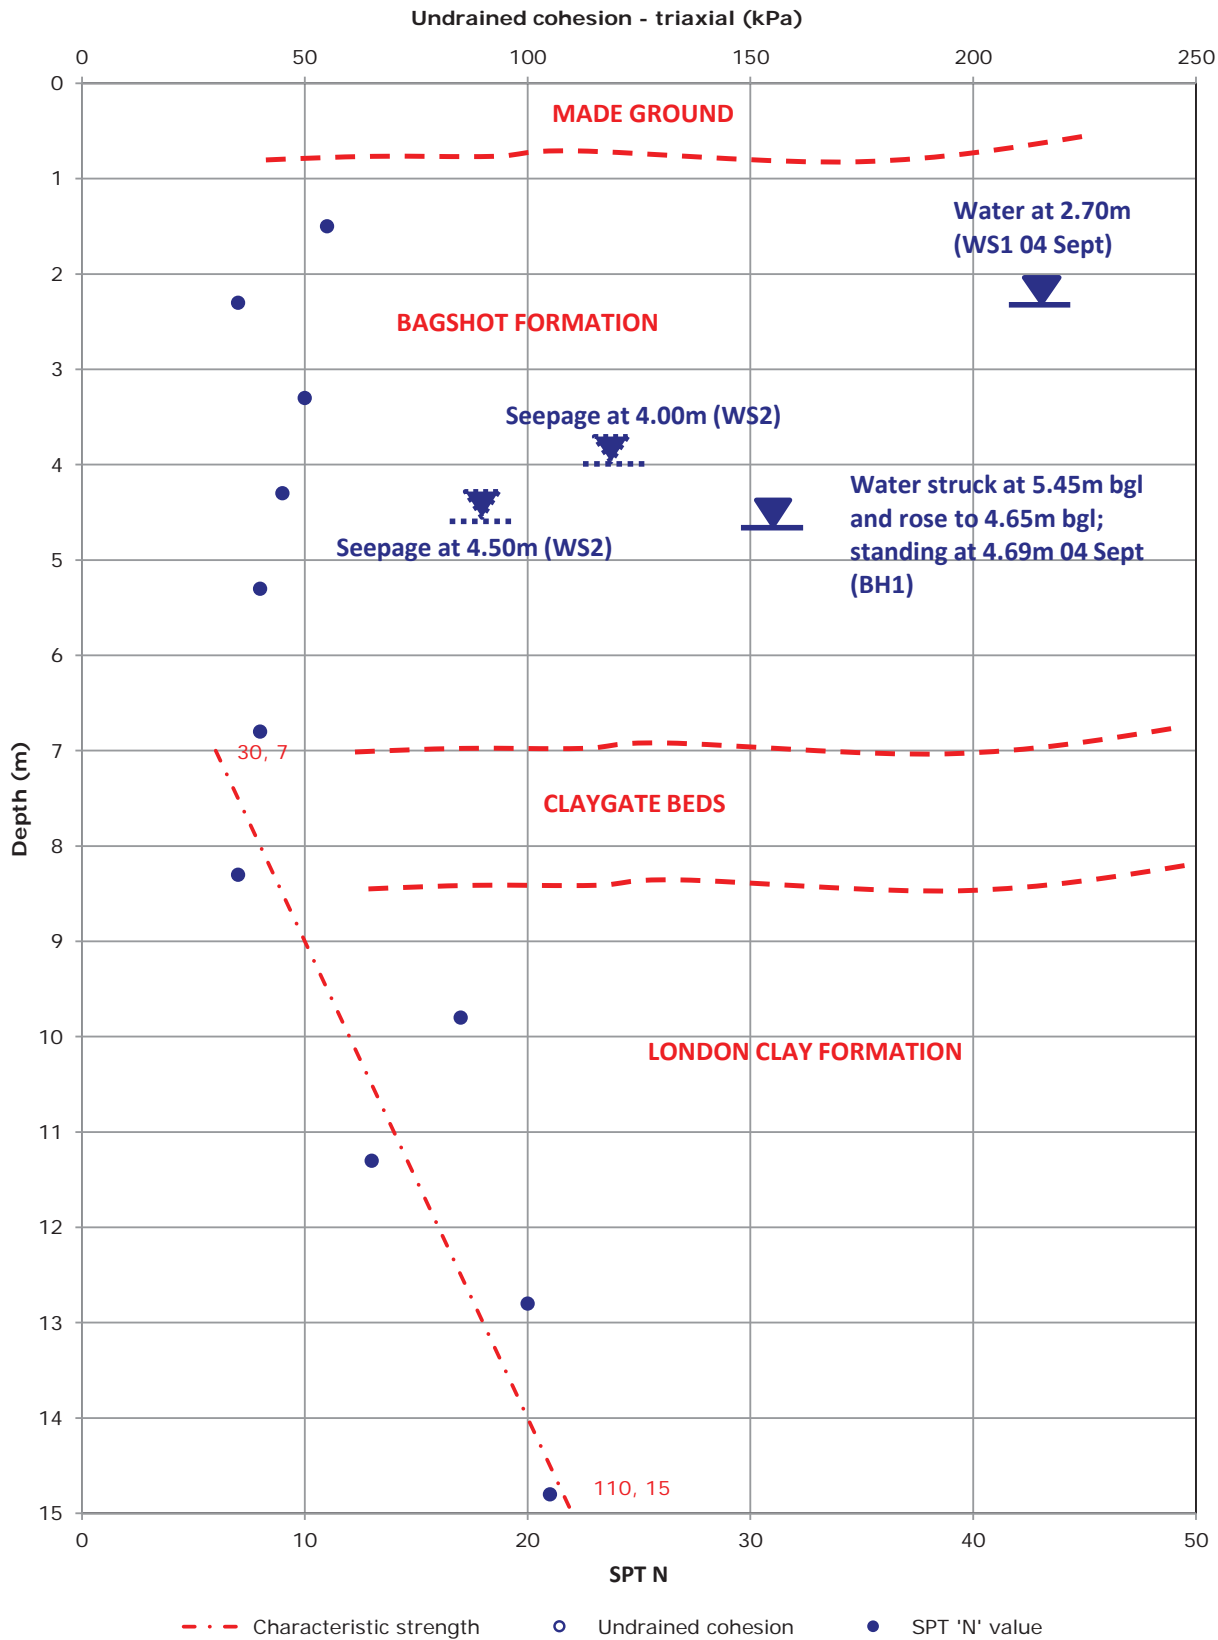
**Undrained cohesion and SPT-N vs depth**

$\Delta c_u = 10\text{kPa/m}$
