ARBORICULTURAL METHOD STATEMENT REPORT
BS 5837:2012 '*Trees in relation to design, demolition, and construction*' - recommendations

PURSUANT TO DISCHARGE CONDITIONS 13 and 14

Land surrounding Snowman and Casterbridge House, Belsize Road, Camden,

DATE: November 2020

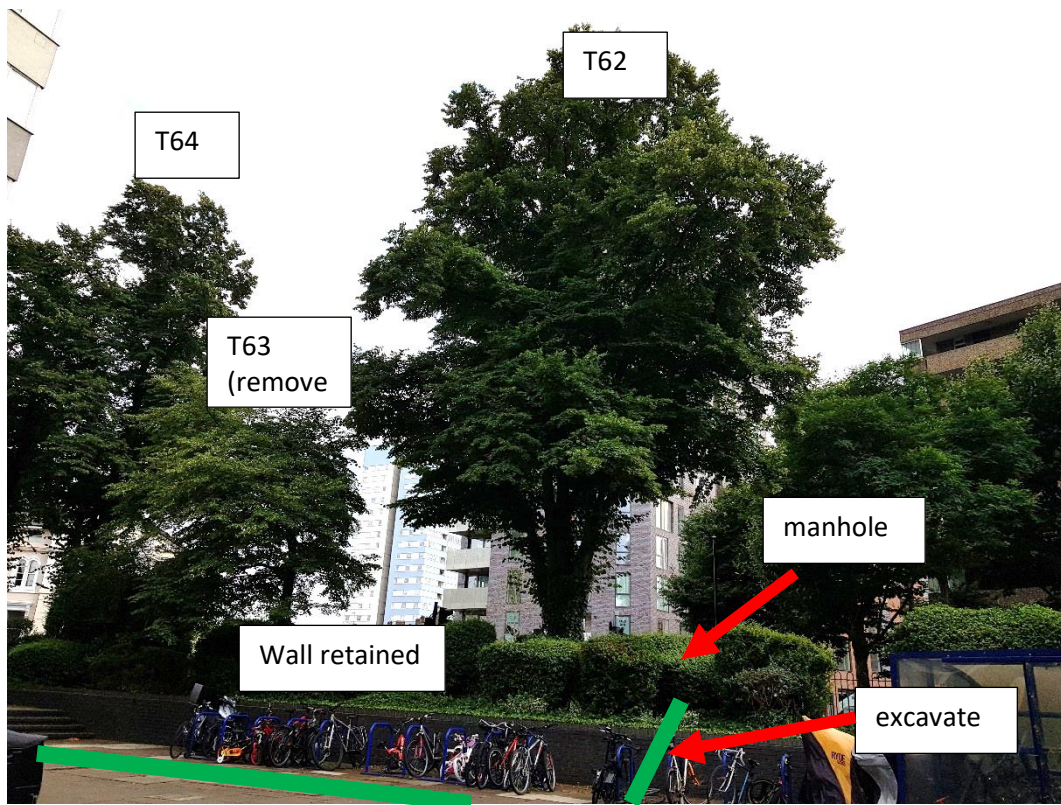
Photo 2 looking south. Green lines – approximately location of underground services.

There is an existing manhole in the raised planter in which the trees are growing. This will need to be connected to the lower hard surfaced area below the wall. This short stretch of excavation will be carried out by a combination of hand digging, and where not possible due to site conditions, by a smooth bucket 300mm wide. This will be supervised by the arboriculturist and a note will be made of roots present. Where possible, roots (diameter greater than 25mm) will be retained with smaller roots pruned with bypass secateurs. It may not be possible to keep the larger roots, depending on the rooting pattern of this tree, and they may need to be pruned.

The wall will be breached to ensure that the pipes can connect to the line to the south of the wall (shown diagrammatically on photo 2 above). It is likely that, despite the calculated root protection area, the majority of the roots are within the planter, but there may be deeper roots below the planter wall's foundation growing under the hard surface. The manhole and underground services will be dug under arboricultural supervision. Where possible, a broken trench method will be used. This means digging an entry area, and retaining as many roots as possible and placing the service pipes underneath, backfilling and starting the next short stretch. The success of this depends on the rooting depth and architecture of the tree, but the intention is to retain roots, wrapping them temporarily in hessian to prevent desiccation, installing the pipe and backfilling with good quality top soil*. The ground conditions and root

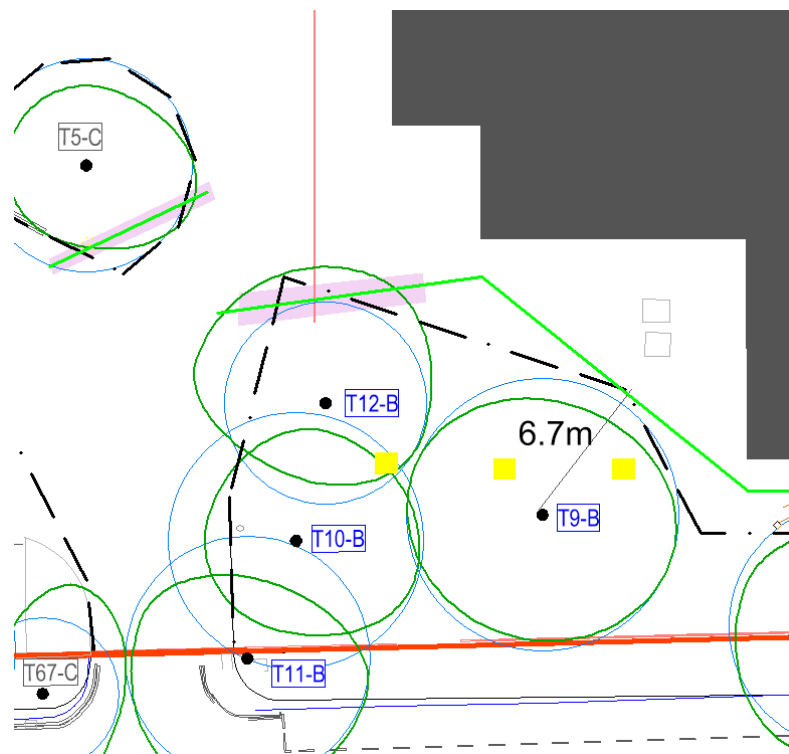
Plan 4 – extract from *SHA 1032 TPP2 A* -do not scale. North is vertical.

The area where this applies is shown by the yellow post squares on plan *SHA 1032 TPP A* affecting T9, T10 and T12.

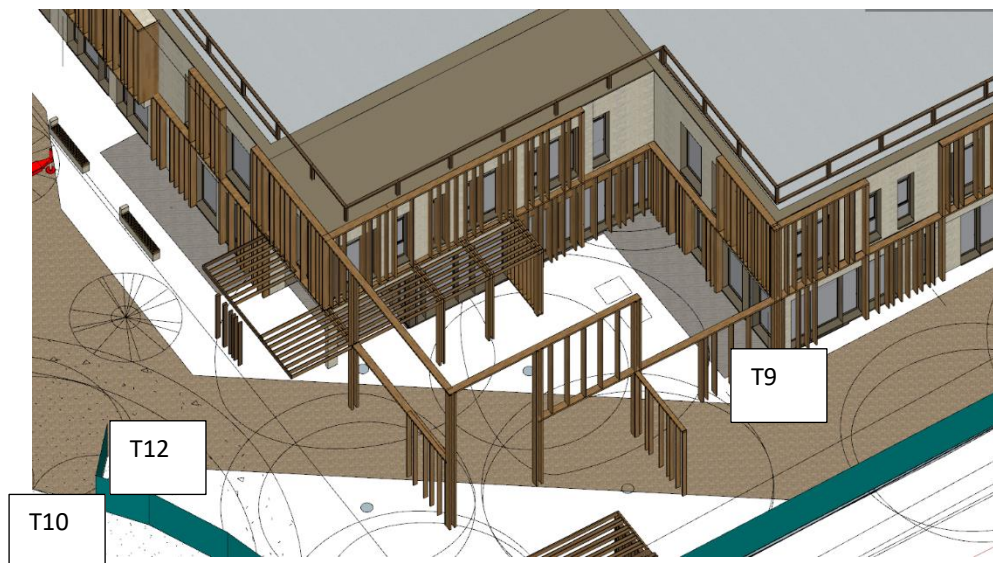
Plan 5 Snapshot of the timber structure looking north-west.

The timber frame structure will be installed using screw piles (or similar to be agreed) following root investigation under arboricultural supervision along the lines of posts. The view above shows the location of the proposed structure relative to the nearest trees, T9, T10 and T12. It is likely that the narrower spaced vertical timbers will not need foundations, but be supported by the corner and the larger timbers and the horizontal support.

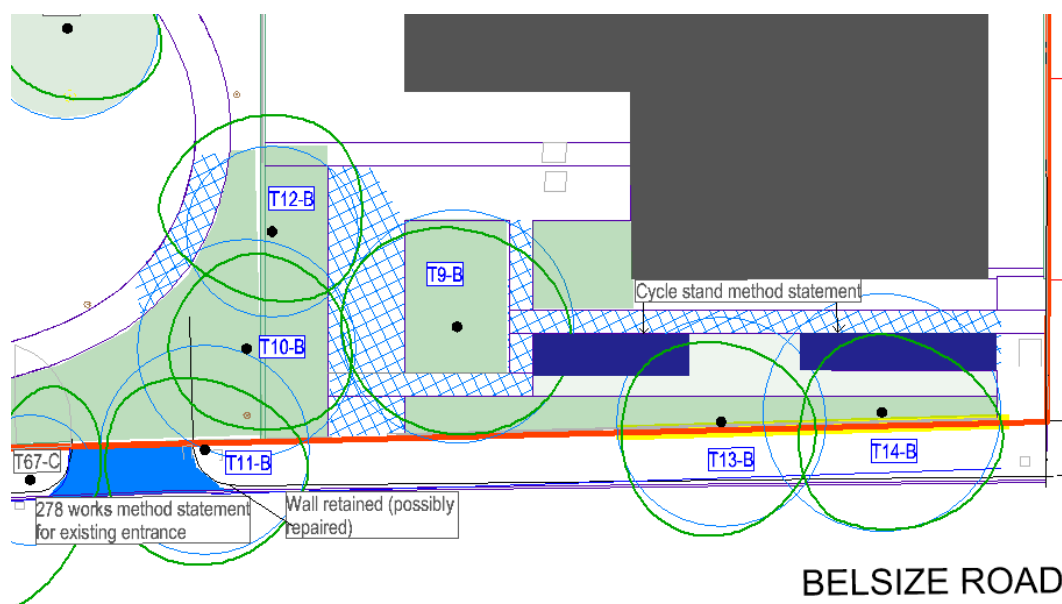
Plan 6 – extract from SHA 1032 TPP3 A -do not scale. North is vertical. Blue crossed hatching is the area where arboricultural method statements apply. Green is where new landscaping method applies.

The areas to which this apply are shown on the tree protection plan *SHA 1032 TPPA 3* at appendix 2 by blue cross hatching. The principle is that the roots will be unaffected by level changes and lack of opportunities for gaseous exchange and water infiltration. All hard surfacing within the site boundary adjacent to trees to be retained will be porous. This applies to new surfacing near the building and on the path around the perimeter of the site.

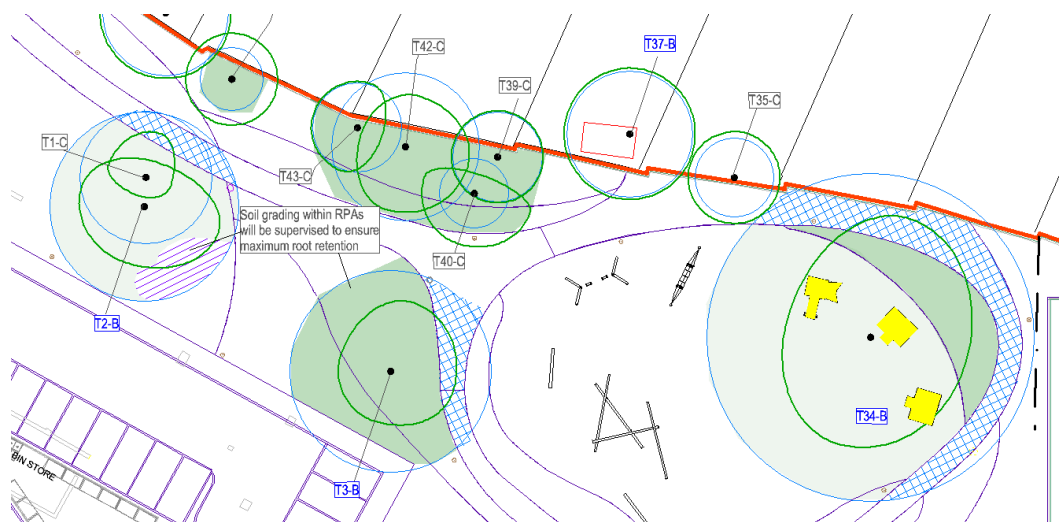
Plan 7 – extract from SHA 1032 TPP3 A -do not scale. North is vertical. Blue crossed hatching is the area where arboricultural method statements apply. Blue is where new landscaping applies.

The surfacing will be self binding gravel which has some porosity, and will be edge with a metal/timber strip. The advantage of this material is that it has a shallow construction depth, which means that levels are achievable close to the building.

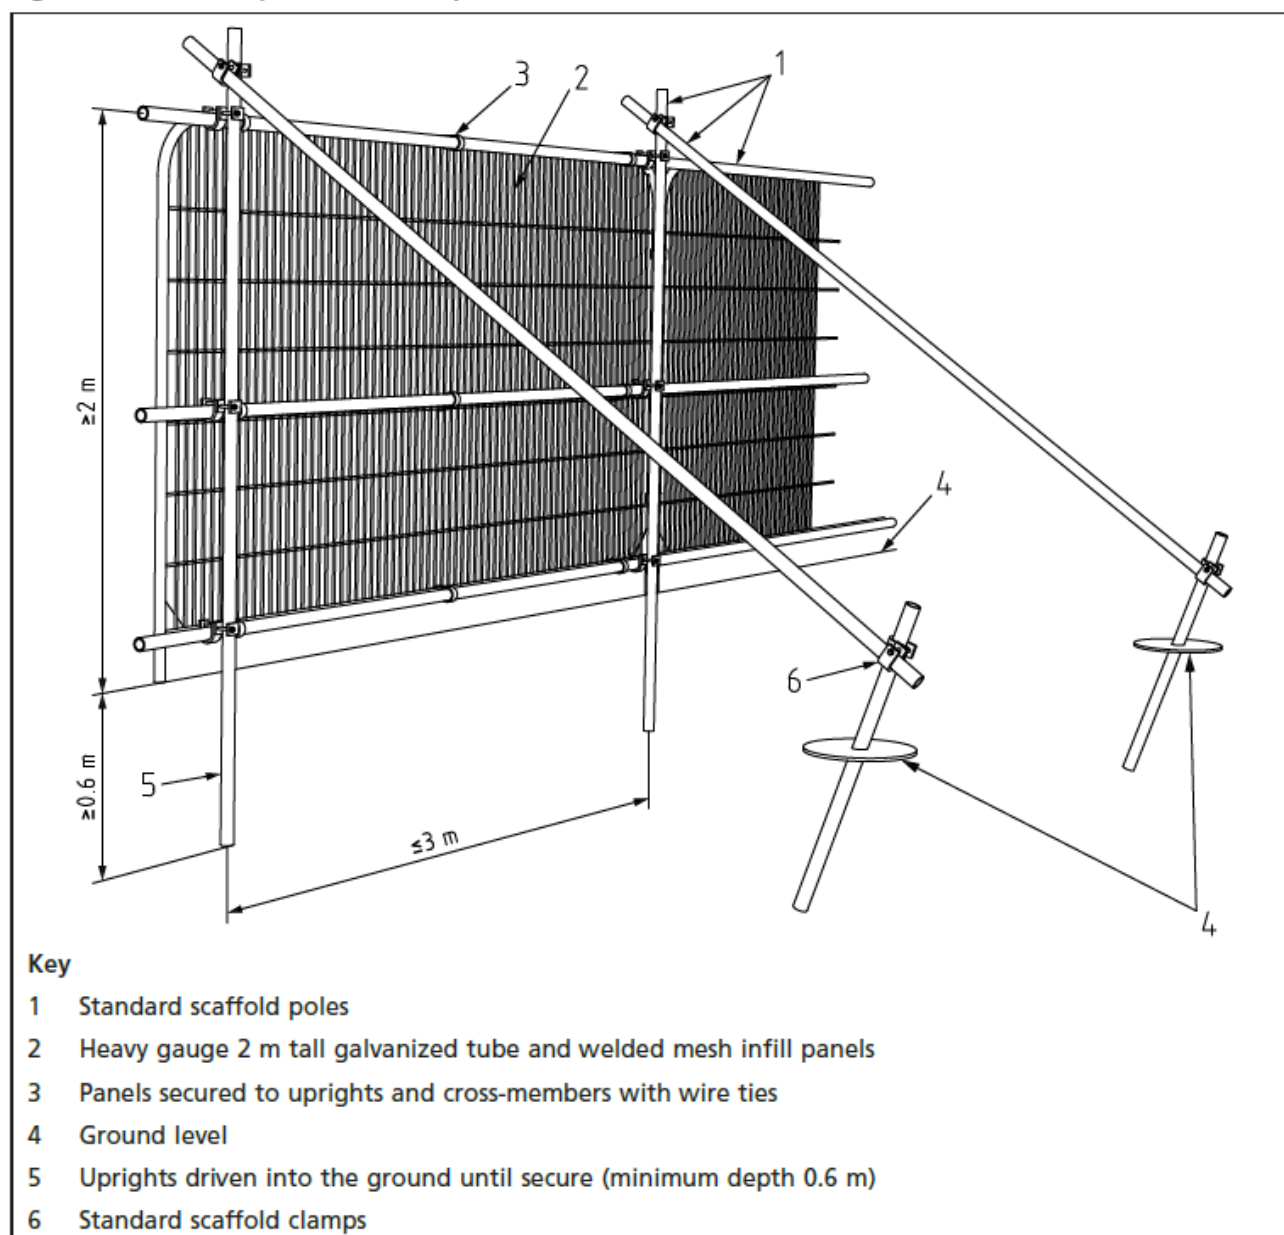
Figure 2 Default specification for protective barrier

Tree protection fencing specification from BS 5837:2012 Figure 2

The default specification is shown above at Figure 2. Care should be taken when locating the vertical poles to avoid underground services and structural roots. Where it is not possible to drive a pole into the ground, for example on hard surfacing, figure 3 overleaf, applies.

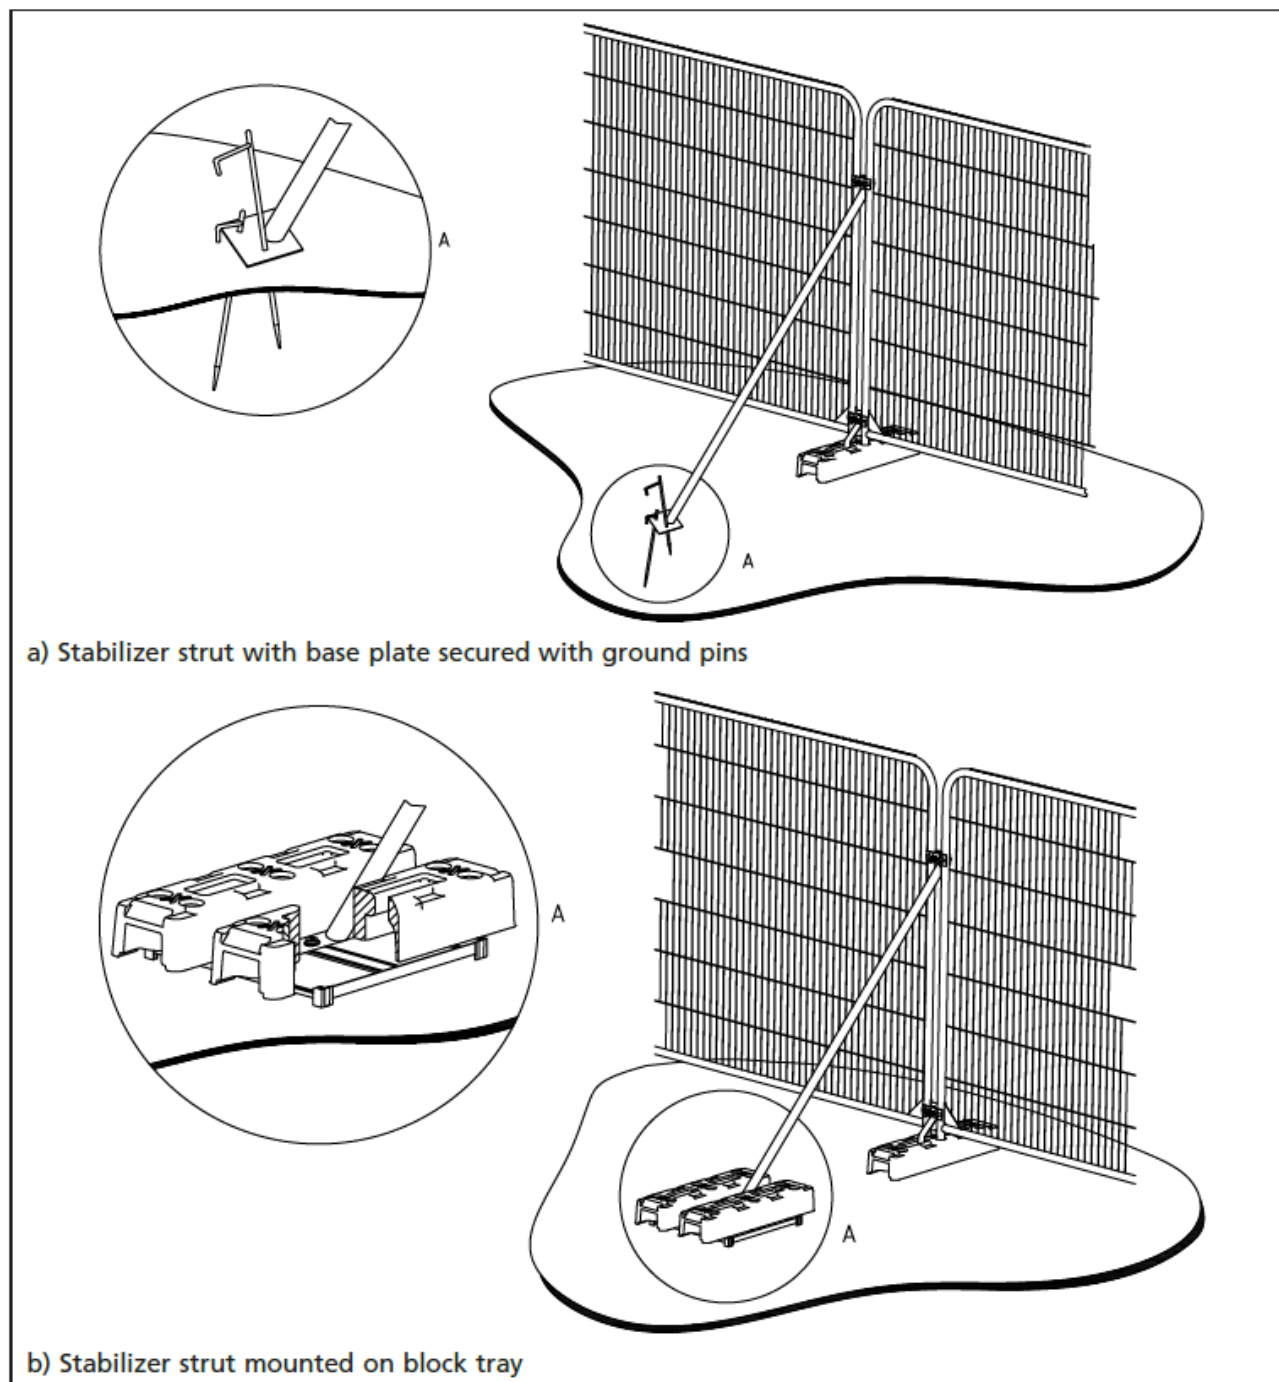
Figure 3 Examples of above-ground stabilizing systems

The location for the tree protection fencing is shown on the tree protection plan delineated by a black dashed line. The location of the fencing is out the outer edge of the root protection area and the dimensions from fixed points are shown on the drawings. All weather signs should be affixed to the barriers, no more than 12m apart. This forms the construction exclusion zone.
